MINERALS PROGRAM INSPECTION REPORT
PHONE: (303) 866-3567

MINE NAME: Climax Mine	MINE/PROSPECTING ID#: M-1977-493	MINERAL: Molybdenum	COUNTY: Summit
INSPECTION TYPE: Monitoring	INSPECTOR(S): Jared L. Ebert	INSP. DATE: February 13, 2019	INSP. TIME: 09:15
OPERATOR: Climax Molybdenum Company	OPERATOR REPRESENTATIVE: Diana Keltz	TYPE OF OPERATION: 112d-3 - Designated Mining Operation	
REASON FOR INSPECTION: Normal I&E Program	BOND CALCULATION TYPE: None	BOND AMOUNT: \$78,246,088.00	
DATE OF COMPLAINT: NA	POST INSP. CONTACTS: None	JOINT INSP. AGENCY: None	
WEATHER: Clear	INSPECTOR'S SIGNATURE:

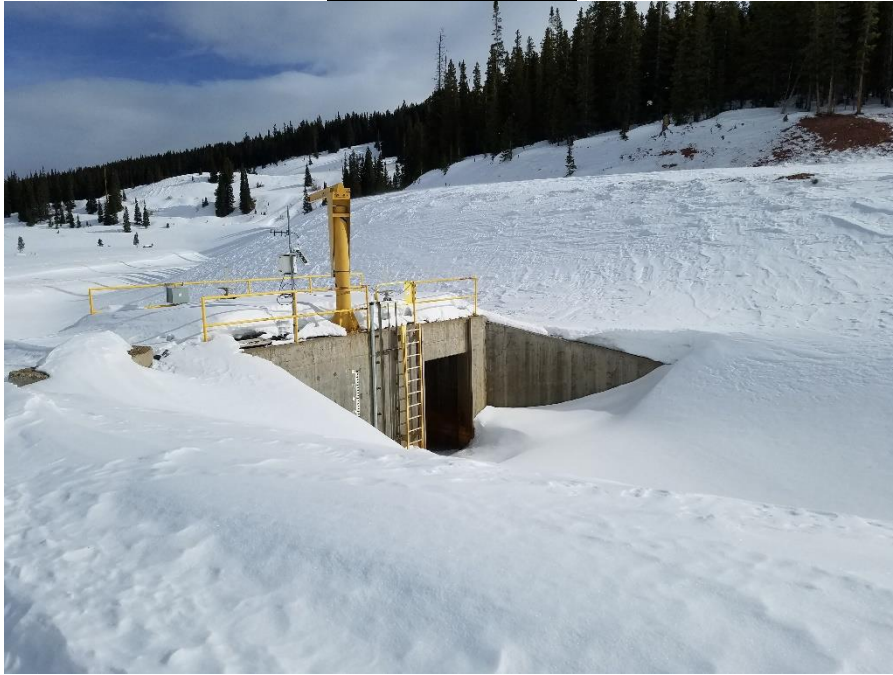
The East Side Channel was discuss with Ms. Keltz. The channel receives flow from the "Camp" area or mine facilities as wells as flow from the Robinson Tailings Storage Facility (TSF). Water from these areas flow into the East Side Channel and then discharge into the Tenmile TSF. The channel was observed downstream of the Camp area. The entire area is covered with snow, but the inlet and outlet structures of the East Side Channel where the Robinson TSF flow enters the channel appeared functional.

Figure 1. East Side Channel outlet, near where the Robinson TSF flow enters the channel.

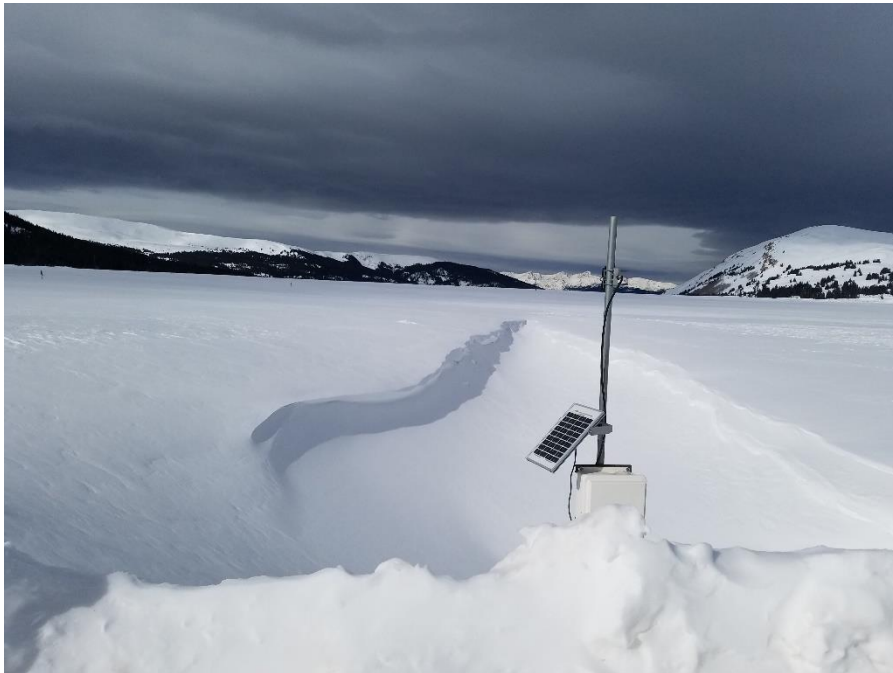
Figure 2. Where flow from the Robinson TSF flows into the East Side Channel.

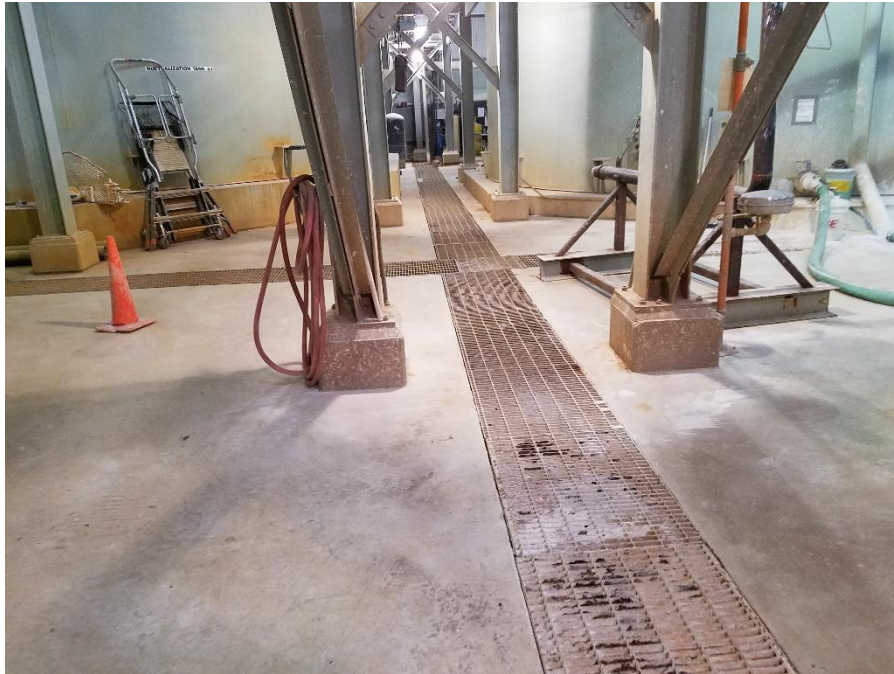
The Sludge Densification Plant (SDP) was observed. The various tanks and equipment within the SDP appeared functional and maintained. The SDP building serves as secondary containment for the various tanks within the structure. Floor drains within the SDP used to collect any spills or leaks appeared clear and functional. The clarifier cell was observed and appeared functional. The sludge cells were snow covered.

Figure 3. Floor drains within the SDP.

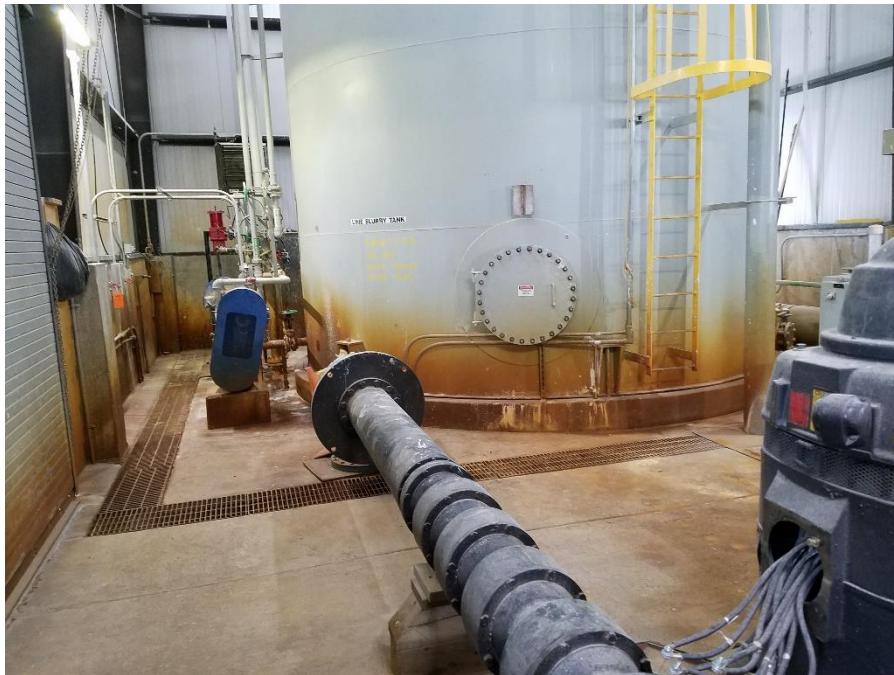
The 3-Dam pump station was observed. The lime slurry tank and the pumps within the station appeared to be maintained and functional.

Figure 4. 3-Dam Seepwater Pump Station.

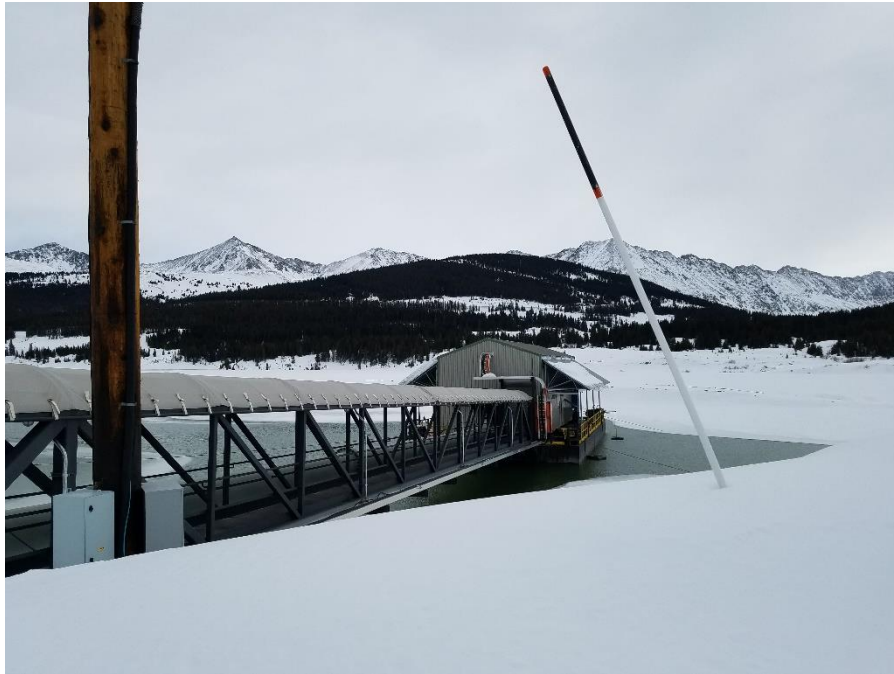
On the northwest side of the Mayflower TSF, the Millwater Barge and Property Discharge Water Treatment Plant (PDWTP) Barge pump systems were observed. Each of these facilities was operational at the time of the inspection and no problems were noted.

Figure 5. Millwater Barge Pumping System.

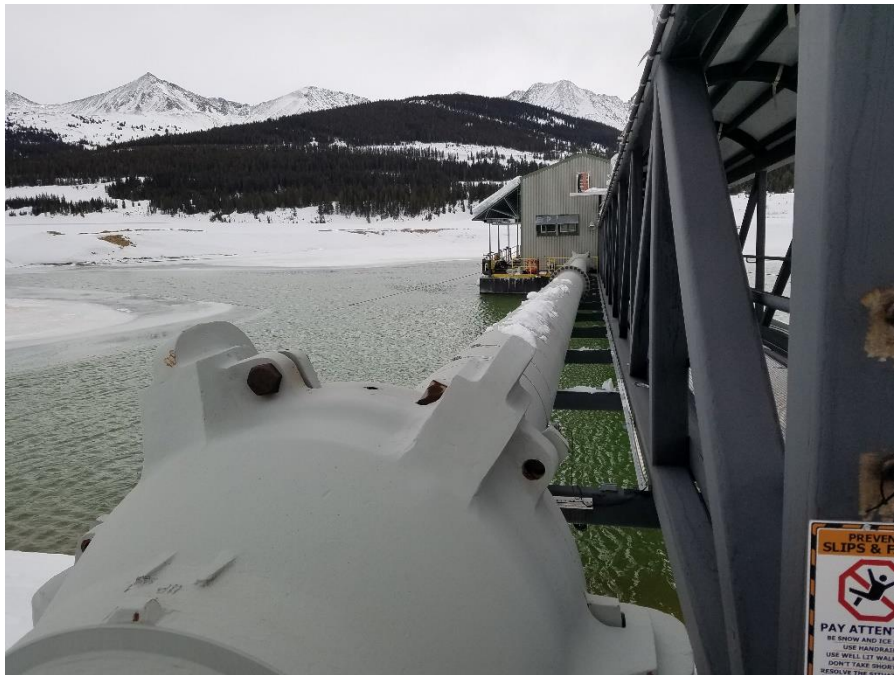
Figure 6. PDWTP Barge Pumping station.

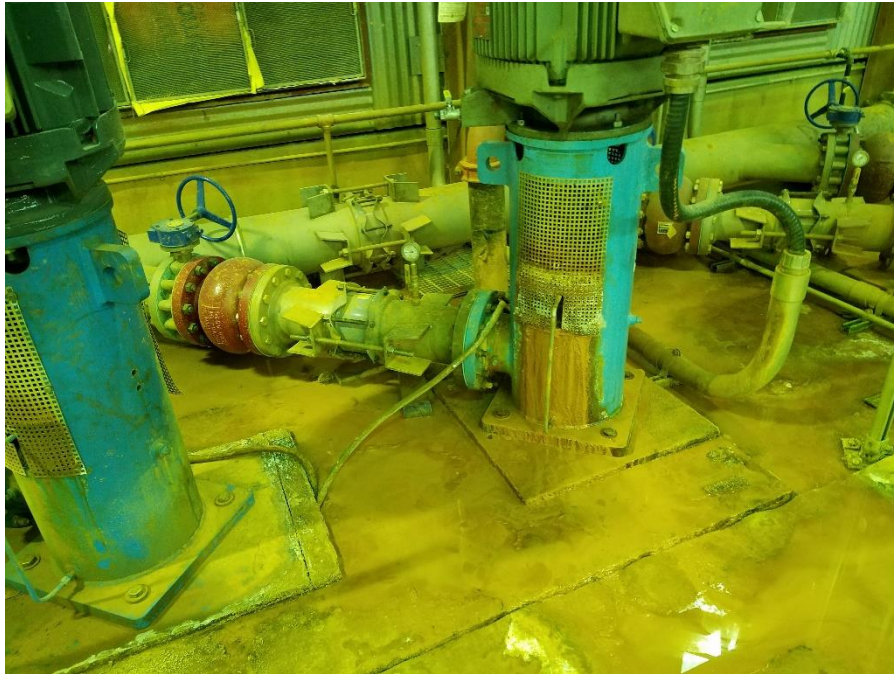
The 5-Dam pump station was observed. A small leak at one of the pumps was flowing into the appropriate floor drain. According to Ms. Keltz, the power may have been affected at this facility as a result of some work by Xcell Energy and that the flow from the pump may have been intentional to prevent the pump from freezing. A back-up generator is in place and a heater was running near the pumps. Ms. Keltz indicated she would look into this further to ascertain if the flow from the pump could be shut-off.

Figure 7. Pump within the 5-dam pump station where flow was observed going into the appropriate floor drain.
