Re: Permit No. M-1980-244; Cripple Creek & Victor Gold Mining Company; Cresson Project; - Addendum to VLF2 Liner Inspection TR100 Record of Construction Report – VLF2 Removal of the Crushed Ore Stockpile & Liner Integrity Verification Project; Adequacy Review Response

Record of Construction Report, VLF2 Removal of the Crushed Ore & Stockpile Liner  
Integrity Verification Project;  
Response to DRMS' Comments

**RE: Cripple Creek & Victor, Co., Cresson Project M-1980-244;  
Review Comments of the Crushed Ore Stockpile & Liner Integrity Verification Project  
Record of Construction Report, (TR-100 Addendum)**

### **Pot Hole Photo Log**

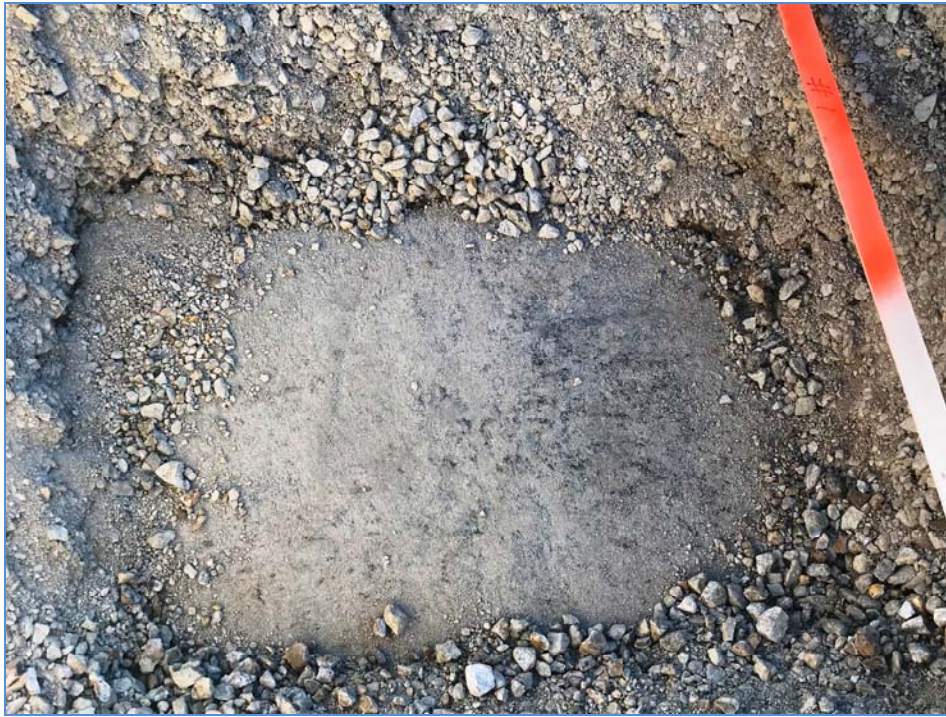
**Pot Hole 1**

*Geomembrane surface doesn't show any signs of damage or distress.*

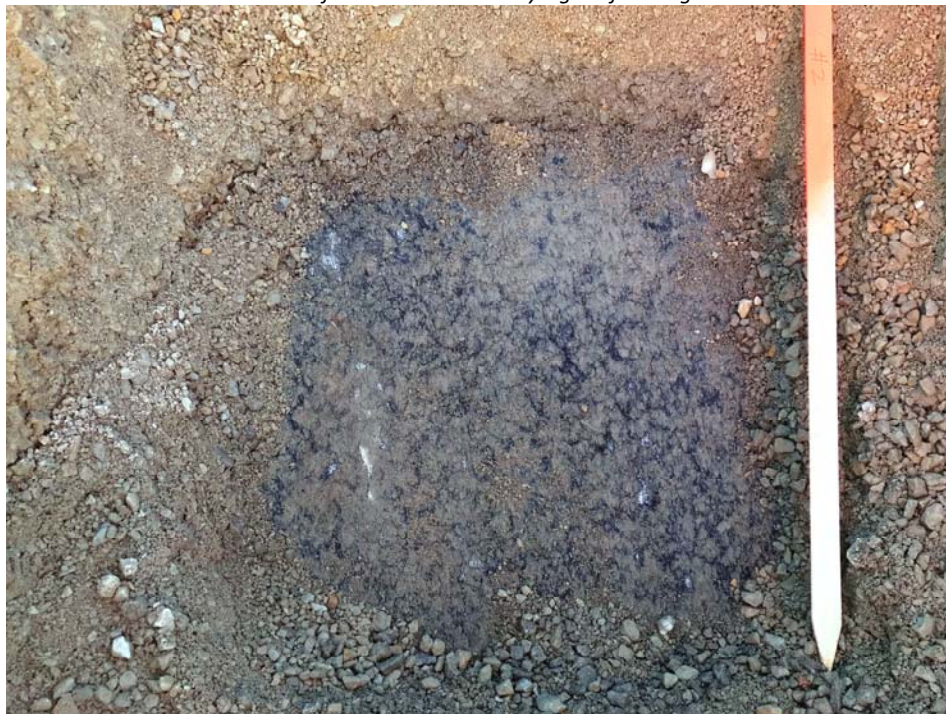
**Pot Hole 2**

*Geomembrane surface doesn't show any signs of damage or distress.*

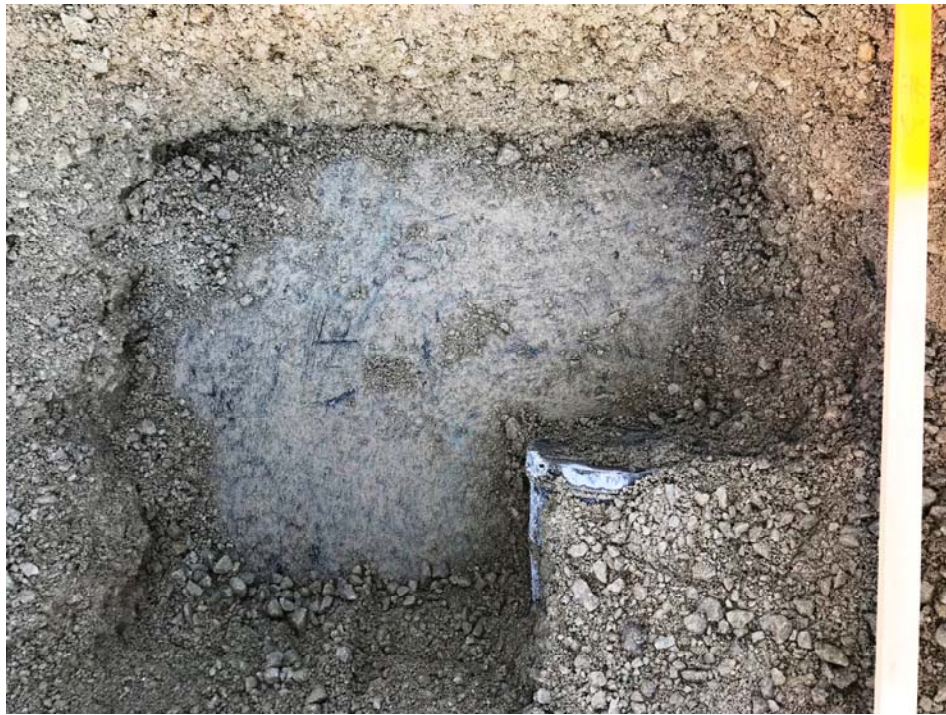
**Pot Hole 3**

*Geomembrane surface doesn't show any signs of damage or distress other than minor surface scratches developed during the excavation of the pot hole. A high volume collection pipe can is present in the lower right hand corner of the pothole.*

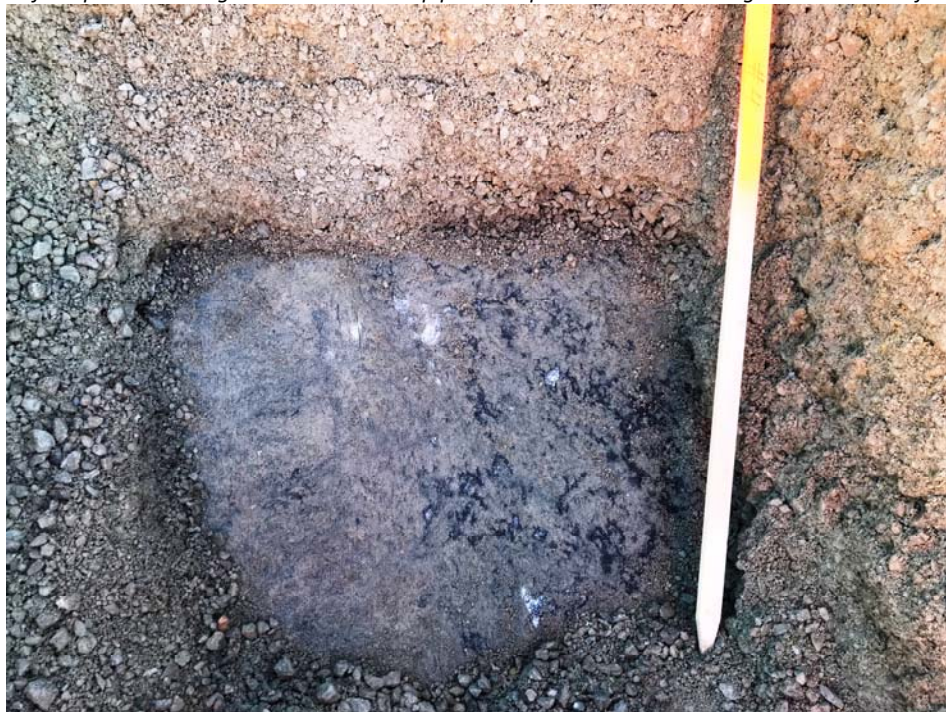
**Pot Hole 4**

*Geomembrane surface doesn't show any signs of damage or distress.*

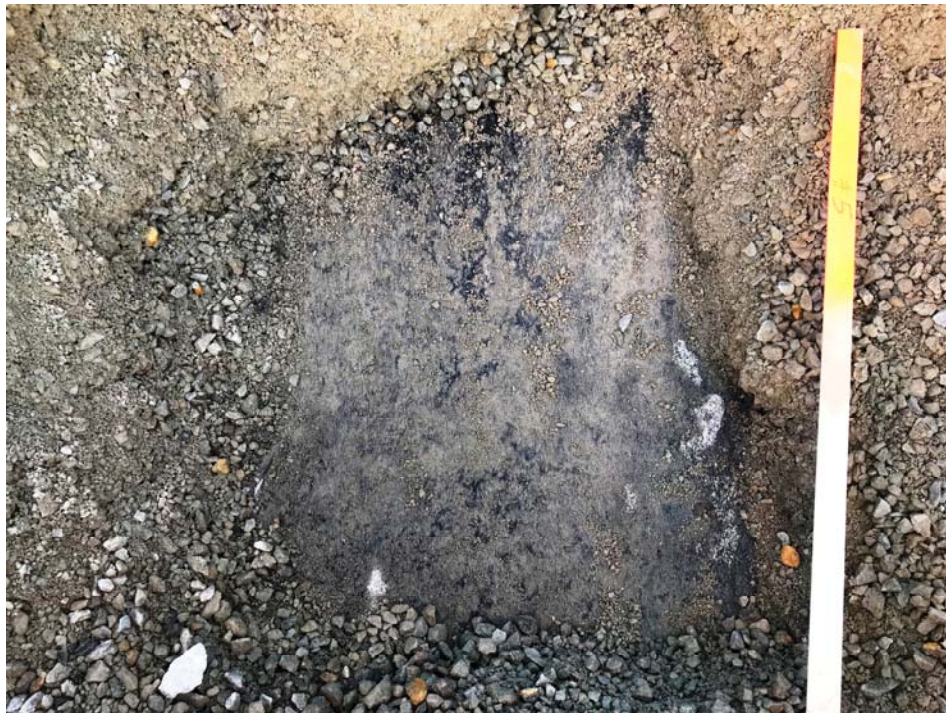
**Pot Hole 5**

*Geomembrane surface doesn't show any signs of damage or distress.*

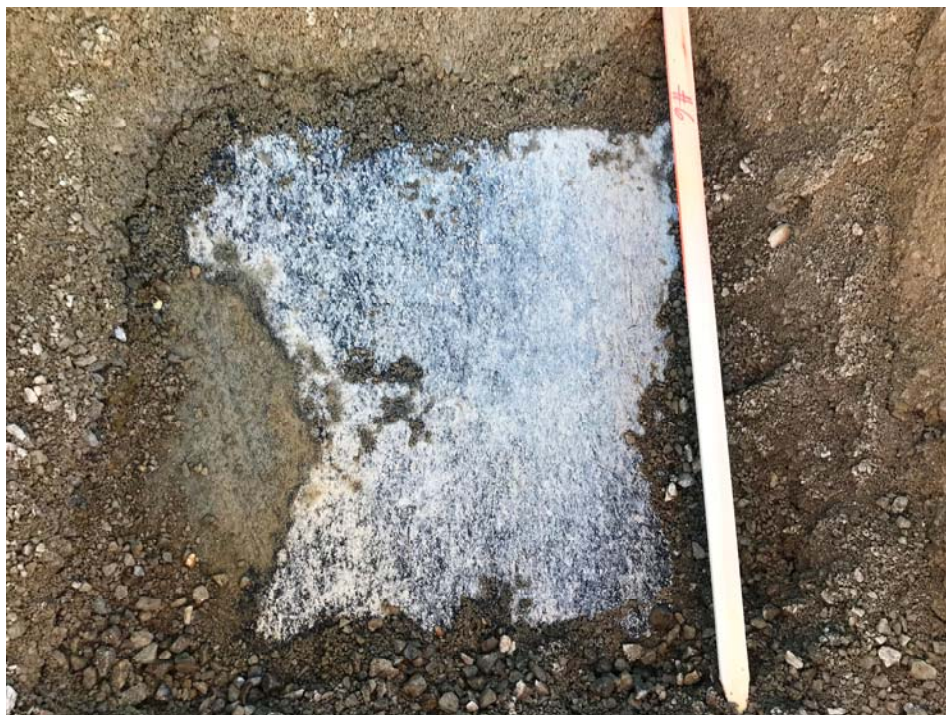
**Pot Hole 6**

*Geomembrane surface doesn't show any signs of damage or distress.*

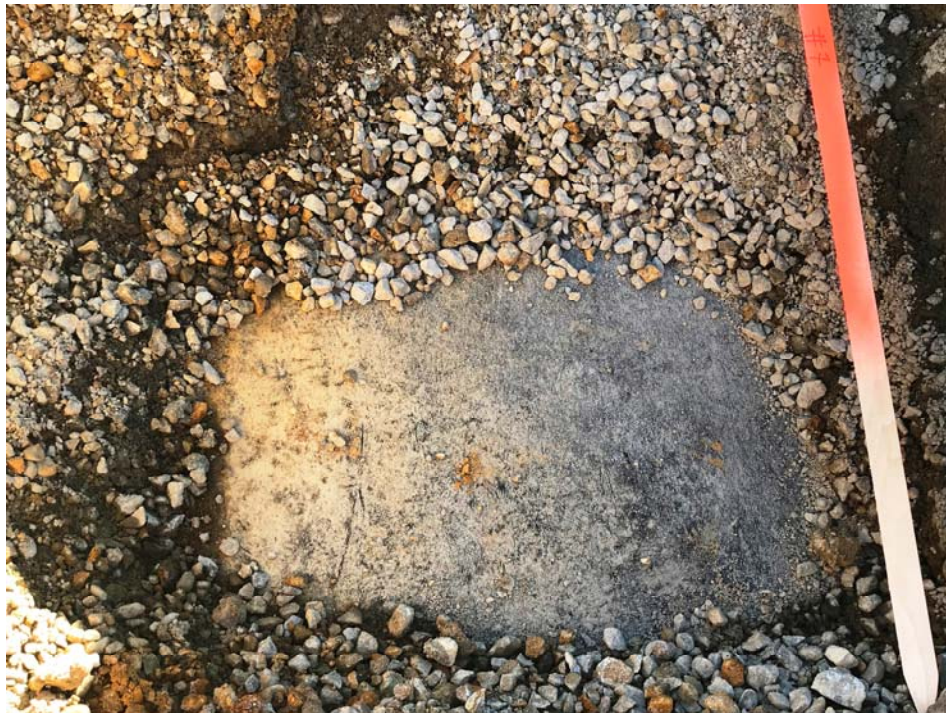
**Pot Hole 7**

*Geomembrane surface doesn't show any signs of damage or distress other than minor surface scratches developed during the excavation of the pot hole.*

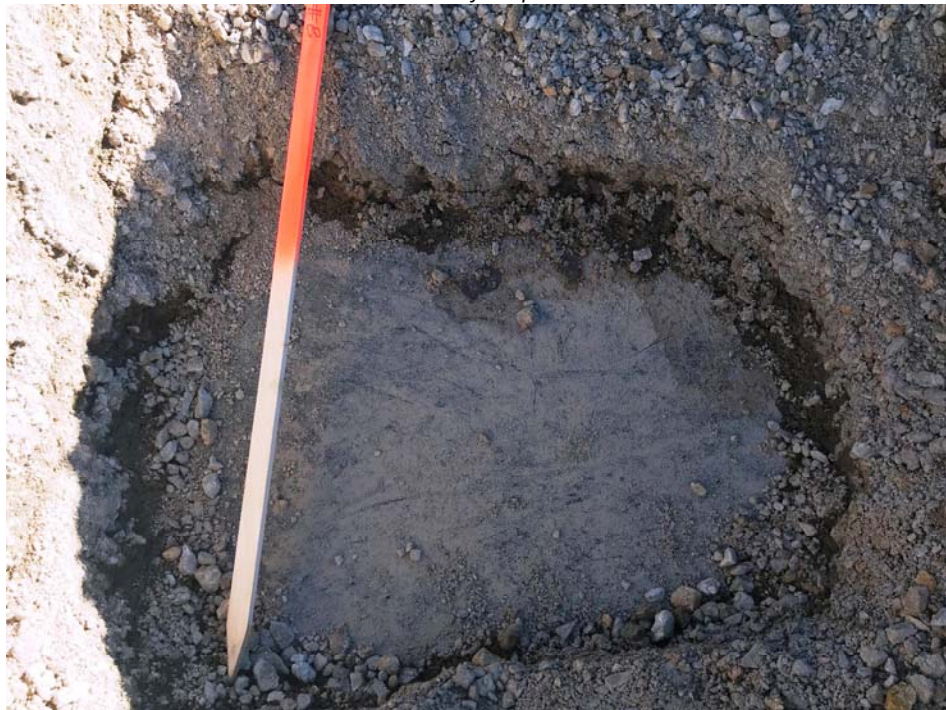
**Pot Hole 8**

*Geomembrane surface doesn't show any signs of damage or distress other than minor surface scratches developed during the excavation of the pot hole.*

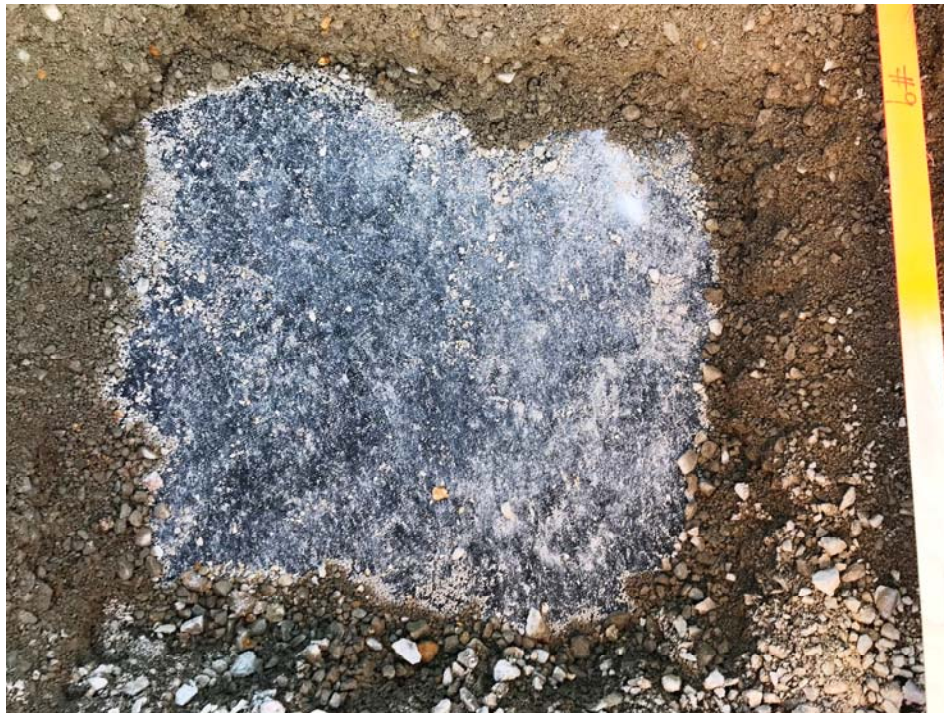
**Pot Hole 9**

*Geomembrane surface doesn't show any signs of damage or distress.*

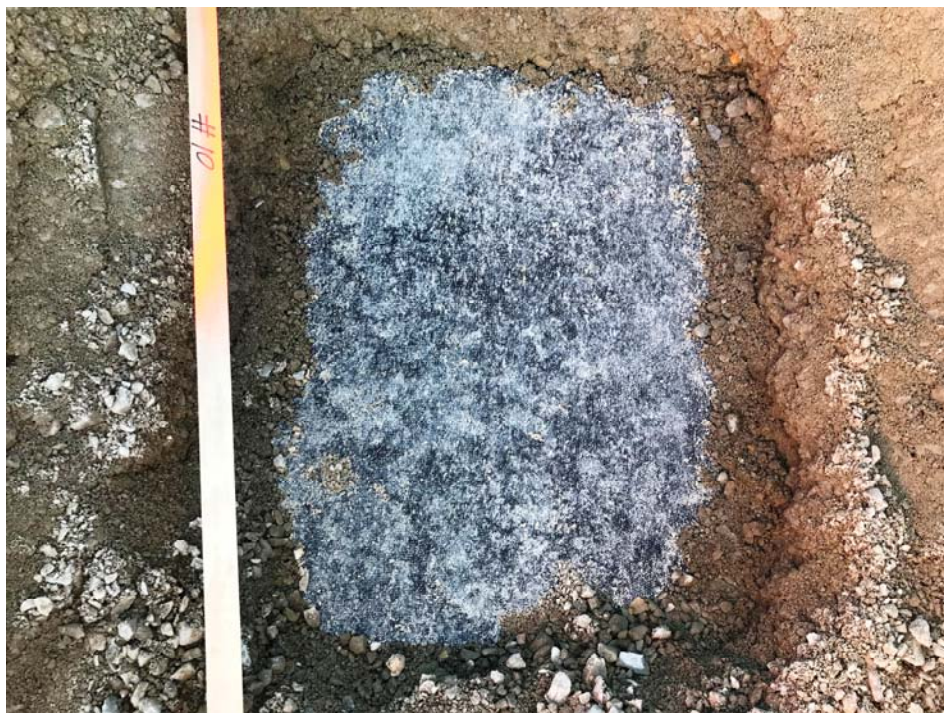
**Pot Hole 10**

*Geomembrane surface doesn't show any signs of damage or distress.*

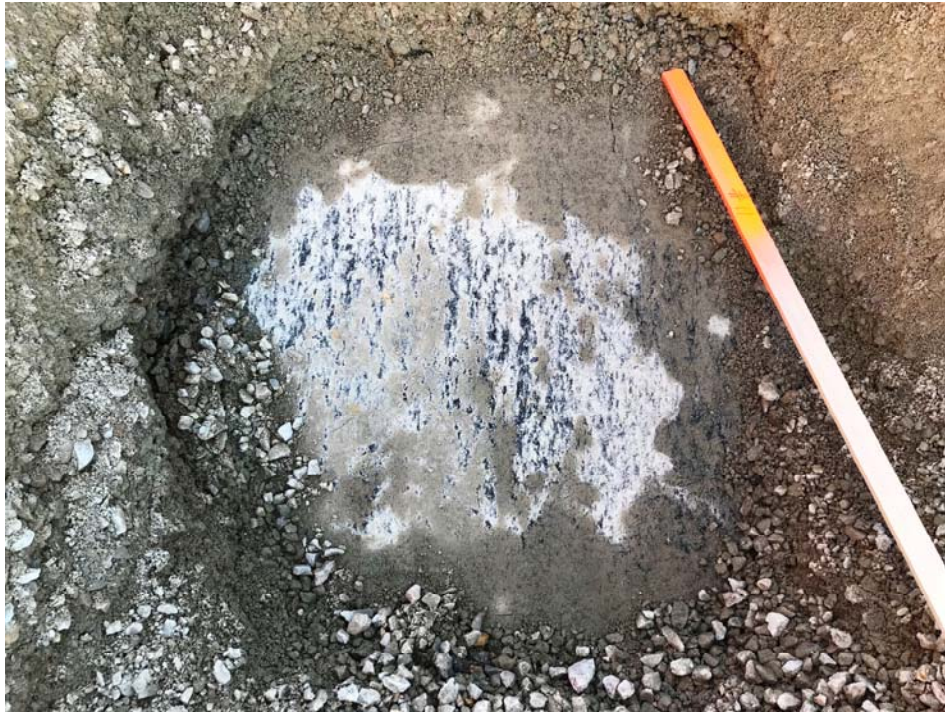
**Pot Hole 11**

*Geomembrane surface doesn't show any signs of damage or distress.*

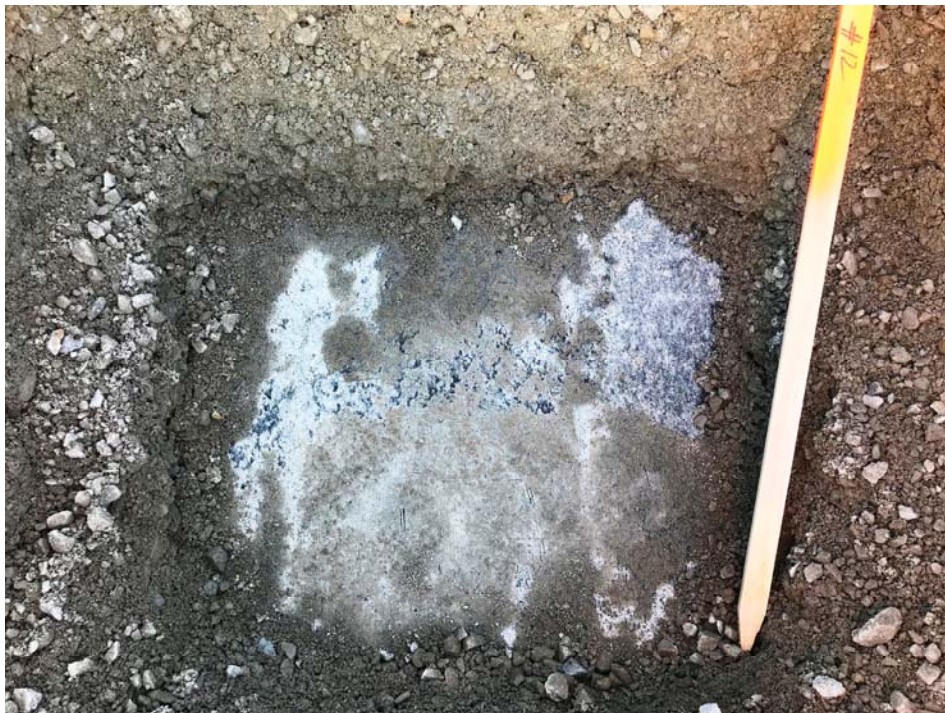
**Pot Hole 12**

*Geomembrane surface doesn't show any signs of damage or distress.*

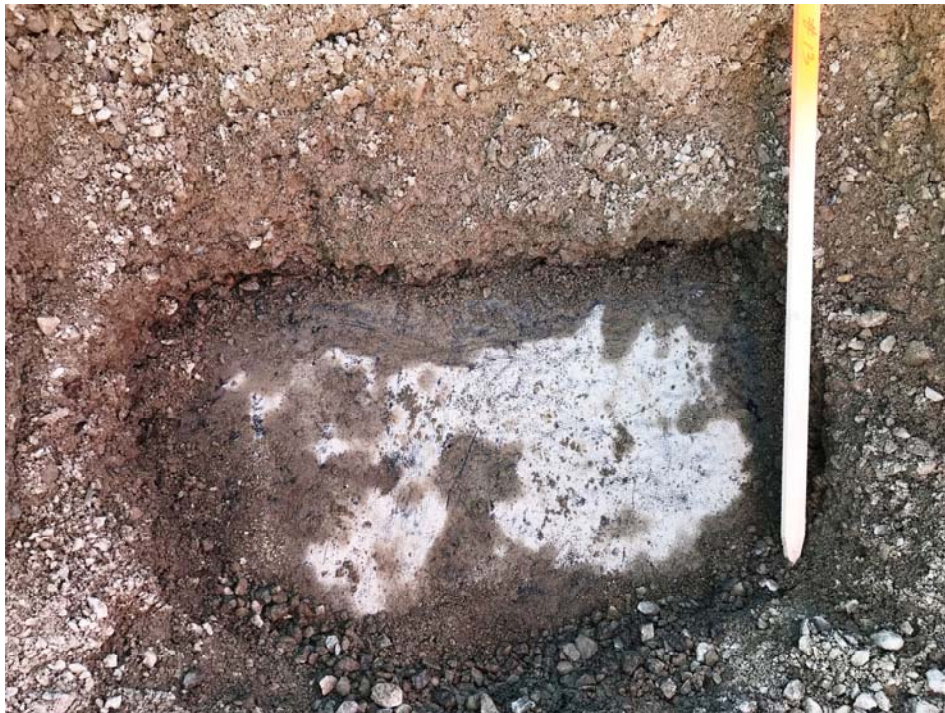
**Pot Hole 13**

*Geomembrane surface doesn't show any signs of damage or distress.*

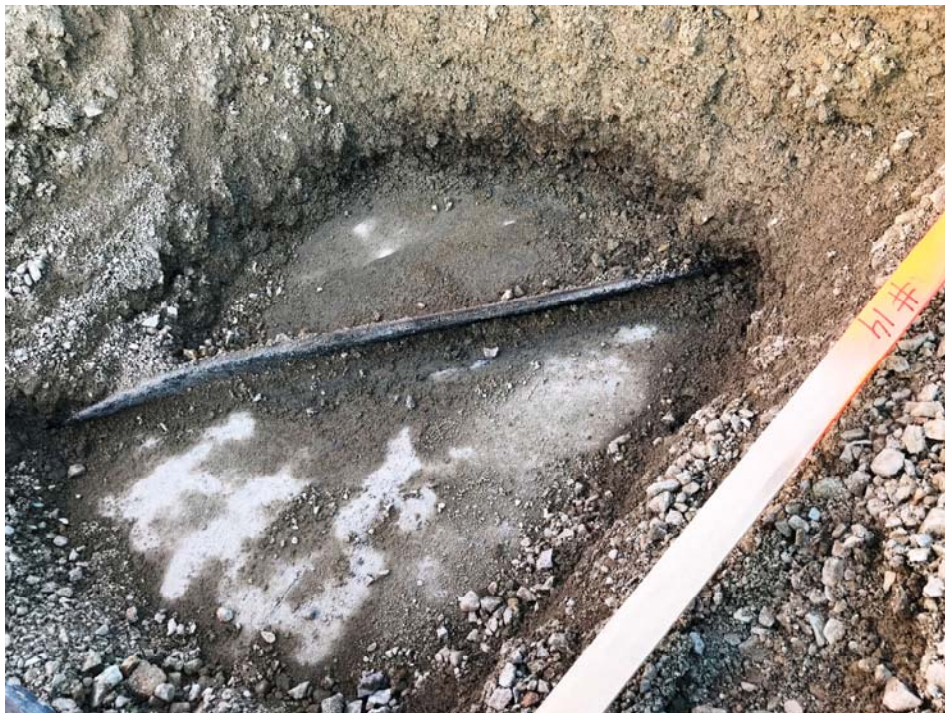
**Pot Hole 14**

- 1. Pot Hole #14: There are no comments in the report specific to any of the potholes, only the photographs. The photograph of pot hole #14 on page 7 of Appendix A shows a large geomembrane wrinkle running diagonally across the pot hole. The DRMS is concerned when several hundred feet of ore is loaded on this wrinkle, it may fold flat and the crease may lead to a tear in the liner. Please provide a summary of observations mad for each of the 34 pot holes and discuss the potential for liner failure when Pot Hole #14 wrinkle is loaded with ore.*

During the installation of the LLDPE geomembrane, it is normal for thermal expansion of the geomembrane to result in the formation of wrinkles. Significant effort is made by the earthworks contractor and the QA/QC team to place Drain Cover Fill (DCF) in a manner that best eliminates small wrinkles and minimizes and reduces the size of large wrinkles. That said, it is impossible to wrinkle-free geomembrane installation; wrinkles are unavoidable.

The State has expressed a concern that the wrinkle in question could fold over and eventually result in a tear in the liner. Wrinkles do not tend to tear on the own, but the apex of wrinkles do result in a stress concentration that research has shown can reduce the service life of the

geomembrane<sup>1</sup>. The physical service life of geomembranes are typically defined by their “half-life”, where material properties have degraded to 50 percent of their original values but the material still functions at a reduced performance level. Service life predictions have been completed, primarily for HDPE, with estimates exceeding 400 years for buried applications<sup>2</sup>. LLDPE geomembranes are assumed to be similar to HDPE.

*Geomembrane surface doesn't show any signs of damage or distress. Additionally, a wrinkle in the geomembrane runs through the pot hole.*

Finally, it is our opinion that for a small wrinkle standing vertical as shown in pot hole #14 the potential negative impacts of exhuming a large area of the pad and capping the wrinkle with an extrusion welded patch would likely result in worse composite liner performance than simply allowing the existing wrinkle to remain.

With all this information in mind, it is our professional opinion that the wrinkle in question does not significantly impact the competence of the existing LLDPE and that exposing and capping will not result in in better containment.

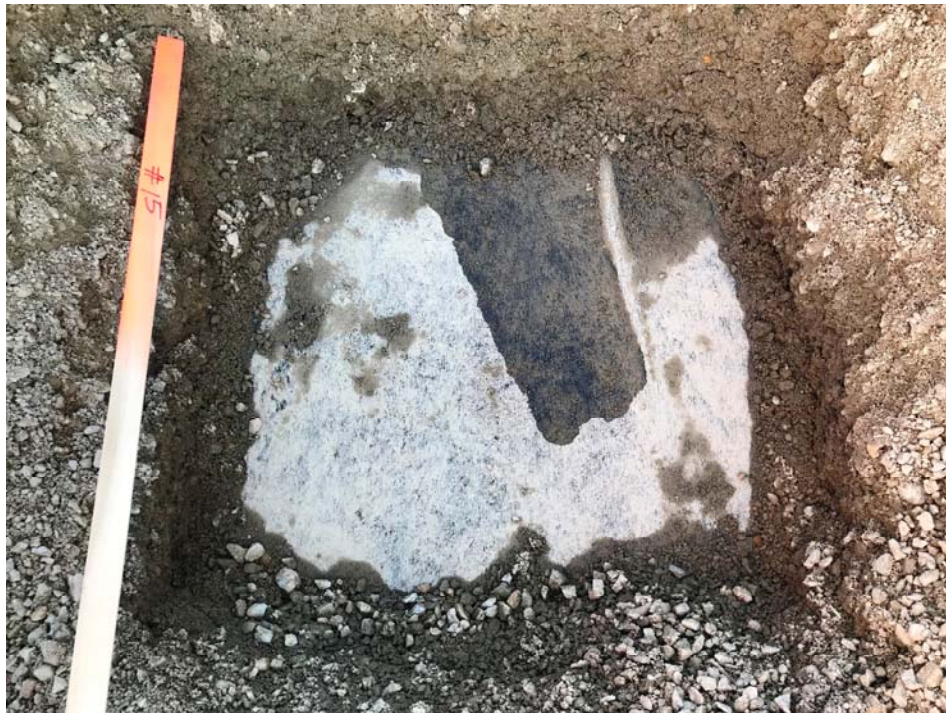
**Pot Hole 15**

*Geomembrane surface doesn't show any signs of damage or distress.*

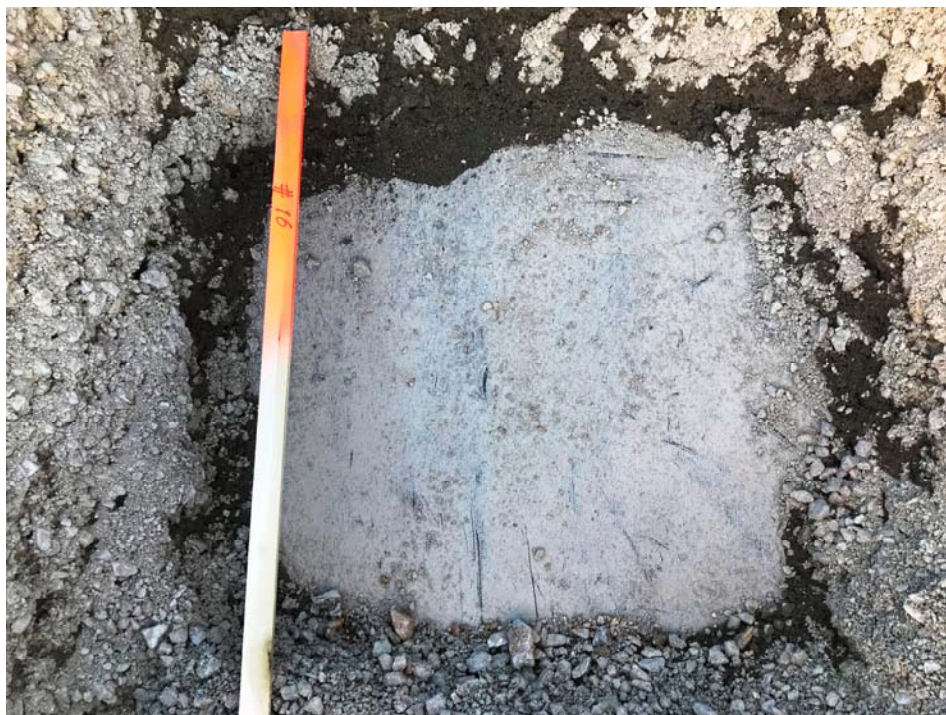
**Pot Hole 16**

*Geomembrane surface doesn't show any signs of damage or distress other than minor surface scratches developed during the excavation of the pot hole.*

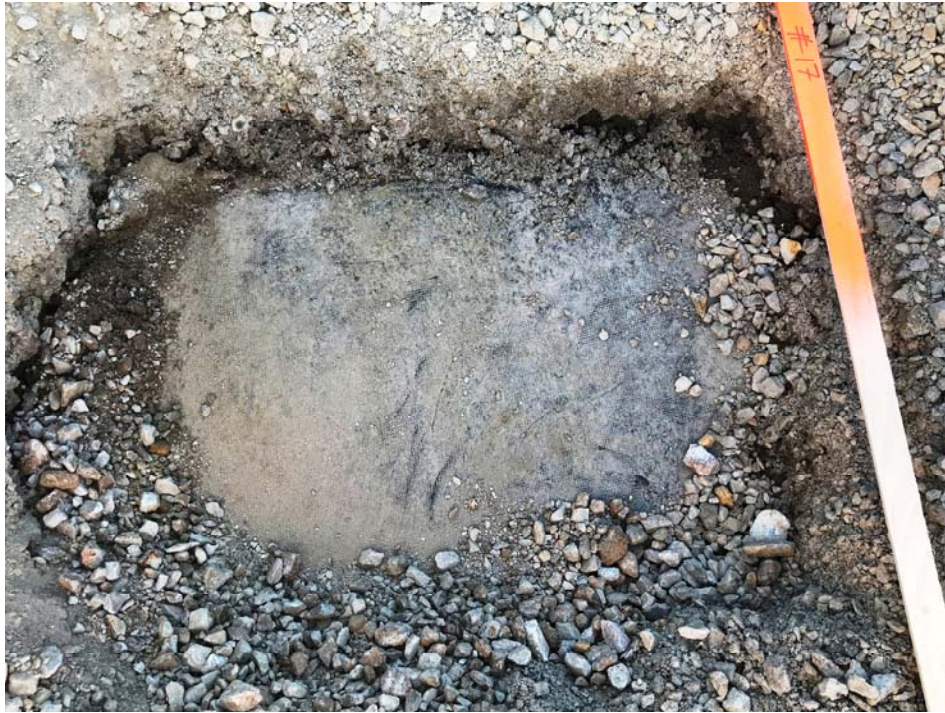
**Pot Hole 17**

*Geomembrane surface doesn't show any signs of damage or distress other than minor surface scratches developed during the excavation of the pot hole.*

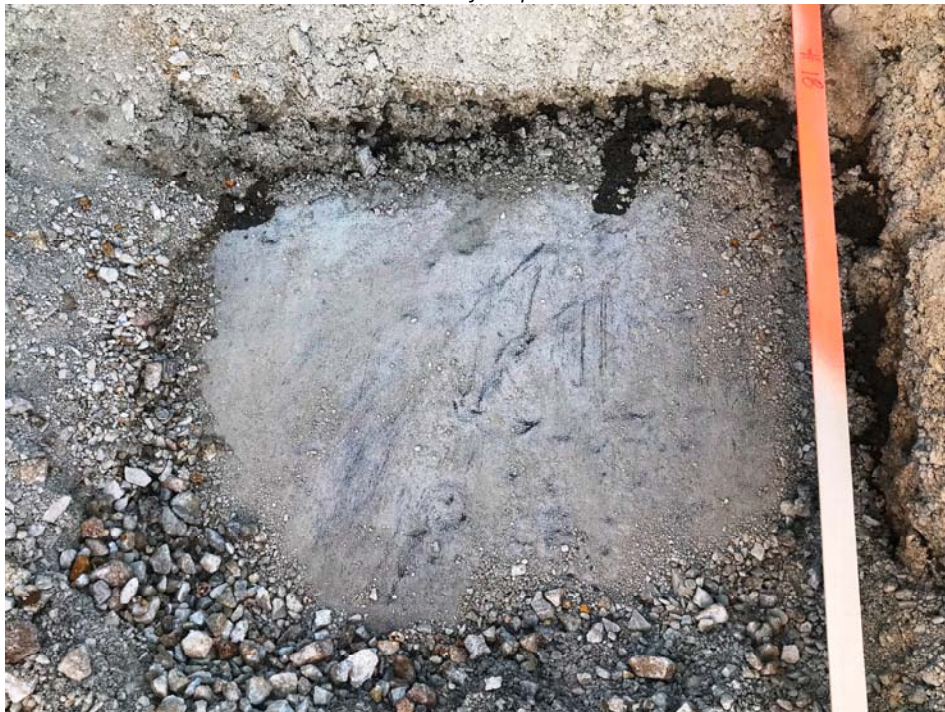
**Pot Hole 18**

*Geomembrane surface doesn't show any signs of damage or distress other than minor surface scratches developed during the excavation of the pot hole.*

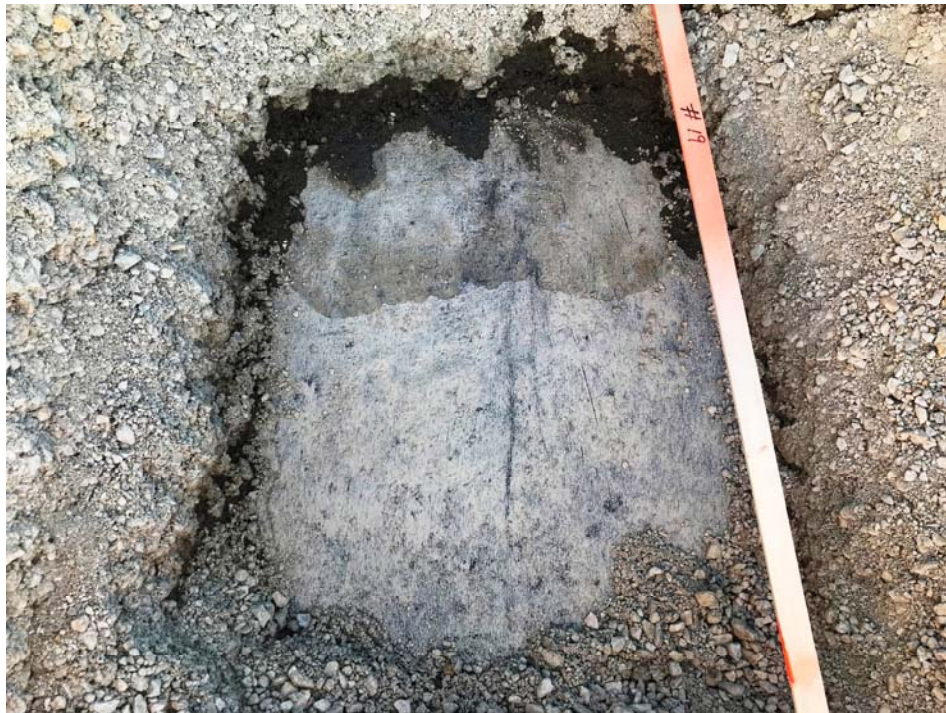
**Pot Hole 19**

*Geomembrane surface doesn't show any signs of damage or distress other than minor surface scratches developed during the excavation of the pot hole.*

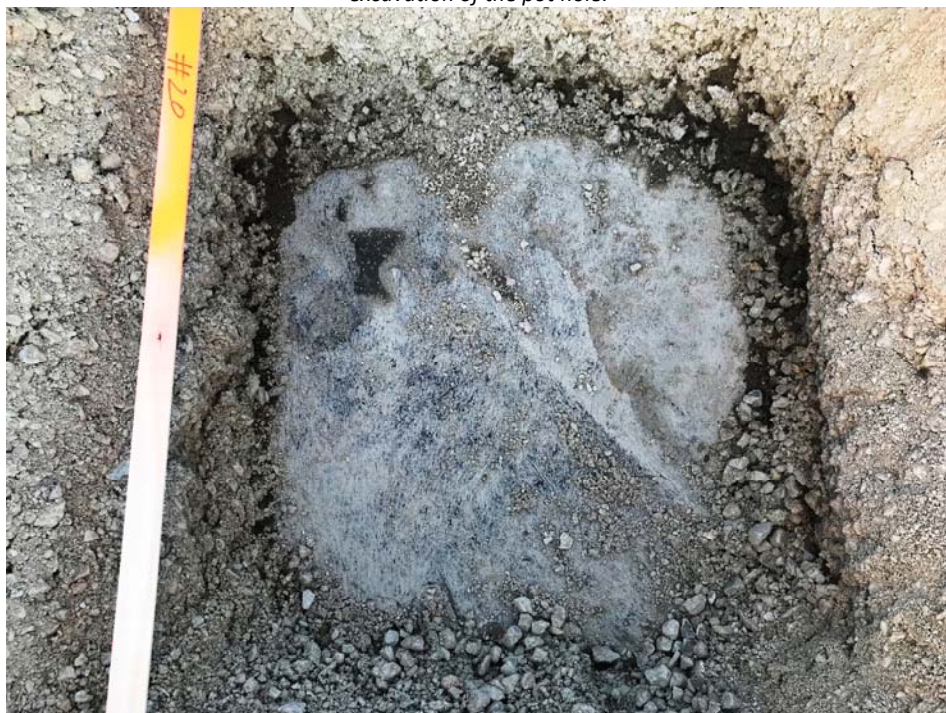
**Pot Hole 20**

*Geomembrane surface doesn't show any signs of damage or distress.*

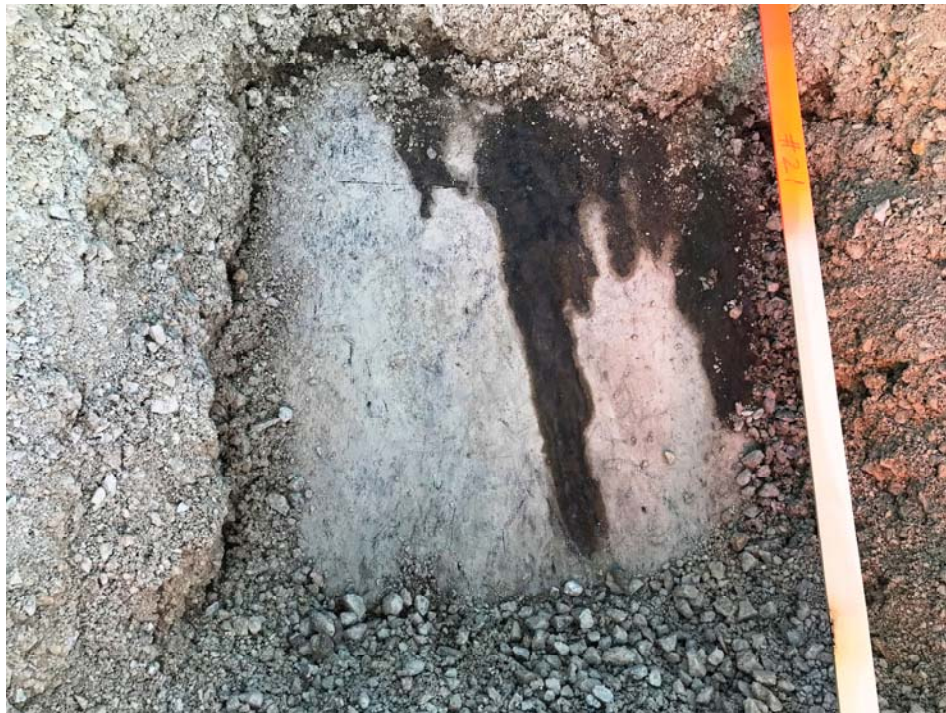
**Pot Hole 21**

*Geomembrane surface doesn't show any signs of damage or distress other than minor surface scratches developed during the excavation of the pot hole.*

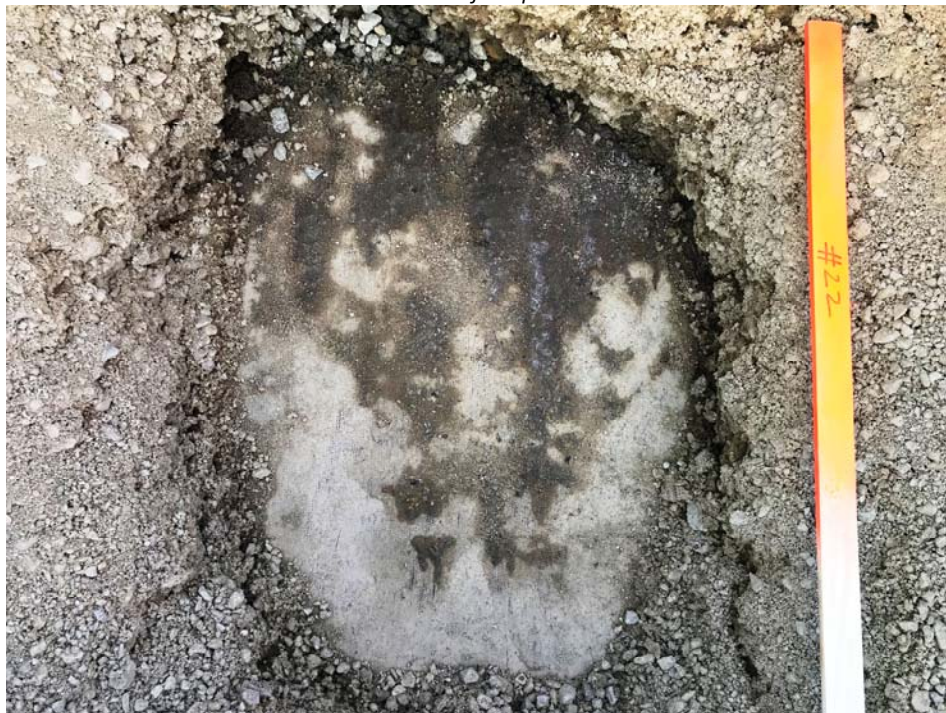
**Pot Hole 22**

*Geomembrane surface doesn't show any signs of damage or distress*

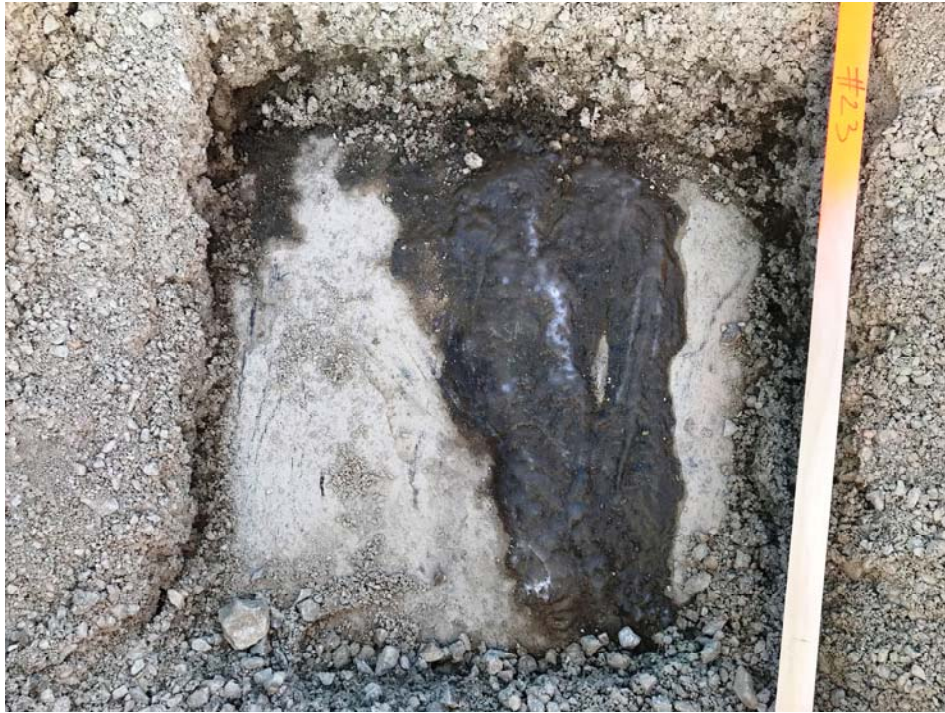
**Pot Hole 23**

*Geomembrane surface doesn't show any signs of damage or distress other than minor surface scratches developed during the excavation of the pot hole.*

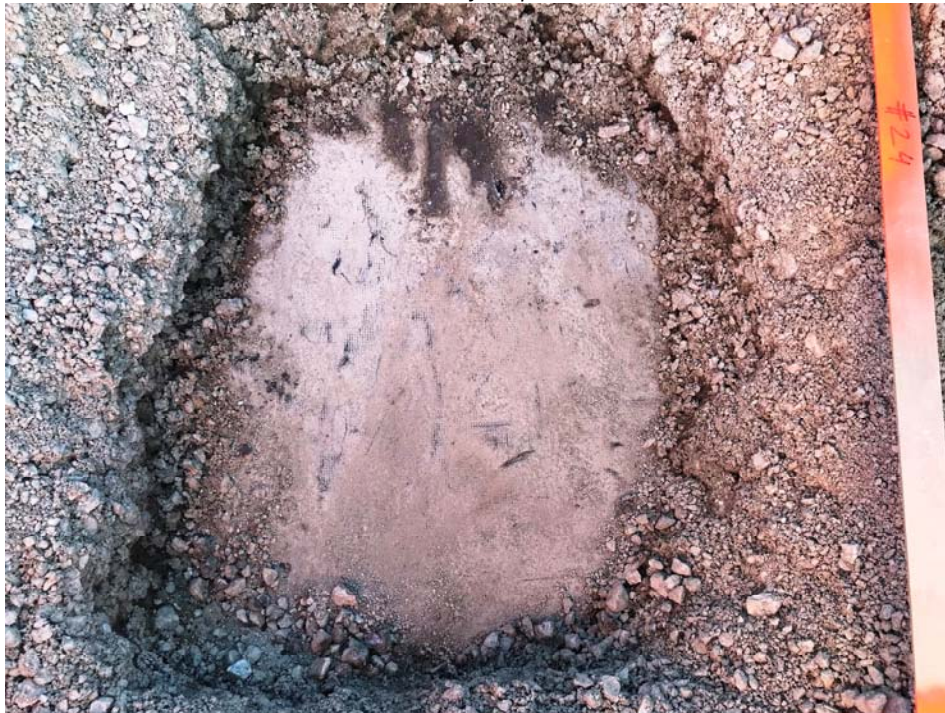
**Pot Hole 24**

*Geomembrane surface doesn't show any signs of damage or distress other than minor surface scratches developed during the excavation of the pot hole.*

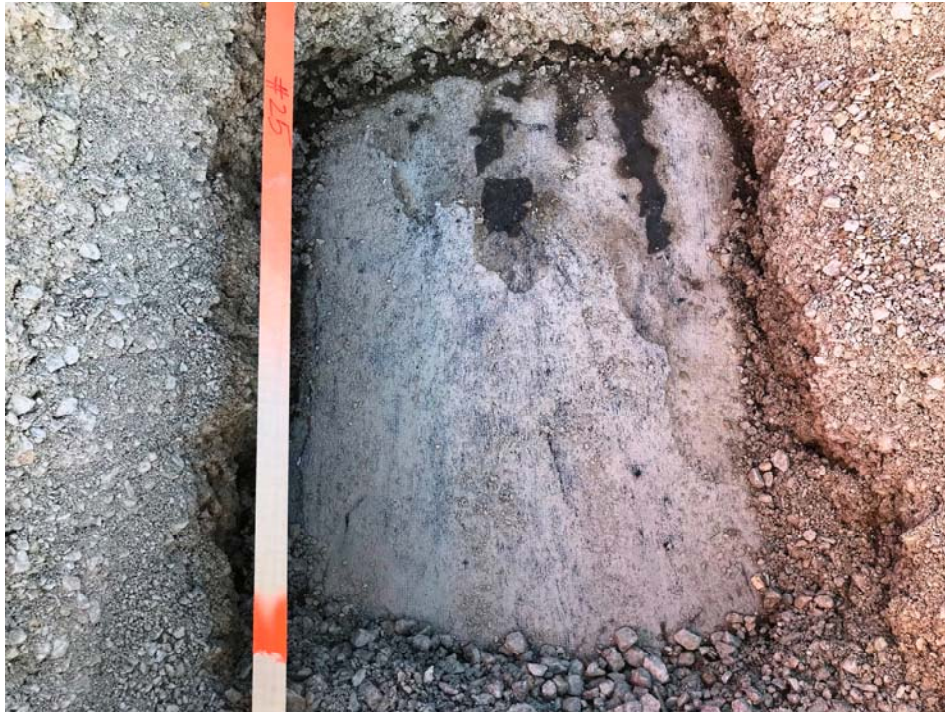
**Pot Hole 25**

*Geomembrane surface doesn't show any signs of damage or distress*

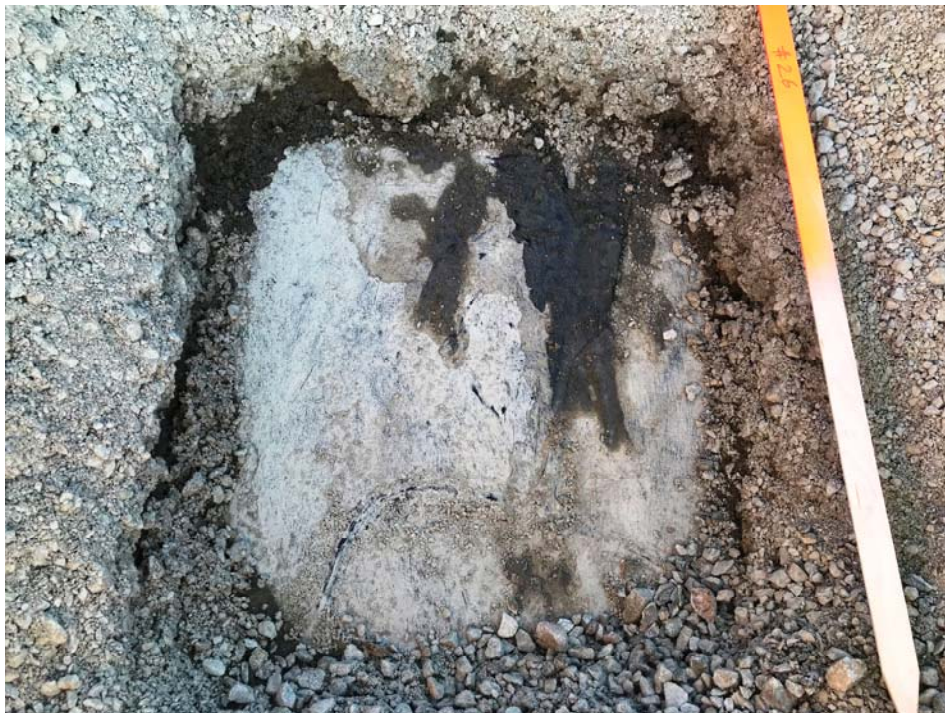
**Pot Hole 26**

*Geomembrane surface doesn't show any signs of damage or distress*

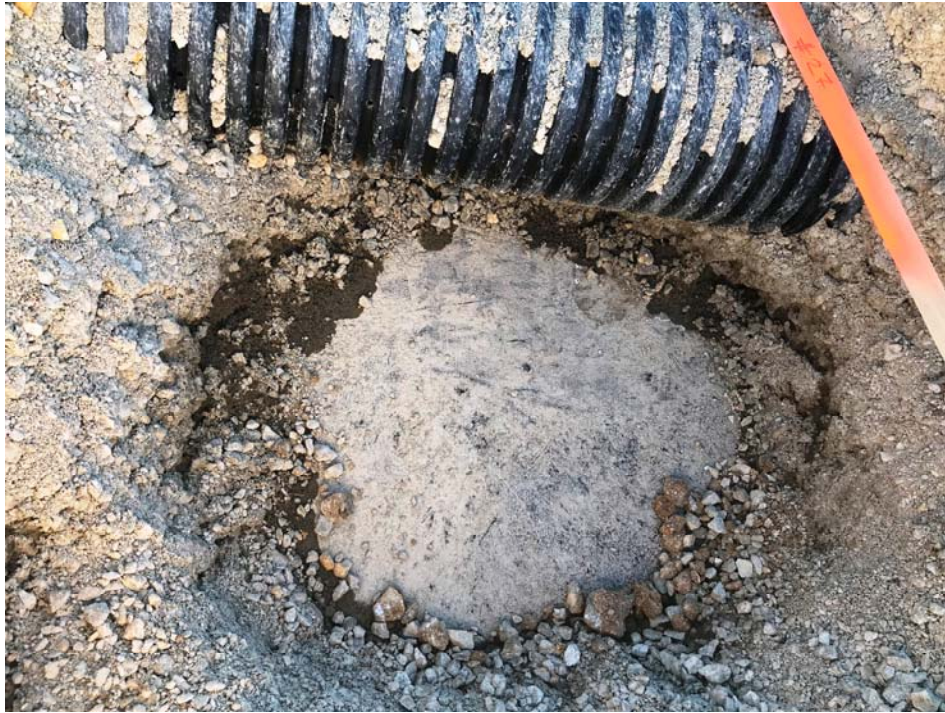
**Pot Hole 27**

*Geomembrane surface doesn't show any signs of damage or distress other than minor surface scratches developed during the excavation of the pot hole. A high volume collection pipe can is present in the lower right hand corner of the pothole.*

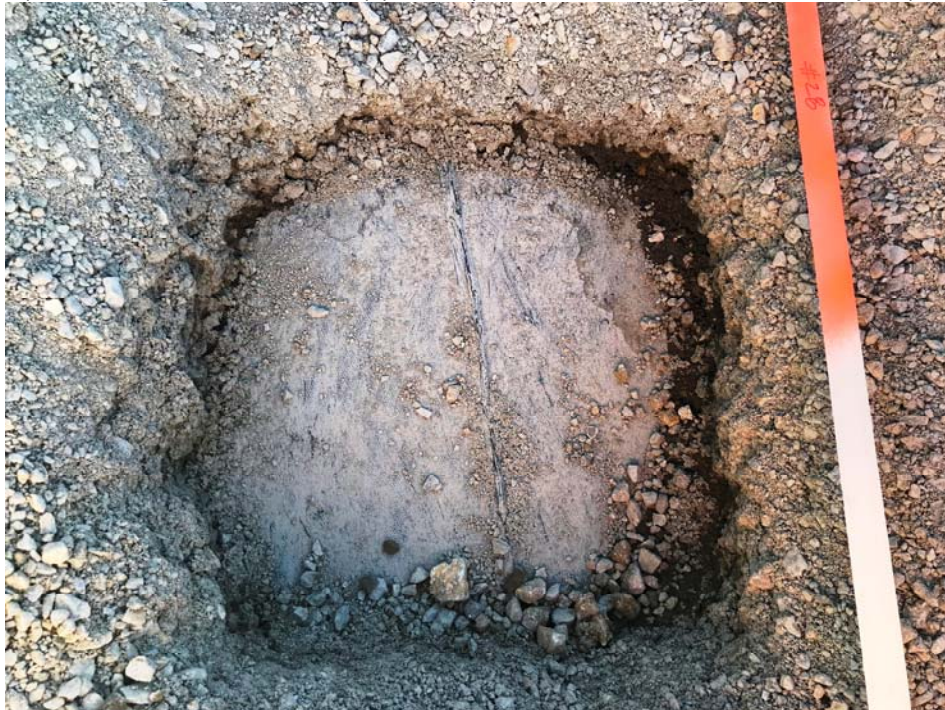
**Pot Hole 28**

*Geomembrane surface doesn't show any signS of damage or distress other than minor surface scratches developed during the excavation of the pot hole.*

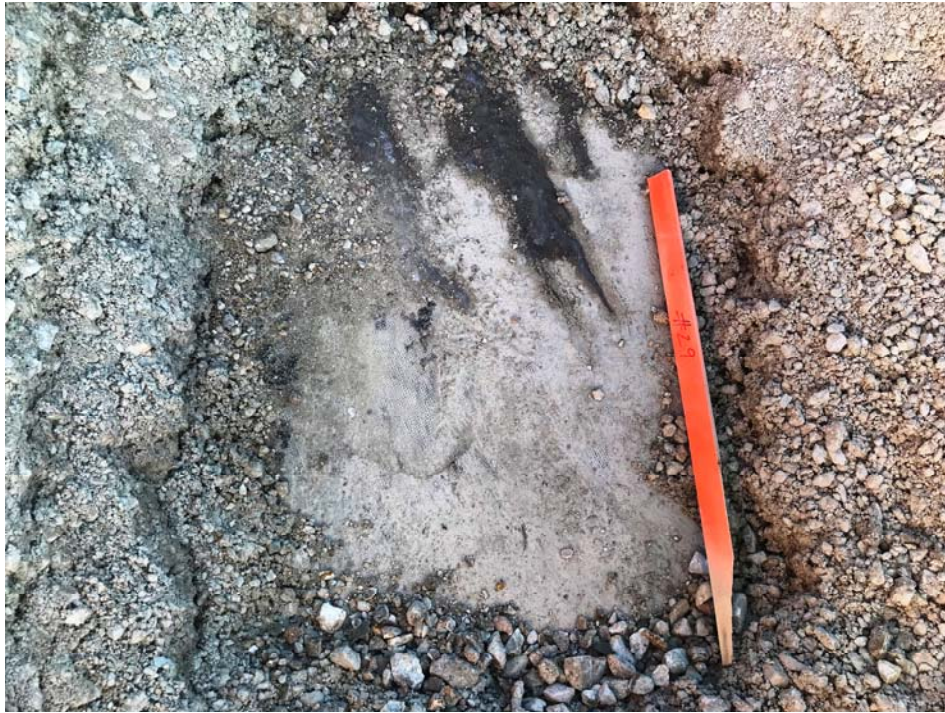
**Pot Hole 29**

*Geomembrane surface doesn't show any signs of damage or distress*

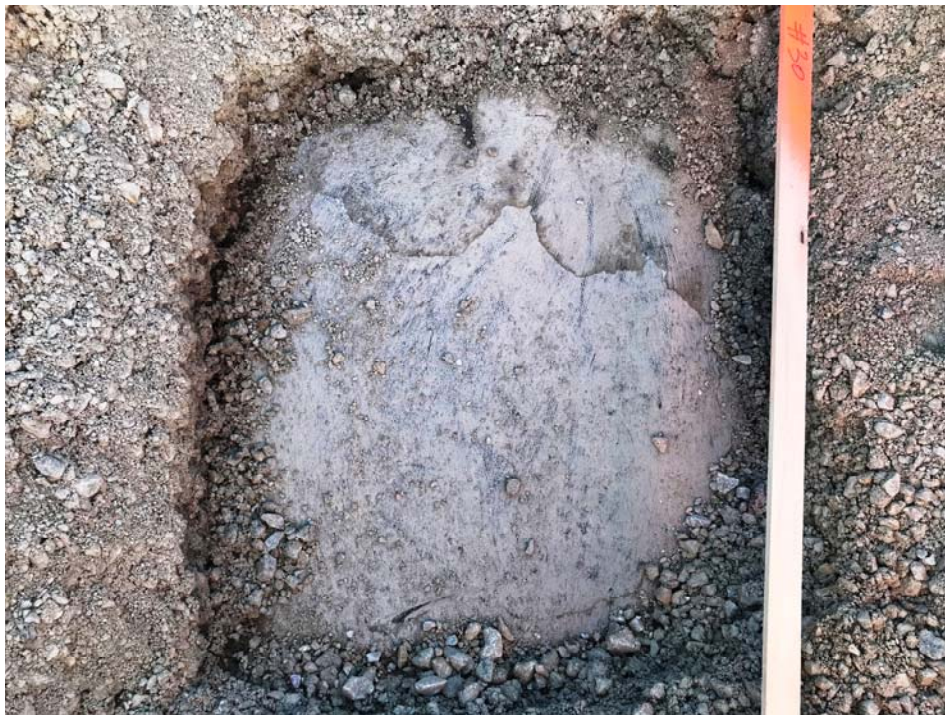
**Pot Hole 30**

*Geomembrane surface doesn't show any signs of damage or distress*

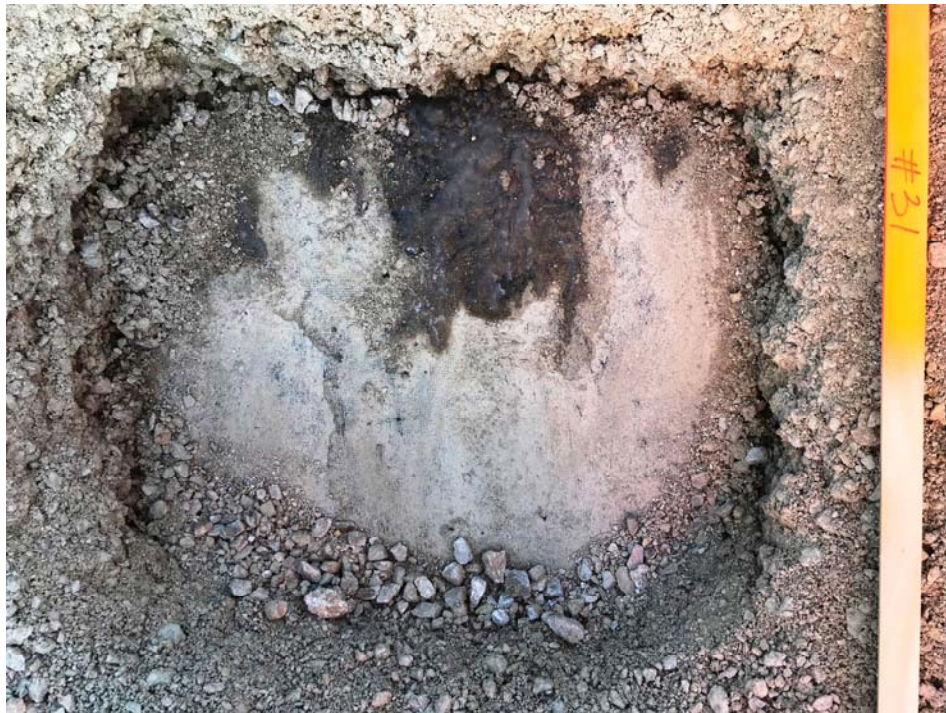
**Pot Hole 31**

*Geomembrane surface doesn't show any signs of damage or distress*
