Re: Permit No. M-1980-244; Cripple Creek & Victor Gold Mining Company; Cresson Project; - Addendum to VLF2 Liner Inspection TR100 Record of Construction Report – VLF2 Removal of the Crushed Ore Stockpile & Liner Integrity Verification Project; Adequacy Review Response

Record of Construction Report, VLF2 Removal of the Crushed Ore & Stockpile Liner  
Integrity Verification Project;  
Response to DRMS' Comments

**RE: Cripple Creek & Victor, Co., Cresson Project M-1980-244;  
Review Comments of the Crushed Ore Stockpile & Liner Integrity Verification Project  
Record of Construction Report, (TR-100 Addendum)**

### **Pot Hole Photo Log**

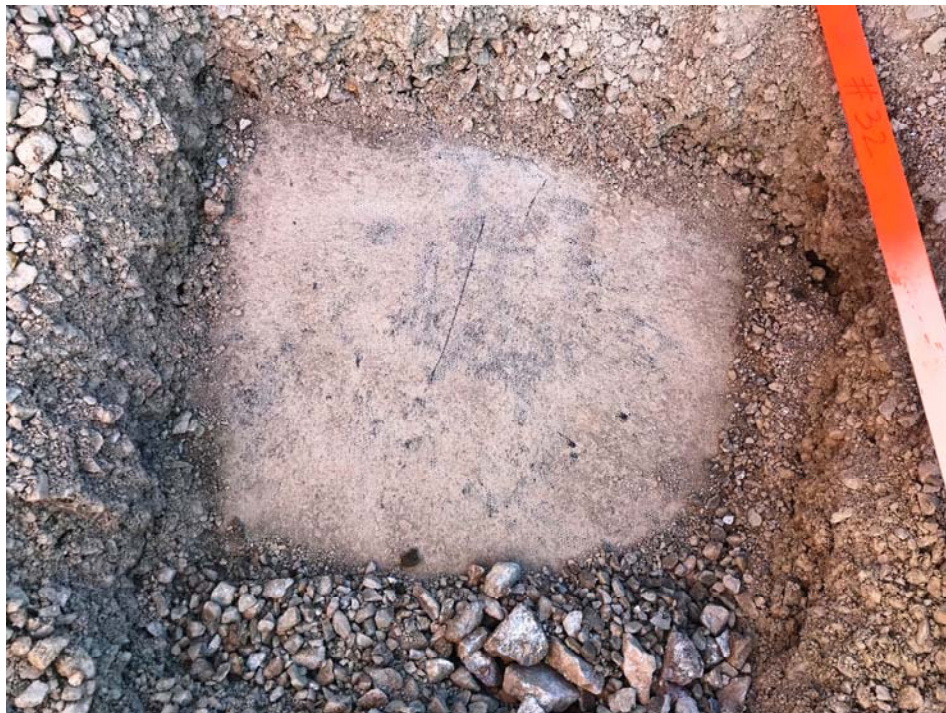
**Pot Hole 32**

*Geomembrane surface doesn't show any signs of damage or distress other than minor surface scratches developed during the excavation of the pot hole.*

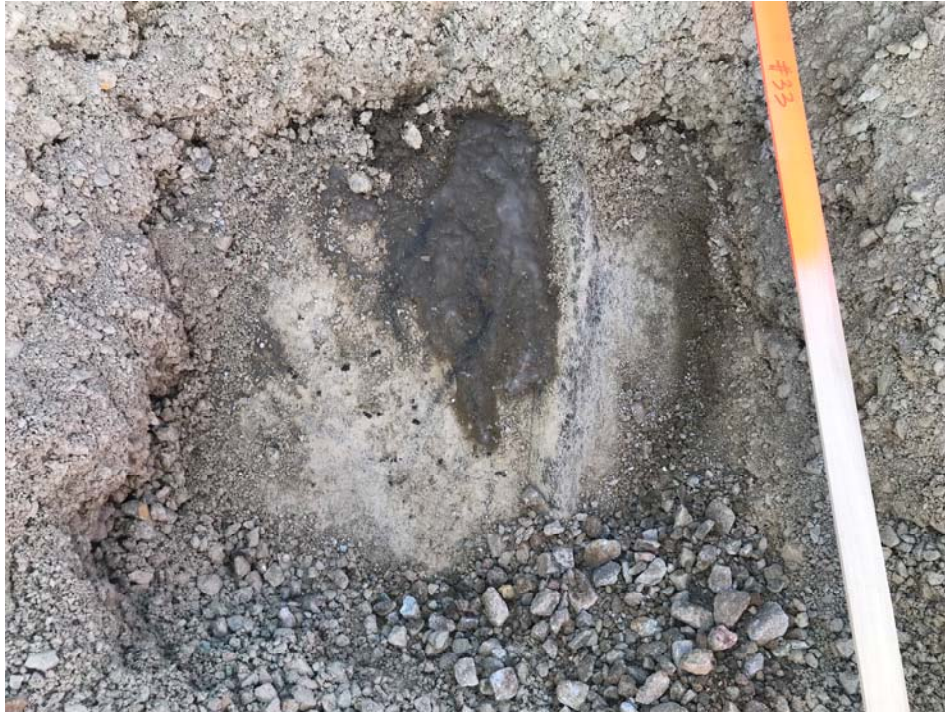
**Pot Hole 33**

*Geomembrane surface doesn't show any signs of damage or distress other than minor surface scratches developed during the excavation of the pot hole.*

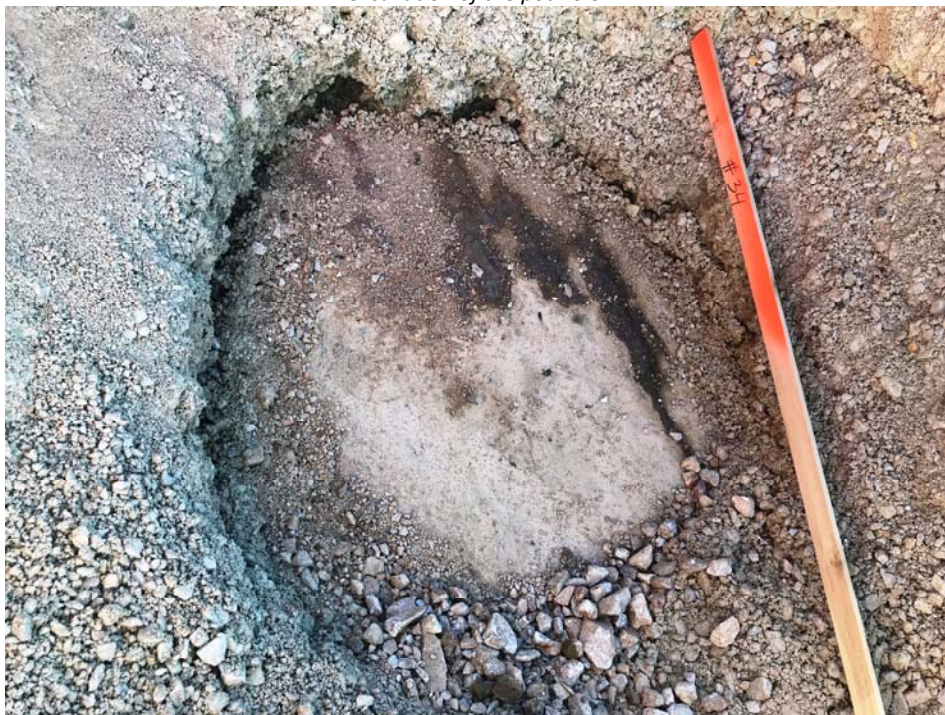
**Pot Hole 34**

*Geomembrane surface doesn't show any signs of damage or distress*
