MINERALS PROGRAM INSPECTION REPORT
PHONE: (303) 866-3567

MINE NAME: Lindstrom Gravel Pit	MINE/PROSPECTING ID#: M-1993-069	MINERAL: Sand and gravel	COUNTY: Logan
INSPECTION TYPE: Monitoring	INSPECTOR(S): Peter S. Hays	INSP. DATE: February 12, 2019	INSP. TIME: 11:30
OPERATOR: Logan County	OPERATOR REPRESENTATIVE: Jeff Reeves	TYPE OF OPERATION: 112c - Construction Regular Operation	
REASON FOR INSPECTION: Normal I&E Program	BOND CALCULATION TYPE: None	BOND AMOUNT: \$0.00	
DATE OF COMPLAINT: NA	POST INSP. CONTACTS: None	JOINT INSP. AGENCY: None	
WEATHER: Windy	INSPECTOR'S SIGNATURE:

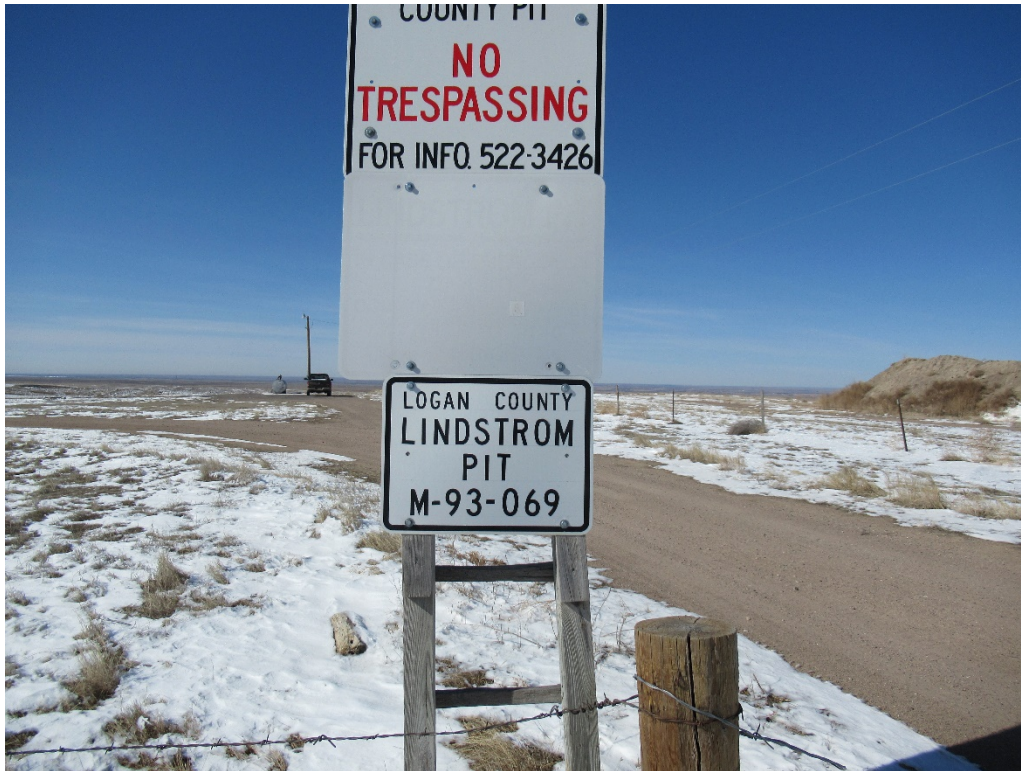
The 112c operation is permitted for 19.79 acres with an approved post-mining land use of rangeland. The site is located approximately 11 miles southwest of Sterling, CO near the intersection of CR 10 and CR 53. The ground was partially snow covered at the time of the inspection. The mine identification sign was posted at the entrance to the site and the boundary was delineated by wood posts and metal t-posts as required by Rule 3.1.12.

Lindstrom Pit mine sign

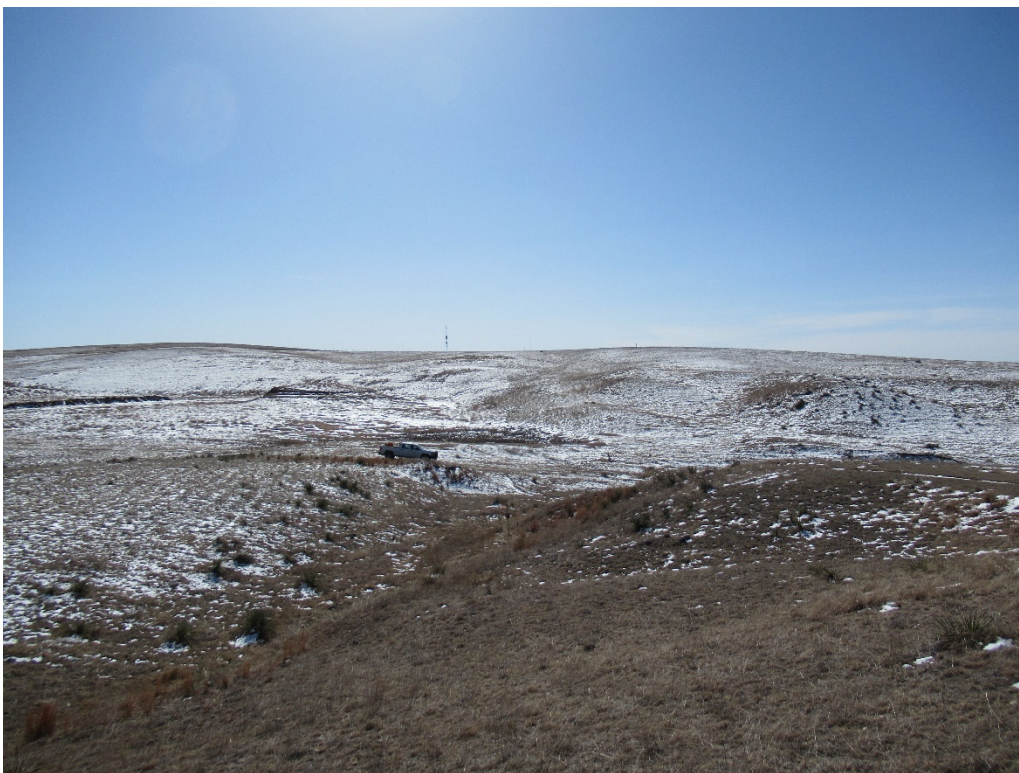
View of the site from the northwest corner looking south

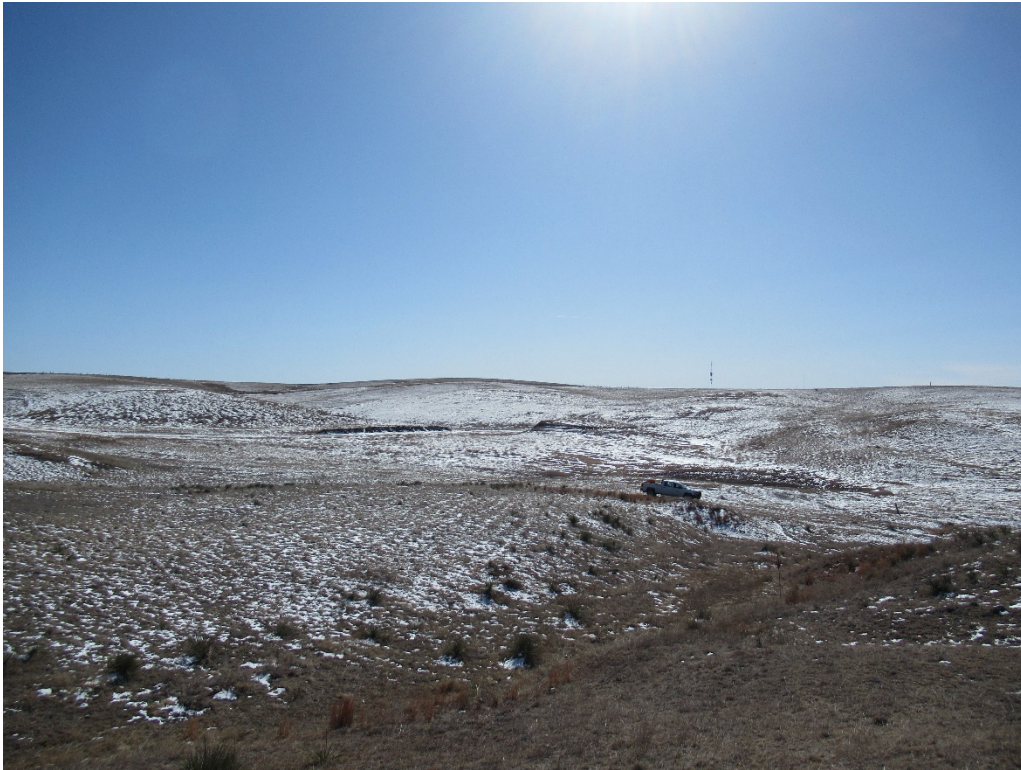
View of the site from the northwest corner looking southeast

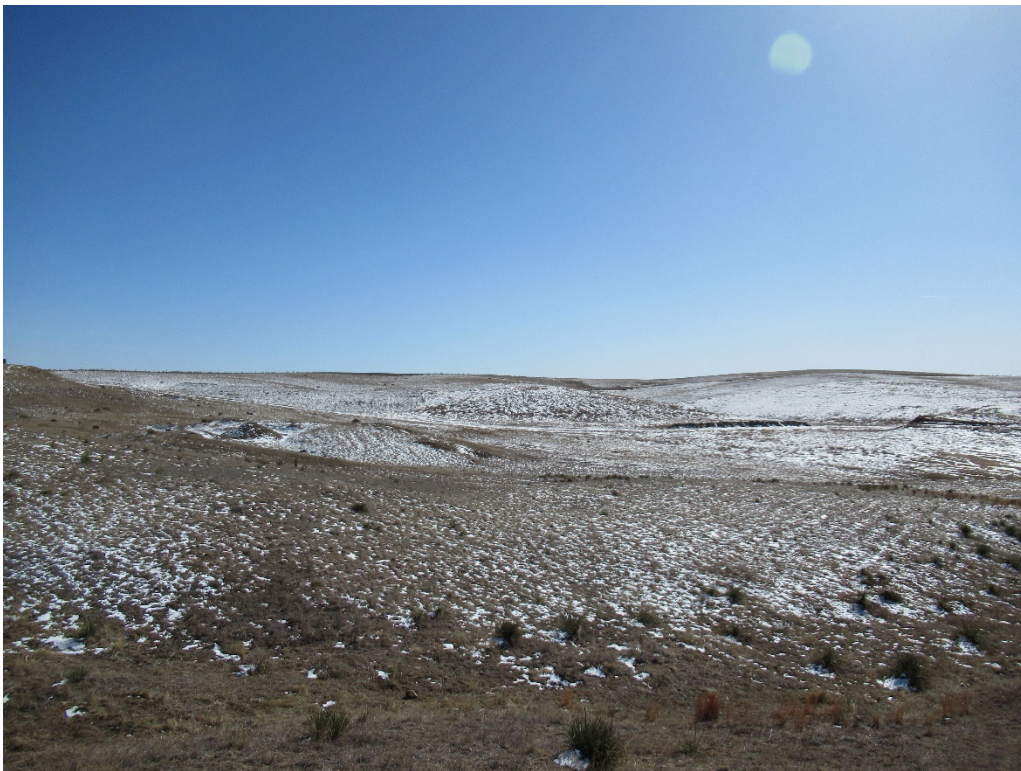
View of the site from the northwest corner looking east

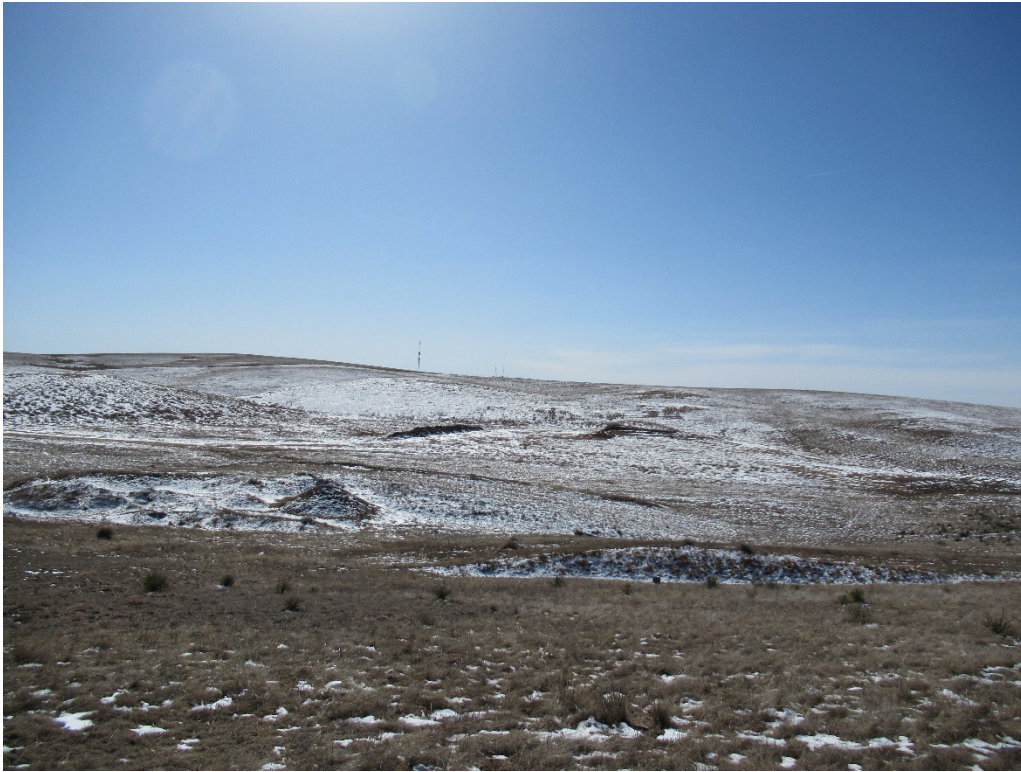
View of site from north side looking south

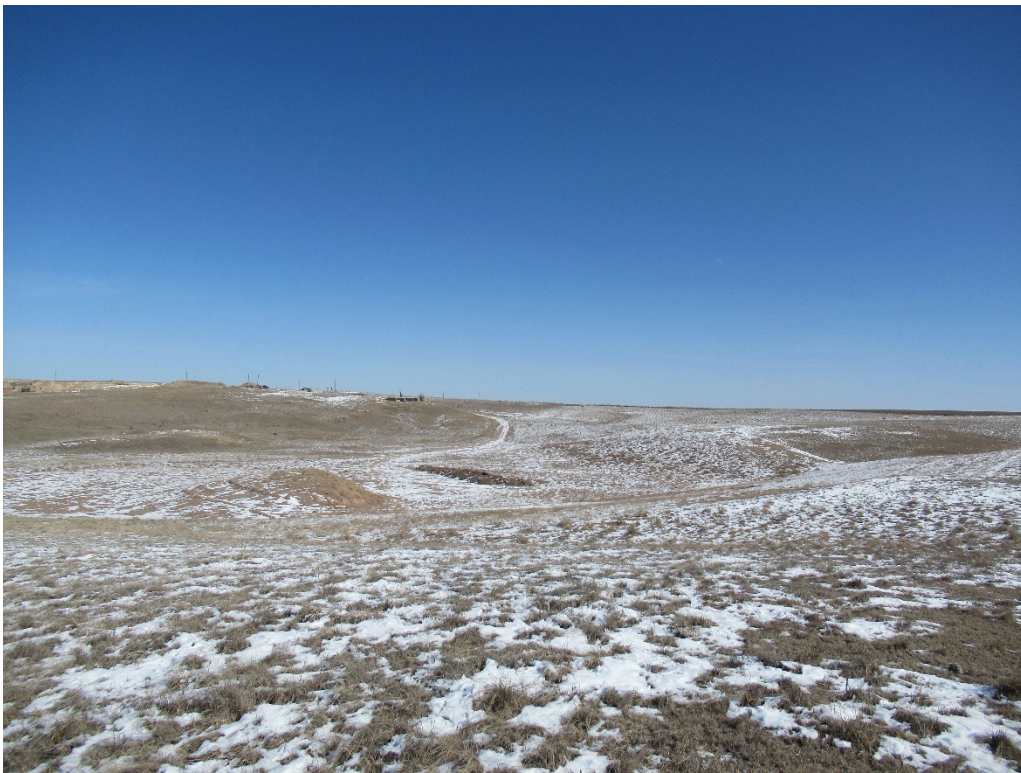
View of the site from the southwest corner looking northeast

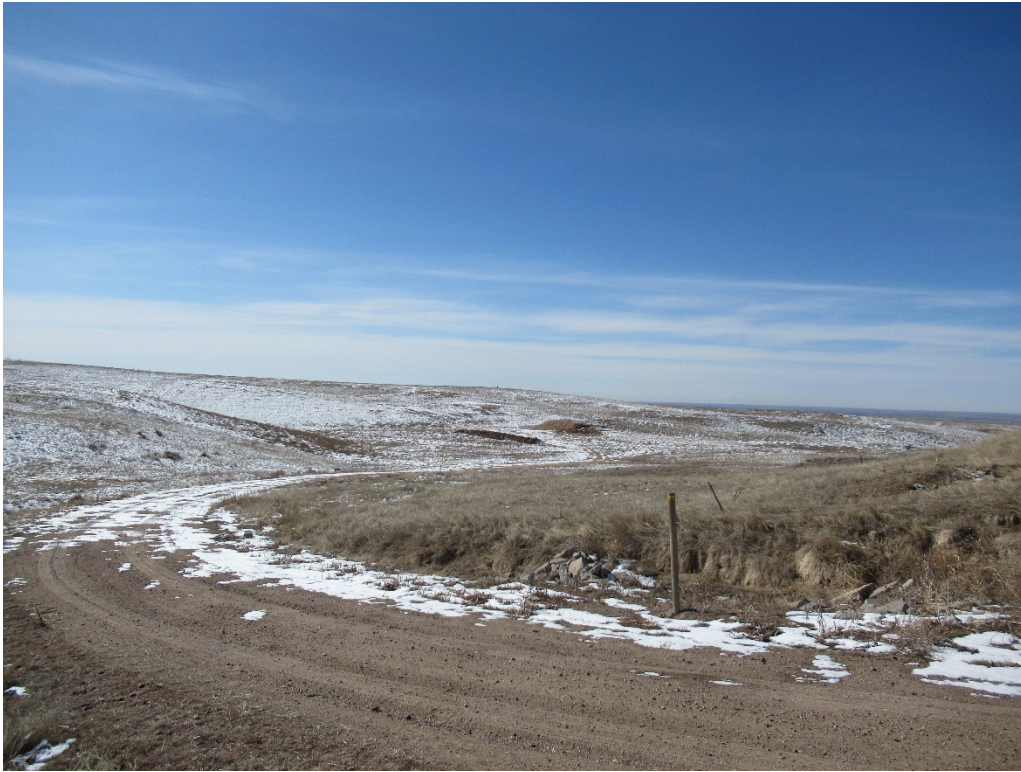
View of the site from the northeast corner looking southwest
