**MINERALS PROGRAM INSPECTION REPORT**  
**PHONE: (303) 866-3567**

<b>MINE NAME:</b> Guenzi S & G Pit	<b>MINE/PROSPECTING ID#:</b> M-1987-159	<b>MINERAL:</b> Sand and gravel	<b>COUNTY:</b> Logan
<b>INSPECTION TYPE:</b> Monitoring	<b>INSPECTOR(S):</b> Peter S. Hays	<b>INSP. DATE:</b> February 12, 2019	<b>INSP. TIME:</b> 10:30
<b>OPERATOR:</b> Logan County	<b>OPERATOR REPRESENTATIVE:</b> Jeff Reeves	<b>TYPE OF OPERATION:</b> 112c - Construction Regular Operation	
<b>REASON FOR INSPECTION:</b> Normal I&E Program	<b>BOND CALCULATION TYPE:</b> None	<b>BOND AMOUNT:</b> N/A	
<b>DATE OF COMPLAINT:</b> NA	<b>POST INSP. CONTACTS:</b> None	<b>JOINT INSP. AGENCY:</b> None	
<b>WEATHER:</b> Windy	<b>INSPECTOR'S SIGNATURE:</b>

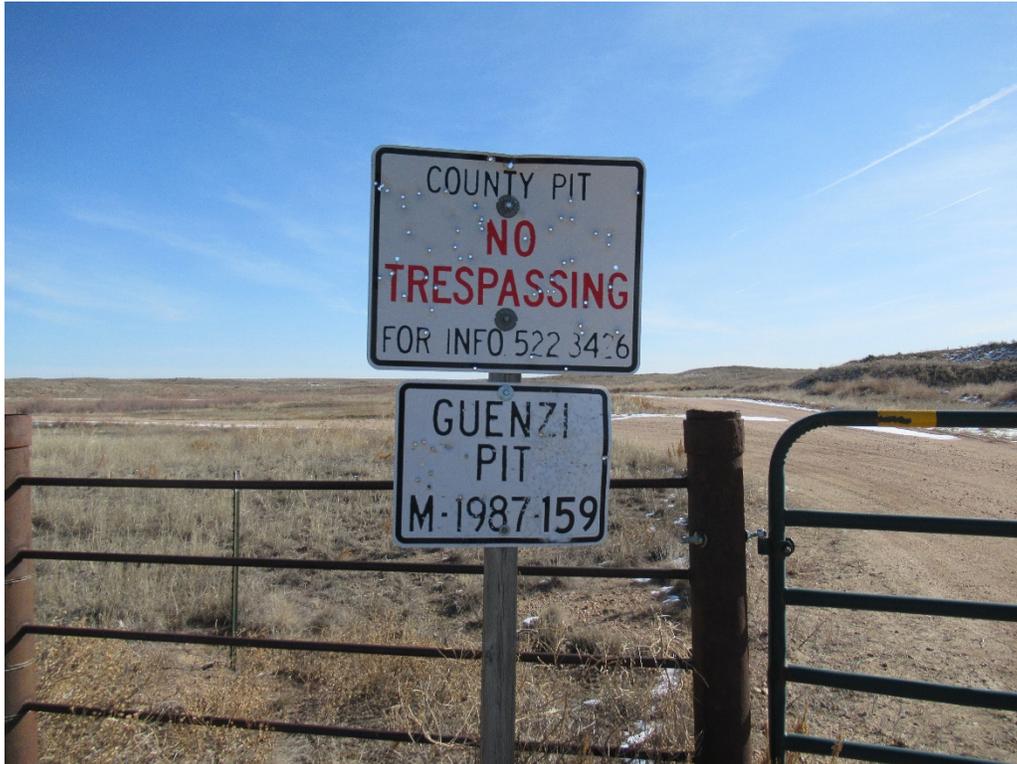
Guenzi Pit mine sign

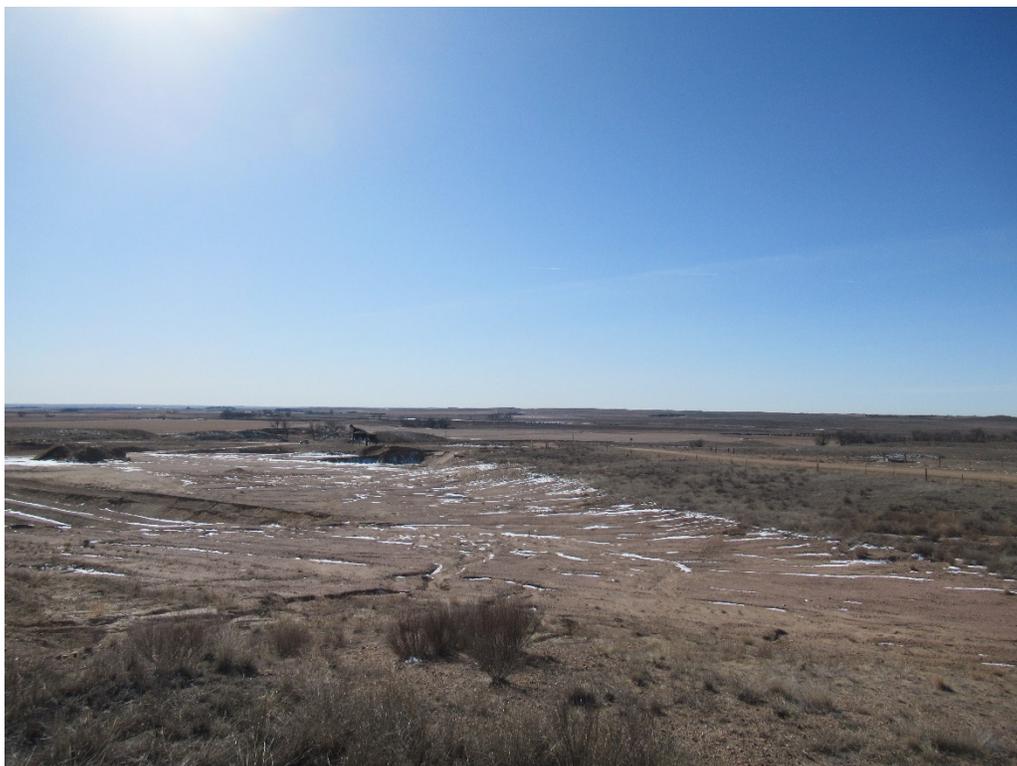
View of site from northwest corner looking south

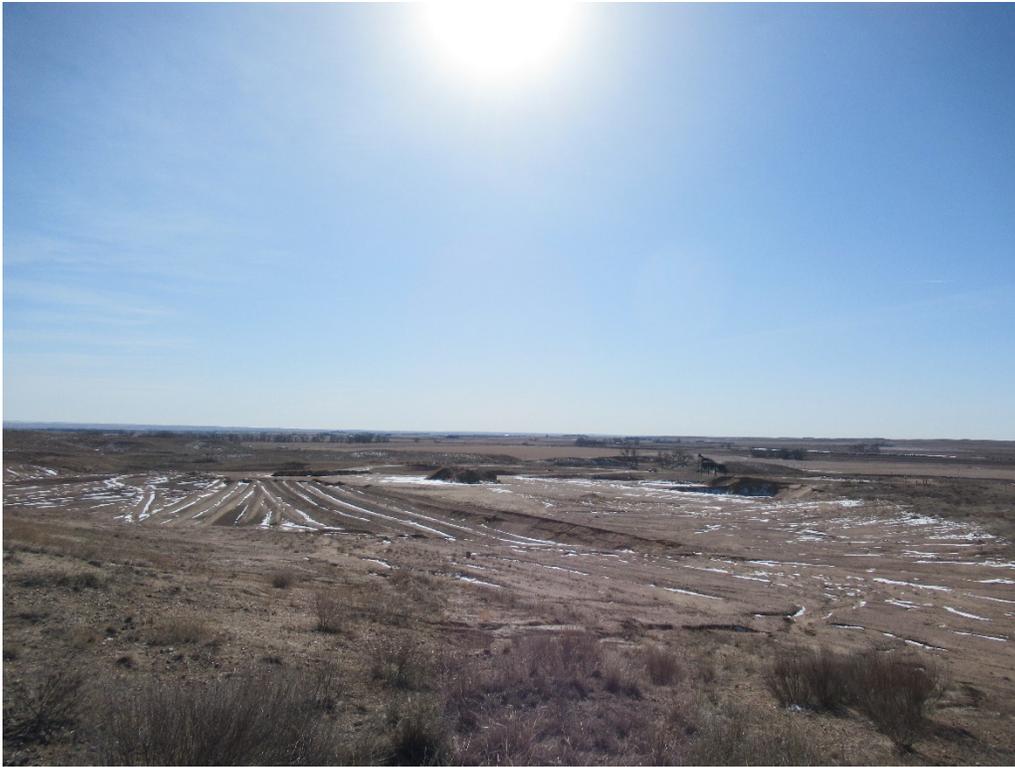
View of site from northwest corner looking southeast

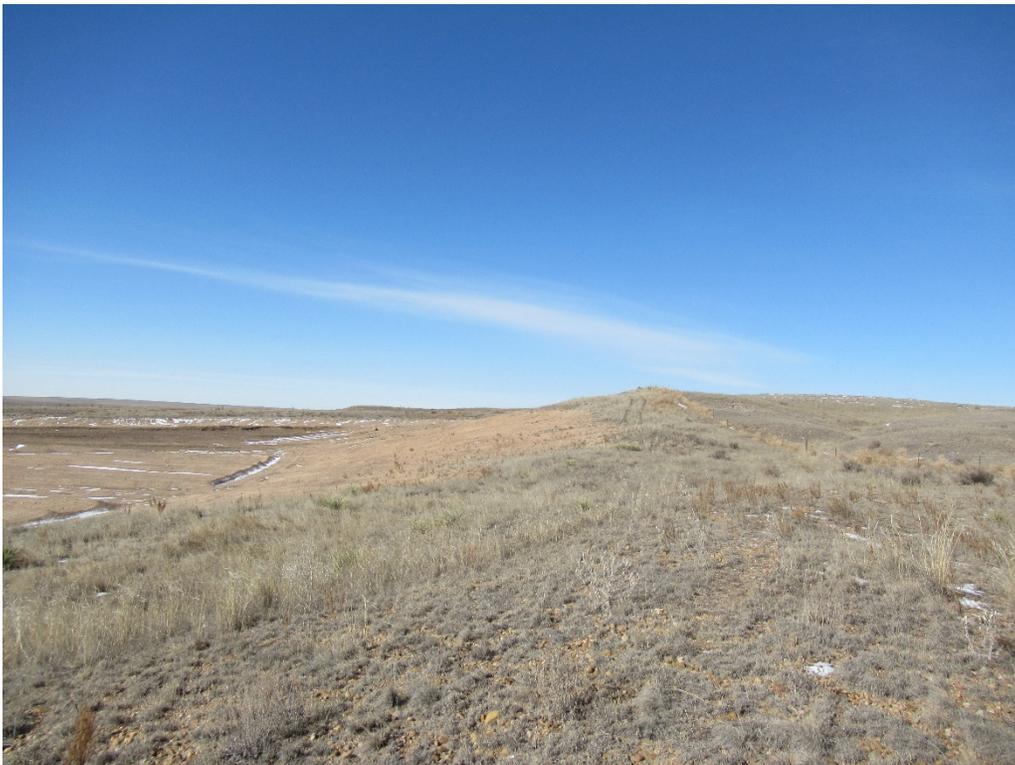
The site is in final reclamation according to the Operator. The north slope was rough graded to the approved 3H:1V slope. The slope appeared stable and no erosion features were observed during the inspection. Two semi-circle shaped highwalls were observed in the southwest corner of the site. The highwalls were estimated at 8 feet in height with a 1H:1V slope. The Operator stated the landowner created the highwalls by excavating material for use on his property. The Operator was aware of the requirement to regrade the highwalls to the approved 3H:1V reclamation slope. A material stockpile and a stockpile of imported topsoil were located on the pit floor. The Operator stated the site would be final graded, topsoiled and reseeded in the fall.

View of the north highwall slope from east end looking west

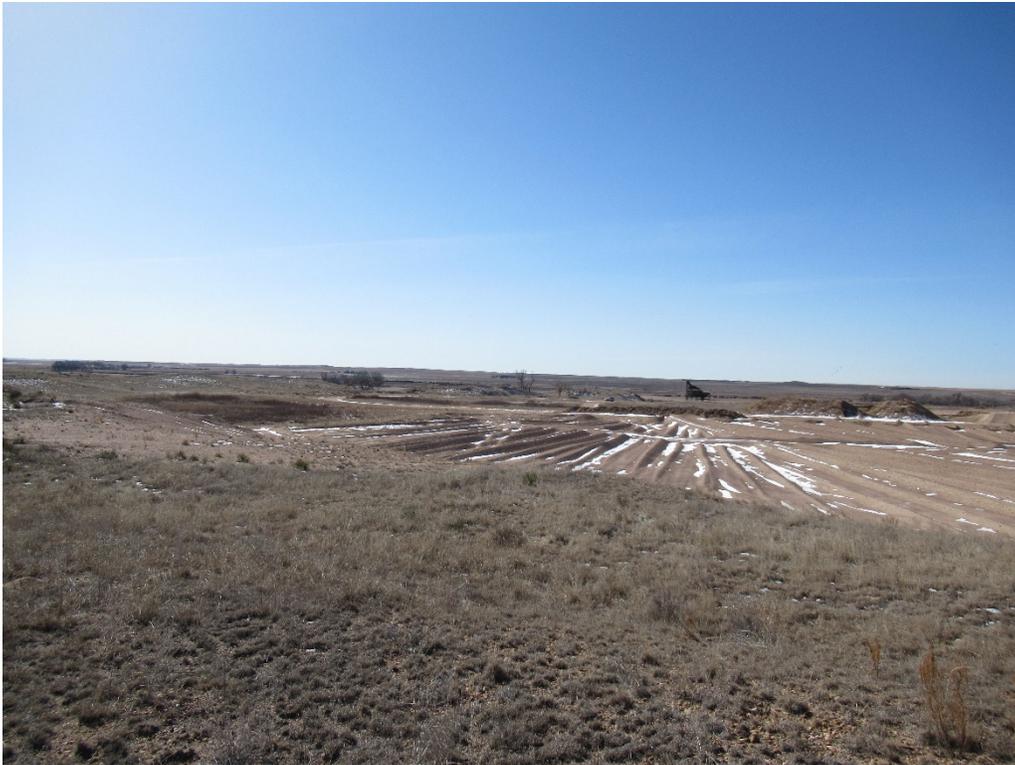
View of the site from the east end of the north highwall looking south

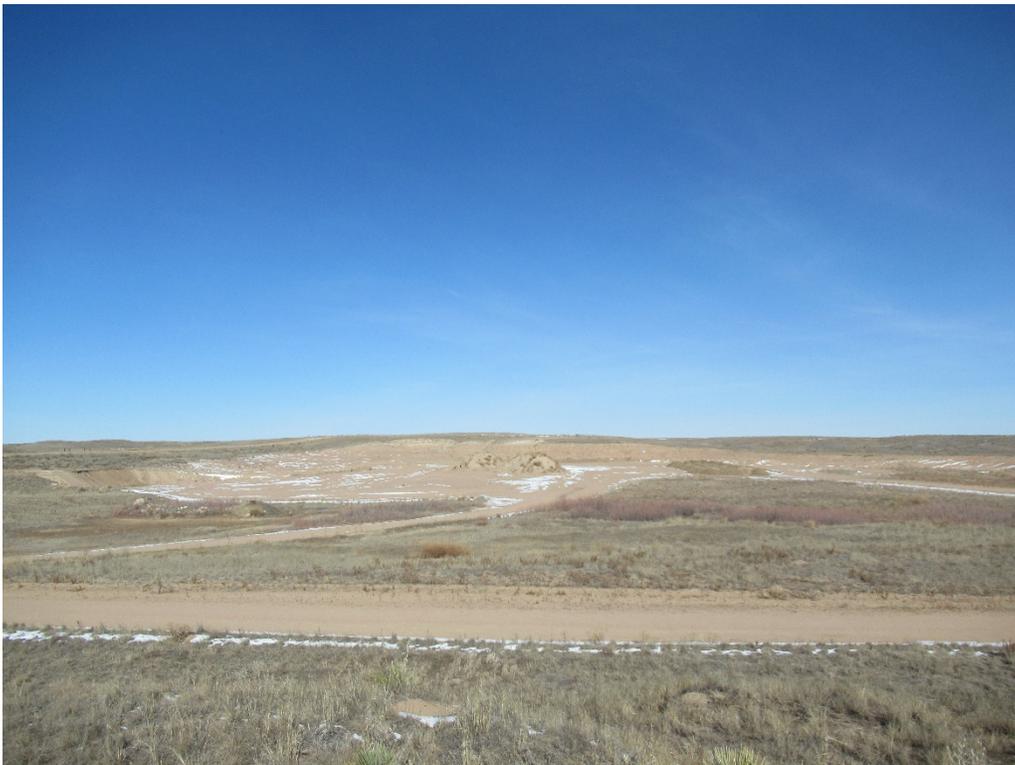
View of site from the south side looking north
