**COLORADO**Division of Reclamation,
Mining and Safety

MINERALS PROGRAM INSPECTION REPORT**PHONE: (303) 866-3567**

| MINE NAME: Bob Terrill Clay Pit | MINE/PROSPECTING ID#: M-1999-029 | MINERAL: Clay (general) | COUNTY: Logan |
| INSPECTION TYPE: Monitoring | INSPECTOR(S): Peter S. Hays | INSP. DATE: February 12, 2019 | INSP. TIME: 12:00 |

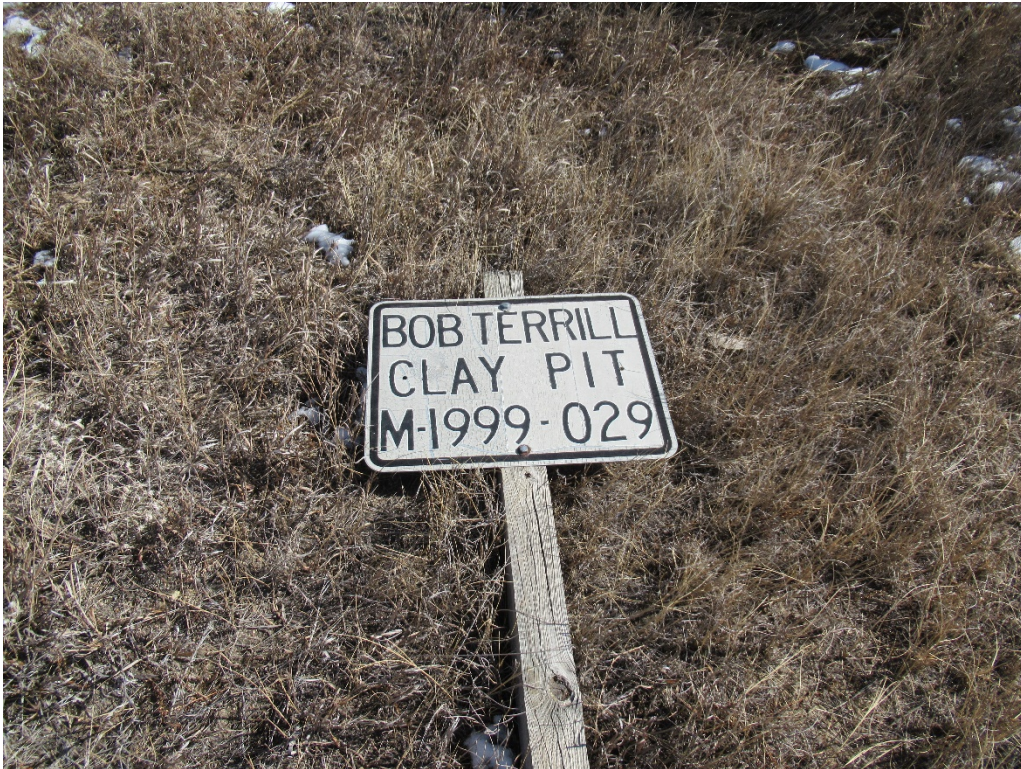
PROBLEM: The mine identification sign was not posted at the entrance of the mine site. This is a problem for failure to post a mine identification sign as required by Rule 3.1.12(1).

and CR 51. The ground was partially snow covered at the time of the inspection. The wood post the mine identification sign was posted on at the entrance to the site was broken and the sign was laying on the ground. As cited as a problem, the Division will require the Operator to submit photo documentation the sign has been repaired by the corrective action date. The Operator stated the sign would be reinstalled on the entrance gate. The permit boundary was delineated by fences on all sides.

Bob Terrill Clay Pit sign laying on the ground

CORRECTIVE ACTIONS: The Operator shall, at the entrance of the mine site, post a sign which shall be clearly visible from the access road with the following: the name of the operator, a statement that a reclamation permit for the operation has been issued by the Colorado Mined Land Reclamation Board; and the permit number. The Operator shall submit photo documentation that a proper sign has been posted by the corrective action date.

CORRECTIVE ACTION DUE DATE: 4/22/19

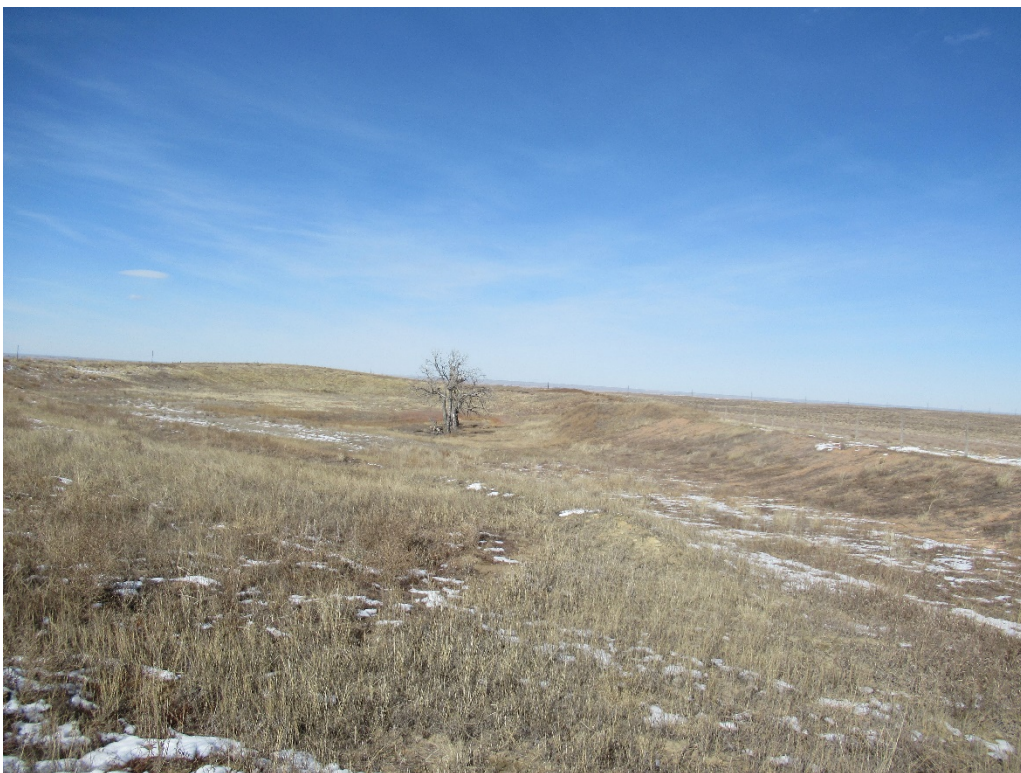
View of site from the entrance looking north

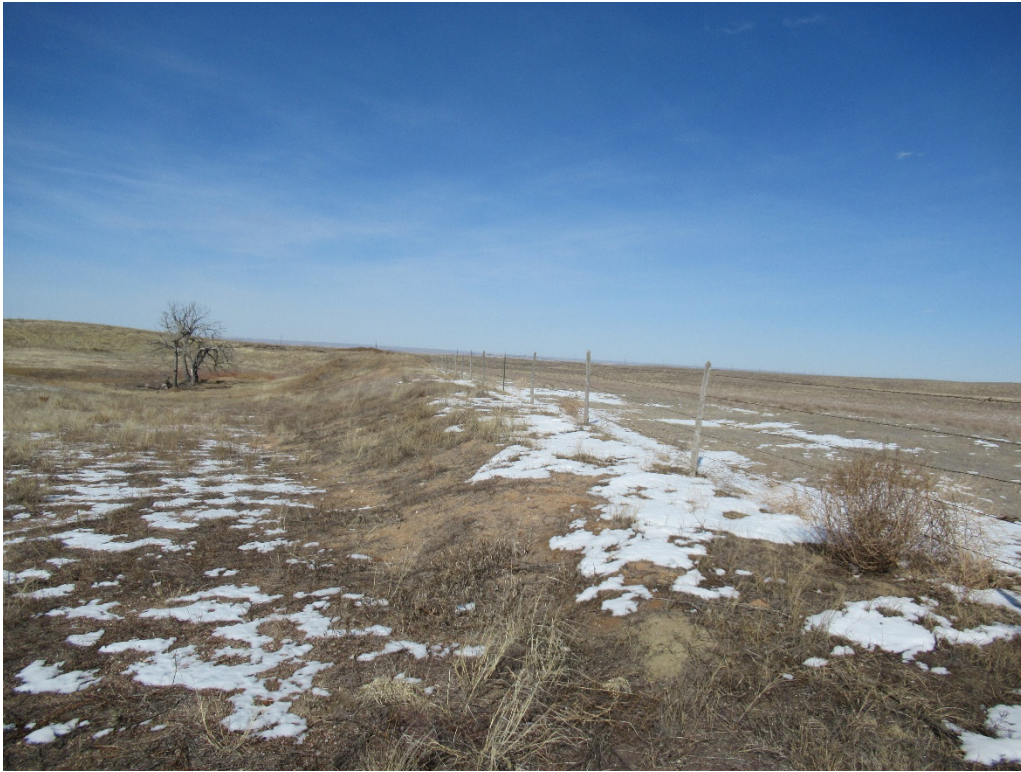
View of the highwall section in the southeast corner of the site

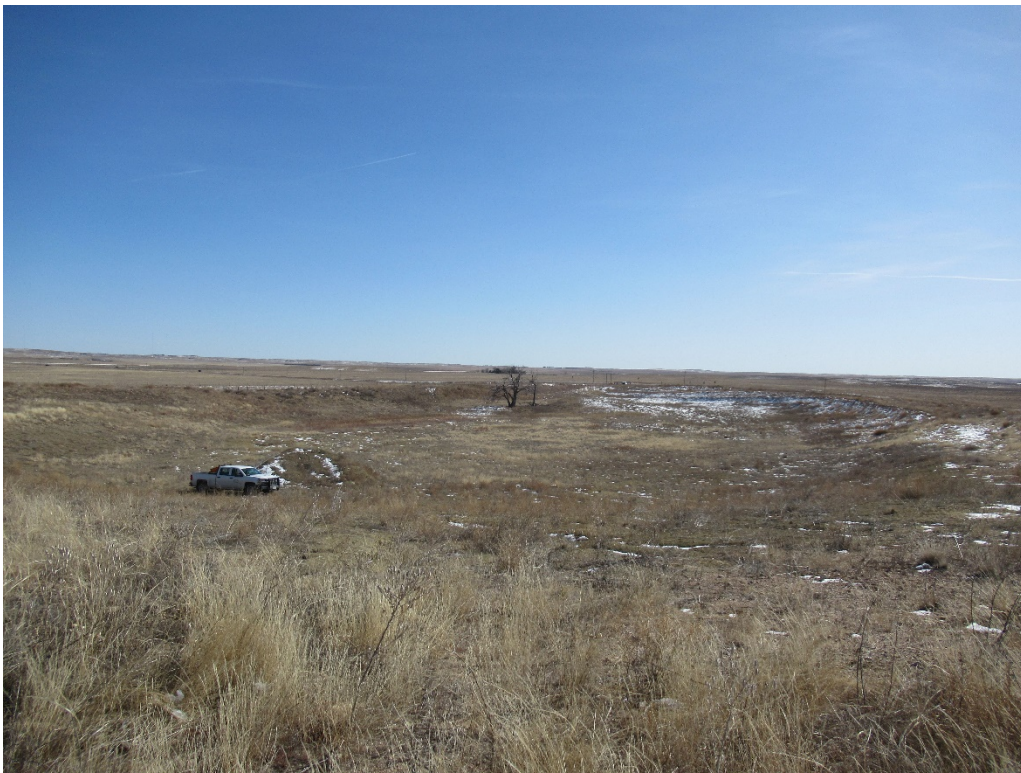
The site is used as a source for clay for the County Landfill only. The site was inactive during the inspection. The Operator stated the mine had not been active in several years. The Operator stated Logan County will reclaim the site this year, since clay material is available from other County operated sites and since the pit is approaching the permit boundary on all sides. A highwall was observed in the southeast corner of the site. The highwall was estimated to be 240 feet long, 3 feet in height and at a 1H:1V slope. The Operator stated the highwall would be backfilled as part of the final reclamation of the site. The remainder of the pit slopes were rutted with erosion features. The pit floor and slopes were covered with volunteered vegetation consisting of native grasses and annual weeds. A small stockpile of material was located in the northern portion of the pit floor.

View of the site from the north highwall looking south with stockpile next to the truck
