Permit Number: C-1981-012 Mine Name: New Elk Mine Operator: New Elk Coal Company, LLC Operator Address: Mr. Louis Head 12250 Highway 12 Weston, CO 81091 County: Las Animas Operation Type: Underground Permit Status: Active Ownership: Private

Inspection Start Date: February 2 Inspection Start Time: 08:00 Inspection End Date: February 2 Inspection End Time: 07:30	·		Inspection Type: Coal Complete Ins Inspection Reason: Normal I&E Pro Weather: Clear	•
Joint Inspection Agency:		Joint Inspection Contacts:		
None				
Post Inspection Agency:		Post Inspection Contacts:		
None				
Inspector(s):	Inspecto	r's Sig	gnature: Signa	ature Date:
Robert D. Zuber, P.E.			Phot D.	24
			2/22/2019

Inspection Topic Summary

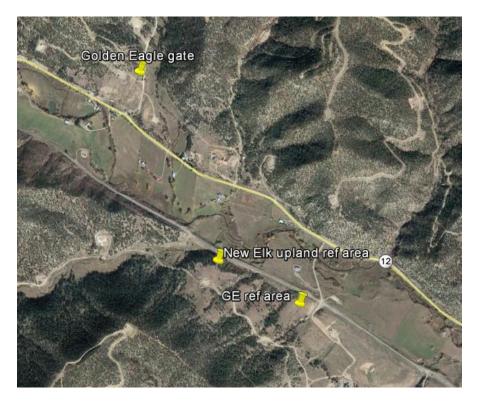
The vegetation reference area shown on the map below was inspected. Only two t-posts were seen, so it is unclear where exactly the reference area is located. NECC needs to clearly delineate the site with markers. This is part of a larger question: does NECC plan to update the revegetation success criteria in the PAP? The area contains some shrubs and small trees so it is possible that it was never disturbed except for possibly tree cutting in the past. There was no sign of recent grazing in the area. A small pile of soil is on or near the reference area; without a complete set of markers it is uncertain if it is in the reference area.

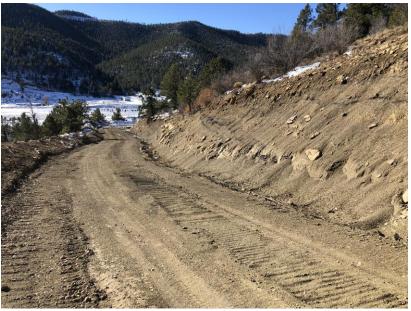
No significant problems with roads were observed. NECC staff have cleaned the roadside ditches along the road to the RDA. The road beside the conveyor to the RDA is in good shape but should be monitored often for erosion.

Road to RDA (ditch on right side has been cleared by Vince Massarotti)

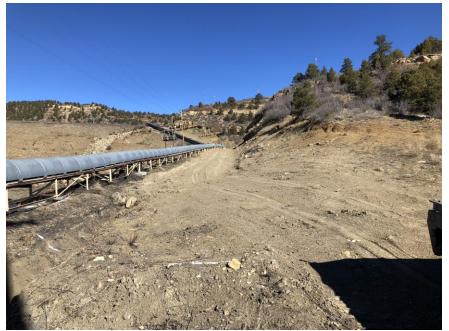
Road by conveyor

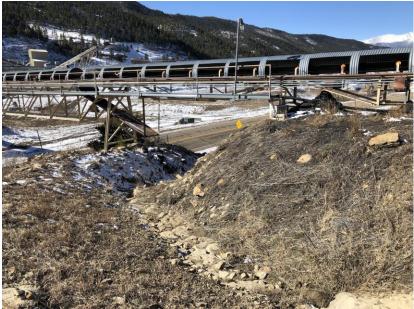
No problems with ditches were identified. The ditch that carries water under the conveyor and into CA#5 is stable, and the BMPs (sump formed from a berm and straw bales) is functioning. The hillside above Ditch C26 (below the water tanks) appeared stable.

Ditch to CA#5

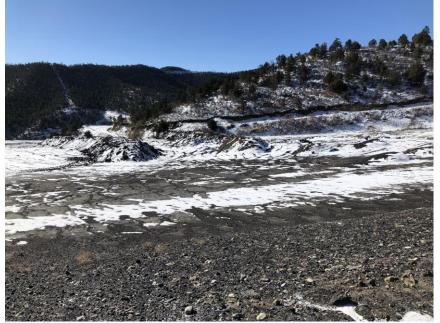
No erosion was seen on the reclaimed portion of the RDA. The ditch between the upper and lower portions of the RDA is in good shape. No ponding or erosion were seen on the upper portion of the RDA. NECC needs to spread some piles of material, preferably soon before spring runoff. No signs of blowouts below the clear water ditches were seen.

RDA – material near west side needs to be spread

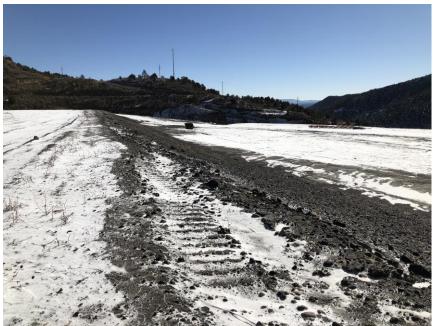
RDA – grade is generally good

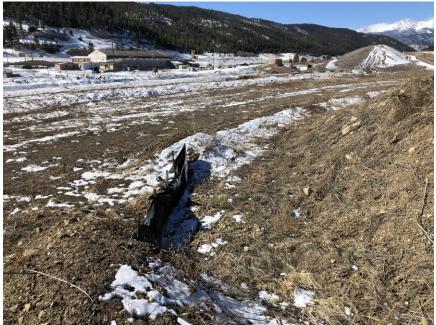
Silt fence at TSS#2

No erosion problems were seen with Topsoil Stockpile #2, although there is little vegetation on it. The silt fence below this pile is functioning, but may need replacement in 2019. No problems were seen with the topsoil pile next to CA#1.

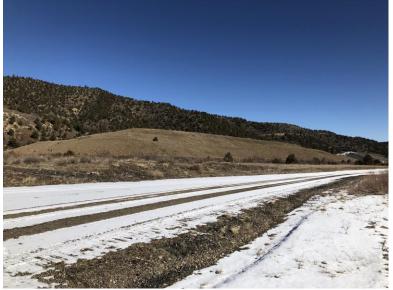
Development Coal Waste Pile

No rills or other problems were seen on the Development Coal Waste Pile.

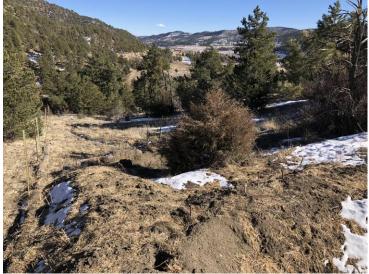
The sediment and erosion BMPs at the Northwest Fan (former Golden Eagle site) require no maintenance at this time.

BMPs at Northwest Fan area
