2019 ANNUAL REPORT STRUCTURAL GEOLOGY EVALUATION SPECIFICATIONS AGGREGATE QUARRY

**Martin Marietta Materials
Golden, Colorado**

18C64008.00
February 21, 2019

**Subject: Project 18C64008.00, 2019 Annual Report, Structural Geology Evaluation,
Specification Aggregates Quarry, Golden, Colorado**

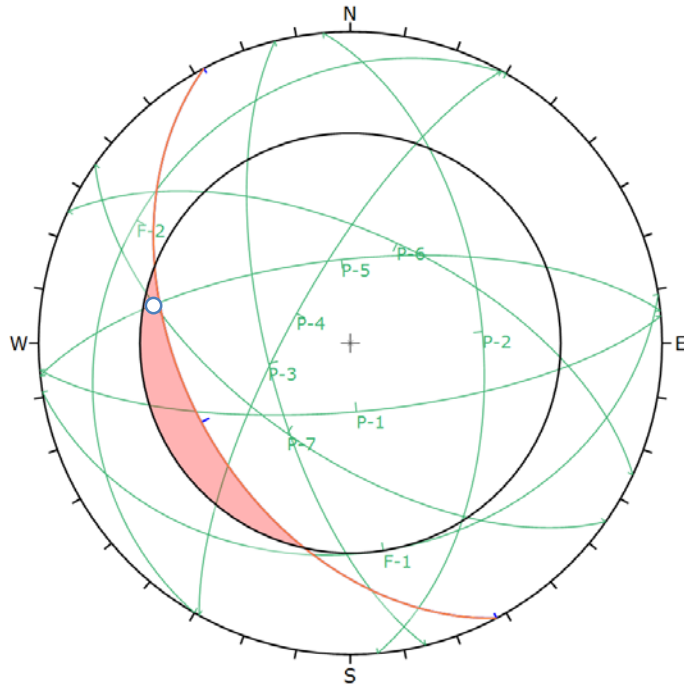
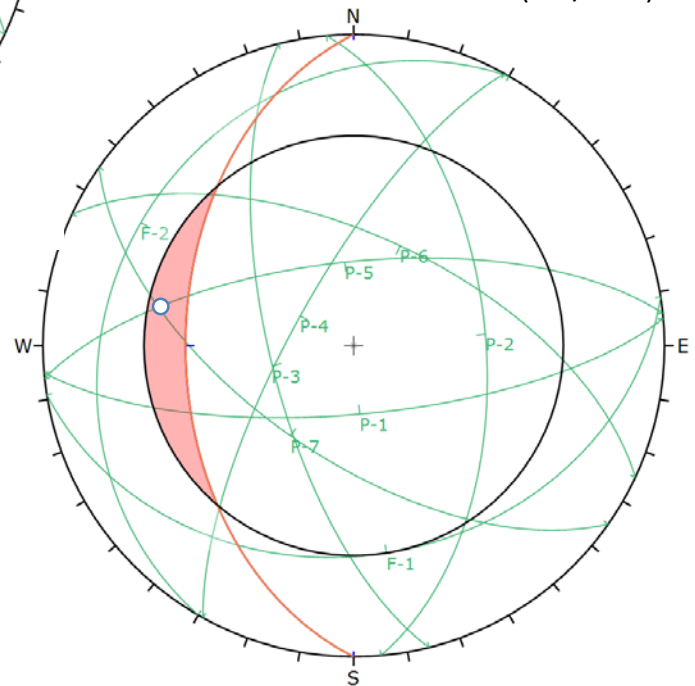
Figure 8

The stereonet plots for East Walls 1 and 2 each show one discontinuity intersection that falls within the failure envelope, suggesting that wedge failure is kinematically possible for these slope orientations (Figure 8). The intersecting set that may result in wedge failure are joint sets P-5 and joint P-7.

The development and size of these wedge failures will be controlled by the variability and limited lateral extent of the discontinuities. Based on the current and previous years’ data sets, these two joint sets (P-5 and P-7) have weak signatures represented by relatively few measured orientations (Figure 6). As excavation proceeds in the vicinity of the eastern walls, additional measurements are needed to refine the representative discontinuity orientations of these joint and foliation sets in this area to evaluate their potential to contribute to large-scale slope failure modes.

As shown in Figure 8, the stereonet plot for East Walls 1 and 2 do not indicate the possibility of planar failure.

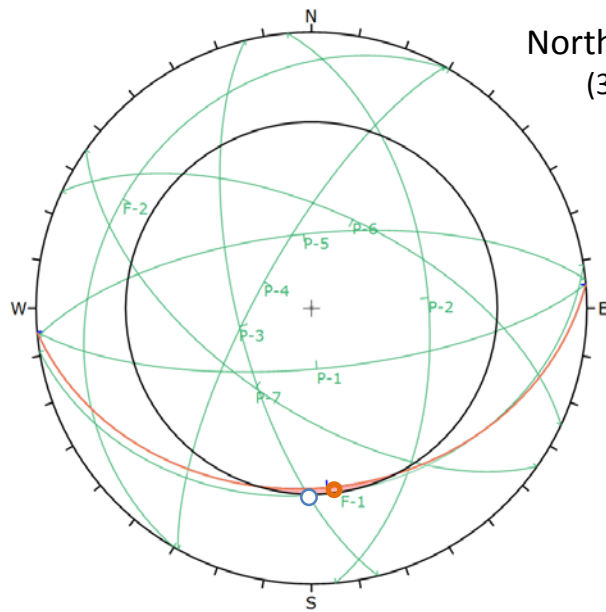
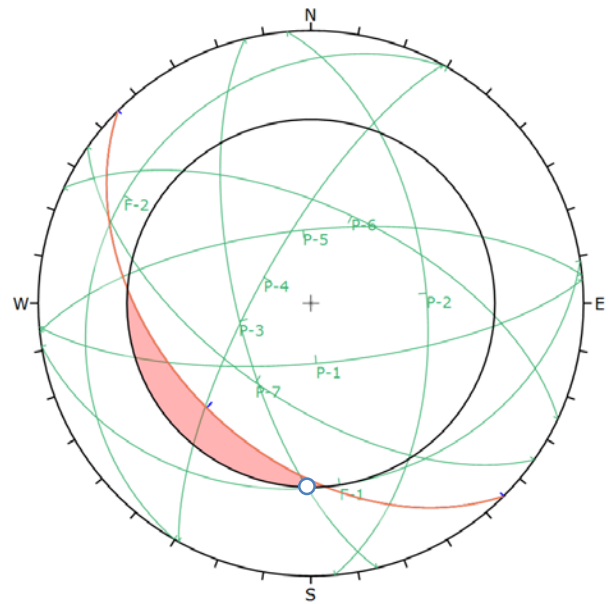
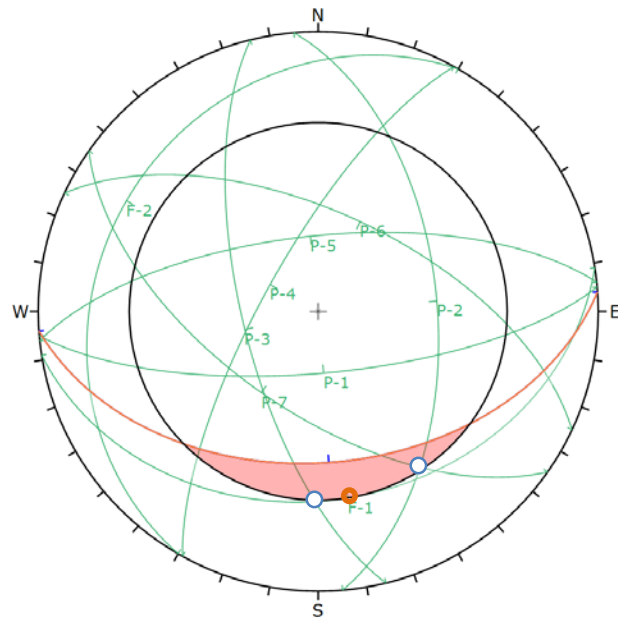
Figure 9

The stereonet plot for Northeast Wall 1 indicates a potential planar failure mode along foliation F-1 for this slope orientation (Figure 9). This is the same foliation orientation that was believed to contribute to the 1998 slope instability (Photo 5). The stereonet plot for Northeast Wall 1 also shows one discontinuity intersection that falls within the failure envelope, suggesting that wedge failure is kinematically possible for this slope orientation (Figure 9). The intersecting sets that may result in wedge failure include foliation F-1 and joint set P-3.

The stereonet plot for Northeast Wall 2 shows one discontinuity intersection that falls within the failure envelope, suggesting that wedge failure is kinematically possible for this slope orientation (Figure 9). The intersecting sets that may result in wedge failure are foliation F-1 and joint set P-3. As described above, the development and size of wedge failures will be controlled by the variability and limited lateral extent of the discontinuities. As excavation proceeds in the vicinity of the northeastern walls, additional measurements are needed to refine the representative discontinuity orientations of these joint and foliation sets in this area to evaluate their potential to contribute to large-scale slope failure modes. Planar failure is not indicated in the stereonet plot for Northeast Wall 2.

The stereonet plot for Northeast Wall 3 indicates a potential planar failure mode along foliation F-1 for this slope orientation (Figure 9). This is the same foliation orientation that was believed to contribute to the 1998 slope instability. The stereonet plot for Northeast Wall 3 shows two discontinuity intersections that fall within the failure envelope, suggesting that wedge failure is kinematically possible for this slope orientation (Figure 9). The intersecting sets that may result in wedge failure are foliation F-1 and joint set P-3, and joint sets P-2 and P-7. Based on the current and previous years' data sets, joint set P-7 has weak signatures represented by relatively few measured orientations representing these features (Figure 6). The Northeast Wall 3 was not accessible for direct measurements or observations during our site visits. Additional measurements and observations are needed to assess the potential for large scale planar sliding along foliation F-1 as excavation continues to extend below Northeast Wall 3 in the future (there is currently no mining activity).

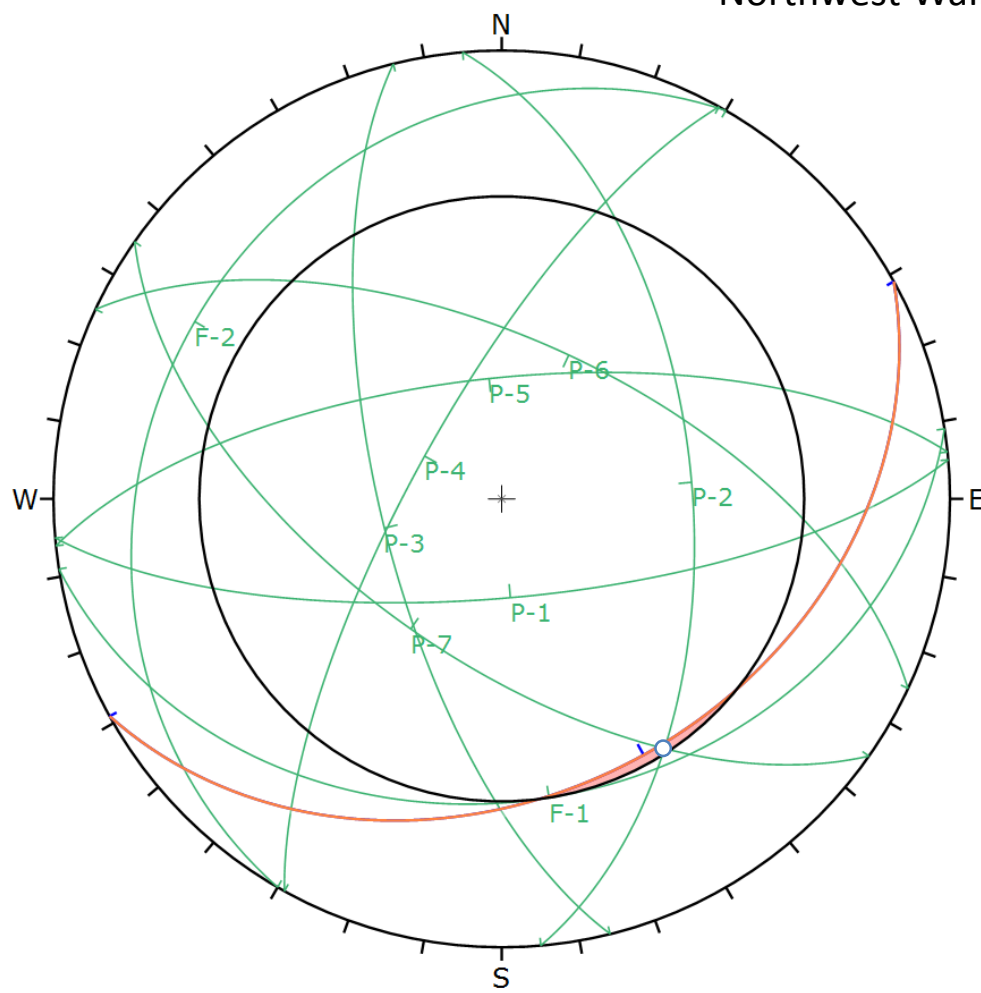
Figure 10

The stereonet plot for the Northwest Wall shows one discontinuity intersection that falls within the failure envelope, suggesting that wedge failure is kinematically possible for this slope orientation (Figure 10). The intersecting sets that may result in wedge failure are joint sets P-2 and P-7. Based on the current and previous years' data sets, joint set P-7 has weak signatures represented by relatively few measured orientations representing these features (Figure 6). Furthermore, even a slight variability of the orientation of joint sets P-2, P-7 and foliation F-1 would create the potential to form wedges within the critical zone for this wall. Planar failure is not indicated in the stereonet plot for the Northwest Wall (Figure 10). However, even a slight variation of the foliation F-1 would create the potential for planar sliding.

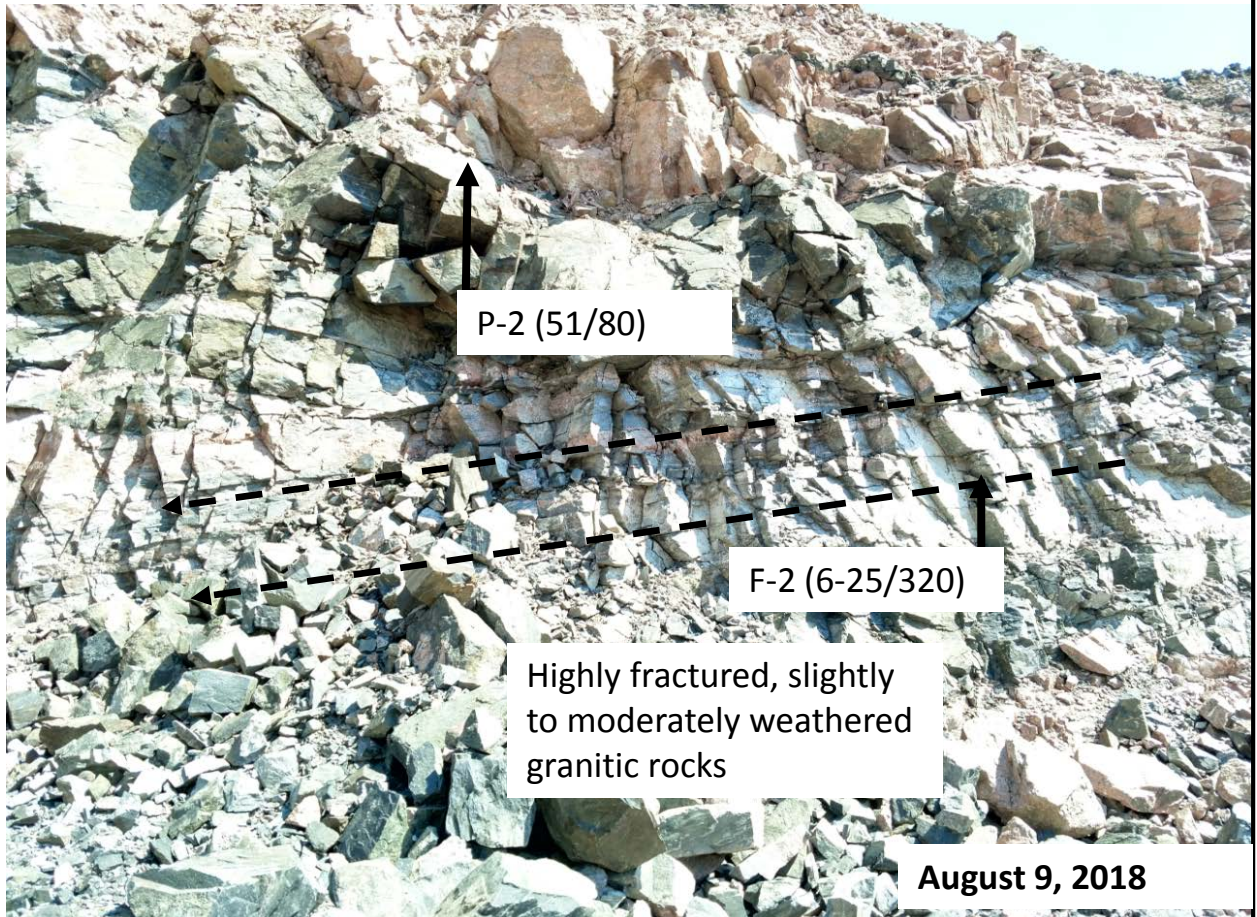
Photo 1

Significant mining activity has taken place in the Southern Expansion Area since our last annual report and between our August 2018 and January 2019 site visits (Photos 1 to 3). The mining is being accomplished with four active temporary benches with reclamation occurring in stages following excavation along permanent benches. The uppermost bench exists near the western margin of the Southern Expansion Area (see Stations 19-04 in Figure 2). The next bench to the east is in the vicinity of Stations 19-01 and 19-05 (Figure 2) and the next near Stations 19-02 and 19-06 (Figure 2). The final, lowest bench is in the vicinity of Stations 19-03 and 19-07 (Figure 2) and is at approximately EL 6,545 ft, based on GPS measurement and concrete monuments spray-painted with elevation markings. Each bench appears to be approximately 35 feet lower than the bench to its west.

Looking southwest (Southwest Wall 2) in an actively-mined area (upper bench, ~EL 6615 ft) of the Southern Expansion Area near Station 19-01 (Figure 2).

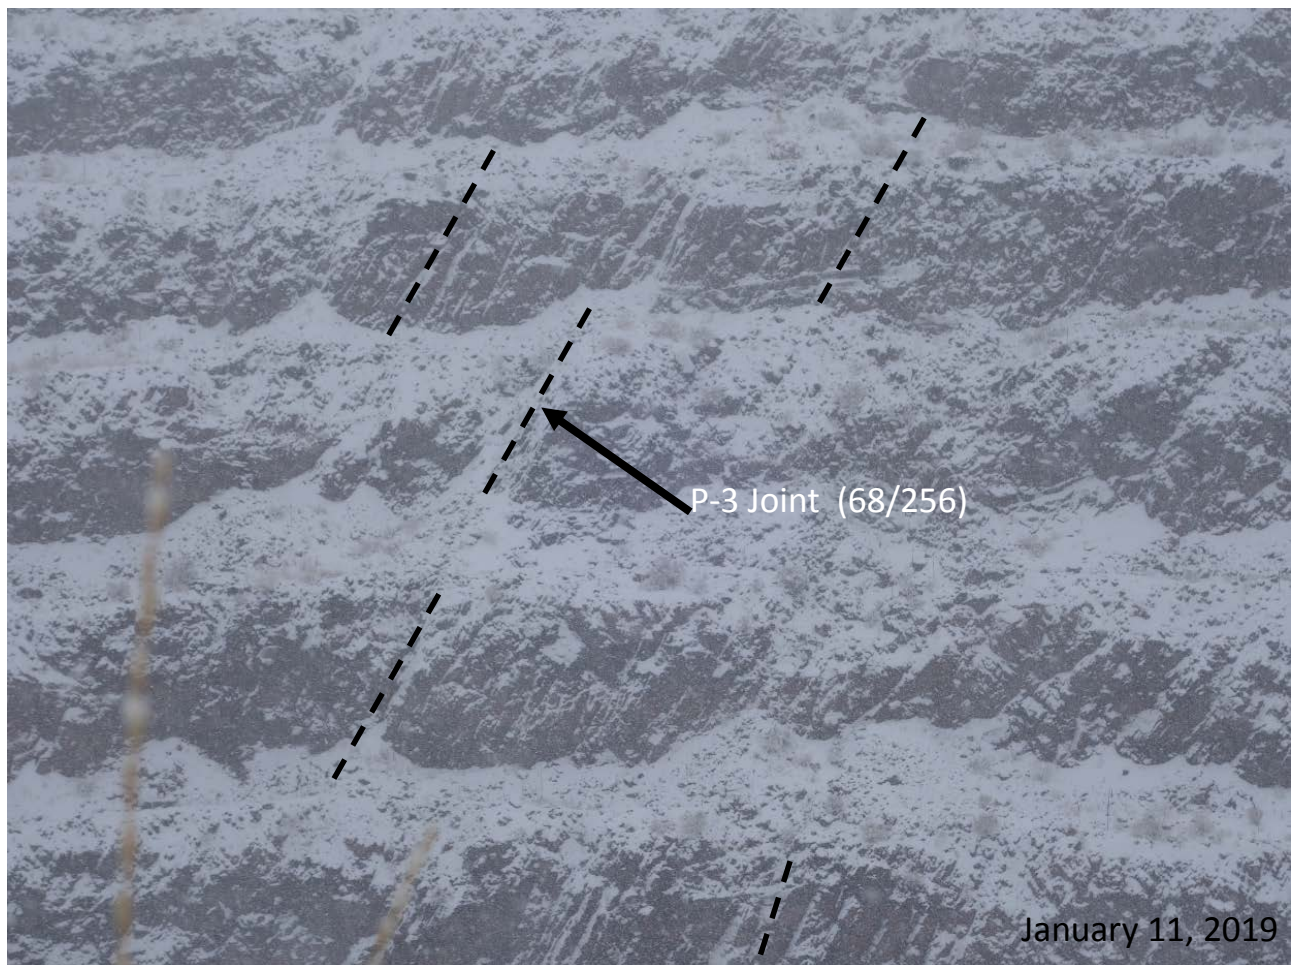
Photo 2

Exposed joint set P-3 highlighted by snow accumulation on temporary north facing wall of the Main Pit Area. Rock is slightly to moderately weathered.

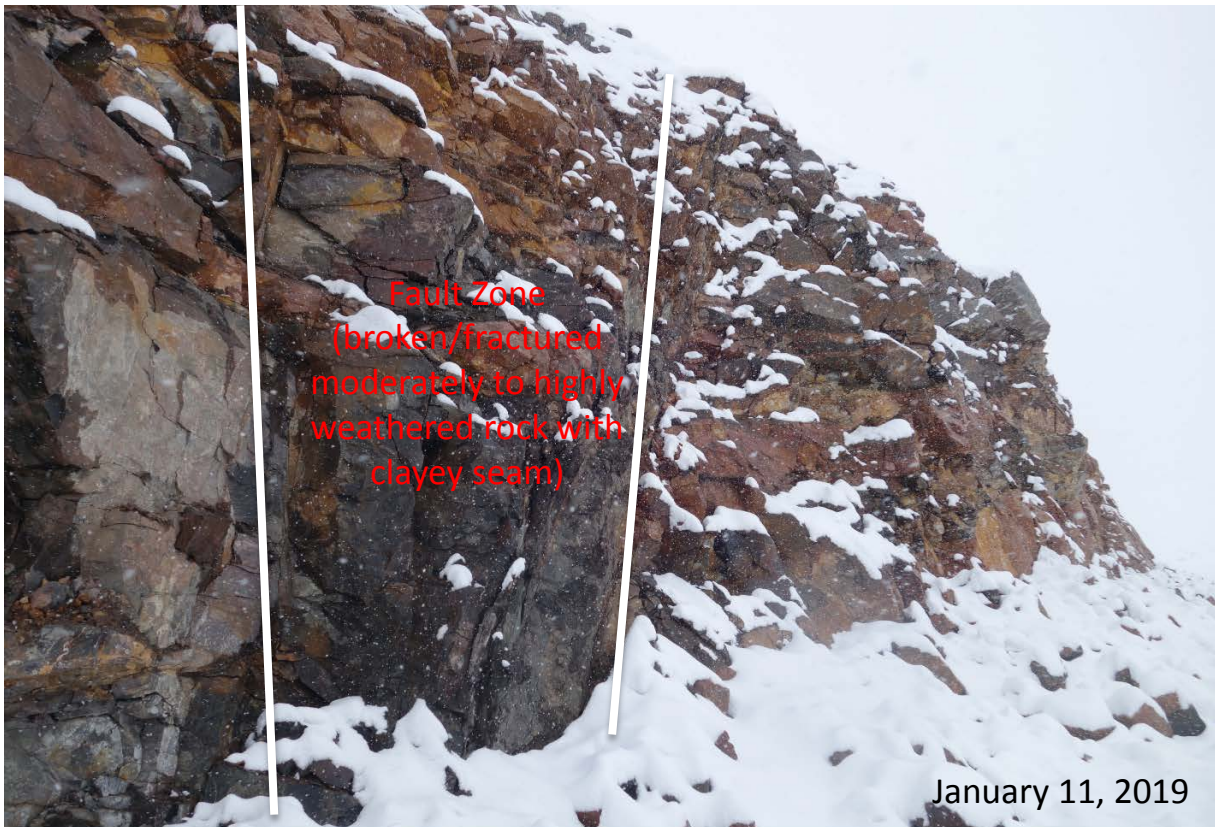
Photo 3

In the Southern Expansion Area, Gable (1968) mapped a third fault that also trends roughly east-west (Figure 3). This fault was initially exposed during the 2006 investigation, and was noted by a distinct pegmatite vein that was surrounded by decomposed weak biotite rich gneiss. The fault was exposed in temporary excavation walls along the western and southern margin of the Southern Expansion Area during previous and current year site visits. GPS measurements taken along the margin of the fault exposure (19-SHEAR) were registered in Google Earth to the existing fault map yielding a good match with the previously mapped trace (Figure 2 and Photo 3). The fresh exposed temporary highwall in the

current lower bench (elevation approximately 6545 feet) show signs of diminishing fault exposure with much narrower width of the shear zone (3 to 5 feet).

During our 2018/2019 site visits, we observed only one fault exposure along the temporary excavation wall in the Southern Expansion Area at station 19-SHEAR (Figure 2, and Photo 3). The fault is oriented approximately east-west, with apparent dip/dip direction of 85/185 and was exposed in the north to northwest facing temporary wall of the expansion area. The fault zone consists of orange-reddish weathered, broken and blocky pegamatite rock, with parallel fracturing with local clayey gouge. The location of this fault is, in general, a good match with the previously mapped trace. The apparent width of the fault zone varies from 3 to 5 feet. The fault orientation measurements for this annual report are presented with previous fault measurements and differentiated by the fault feature they represent in Figure 4.

Looking from Station 19-Shear (Figure 2) at near vertical east-west trending fault (3 to 5 feet wide) observed in an actively-mined portion of the Southern Expansion Area at ~EL 6545 ft.

We also recommend that known faults are tracked and observed in new exposures to confirm orientation and character for supplemental stability analysis, as needed. We expect the southern fault identified by Gable (1968) and in previous years site visits (Figure 3) may be exposed in other locations as excavation continues in the Southern Expansion Area. Additionally, the unmapped fault generally located in the central portion of the quarry may be exposed for mapping in the future. As recommended in the previous reports, evaluations will be conducted during future investigations to assess whether or not any of the foliation sets (F-1 through F-3) are caused due to localized faulting that may have resulted in “structural regions” that have created areas in which the varying orientation of the foliation planes occur. These questions will continue to be addressed as more data is collected.

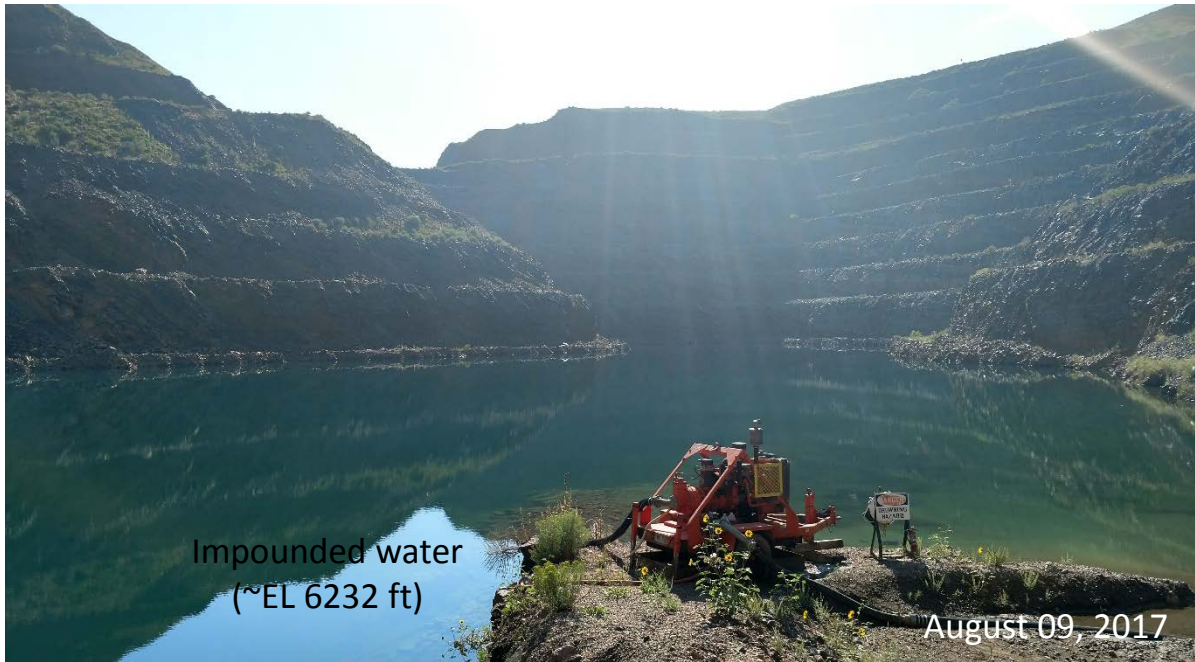
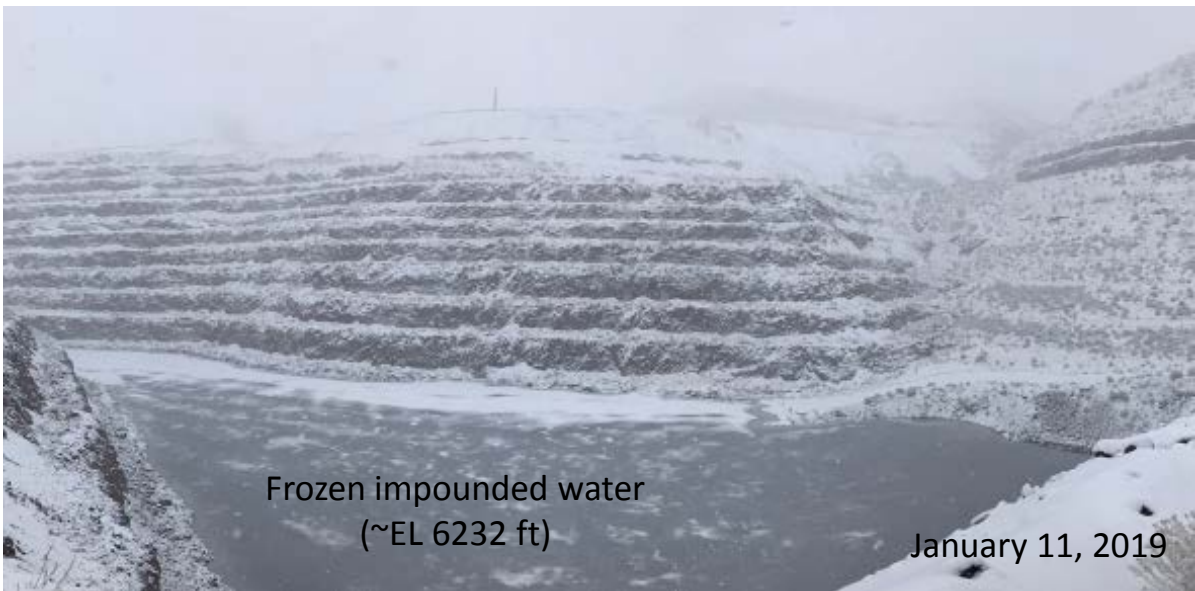
Photo 4

Mining activities have typically been focused in two distinct areas: the Main Pit and the Southern Expansion Area (Figure 2). It is our understanding that minimal or no mining activity has occurred in the Main Pit Area since our last report with the exception of minimal pumping of the impounded water.

Main Pit area showing temporary walls and impounded water.

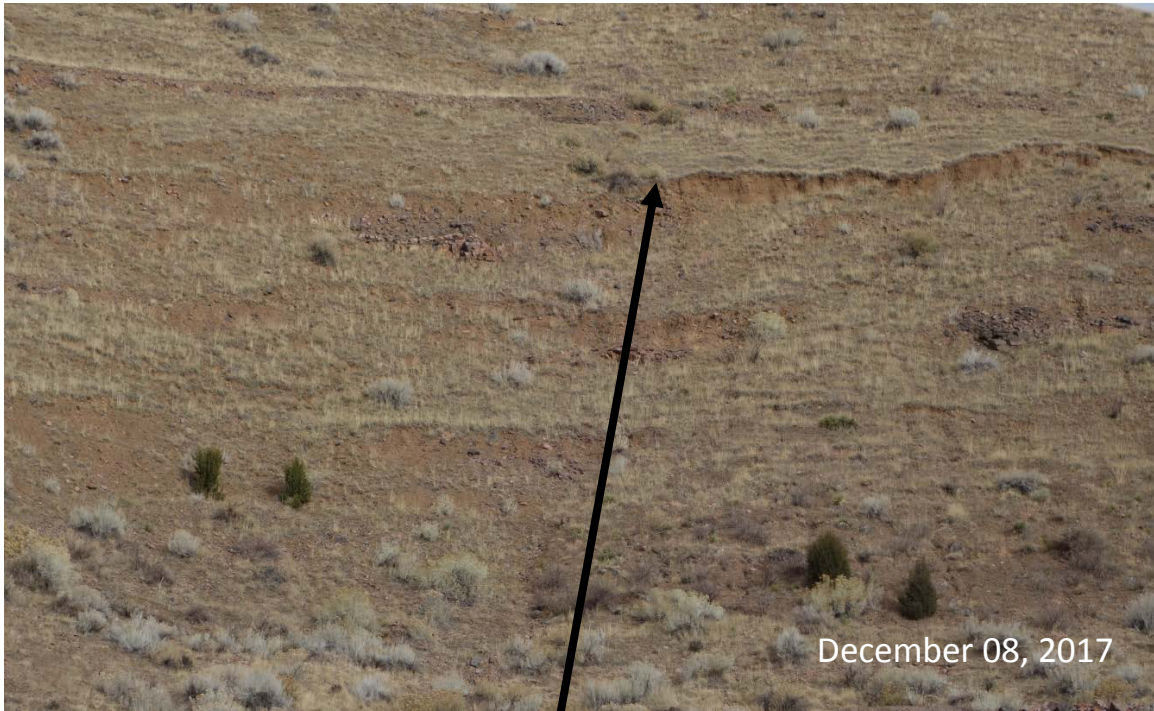
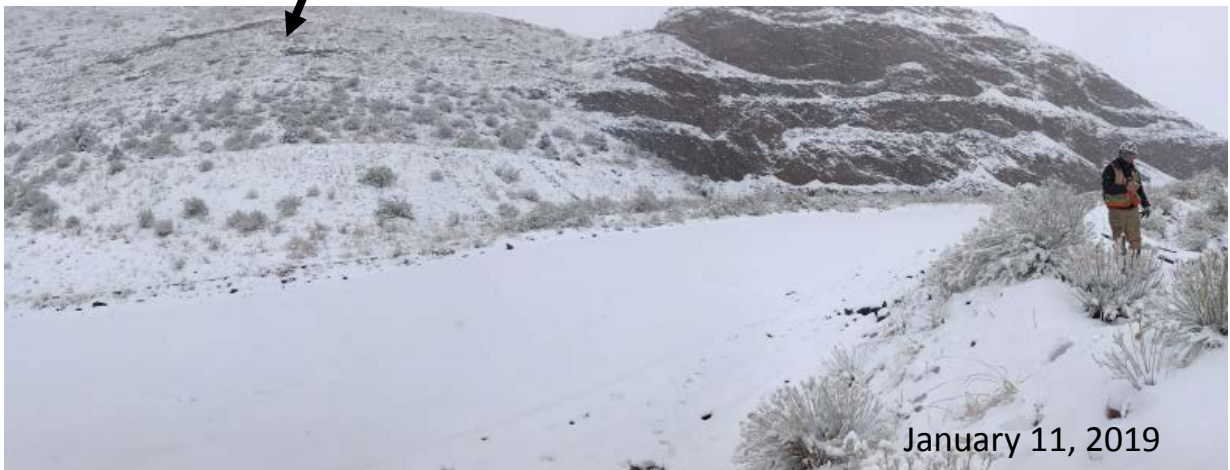
After planar failure along foliation planes in 1998 and 1999, the overall effective angle of the last three benches of Northeast Wall 1 and the Northwest Wall were reduced to an angle of 35°, which is consistent with the 2003 Lachel geotechnical evaluation (Lachel, 2003). The failure surfaces (i.e., the surfaces along which movement has occurred) remain at a “residual strength” and therefore are less resistant to

additional loading. Based on visual inspection from the access road and bottom of the pit, these slopes did not appear to show signs of additional movement during the site visits for this study (Photo 5). Although the slope configuration is currently stable, the failure mechanism could potentially be reactivated, resulting in movement of additional material. The Northwest Wall, Northeast Wall 1, and Northeast Wall 3 (Figure 2) should continue to be visually monitored for indications of instability.

Looking north from the Main Pit Area at pre-existing scarp feature on the north slope. It appears unchanged since December 2017.
