**MINERALS PROGRAM INSPECTION REPORT**  
**PHONE: (303) 866-3567**

| <b>MINE NAME:</b><br>San Luis Project | <b>MINE/PROSPECTING ID#:</b><br>M-1988-112 | <b>MINERAL:</b><br>Gold and silver | <b>COUNTY:</b><br>Costilla |
| <b>INSPECTION TYPE:</b><br>Multi Person Inspection | <b>INSPECTOR(S):</b><br>Timothy A. Cazier | <b>INSP. DATE:</b><br>June 20, 2018 | <b>INSP. TIME:</b><br>09:30 |

This inspection report supplements the inspection report by Lucas West in that this report focuses on the inspection of the tailings facility embankment. This inspector accompanied Ms. Deb Miller (engineer of record) with Miller Geotechnical Consultants for the inspection of the embankment.

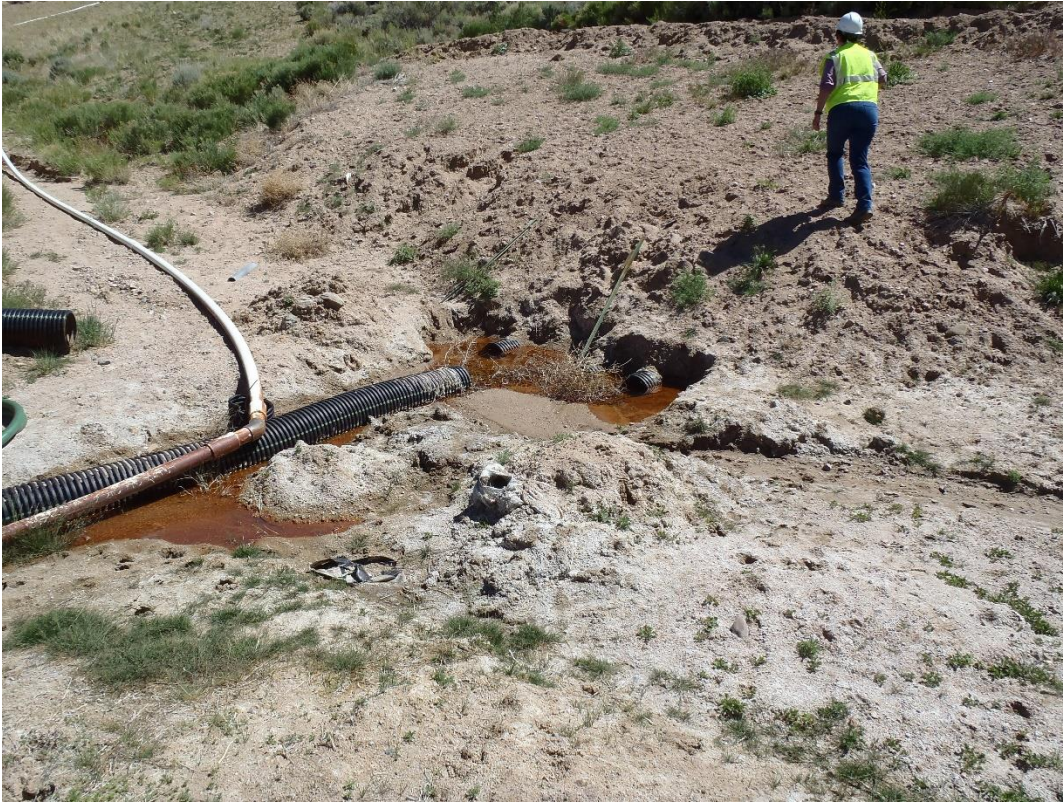
**Toe Drains:** There was no visual evidence of seepage through the toe. The three toe drain discharge pipes (see **Photo 1**) appeared to be functioning, although these were disconnected from a previously attached manifold. The only observed sign of water seeping through the dam was from these three pipes. As the outlets were partially submerged it was difficult to gage the flows from each individual pipe. The ponding did not appear to be significant. However, modifying the outfall drainage such that it is free draining away from the toe would improve performance and long term stability by lowering the risk of pore pressure buildup.

Photo 1. Three toe drain discharge pipes (manifold disconnected).

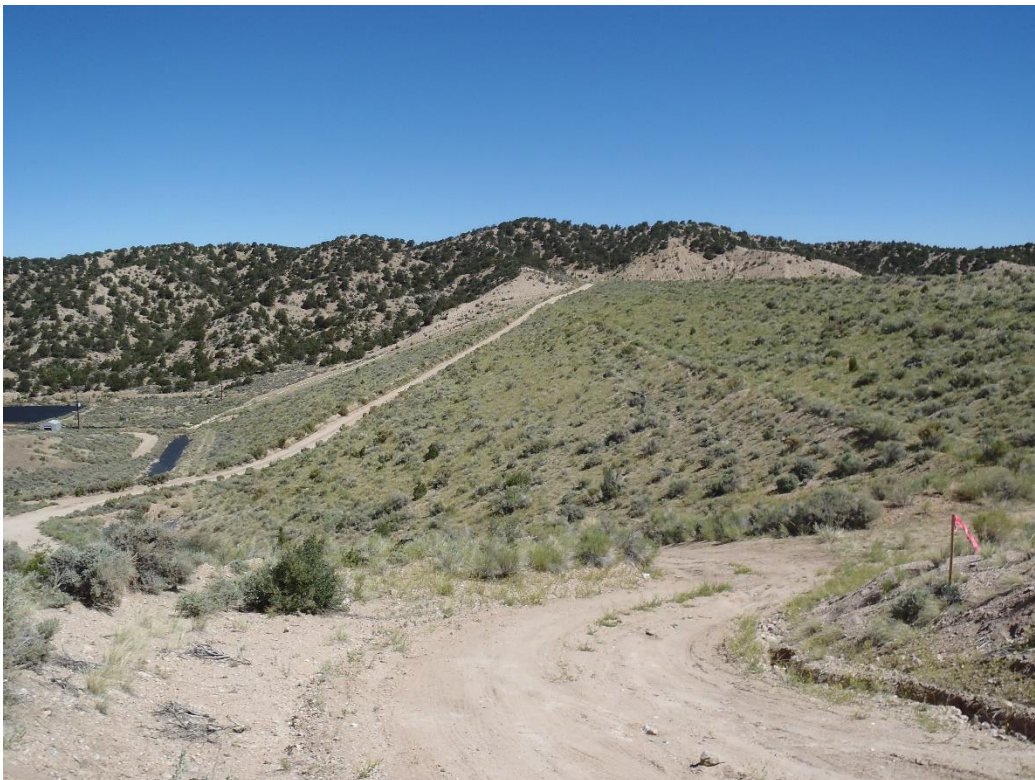
**Downstream Slope:** The downstream slope of the dam was walked to determine the overall condition of the dam. The downstream slope appeared to be in good condition (exceptions on the north end discussed below) and was covered with grasses and small shrubs (see **Photo 2**). Some erosion gullies were observed on the north end of the downstream slope (see **Photo 3**). Ms. Miller indicated previous erosion gullies were much worse and the mine had initiated repairs (see **Photos 4 and 5**) are revegetation efforts greatly improving the situation. However, she agreed additional erosion control efforts needed to be implemented. Some of the small riprap on the geotextile had been washed off by runoff in these downchutes (see **Photo 6**) and the energy from these flows had eroded the downstream edge of the intercepting cross channels (see **Photo 7**). My field experience suggests riprap on slopes steeper than about 10 to 12 percent is easily washed off geotextile filters. I recommend using a granular filter for long term performance on steep slopes. Vegetation was not yet fully established on the north end where previous erosion repairs were completed (see **Photo 8**).

Photo 2. Downstream slope (looking north from left groin).

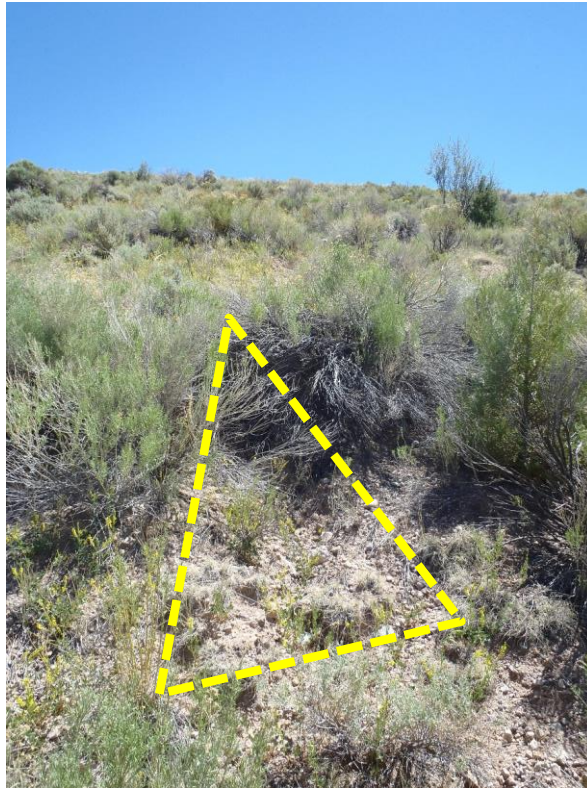
Photo 3. Typical erosion gully observed on the north end of the downstream slope (looking upslope).

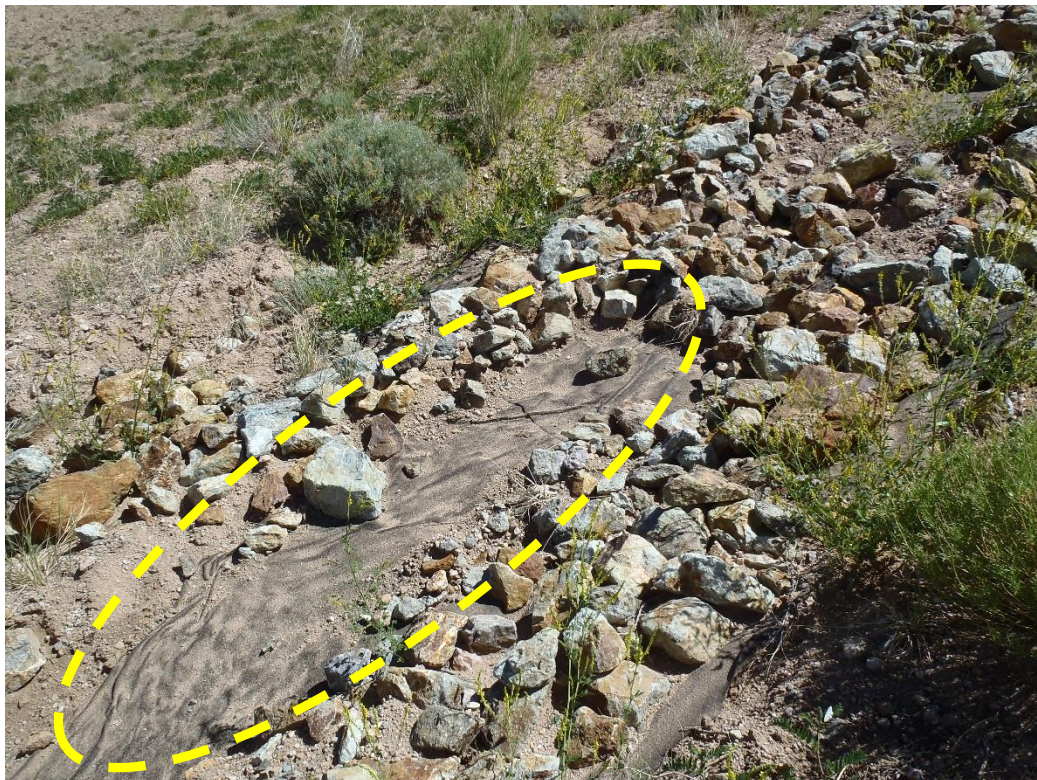
Photo 4. Drainage repair work (downchute) needing maintenance (note exposed geotextile filter).

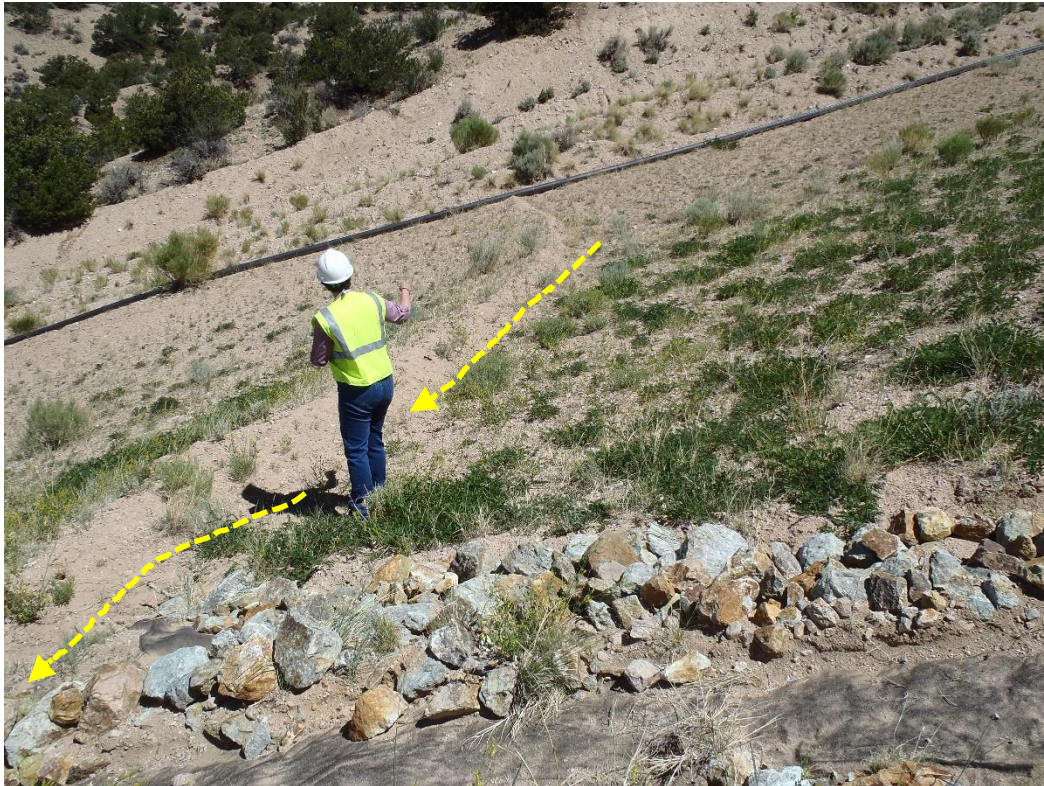
Photo 5. Drainage repair (cross channel) needing maintenance (some cross channels eroded right banks).

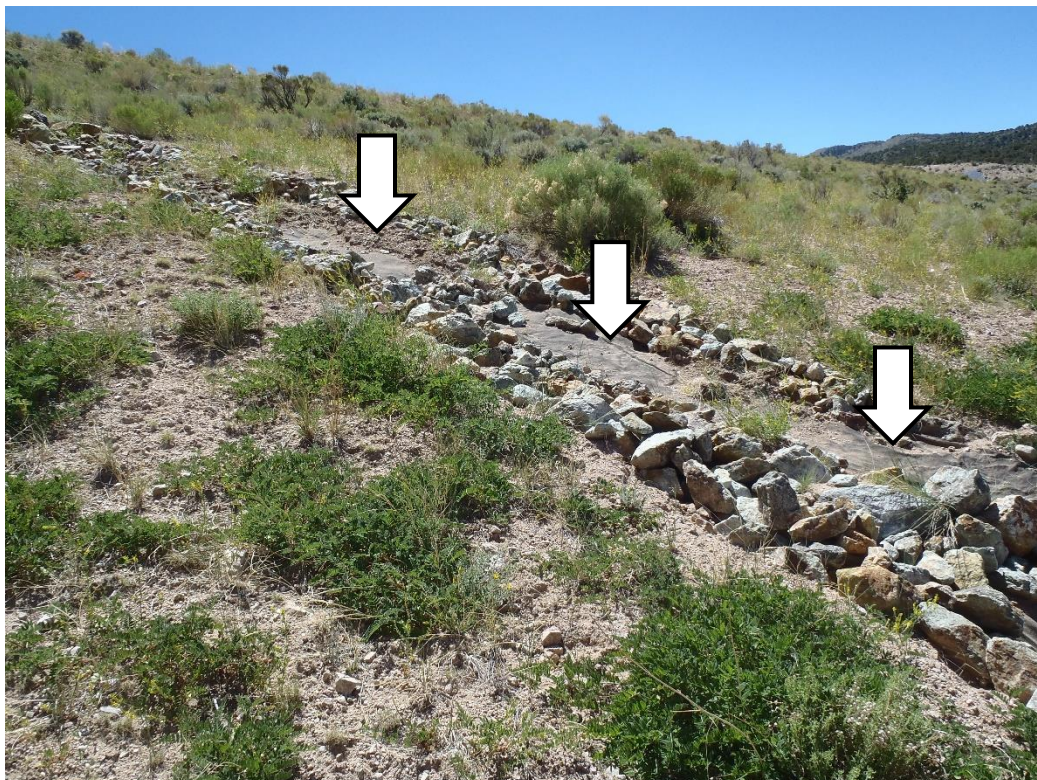
Photo 6. Drainage repair (downchutes) needing maintenance (small riprap washed of geotextile filter).

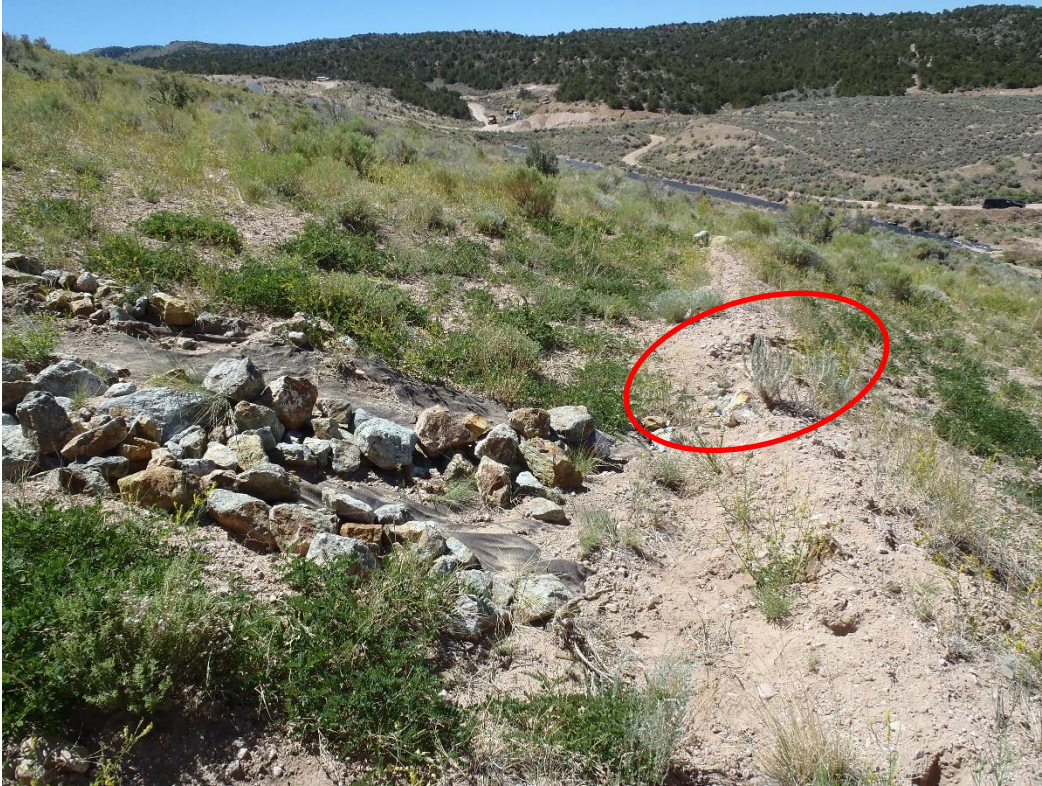
Photo 7. Drainage repair (cross channel) needing maintenance (some cross channels eroded right banks).

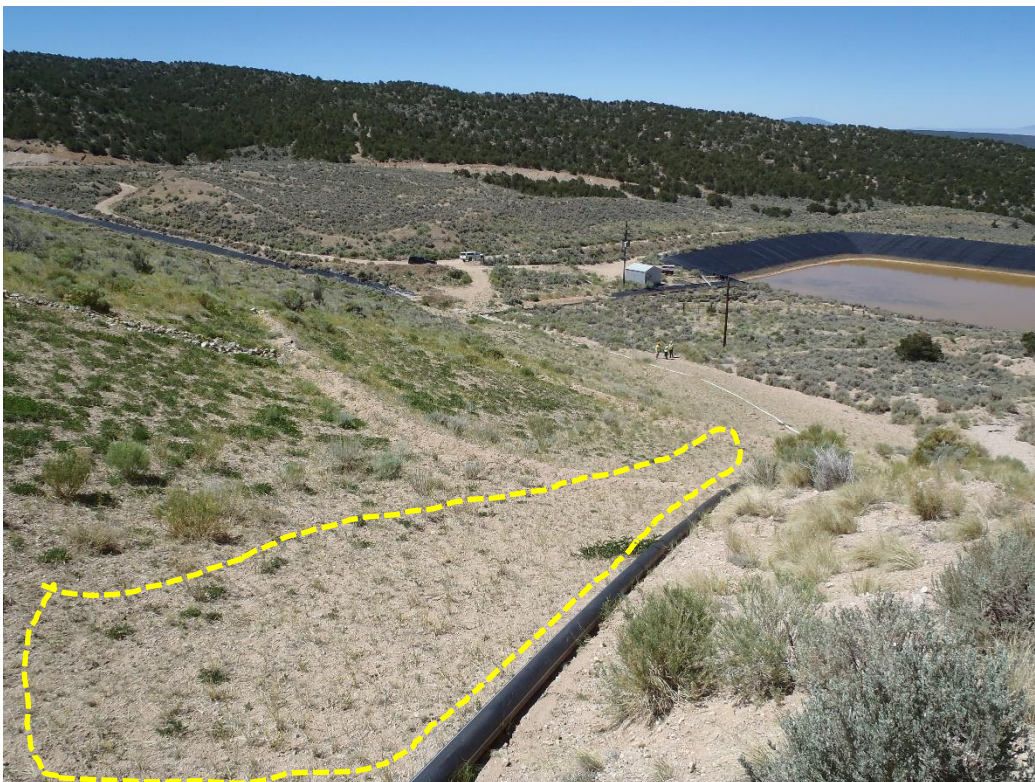
Photo 8. Vegetation not fully established, north end of previously completed erosion repairs (looking SW).

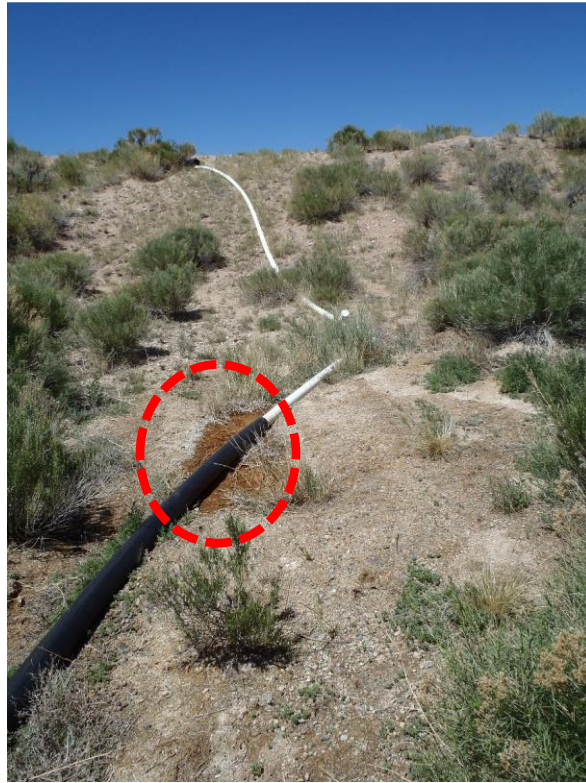
**Upstream Face:** The upstream face appeared in good condition. The pump back line towards the north end did show signs of leaking (see **Photo 9**). This should be repaired.

Photo 9. Leaking pump back line (north end of beach, looking west).

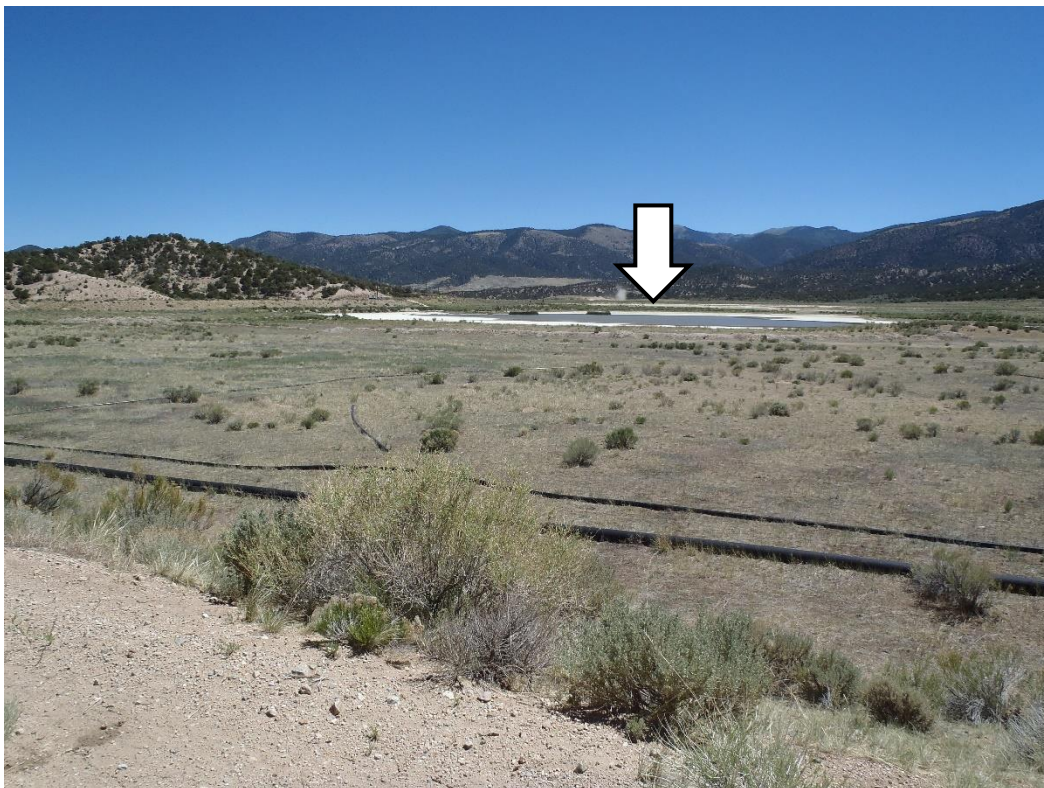
**Water Level:** The level pool was estimated to be between 700 and 800 feet from the crest (see **Photo 10**).

Photo 10. Level pool (looking NE from near center of dam crest).

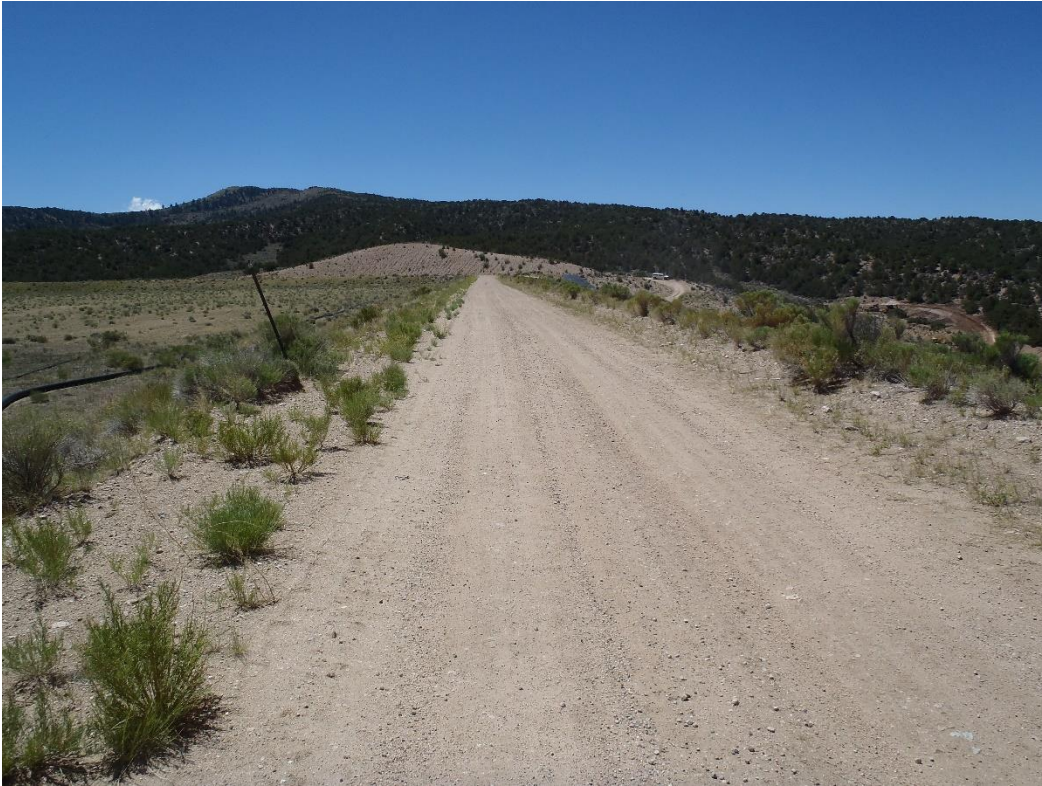
**Crest Condition:** The crest and upstream face appeared to be in good condition (see **Photos 11 and 12**). The crest is maintained as an access road to the south side of the facility.

Photo 11. Dam crest (looking south from near center of dam crest).

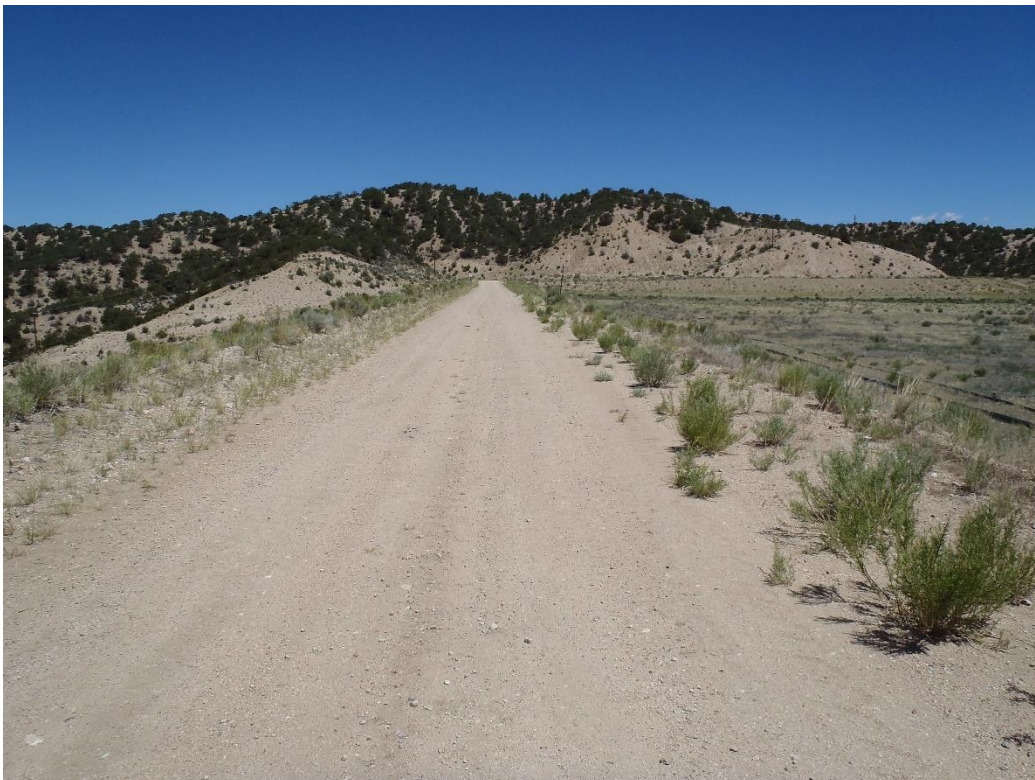
Photo 12. Dam crest (looking north from near center of dam crest).
