MINERALS PROGRAM INSPECTION REPORT

MINE NAME: Simla Highway Pit	MINE/PROSPECTING ID#: M-1995-095	MINERAL: Gravel	COUNTY: El Paso
INSPECTION TYPE: Surety-Related Inspection	INSPECTOR(S): Timothy A. Cazier	INSP. DATE: February 21, 2019	INSP. TIME: 12:30
OPERATOR: Hill Top Gravel LLC	OPERATOR REPRESENTATIVE: Blake Tope	TYPE OF OPERATION: 110c - Construction Limited Impact	
REASON FOR INSPECTION: Surety Related	BOND CALCULATION TYPE: Complete Bond	BOND AMOUNT: \$11,280.00	
DATE OF COMPLAINT: NA	POST INSP. CONTACTS: None	JOINT INSP. AGENCY: None	
WEATHER: Clear	INSPECTOR'S SIGNATURE:

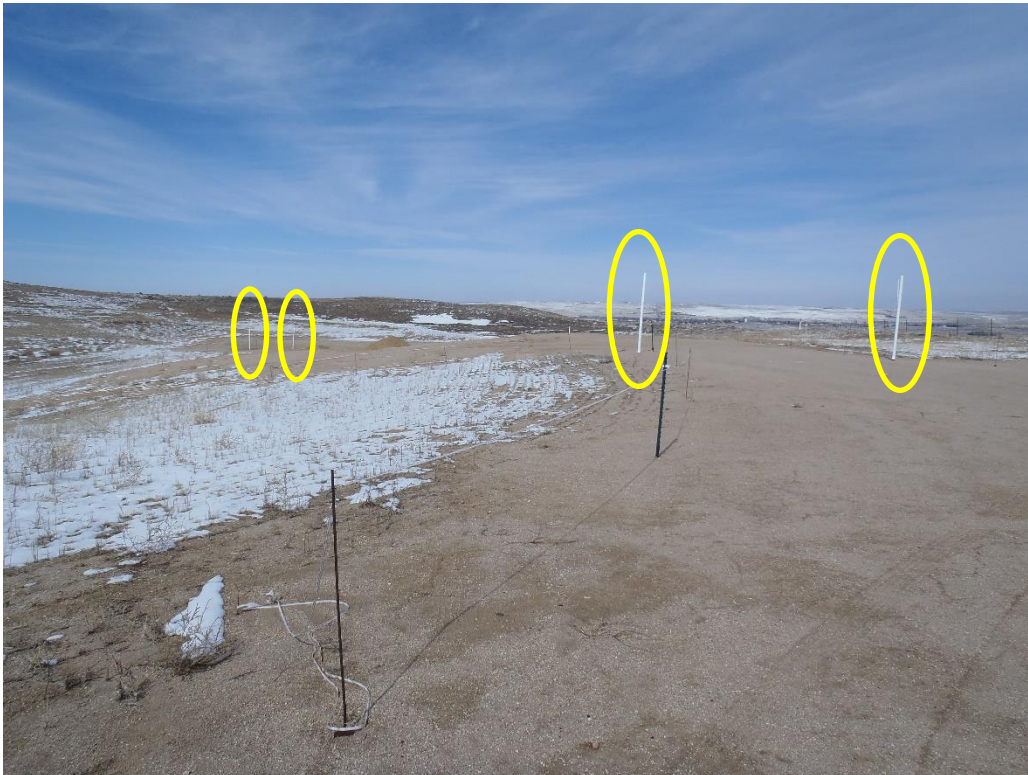
The site was in a similar condition as when inspected by the DRMS on April 10, 2018. Large white pipes (see **Photo 1**) marking the corners of affected area boundary were still present. The active mining area was confined to this area. A product stockpile was observed in the affected area boundary (see **Photo 2**).

Photo 1. Affected area (active area) boundary markers (looking north).

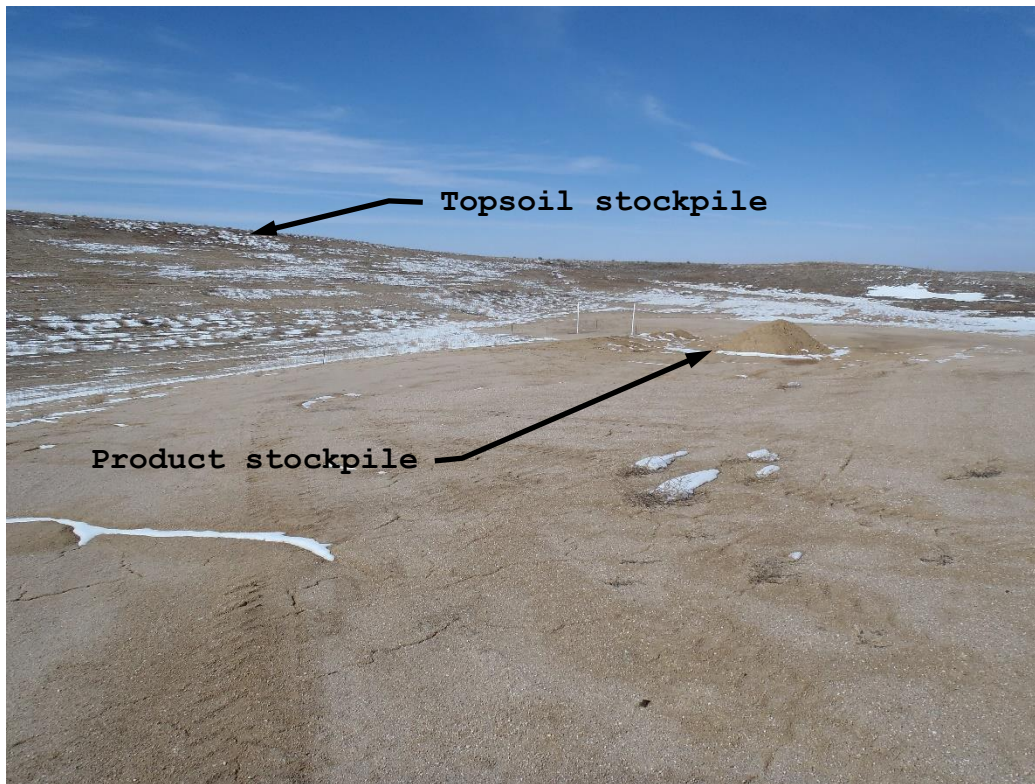
Photo 2. Active working area, (looking NW).

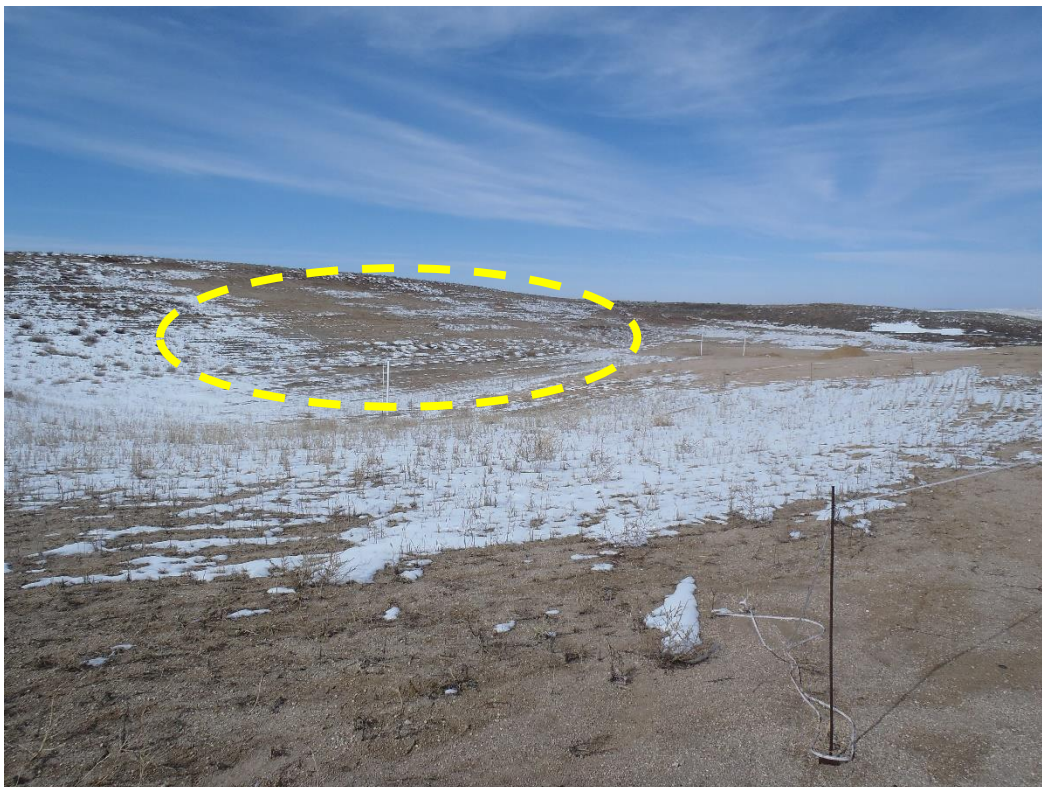
The site had recently been hydromulched prior to the previous inspection. It was noted that vegetation on the west side of the pit (east facing slope, see **Photo 3**) did not appear to be supporting new vegetation that would have been expected to grow during the 2018 growing season. I mentioned to Mr. Tope the topsoil stockpiled on the west crest (see **Photo 2**) was not utilized when reclamation was initiated on this slope in 2018, and that certainly is expected to make a difference.

Photo 3. Previously hydromulched west slope not supporting vegetation (looking NW).

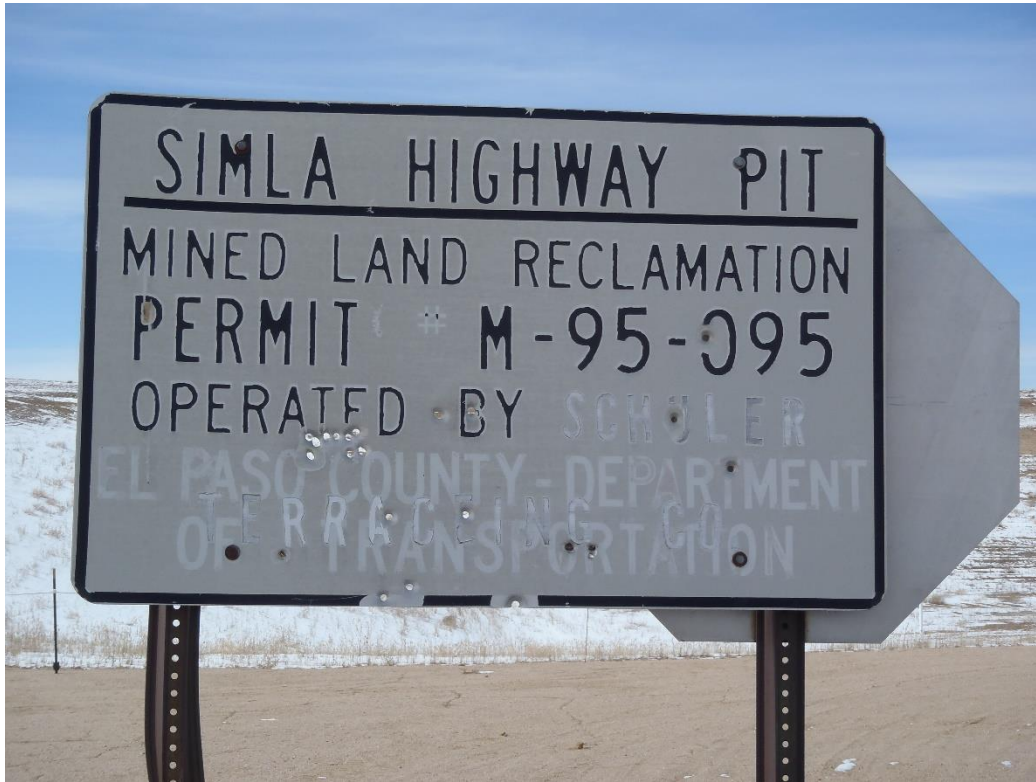
The permit sign was in place at the entrance (see **Photo 4**). Schuler Terracing (the permittee until August 2018) had been removed from the sign. [The current permittee name, "Hill Top Gravel" needs to be added to the permit sign.](#)

Photo 4. Permit sign at entrance, needing "Hill Top Gravel" added.
