MINERALS PROGRAM INSPECTION REPORT
PHONE: (303) 866-3567

MINE NAME: Lone Tree Pit	MINE/PROSPECTING ID#: M-2014-034	MINERAL: Sand and gravel	COUNTY: Huerfano
INSPECTION TYPE: Monitoring	INSPECTOR(S): Patrick Lennberg	INSP. DATE: February 20, 2019	INSP. TIME: 13:30
OPERATOR: Huerfano County	OPERATOR REPRESENTATIVE: Bill Cordova	TYPE OF OPERATION: 112c - Construction Regular Operation	
REASON FOR INSPECTION: Normal I&E Program	BOND CALCULATION TYPE: None	BOND AMOUNT: \$0.00	
DATE OF COMPLAINT: NA	POST INSP. CONTACTS: None	JOINT INSP. AGENCY: None	
WEATHER: Windy	INSPECTOR'S SIGNATURE:

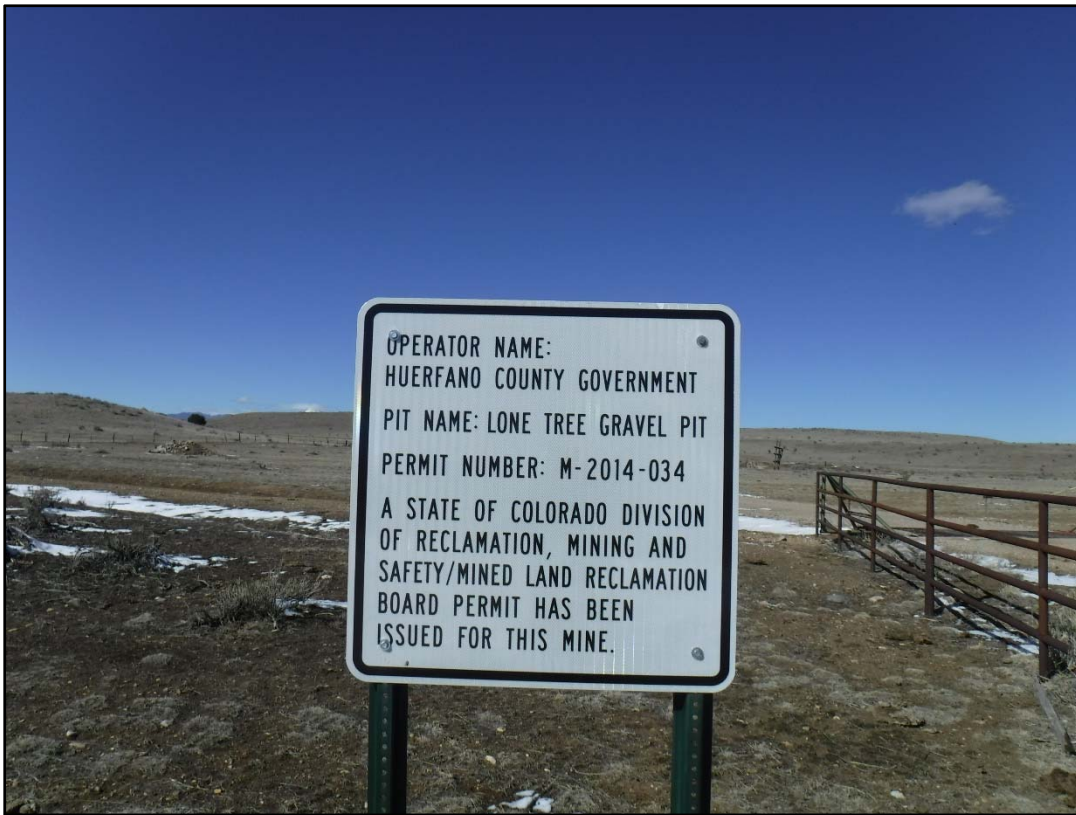
The Lone Tree Pit was located approximately 4.5 miles northeast of Walsenburg, Colorado north of Highway 160. The Lone Tree Pit is a 56 acre pit for the removal of construction materials, primarily sand and gravel. Of the 56 acres approximately 16 acres comprise the haul road that extends 2.6 miles from Highway 10 to where the pit is located. The site is surrounded by rangeland. The approved post-mining land use is rangeland. A mine sign was observed as required by Rule 3.1.12.

Photo 1: Mine sign at entrance off Highway 10

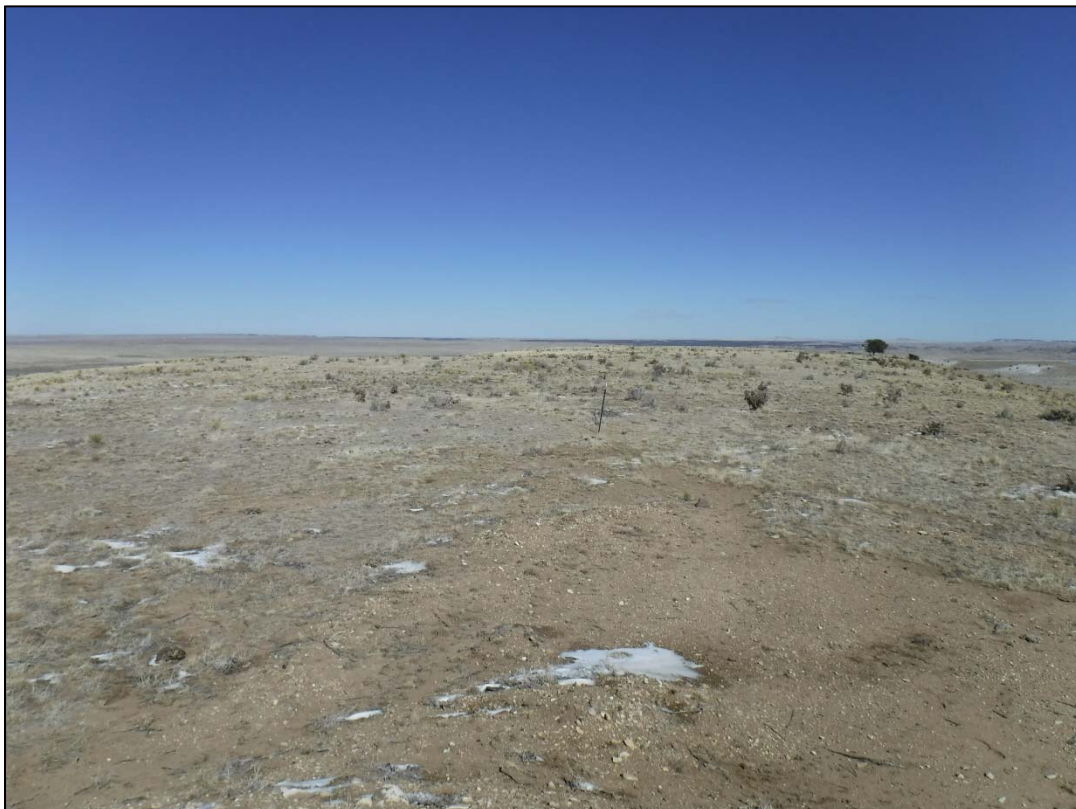
The Division was able to GPS all permit boundary markers. All current mining is well within the permit boundaries.

Photo 2: Boundary marker in the northeastern point of permit boundary

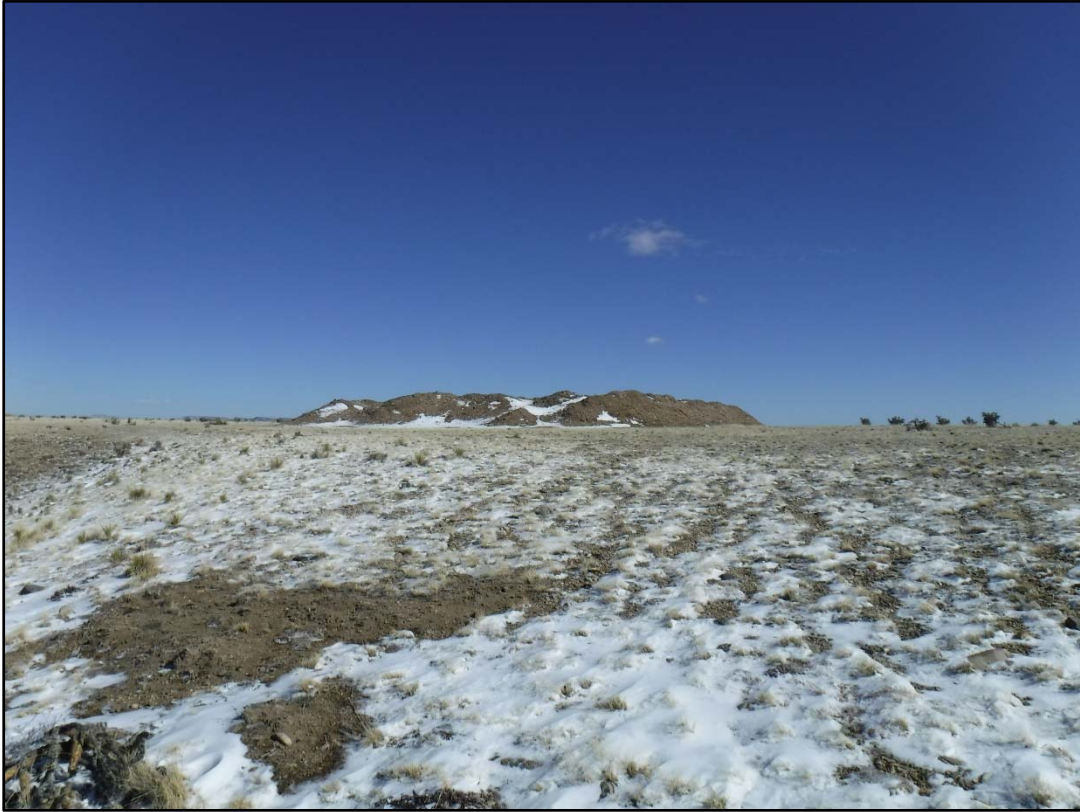
Photo 3: Topsoil stockpile

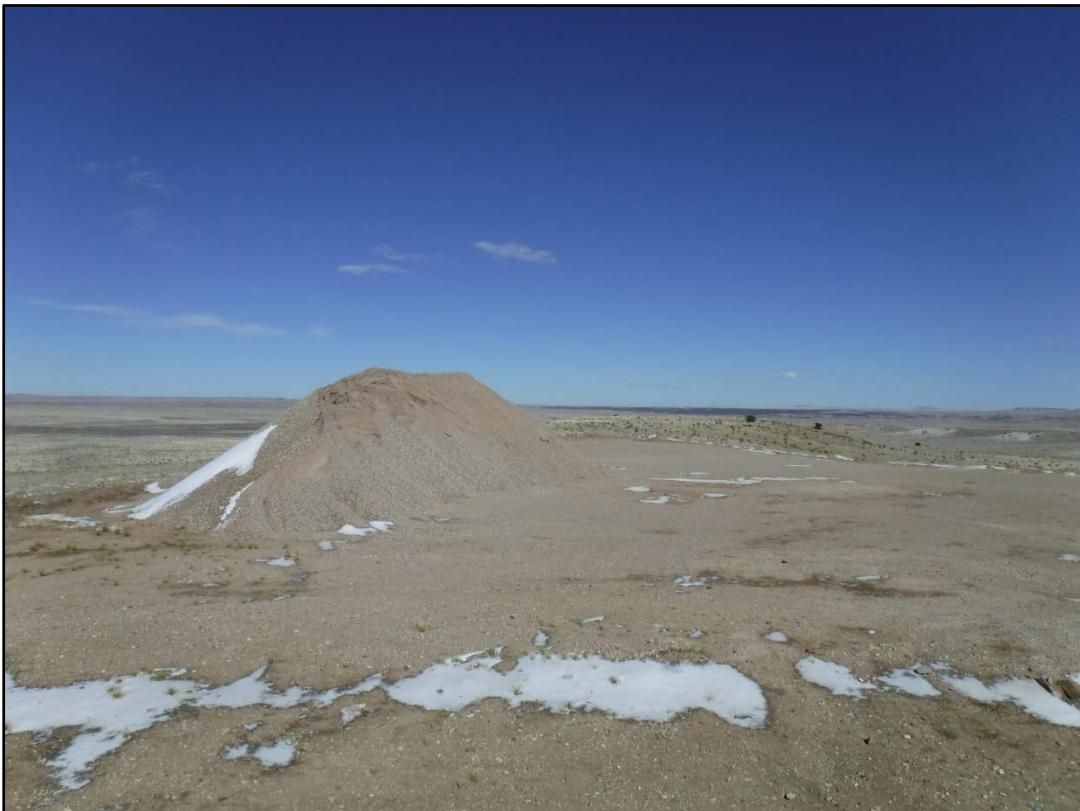
Photo 4: Processed material stockpile located in Phase 1

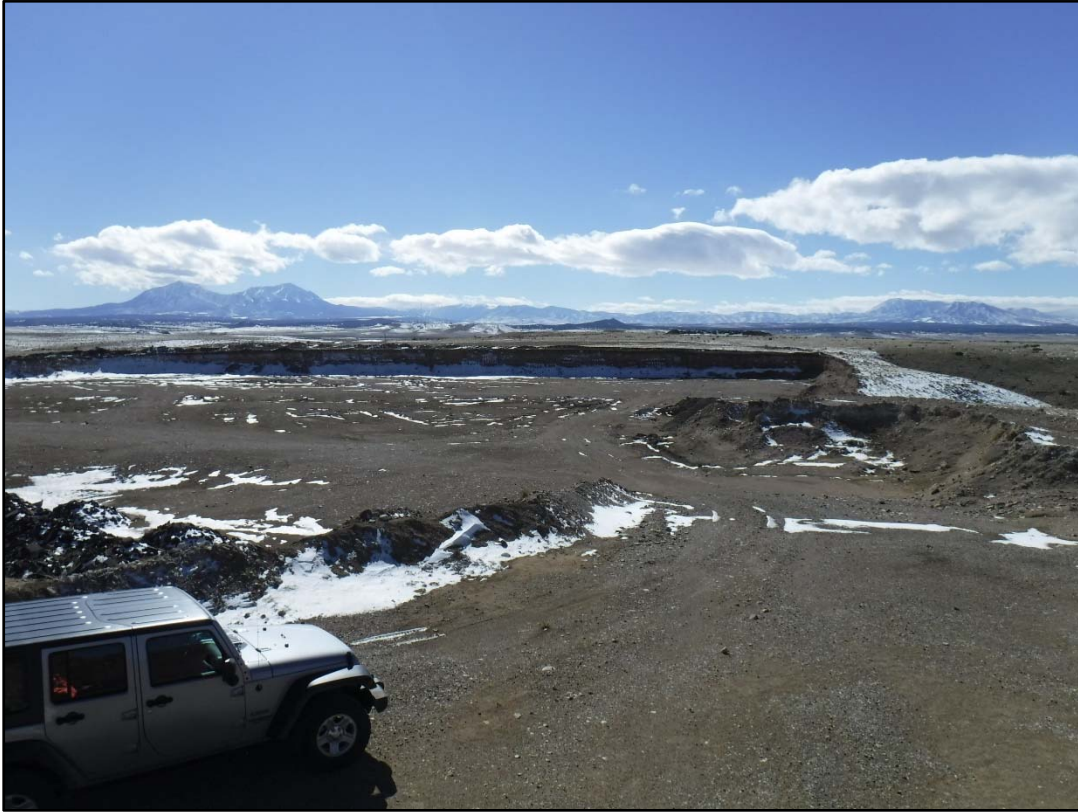
Photo 5: Pit area

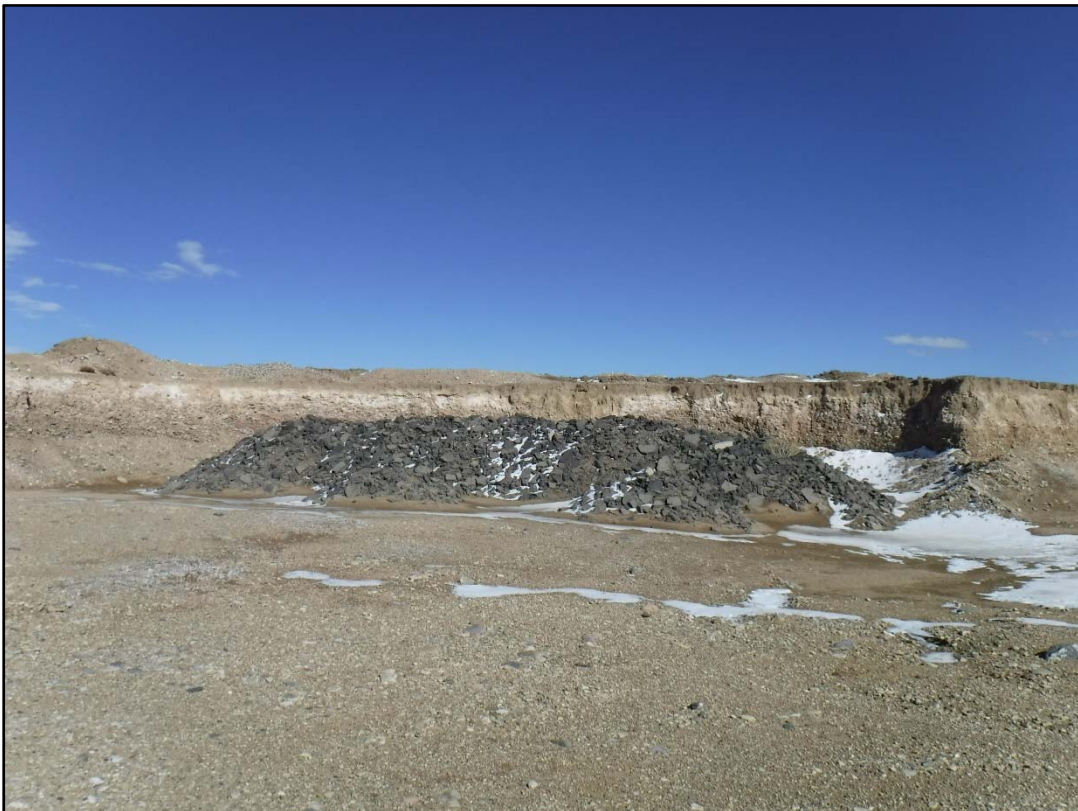
Photo 6: Asphalt material that is going to be crushed and blended into processed material

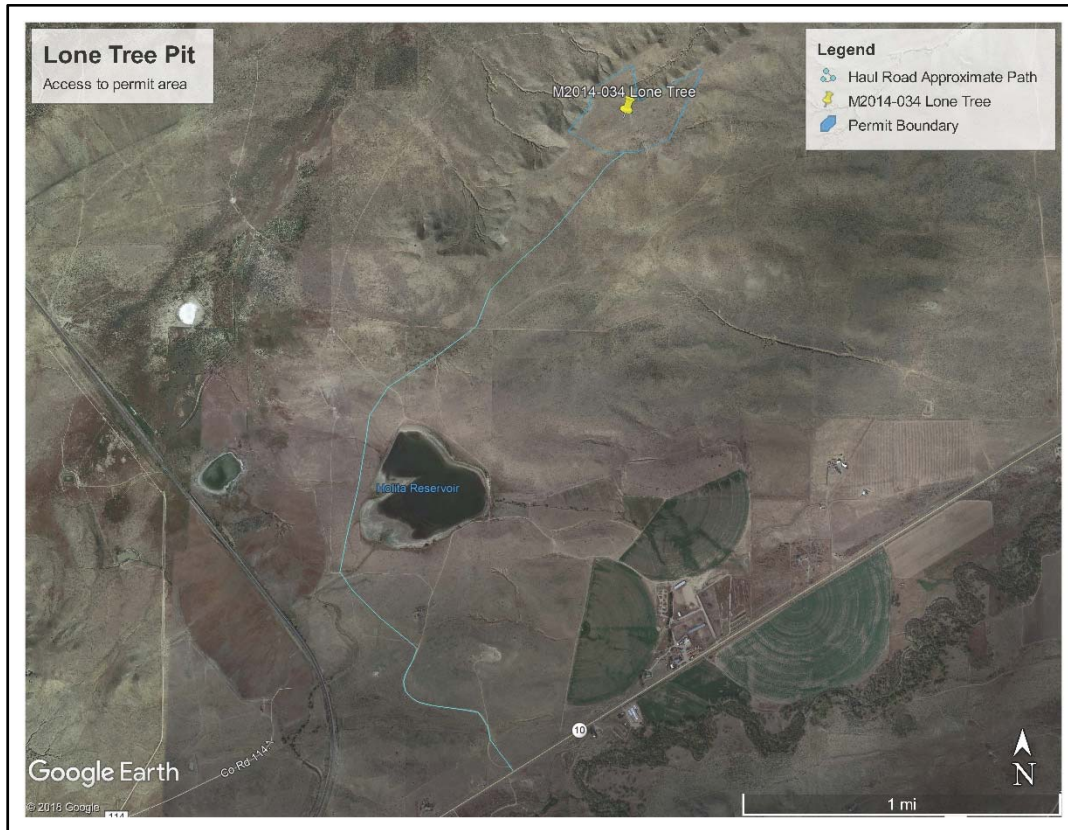
Figure 1: Haul road to permit area from Highway 10

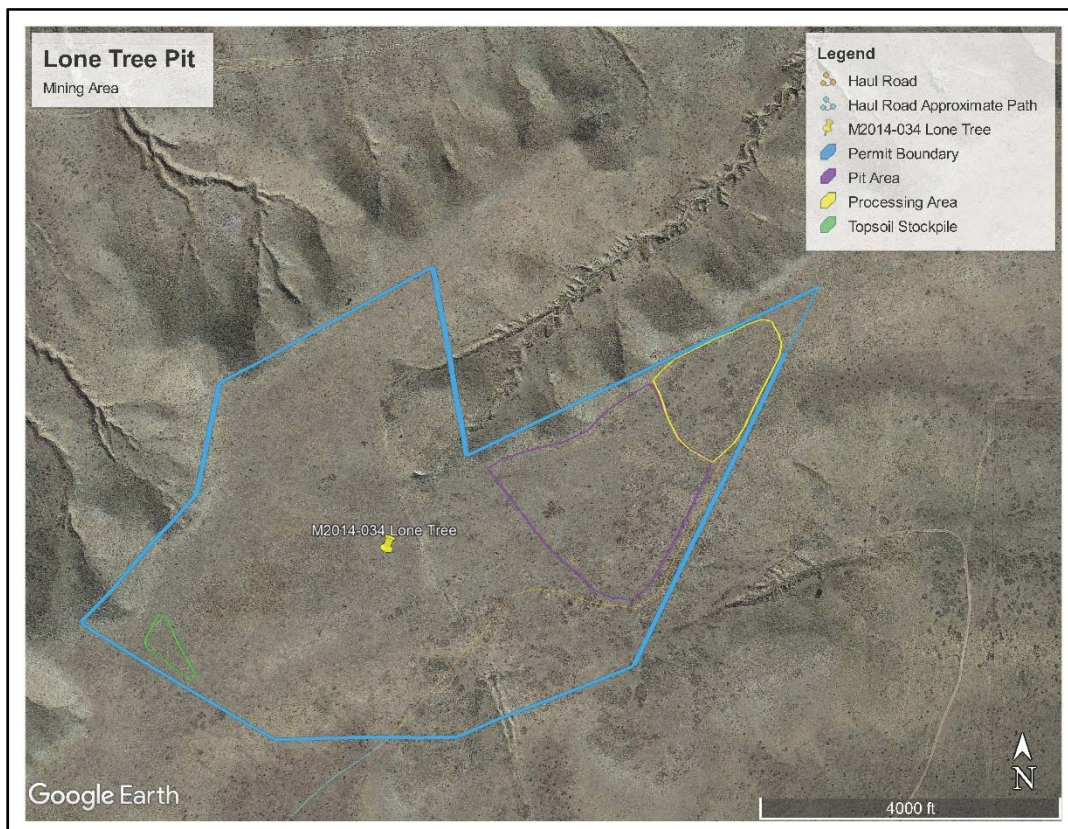
Figure 2: Permit Area
