**COLORADO**Division of Reclamation,  
Mining and Safety

**MINERALS PROGRAM INSPECTION REPORT****PHONE: (303) 866-3567**

| <b>MINE NAME:</b><br>McKenna Limestone Quarry | <b>MINE/PROSPECTING ID#:</b><br>M-2000-039 | <b>MINERAL:</b><br>Limestone (general) | <b>COUNTY:</b><br>Huerfano |
| <b>INSPECTION TYPE:</b><br>Monitoring | <b>INSPECTOR(S):</b><br>Patrick Lennberg | <b>INSP. DATE:</b><br>February 20, 2019 | <b>INSP. TIME:</b><br>12:30 |

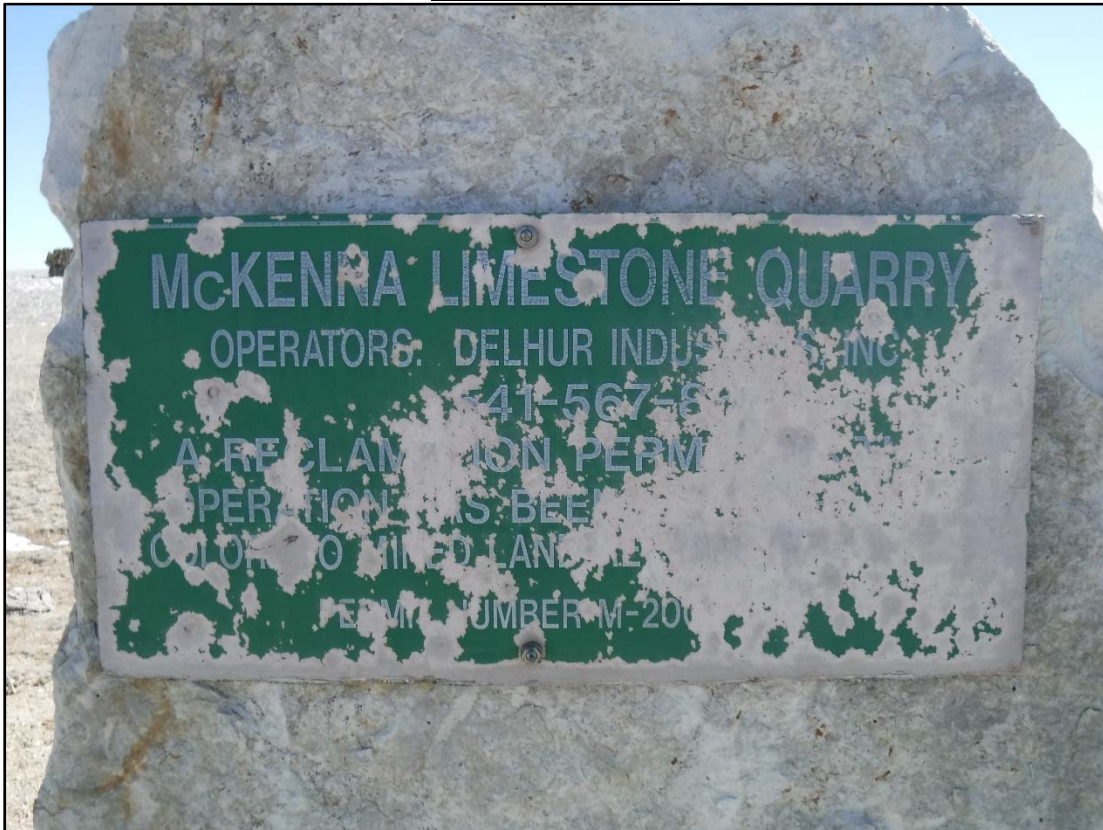
**PROBLEM/POSSIBLE VIOLATION:** Problem: The mine identification sign is very faded and the mine permit number is no longer legible. This is a problem for failure to maintain a mine identification sign as required by Section 3.1.12(1) of the rule.

The quarry is located approximately 3.5 miles southeast of the intersection of Colorado Highway 10 and County Road (CR) 210, which is about 8 miles northeast of Walsenburg, Colorado. The mine entrance road is approximately 1.5 miles southeast of the intersection of CR 210 and CR 211. The quarry is a 110c mining operation. The approved post-mining land use is rangeland. A mine sign was observed as required by Rule 3.1.12, although the sign is very faded and peeling away. It should be replaced.

**Photo 1:** Mine sign at junction of haul road and CR 211

**CORRECTIVE ACTIONS:** The operator shall, at the entrance of the mine site, repost a sign which shall be clearly visible from the access road with the following: the name of the operator, a statement that a reclamation permit for the operation has been issued by the Colorado Mined Land Reclamation Board; and the permit number. The operator shall submit photo documentation that a proper sign has been posted by the corrective action date.

**CORRECTIVE ACTION DUE DATE:** 5/04/19

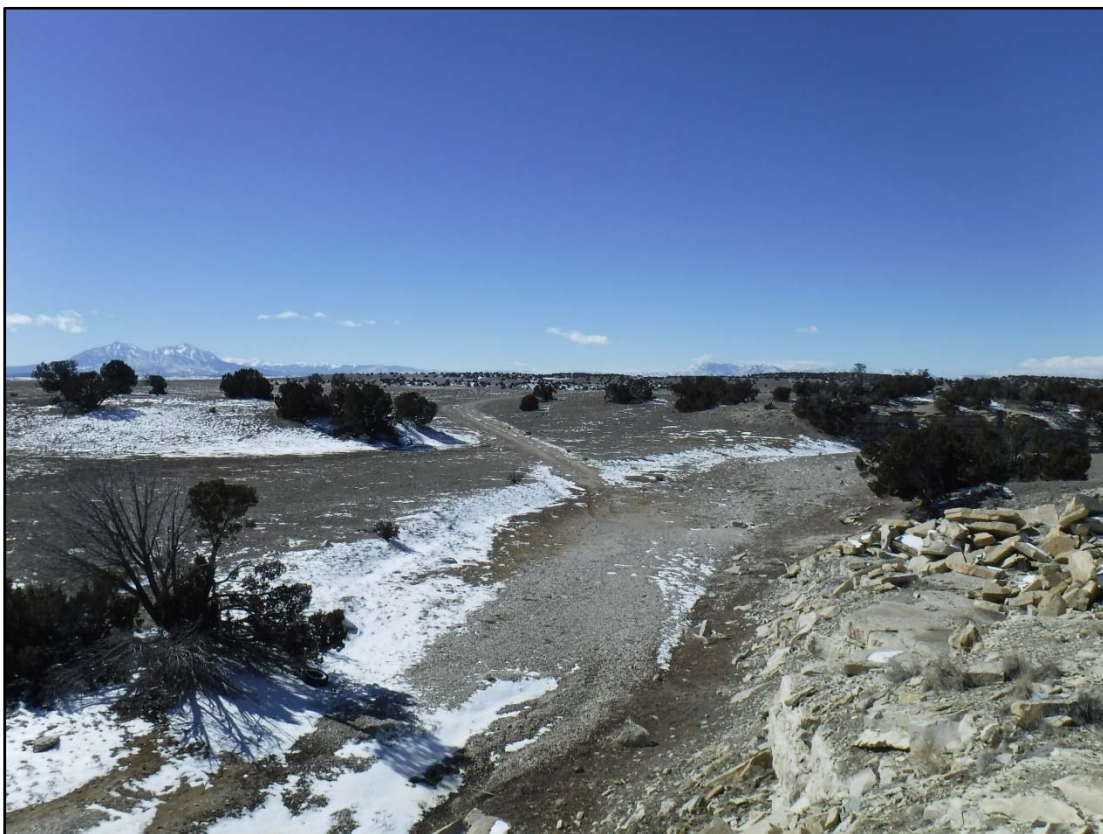
The pit and surrounding disturbed area is sloped to drain to the adjacent arroyo. There was some minor rilling observed. The haul road is in a 30 foot easement and is approximately 0.3 miles long from CR 211 that is allowed to remain in place after mining is complete.

**Photo 2:** Haul road as it comes to the site crossing the arroyo

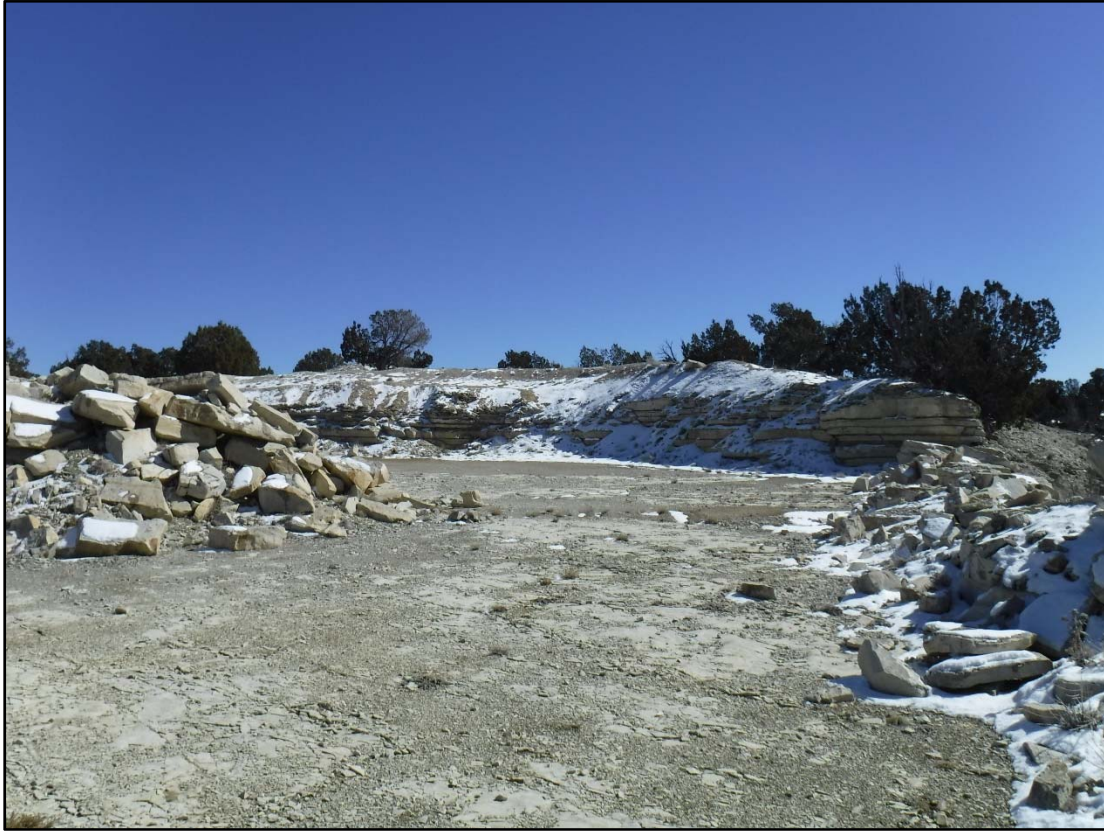
**Photo 3:** Highwall area with a small stockpile of dimensional stone to the left

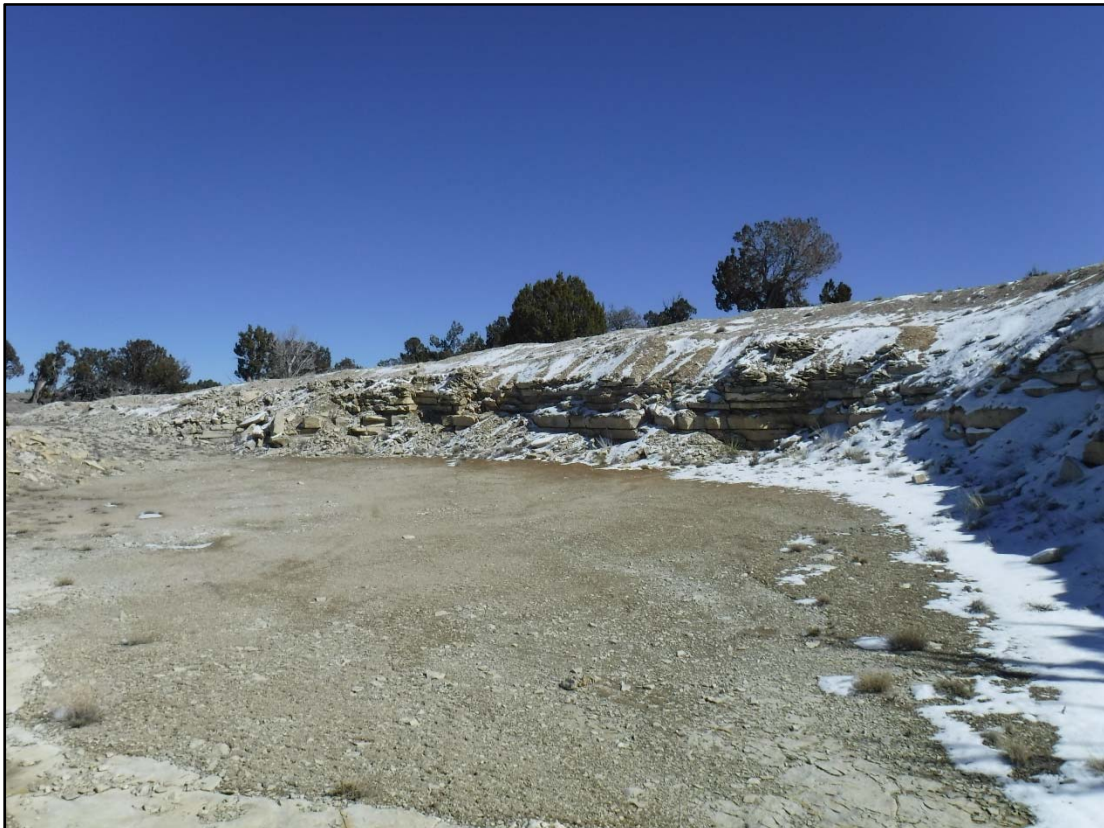
The disturbed area consists of a pit highwall located in the southern portion that is 6-12 feet high and is approximately 350 feet long. In the central part of the area there are two stockpiles of dimensional stone in a matrix of fine grained material. To the north there is a large stockpile of dimensional stone similar to the other piles. Finally, there is a large topsoil stockpile along the northern boundary of the permit area. Rick indicated that the limestone was mined in support of remediation efforts at the Summitville Mine Superfund Site.

**Photo 4:** Highwall area looking east

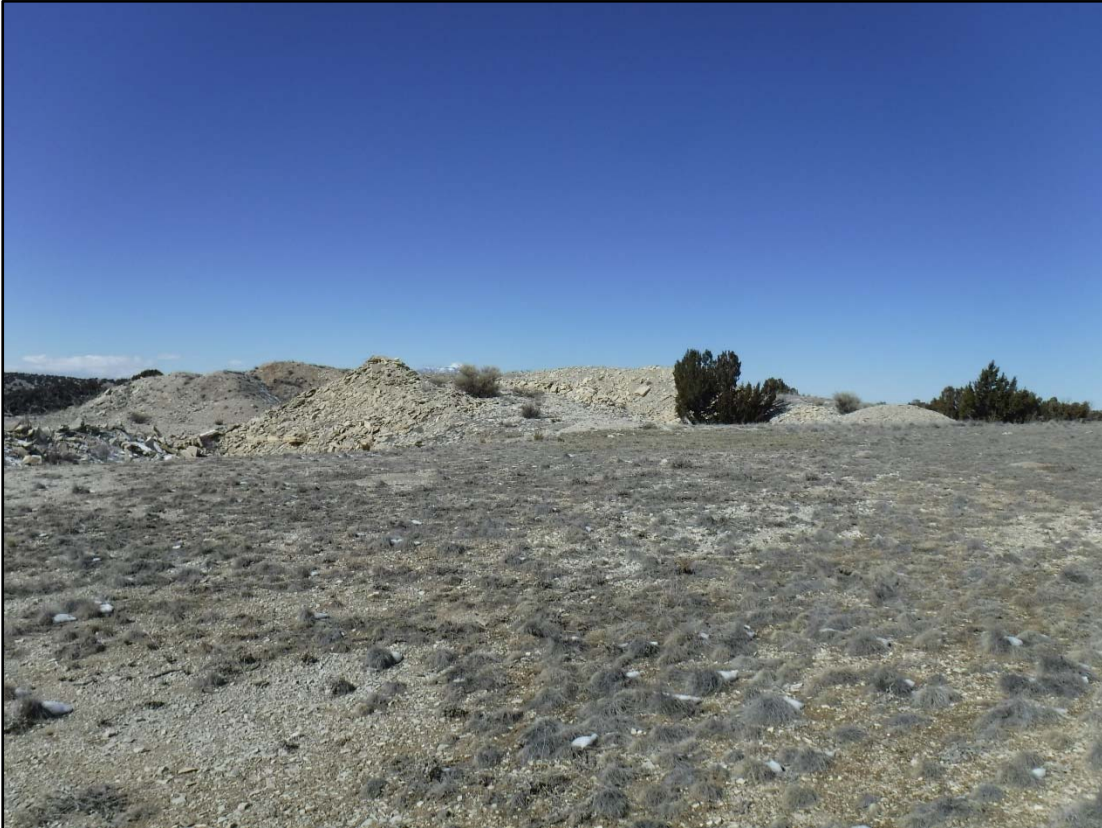
**Photo 5:** Looking north towards topsoil stockpile background with undisturbed land in the foreground

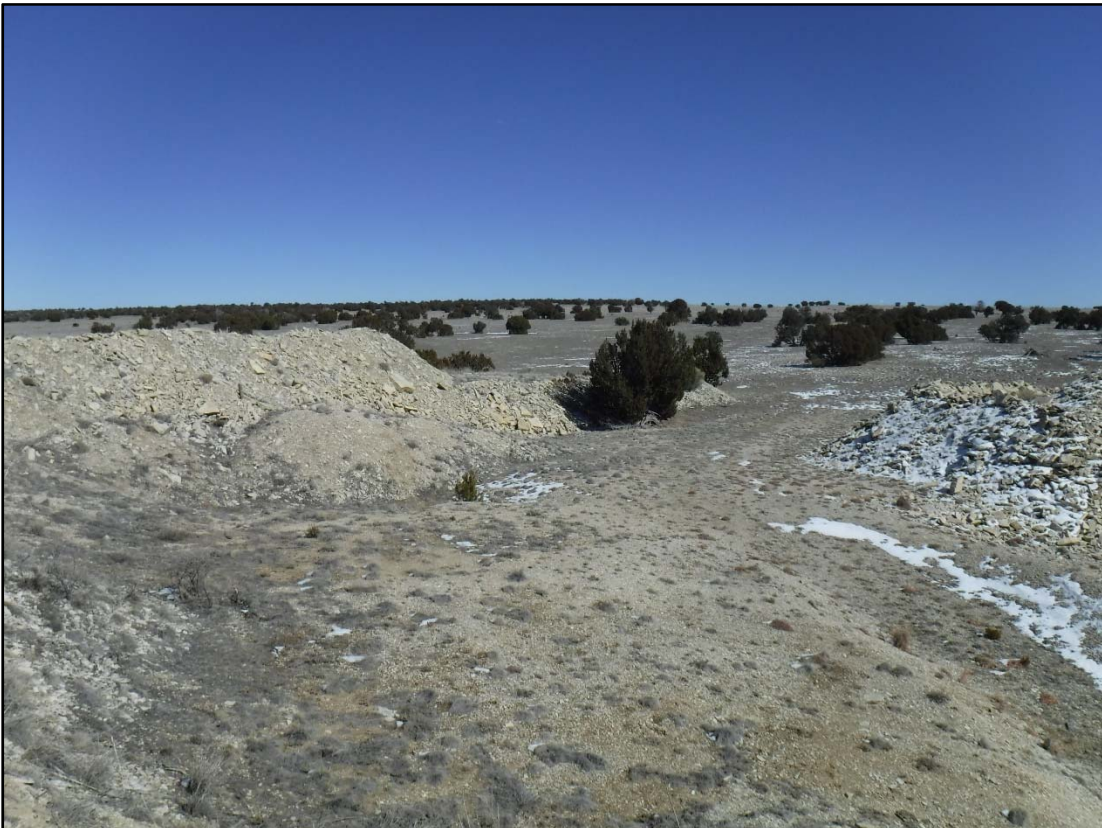
**Photo 6:** Looking southeast from the top of the topsoil stockpile, larger material stockpile to the right of photo

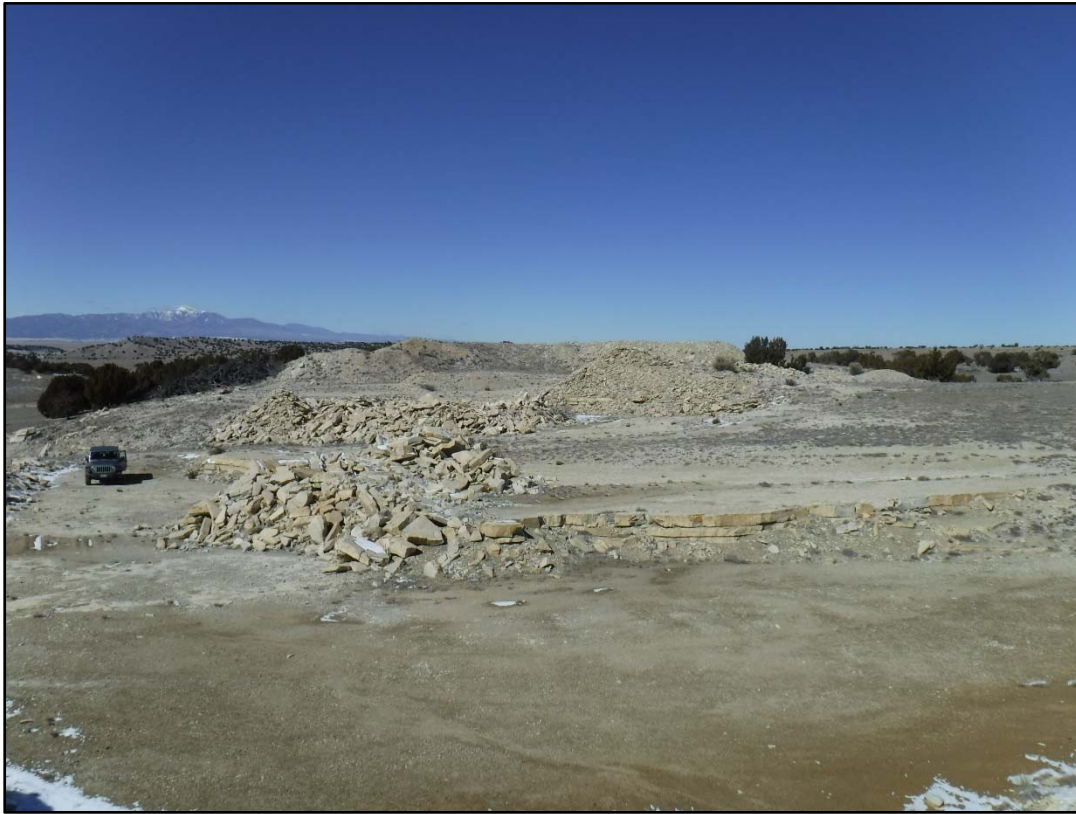
Photo 7: Looking north across the site
