MINERALS PROGRAM INSPECTION REPORT
PHONE: (303) 866-3567

MINE NAME: H/S Properties Gravel Pit	MINE/PROSPECTING ID#: M-2007-042	MINERAL: Sand and gravel	COUNTY: Montrose
INSPECTION TYPE: Surety-Related Inspection	INSPECTOR(S): Lucas J. West	INSP. DATE: February 26, 2019	INSP. TIME: 08:35
OPERATOR: H/S Properties	OPERATOR REPRESENTATIVE: None	TYPE OF OPERATION: 110c - Construction Limited Impact	
REASON FOR INSPECTION: Surety Related	BOND CALCULATION TYPE: Complete Bond	BOND AMOUNT: \$21,973.00	
DATE OF COMPLAINT: NA	POST INSP. CONTACTS: None	JOINT INSP. AGENCY: None	
WEATHER: Cloudy	INSPECTOR'S SIGNATURE:

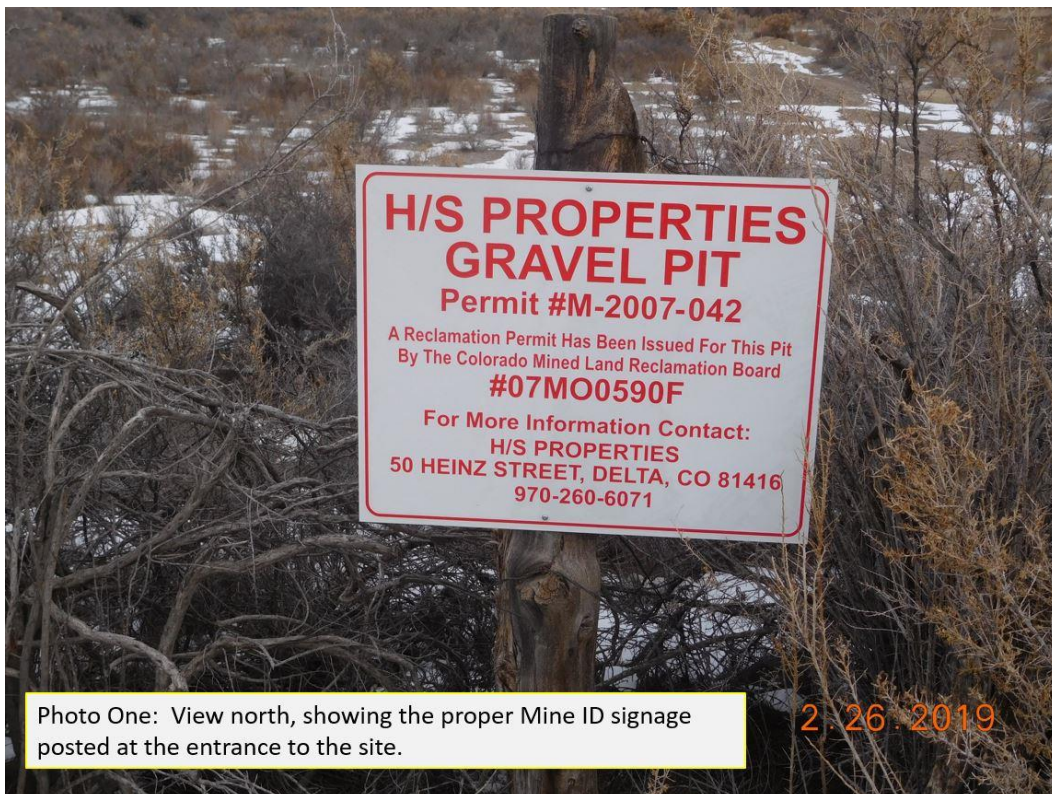
The proper mine identification signage was posted at the entrance to the site and can be seen in Photo One. The permit boundaries are clearly delineated by an old fence line to the west and the access road to the east. There was no equipment present on site and the site was not active during the day of the inspection. The site is completely undisturbed and no mining or reclamation has taken place. There is no signs of erosion or sedimentation, and the site is well vegetated with native vegetation with as good or better vegetative cover than adjacent undisturbed areas. Photos Two and Three show different views of the site.
