MINERALS PROGRAM INSPECTION REPORT
PHONE: (303) 866-3567

MINE NAME: Olathe Pit	MINE/PROSPECTING ID#: M-1984-108	MINERAL: Sand and gravel	COUNTY: Montrose
INSPECTION TYPE: Monitoring	INSPECTOR(S): Lucas J. West	INSP. DATE: February 26, 2019	INSP. TIME: 08:51
OPERATOR: Western Gravel, Inc.	OPERATOR REPRESENTATIVE: None	TYPE OF OPERATION: 110c - Construction Limited Impact	
REASON FOR INSPECTION: Normal I&E Program	BOND CALCULATION TYPE: None	BOND AMOUNT: \$10,975.00	
DATE OF COMPLAINT: NA	POST INSP. CONTACTS: None	JOINT INSP. AGENCY: None	
WEATHER: Clear	INSPECTOR'S SIGNATURE:

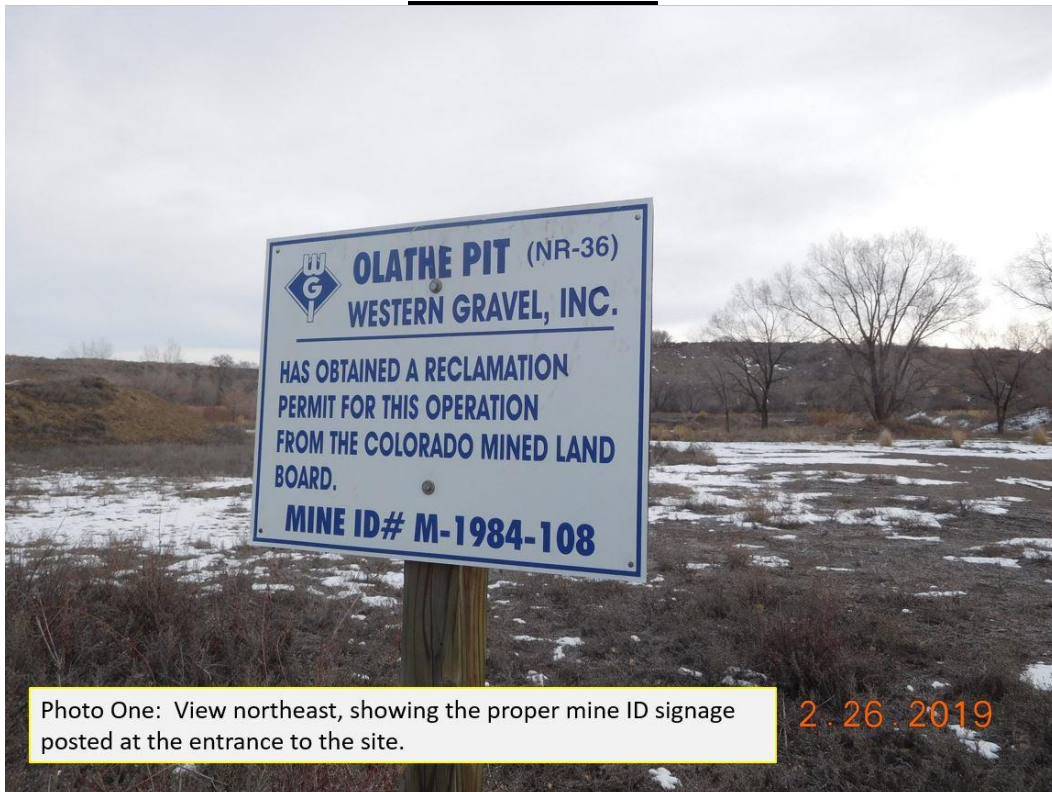
The proper mine identification signage was posted at the entrance to the site and can be seen in Photo One. The site was not active during the day of the inspection and no equipment was present. The reclamation of the site will be conducted to support a post mining land use of wildlife habitat. The site consists of two pond areas, herein referred to as the north pond and the south pond. The north pond has been nearly completely reclaimed and can be seen in Photos Two and Three. The grading around the south pond is at or near a 3H: 1V and appears to be stable. The entire perimeter of the pond is well vegetated with a variety of wetland and riparian species around the pond fringe as well as upland grasses in the outer areas. The reclamation work that remains to be conducted in the north pond area is mainly noxious weed management in the treatment and removal of the Russian Knapweed populations as well as the Russian olive trees.

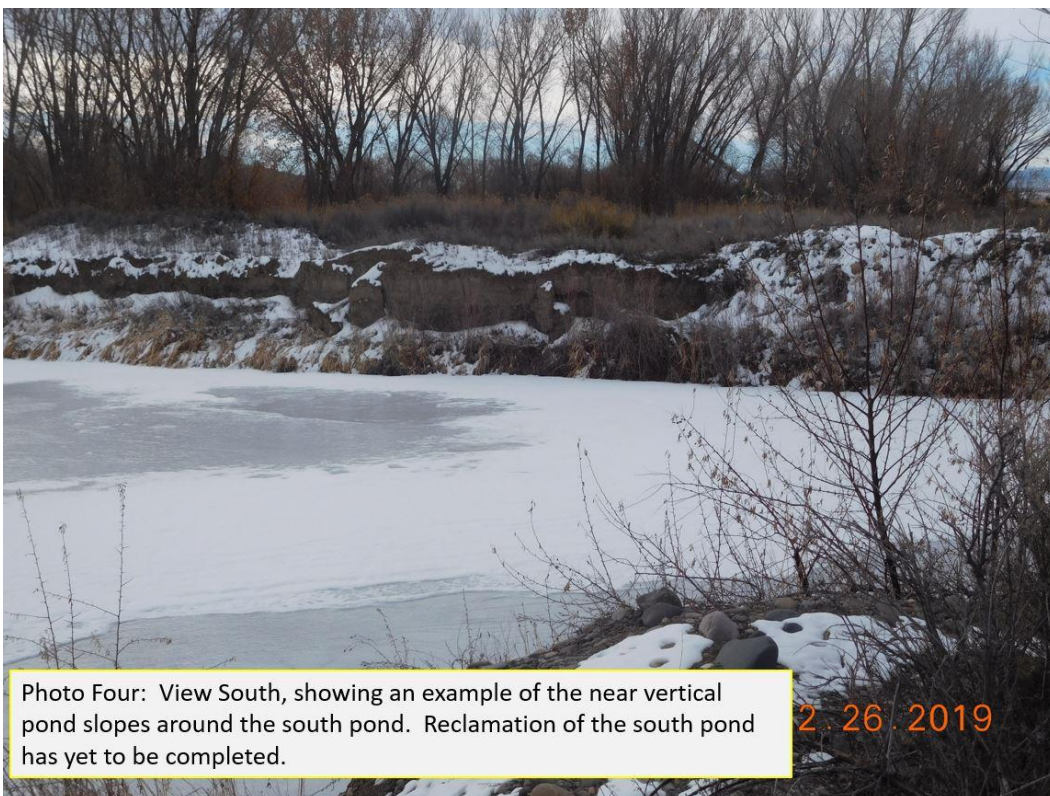
The south pond has not been reclaimed and can be seen in Photos Four and Five. The pond slopes range from near vertical to roughly 1H: 1V. Some areas around the pond show signs of sloughing into the pond. The area immediately around the pond as well as the upland areas are heavily infested with Russian Knapweed as well as Russian olive trees. This was cited as a problem on the inspection report dated July 10, 2018. Measures have been taken but have yet to be effective in the eradication of the knapweed. Discussions with the Operator indicate that the reclamation of the south pond and major weed removal activities will be taking place this spring.

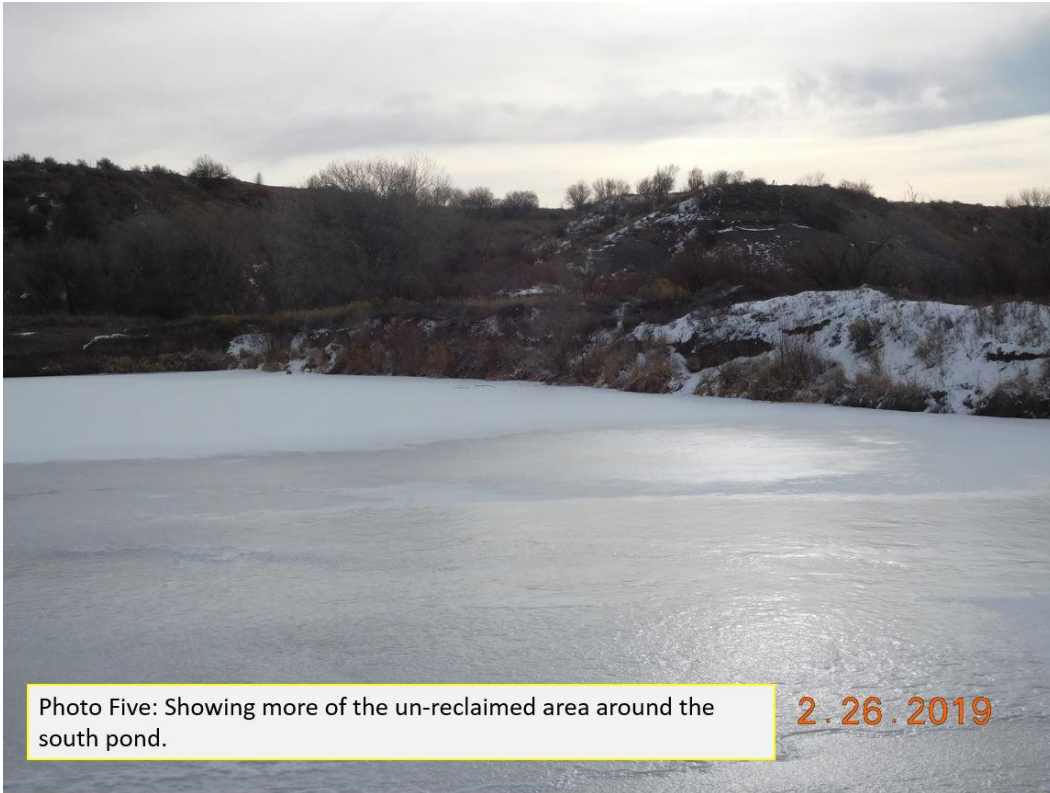
Photo Five: Showing more of the un-reclaimed area around the south pond.
