**Annual Report – 2018
Henderson Mine and Mill Reclamation Activities
Permit No. M-1977-342**

Mill Tailing Impoundment Flood Storage Capacity Analysis

Re: **#1333.0 - Henderson Mill
TSF Flood Storage**

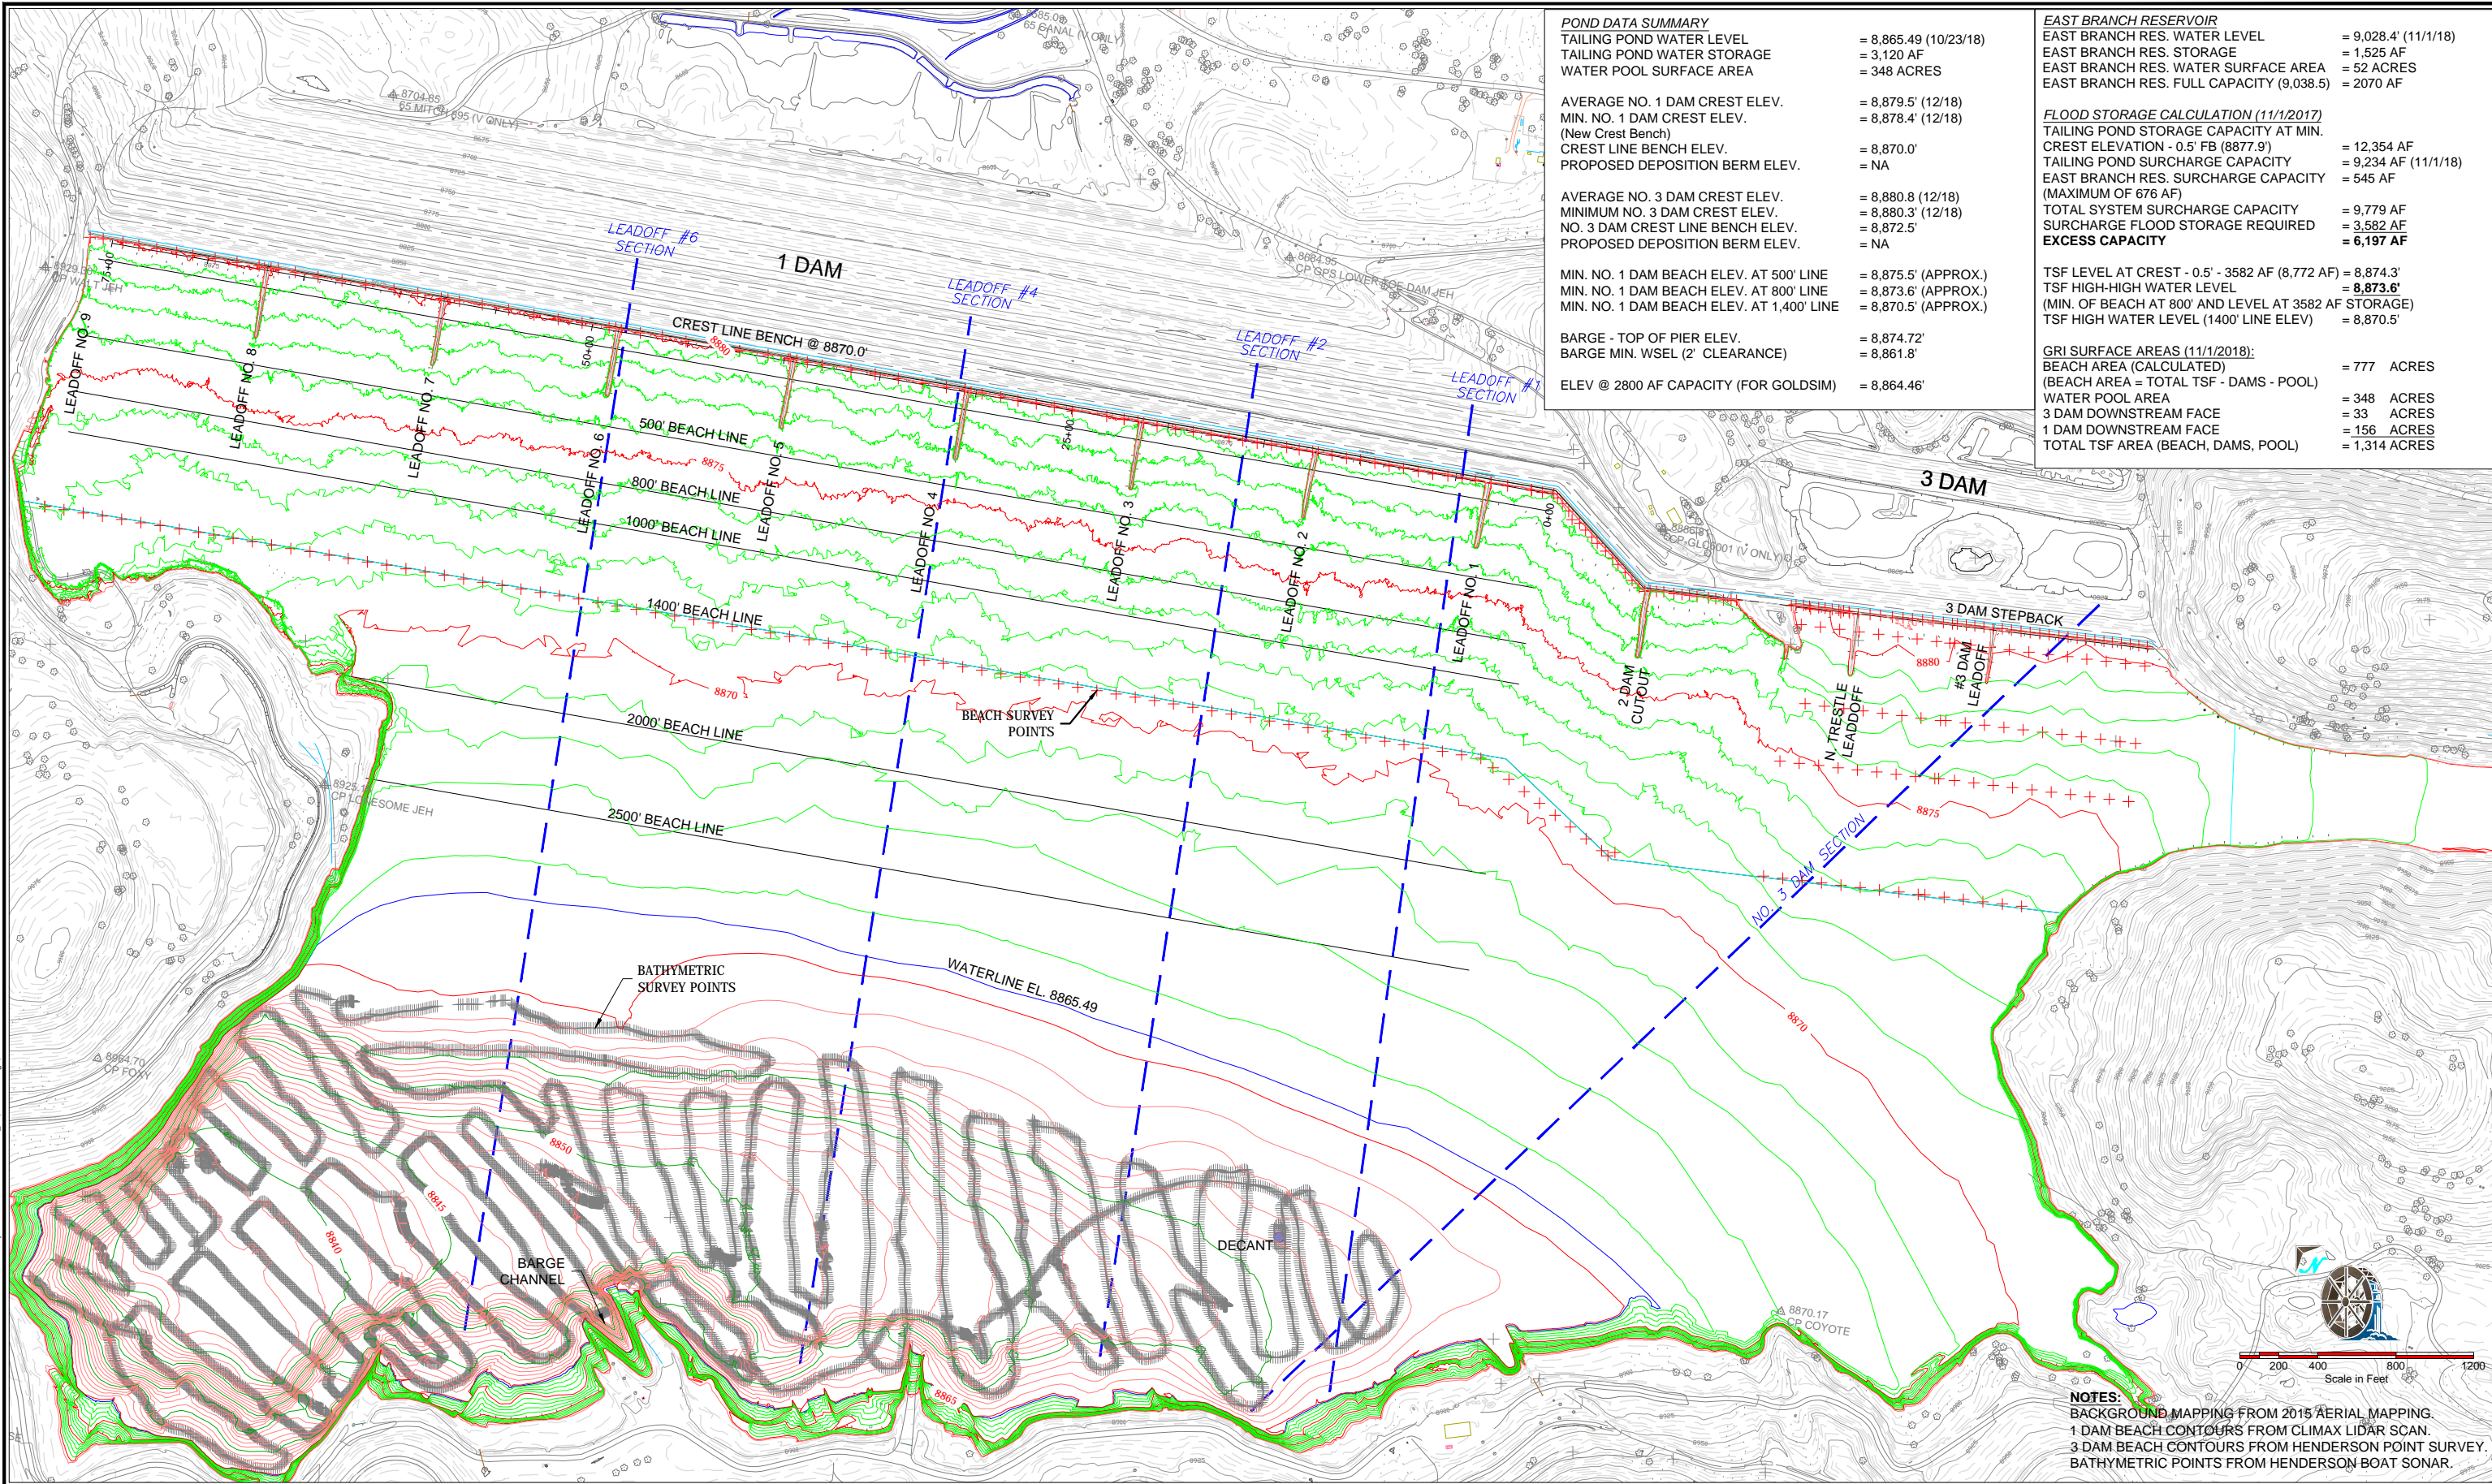
FIGURE 1

One of the primary uses of the survey data is to evaluate the flood storage capacity conditions in the water system. As summarized on Figure 1, at the approximate time of the fall survey there was a total system surcharge storage capacity of about **9,779 acre-feet** in the system. This capacity includes both the TSF and East Branch Reservoir and is based on 0.5 feet of residual freeboard below the minimum dam crest elevation of 8,878.4' and a water level of 8,865.5'. The flood storage requirement for the system is **3,582 acre-feet**. This requirement is based on hydrologic modeling of the probable maximum precipitation (PMP) event. The available flood storage capacity in the system at the time of the survey

significantly exceeds the storage requirement. However, this excess capacity will decrease throughout the coming year as additional inflows to the system occur and a portion of the storage space is filled with deposited tailing.
