**MINERALS PROGRAM INSPECTION REPORT**  
**PHONE: (303) 866-3567**

<b>MINE NAME:</b> South D-20 Pit	<b>MINE/PROSPECTING ID#:</b> M-1992-102	<b>MINERAL:</b> Sand and gravel	<b>COUNTY:</b> Montrose
<b>INSPECTION TYPE:</b> Monitoring	<b>INSPECTOR(S):</b> Lucas J. West	<b>INSP. DATE:</b> February 26, 2019	<b>INSP. TIME:</b> 09:56
<b>OPERATOR:</b> The Uncompahgre Valley Water Users Assoc	<b>OPERATOR REPRESENTATIVE:</b> Gary Cooper	<b>TYPE OF OPERATION:</b> 112c - Construction Regular Operation	
<b>REASON FOR INSPECTION:</b> Normal I&E Program	<b>BOND CALCULATION TYPE:</b> Complete Bond	<b>BOND AMOUNT:</b> \$121,573.00	
<b>DATE OF COMPLAINT:</b> NA	<b>POST INSP. CONTACTS:</b> None	<b>JOINT INSP. AGENCY:</b> None	
<b>WEATHER:</b> Clear	<b>INSPECTOR'S SIGNATURE:</b>

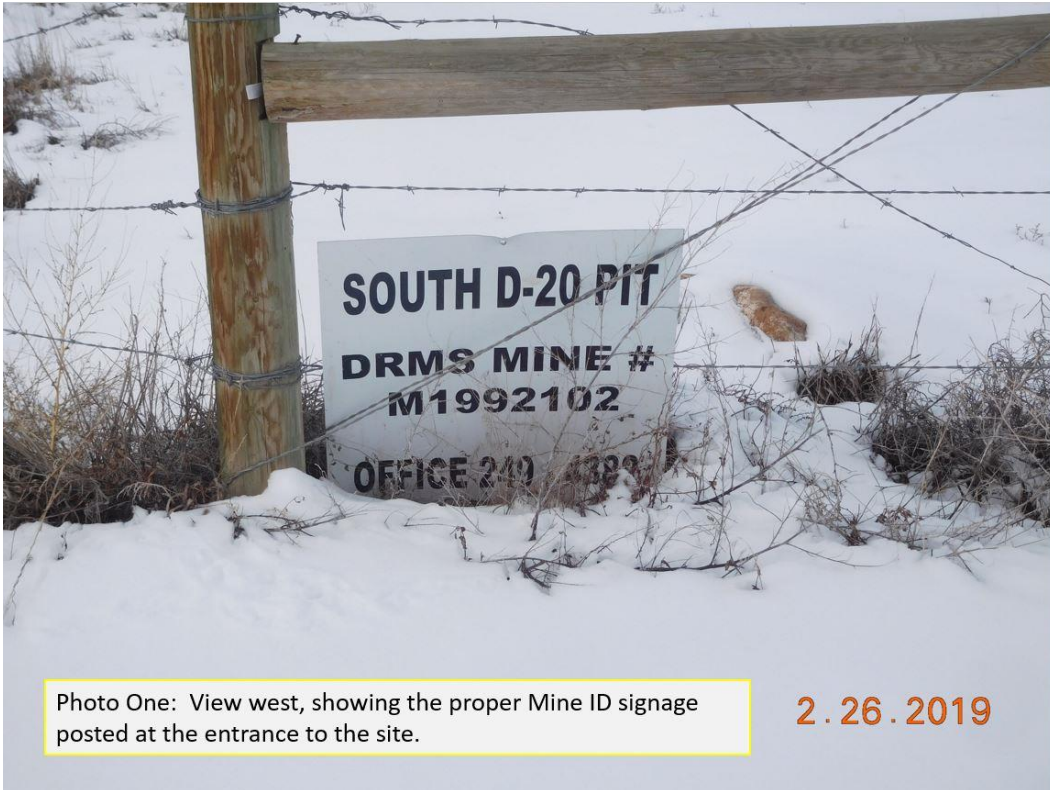
The proper mine identification signage was posted at the entrance to the site and can be seen in Photo One and the permit boundaries were clearly marked. Various mining related equipment was present on site but the site was not active the day of the inspection. Mining activities in the area identified as Phase2, have been completed and the area has been reclaimed. All grading, earthwork and revegetation has been completed. This area can be seen in Photos Two and Three. The grading all appears to be stable and in good condition, no signs of settling, slumping or erosion were noted. The vegetative cover appears to be dense and diverse despite being partially buried in snow. On site discussions with the Operator Representative indicates that mining and reclamation activities in the area are complete and that they would be interested in an Acreage and Surety Reduction. The Division advised the Operator to await the onset of the growing season then submit an Acreage Reduction Request (enclosed) if they feel they have met their reclamation requirements.

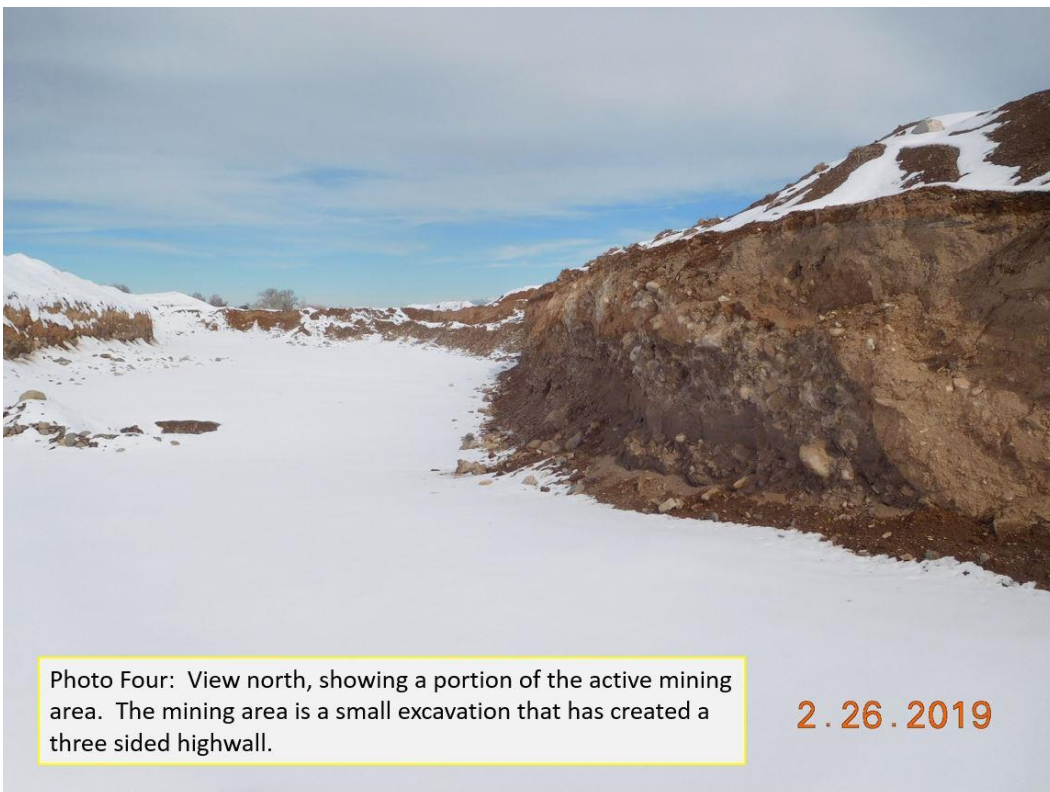
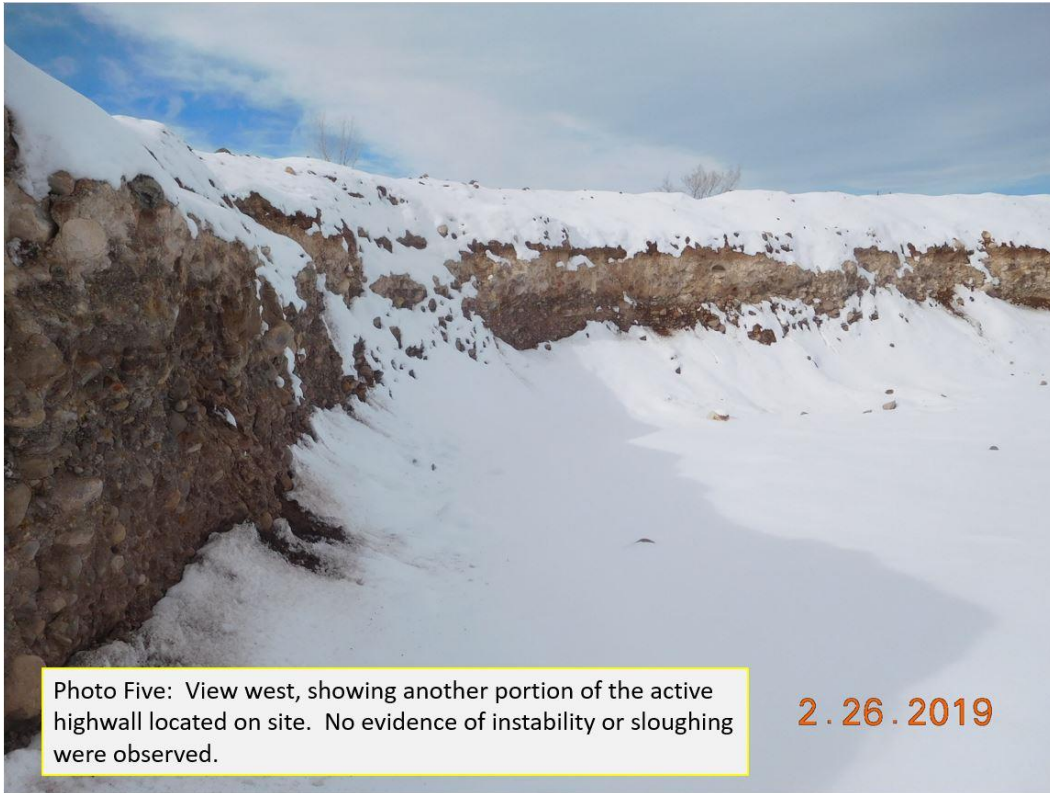
The active mining area is focused in the northern section of the Phase One Area. It consists mostly of a small excavation forming a three sided highwall which can be seen in Photos Four and Five. The highwall is an average of 12 feet tall and spans approximately 300 Linear Feet. The highwall appears stable and in good condition with no signs of sloughing observed. Adjacent to the mining area is the main processing and stockpile areas. Several stockpiles of various sized materials were observed. All stockpiles appear to be stable and in good condition. An Example of the stockpiled material can be seen in Photo Six. The main pit floor and processing area exhibits positive drainage and no impounded surface water was observed. Also, no signs of settling slumping or erosion was noted in the active areas. The Operator's Representative indicated that weed management is continuous and active. No state listed noxious weeds were observed during the inspection.
