MINERALS PROGRAM INSPECTION REPORT**PHONE: (303) 866-3567**

| MINE NAME: East Rigden Pit | MINE/PROSPECTING ID#: M-1979-097 | MINERAL: Sand and gravel | COUNTY: Larimer |
| INSPECTION TYPE: Monitoring | INSPECTOR(S): Amy Eschberger | INSP. DATE: January 31, 2019 | INSP. TIME: 10:00 |

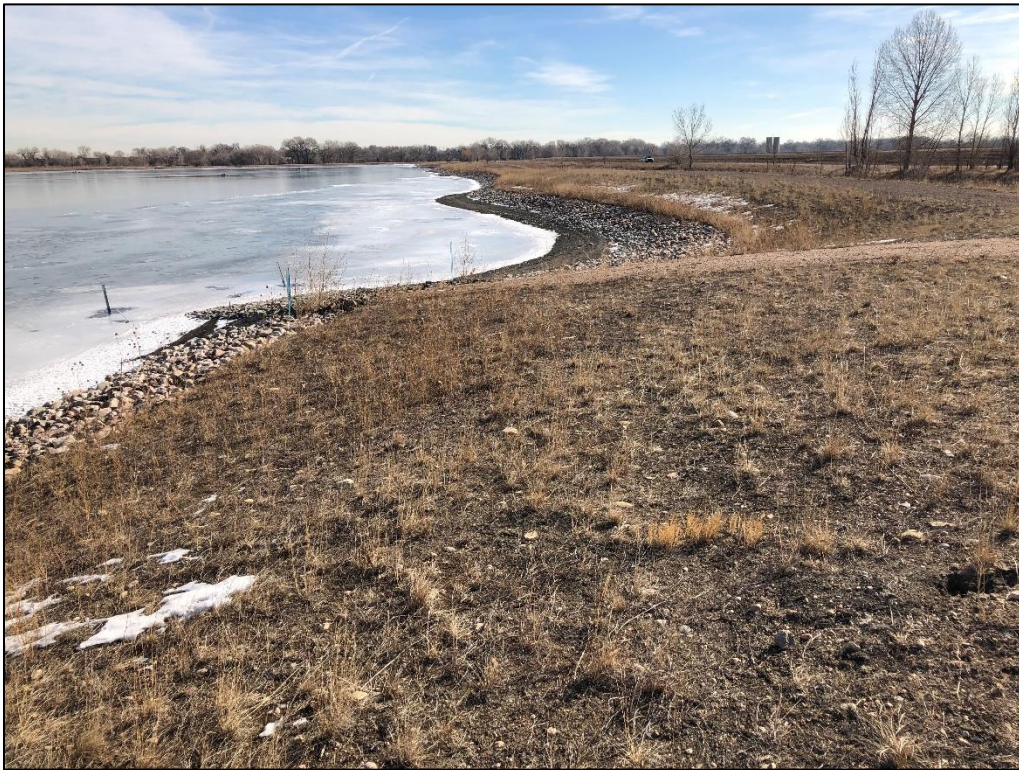
Photo 1. View looking east across southwestern shoreline of lined reservoir, showing slopes graded 4H:1V or flatter with fairly good grass cover.

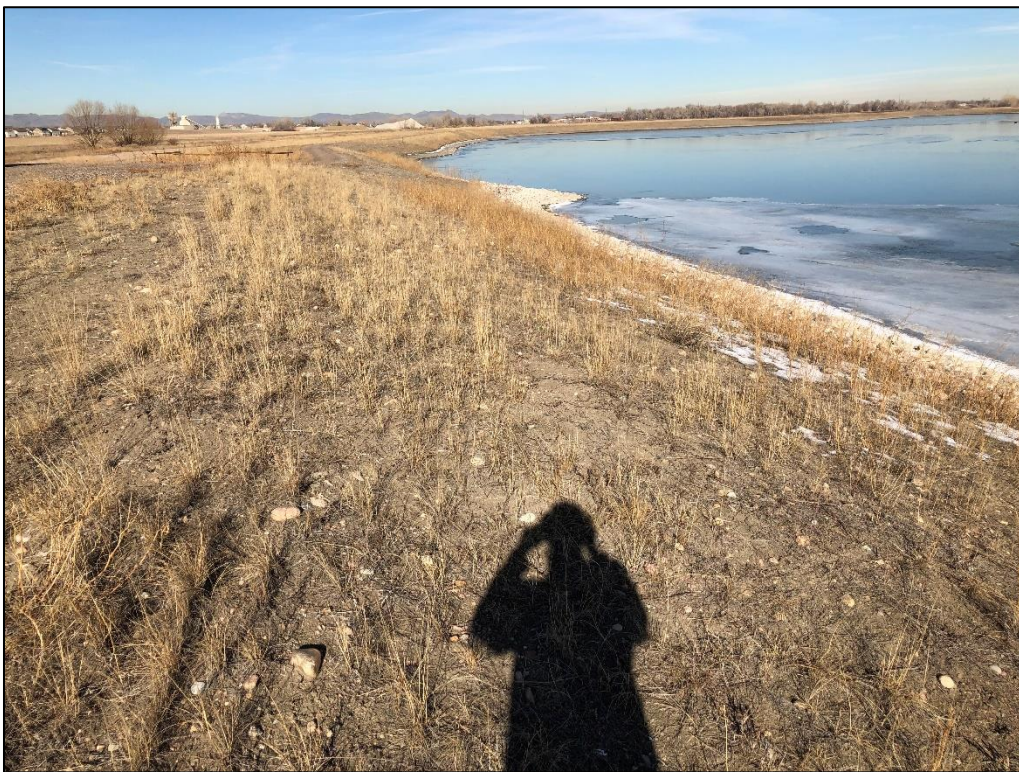
Photo 2. View looking northwest across western shoreline of lined reservoir, showing slopes graded 4H:1V or flatter with fairly good grass cover.

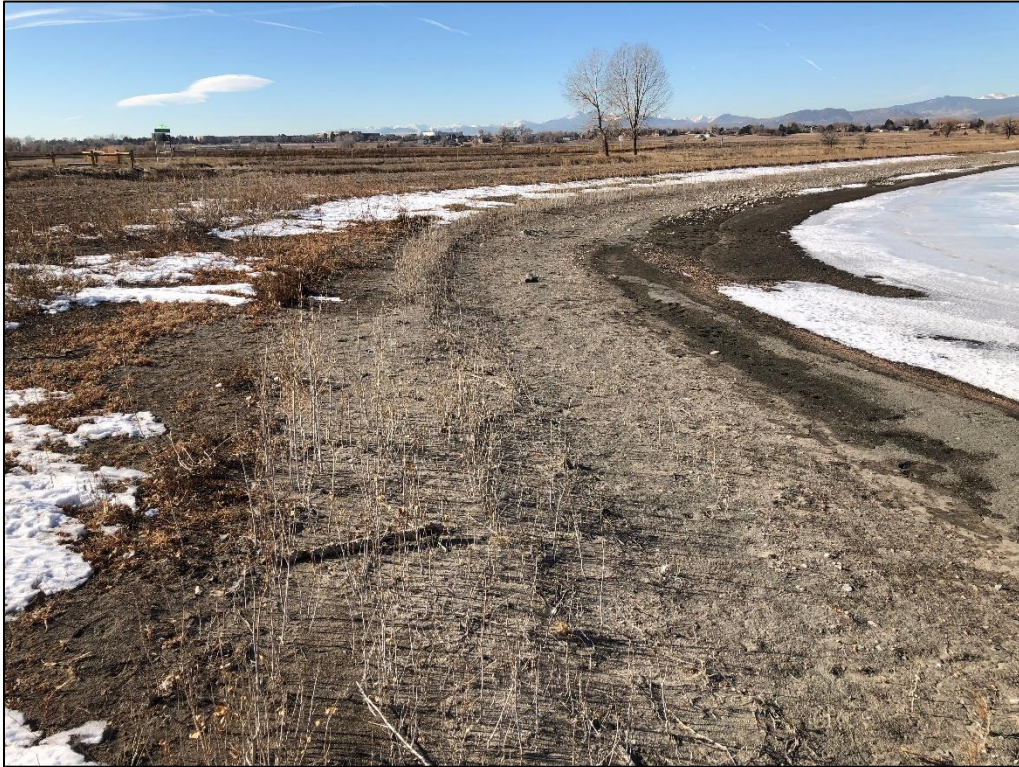
Photo 3. View looking south across southeastern shoreline of lined reservoir, showing slopes graded 4H:1V or flatter with very little to no vegetative cover.

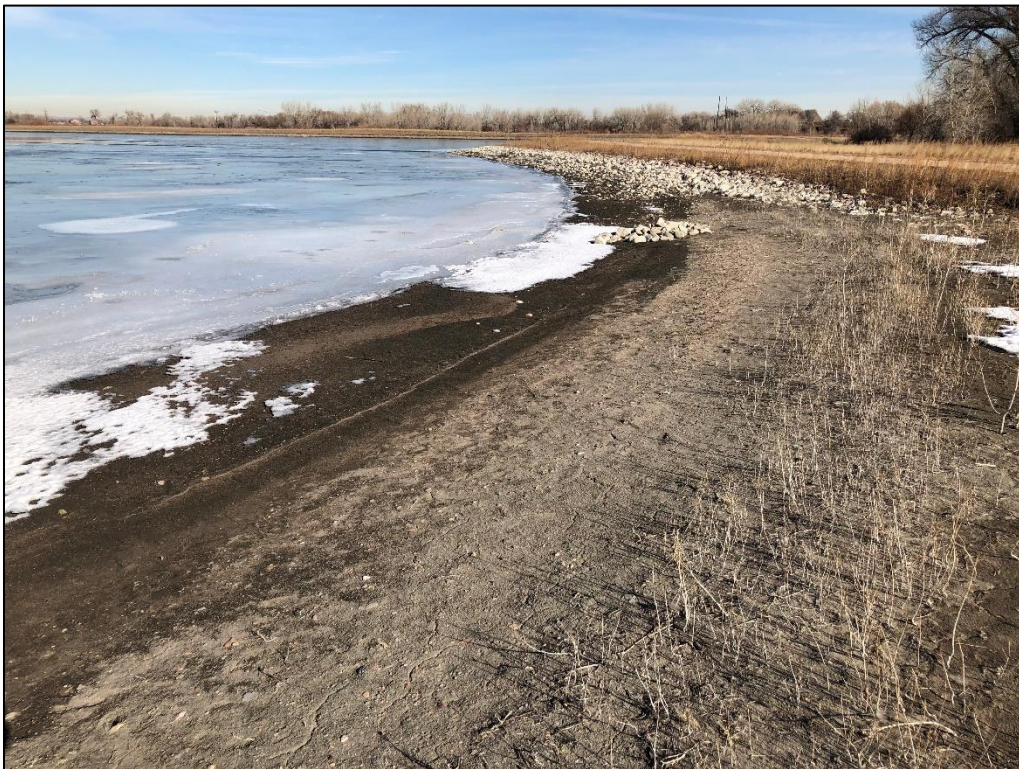
Photo 4. View looking north across southeastern shoreline of lined reservoir, showing slopes graded 4H:1V or flatter with very little to no vegetative cover.

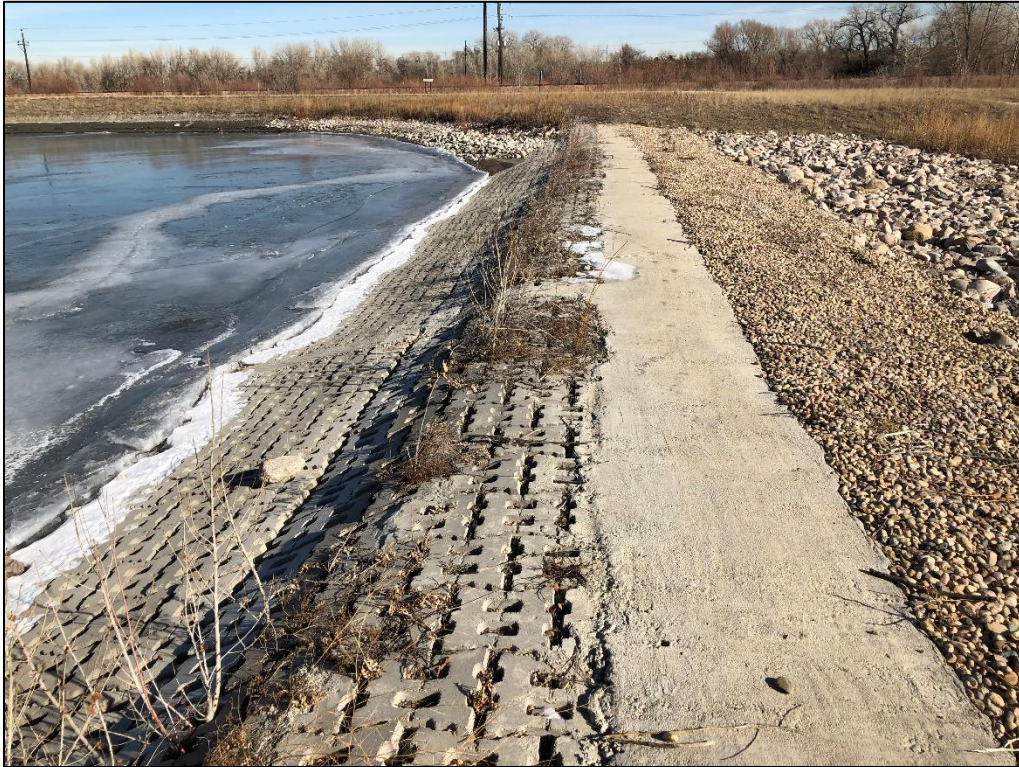
Photo 5. View looking north across concrete revetment block spillway constructed at northeastern edge of lined reservoir for river overflow.

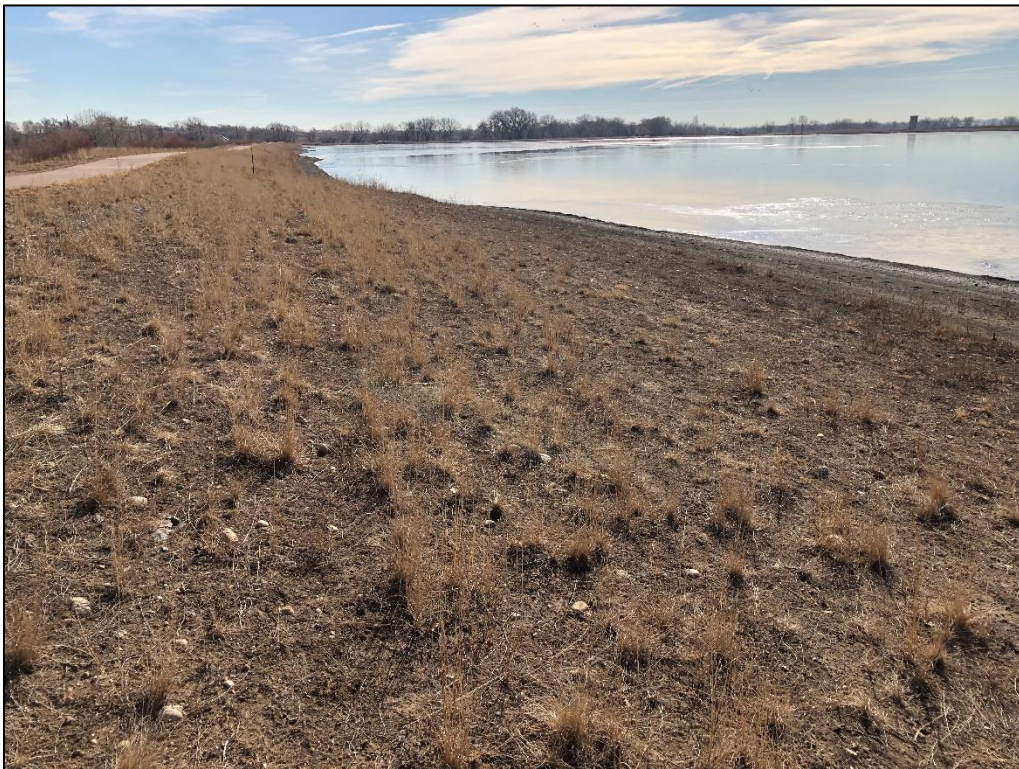
Photo 6. View looking east across northern shoreline of lined reservoir, showing slopes graded 4H:1V or flatter with fairly good grass cover.

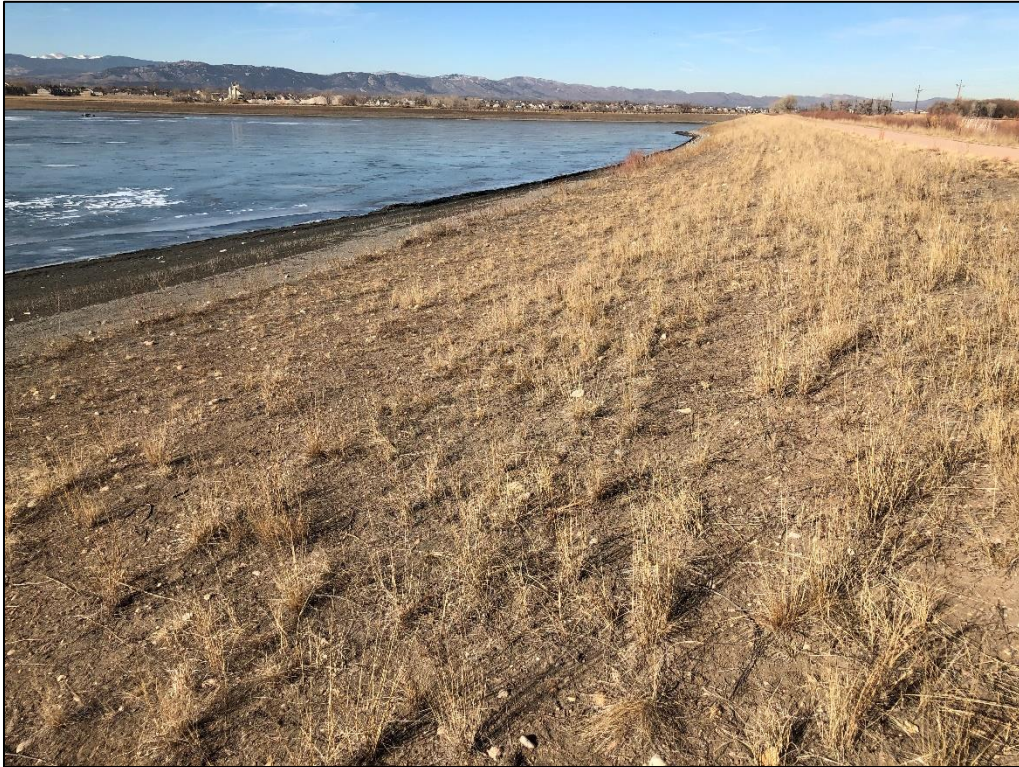
Photo 7. View looking west across northern shoreline of lined reservoir, showing slopes graded 4H:1V or flatter with fairly good grass cover.

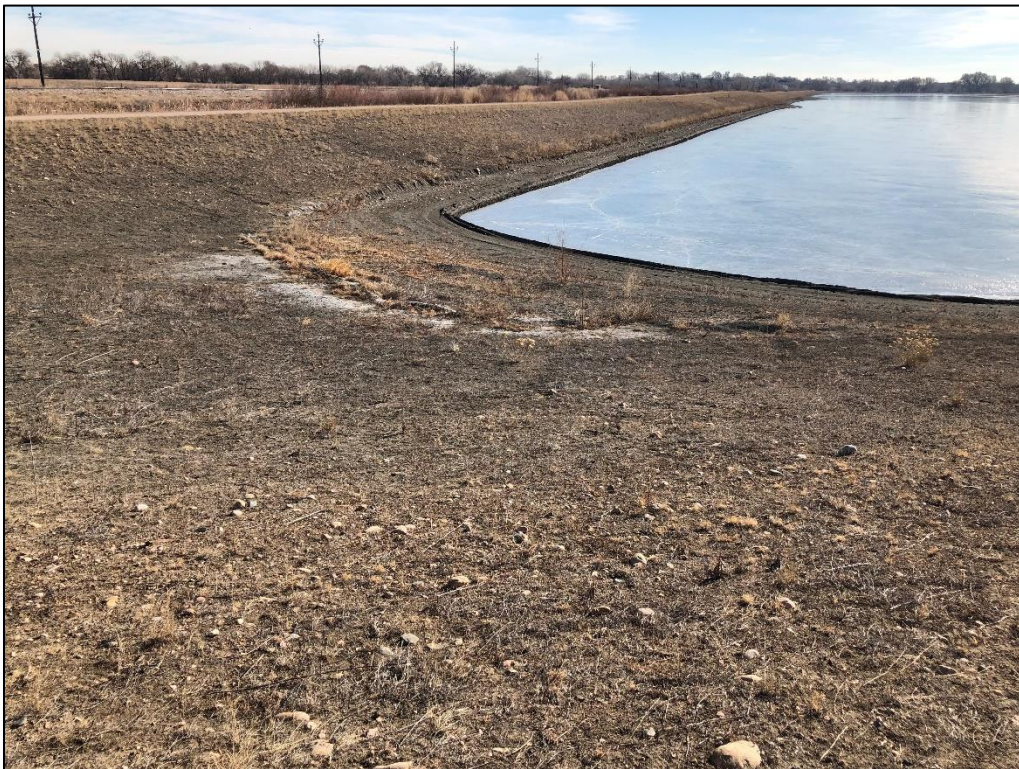
Photo 8. View looking north across northwestern shoreline of lined reservoir, showing slopes graded 4H:1V or flatter with some grass cover.

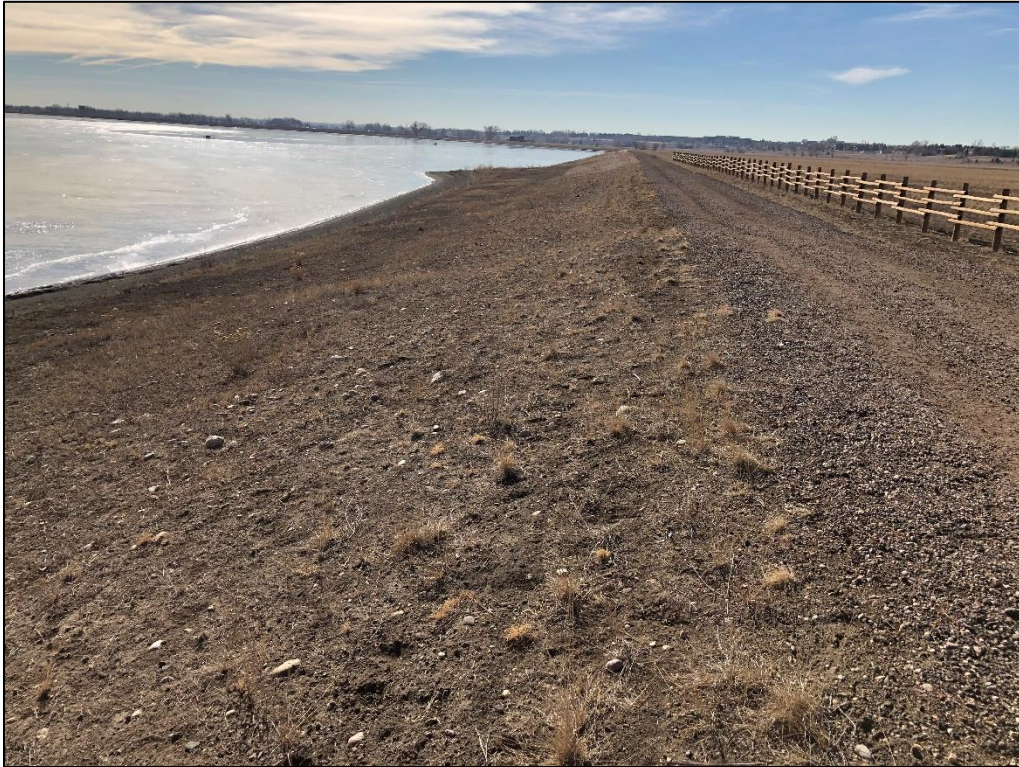
Photo 9. View looking south across western shoreline of lined reservoir, showing slopes graded 4H:1V or flatter with some grass cover. Recreation/maintenance path along perimeter of reservoir (shown at far right) to remain for reclamation.

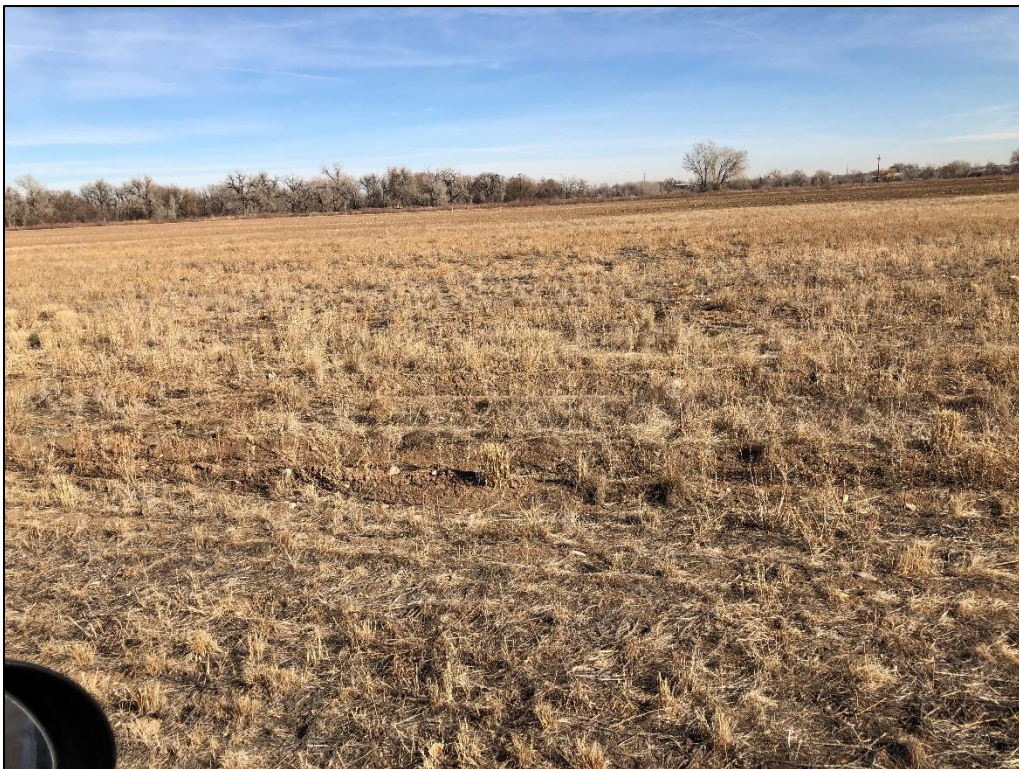
Photo 10. View looking northeast across area located northwest of reservoir and north of batch plant, showing good grass growth in areas not re-disturbed by underdrain installation.

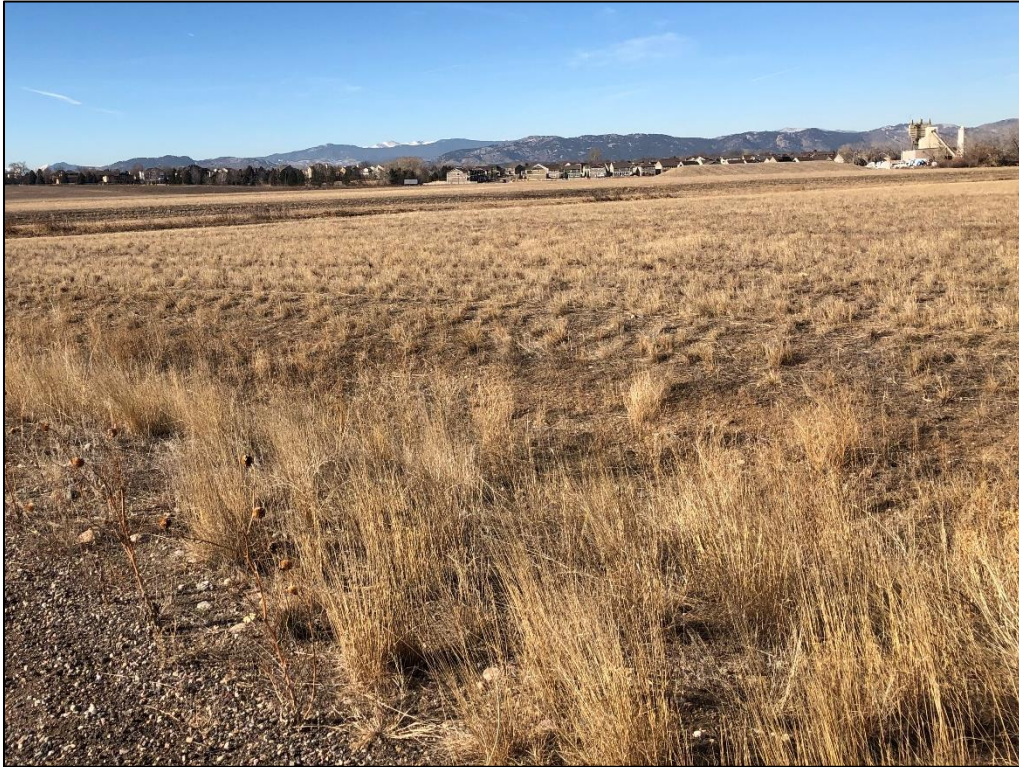
Photo 11. View looking west across area located northwest of reservoir and north of batch plant, showing good grass growth in areas not re-disturbed by underdrain installation.

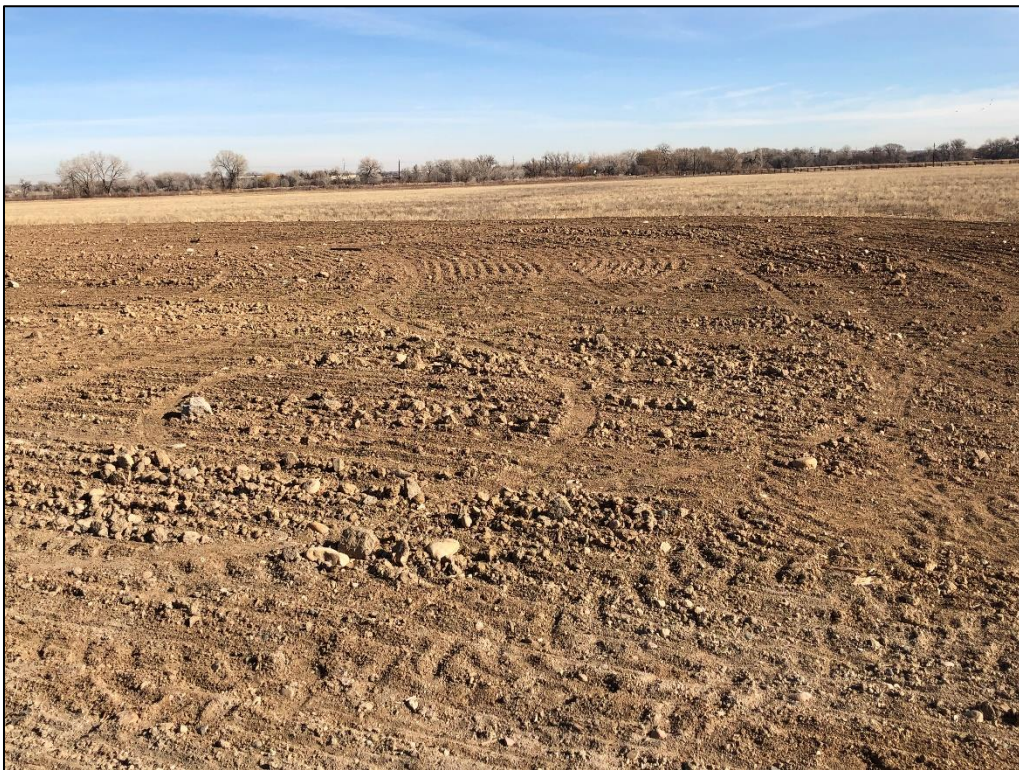
Photo 12. View looking east across disturbed land located east of batch plant and Boxelder Ditch which may require reseeding. This area was previously used for stockpiling and equipment storage.

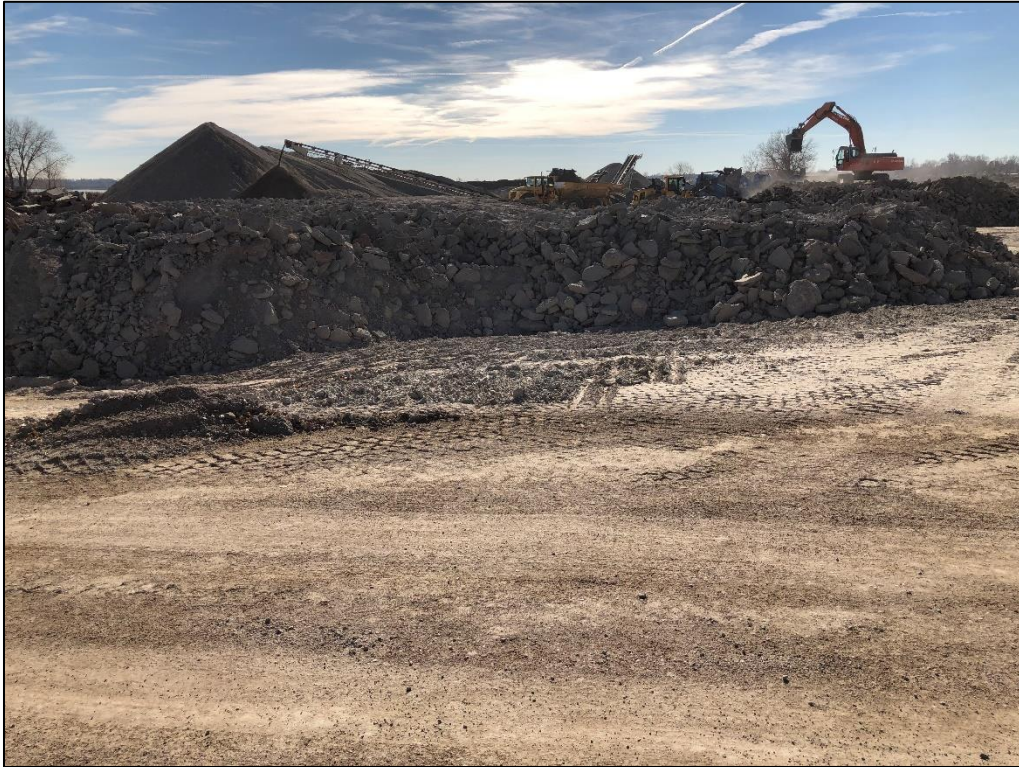
Photo 13. View looking south across active batch plant area.

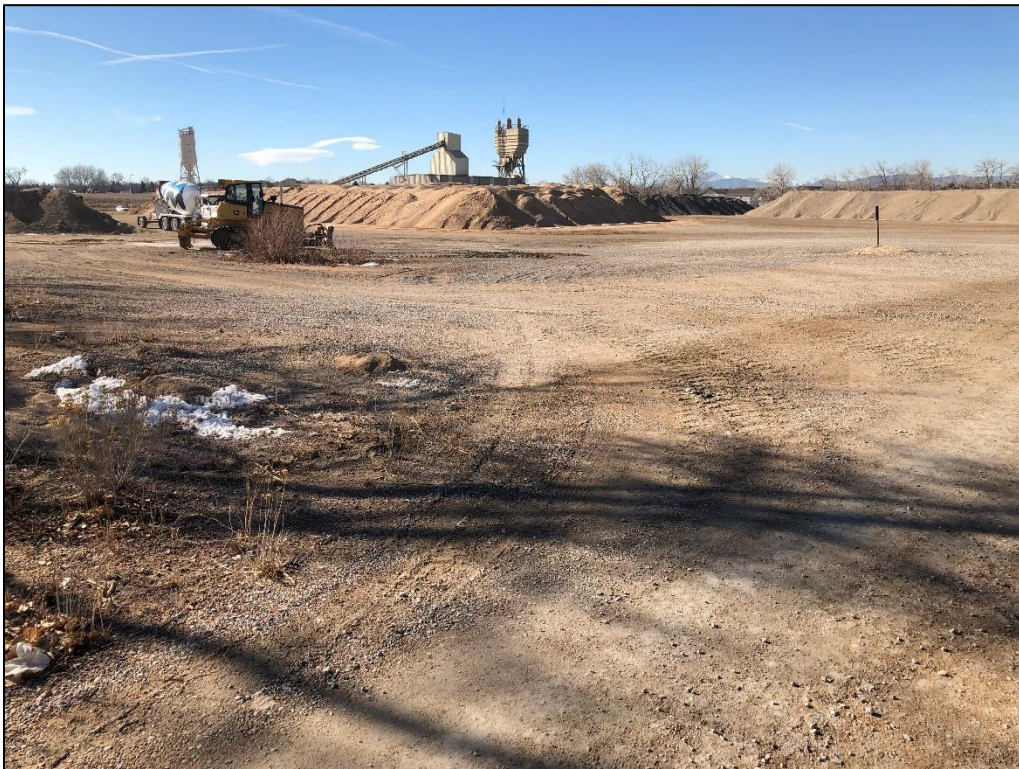
Photo 14. View looking southwest across active batch plant area.

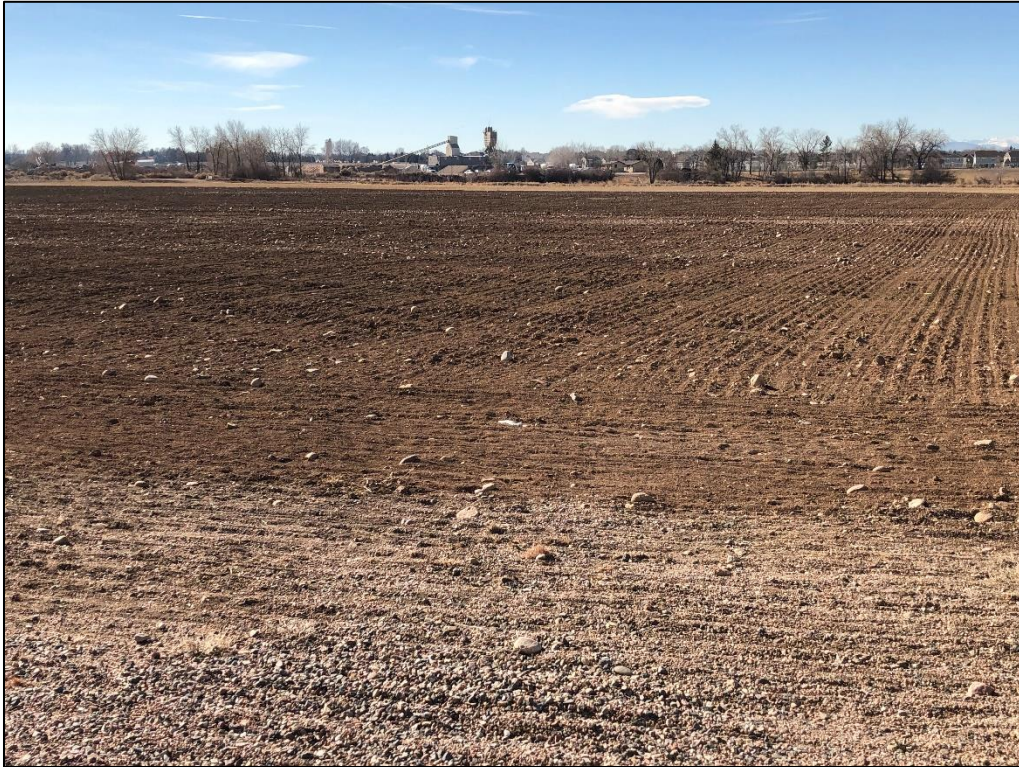
Photo 15. View looking south across area located northwest of reservoir and north of batch plant which was re-disturbed by underdrain installation. This area was retopsoiled and seeded in Spring of 2018, and may require reseeding.

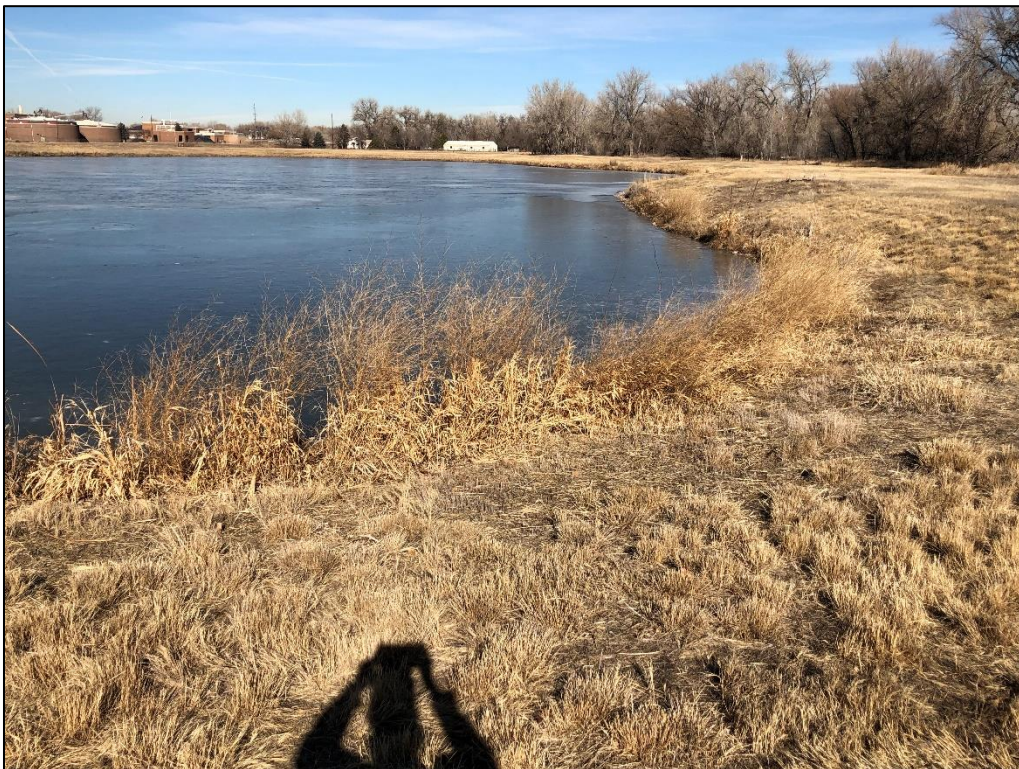
Photo 16. View looking north across eastern shoreline of northwestern pond located north of railway, showing slope gradients at 3H:1V or flatter with good grass cover.

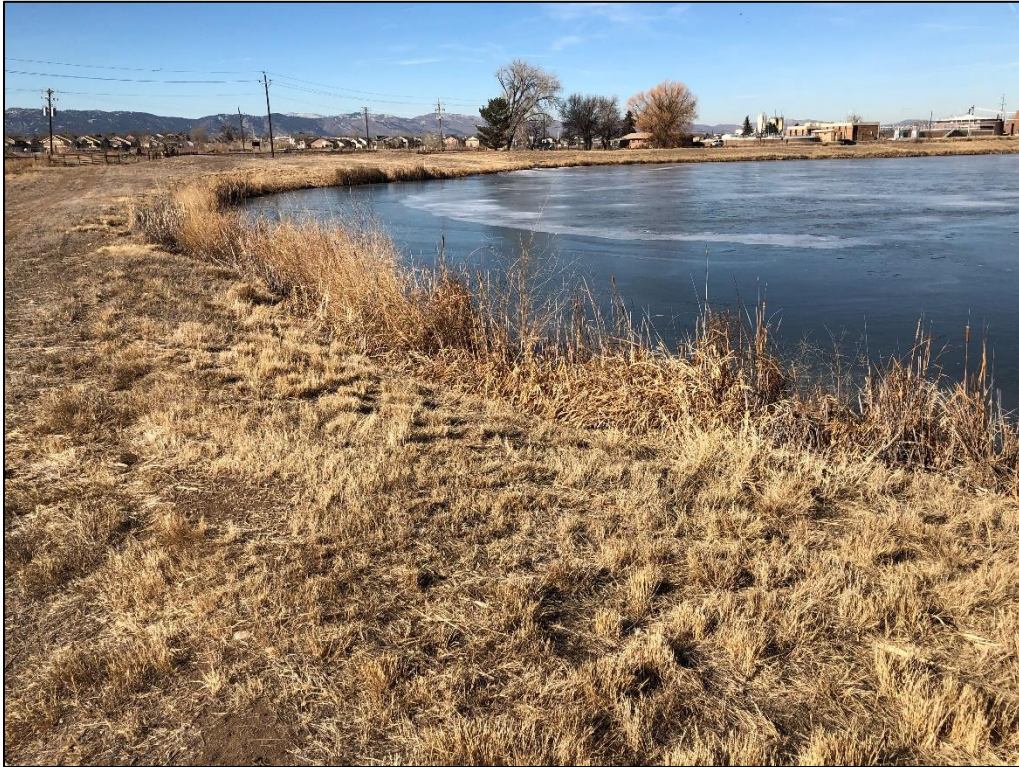
Photo 17. View looking west across southern shoreline of northwestern pond located north of railway, showing slope gradients at 3H:1V or flatter with good grass cover.

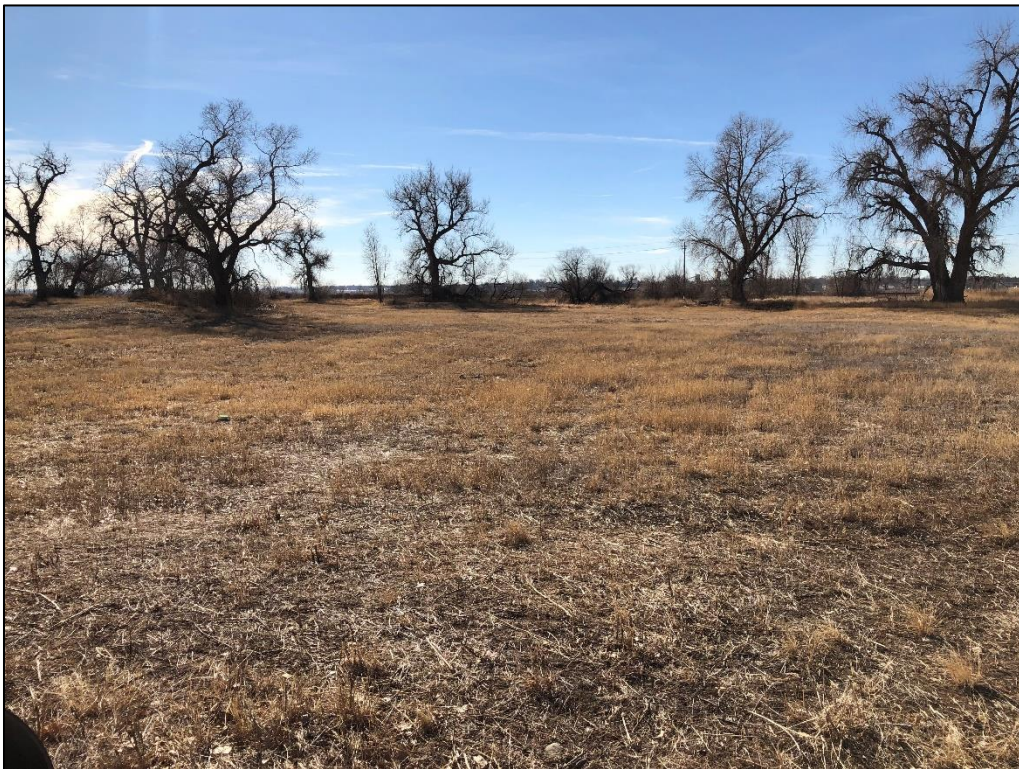
Photo 18. View looking north across reclaimed land between two ponds located north of railway.

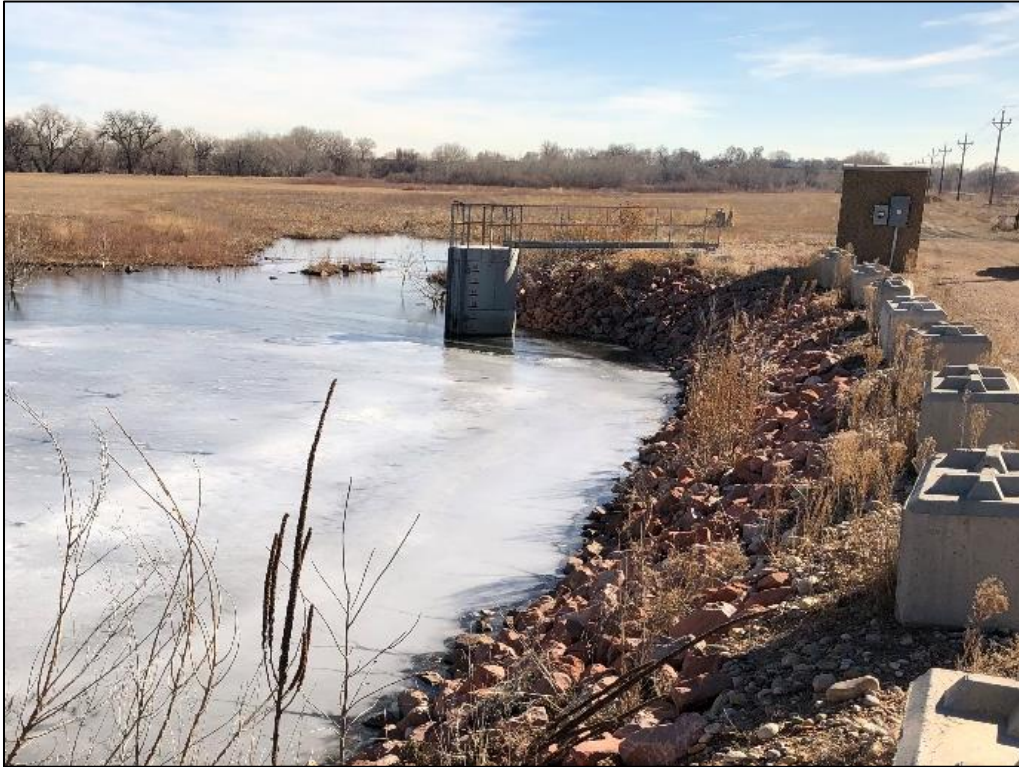
Photo 19. View looking east, showing dewatering manhole and pump station constructed at southeastern edge of larger pond located north of railway.

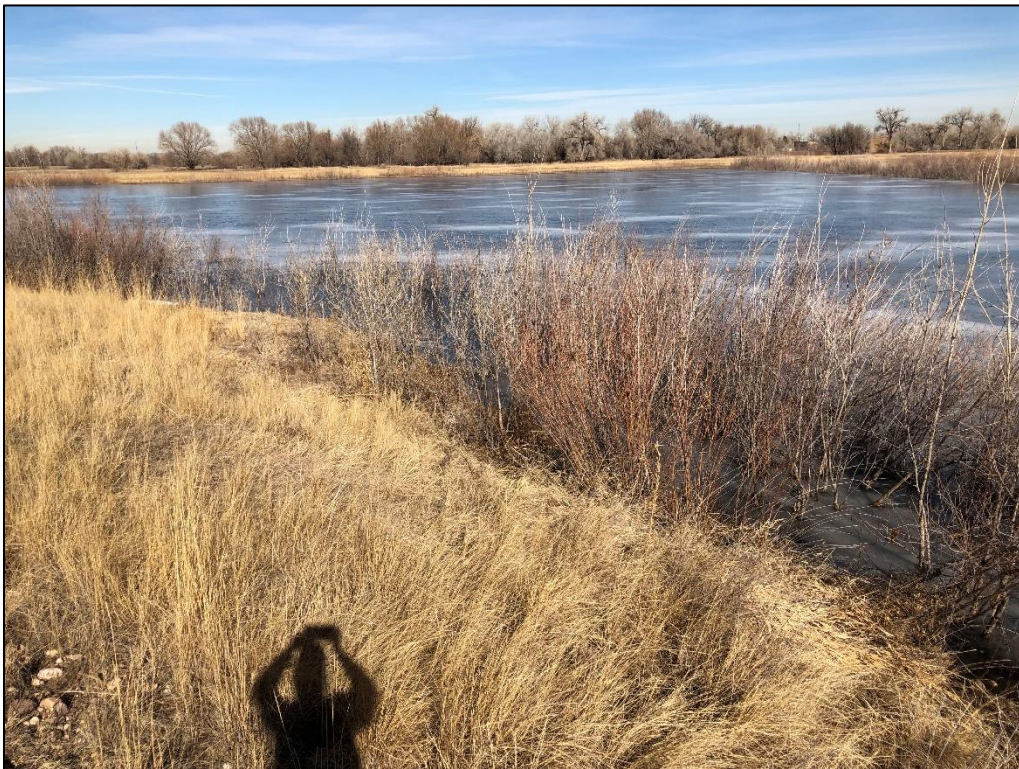
Photo 20. View looking northwest across southern shoreline of larger pond located north of railway, showing slope gradients at 3H:1V or flatter with good grass cover.

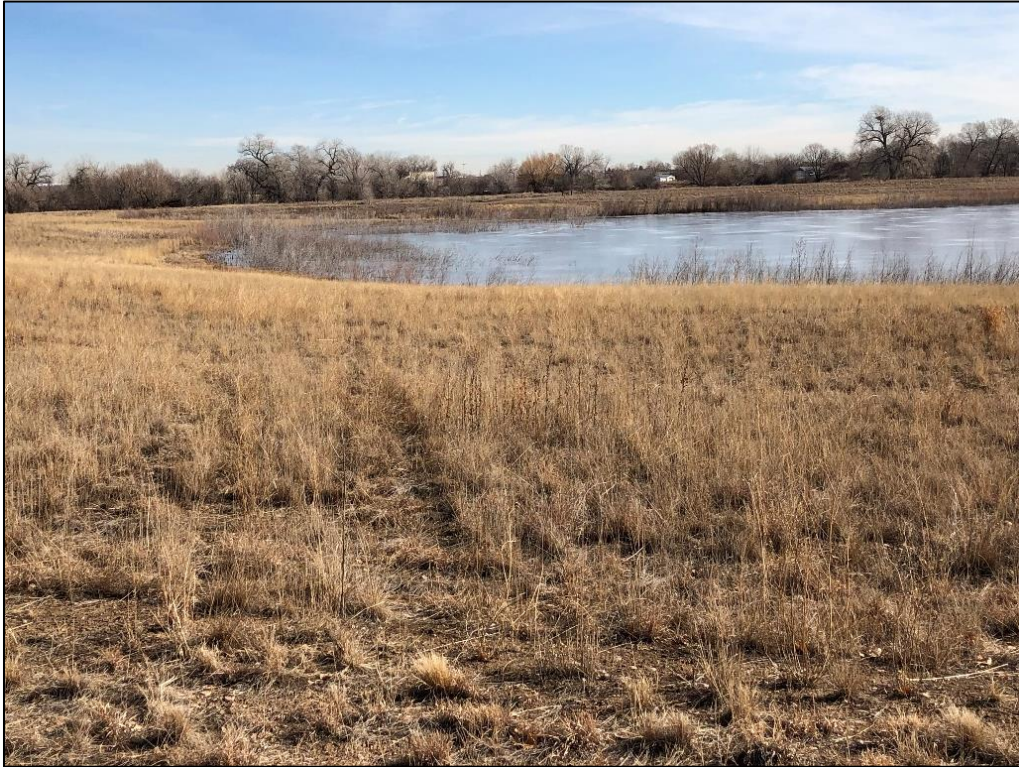
Photo 21. View looking north across western portion of larger pond located north of railway, showing slope gradients at 3H:1V or flatter with good grass cover.

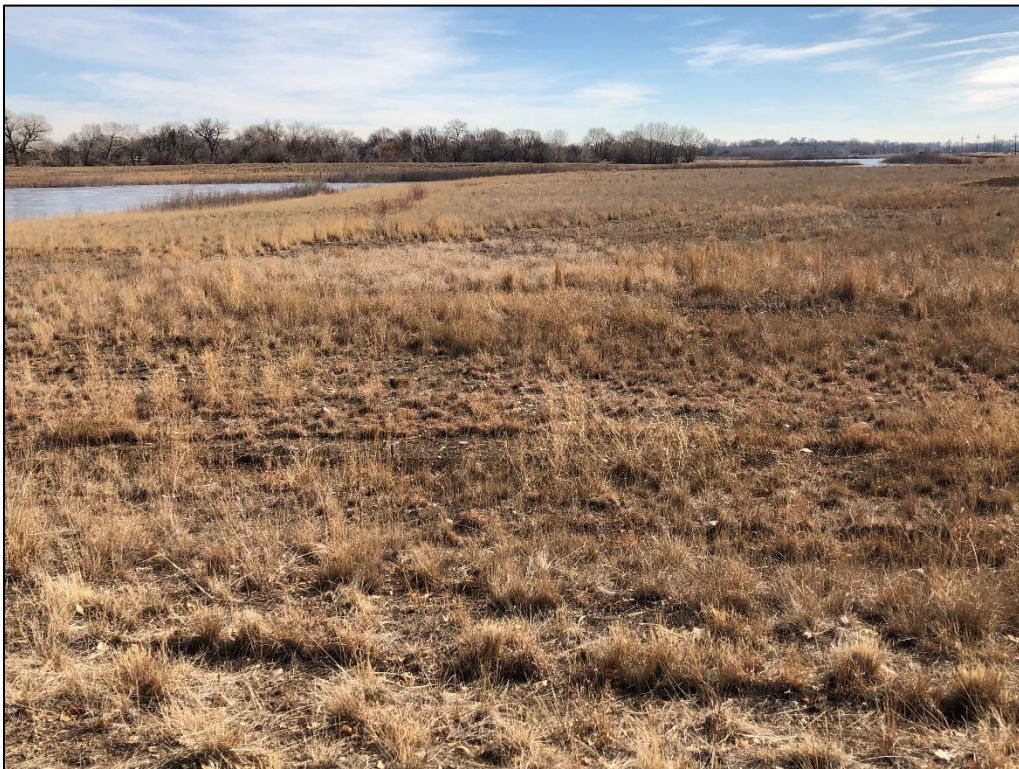
Photo 22. View looking east across area south of larger pond located north of railway, showing good grass cover in this area.

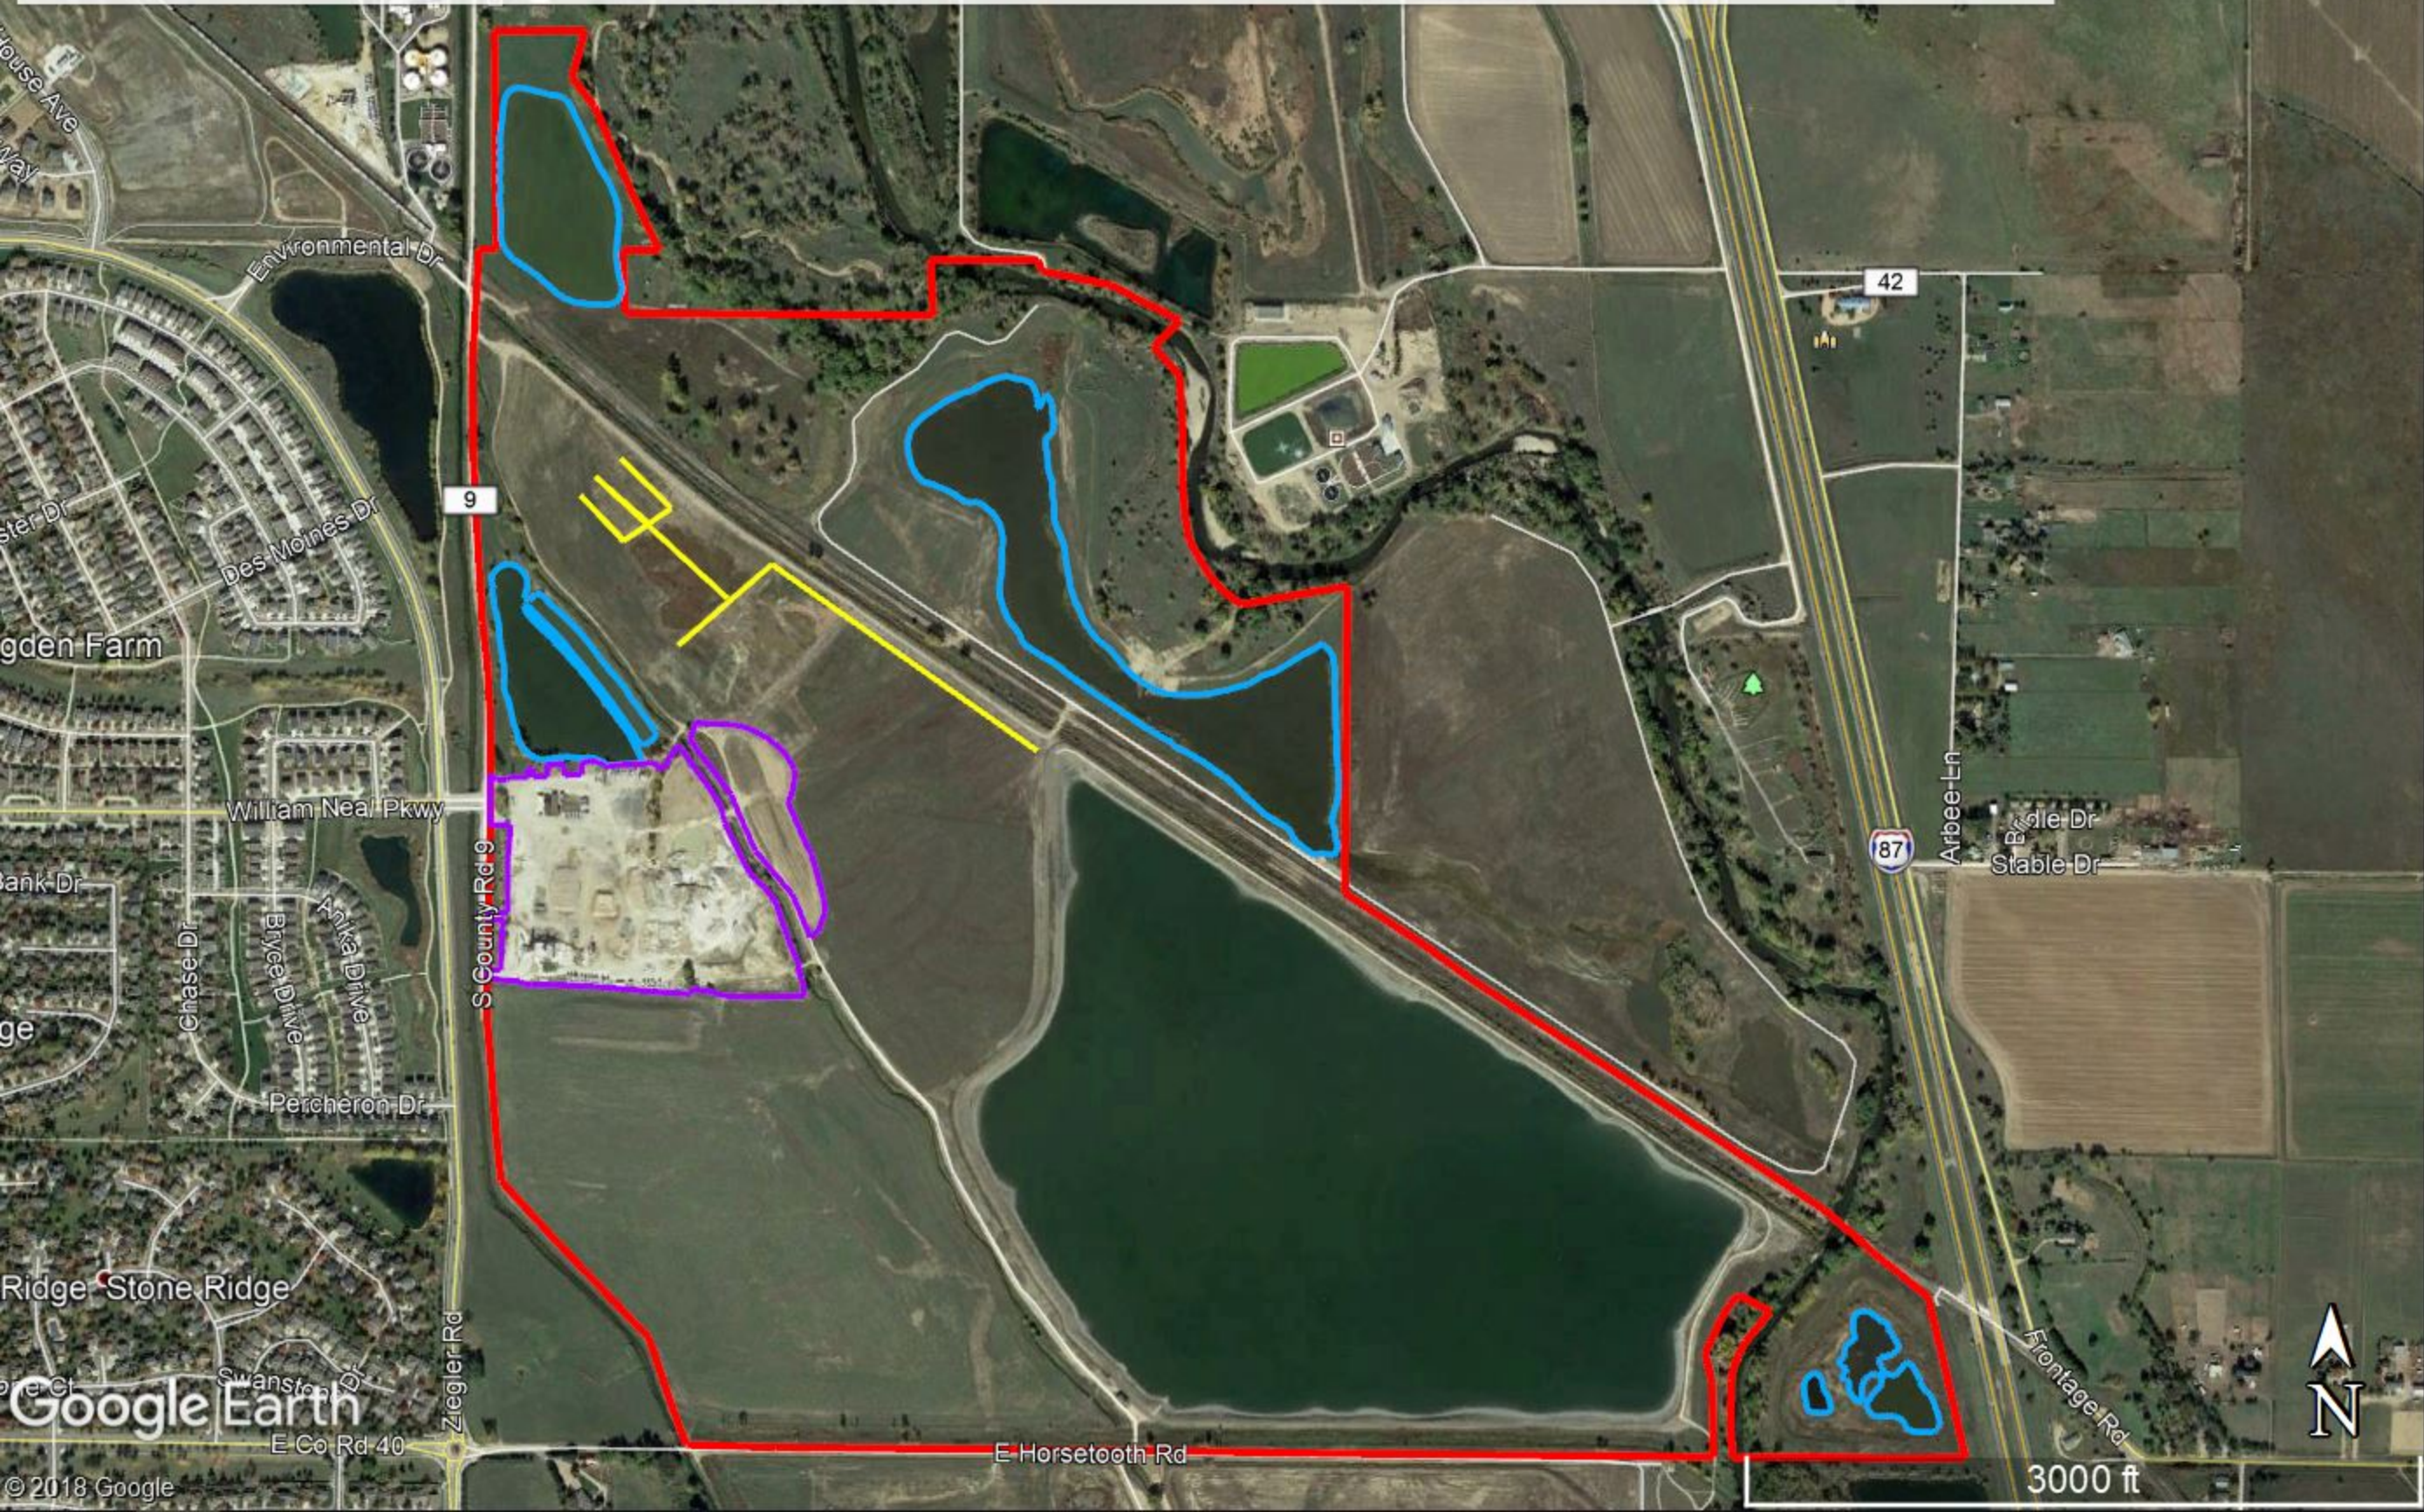
Purple Outline = 30.45 acres = Disturbed Areas Associated with Batch Plant (25.5 acres + 4.95 acres)

Blue Outline = 41.97 acres = Exposed Groundwater = (8.88 ac NW pond + 22.5 ac N pond + 7.67 ac W pond + 2.92 ac SE ponds)

Yellow Lines = Approximate location of underdrain system installed in 2017/2018
