MINERALS PROGRAM INSPECTION REPORT
PHONE: (303) 866-3567

MINE NAME: Gray Pit #1	MINE/PROSPECTING ID#: M-2003-092	MINERAL: Sand and gravel	COUNTY: Montrose
INSPECTION TYPE: Monitoring	INSPECTOR(S): Lucas J. West	INSP. DATE: February 26, 2019	INSP. TIME: 11:59
OPERATOR: Nick H. Gray	OPERATOR REPRESENTATIVE: Chauncy Luttrell, Skip Huston	TYPE OF OPERATION: 112c - Construction Regular Operation	
REASON FOR INSPECTION: Normal I&E Program	BOND CALCULATION TYPE: Complete Bond	BOND AMOUNT: \$61,240.00	
DATE OF COMPLAINT: NA	POST INSP. CONTACTS: None	JOINT INSP. AGENCY: None	
WEATHER: Clear	INSPECTOR'S SIGNATURE:

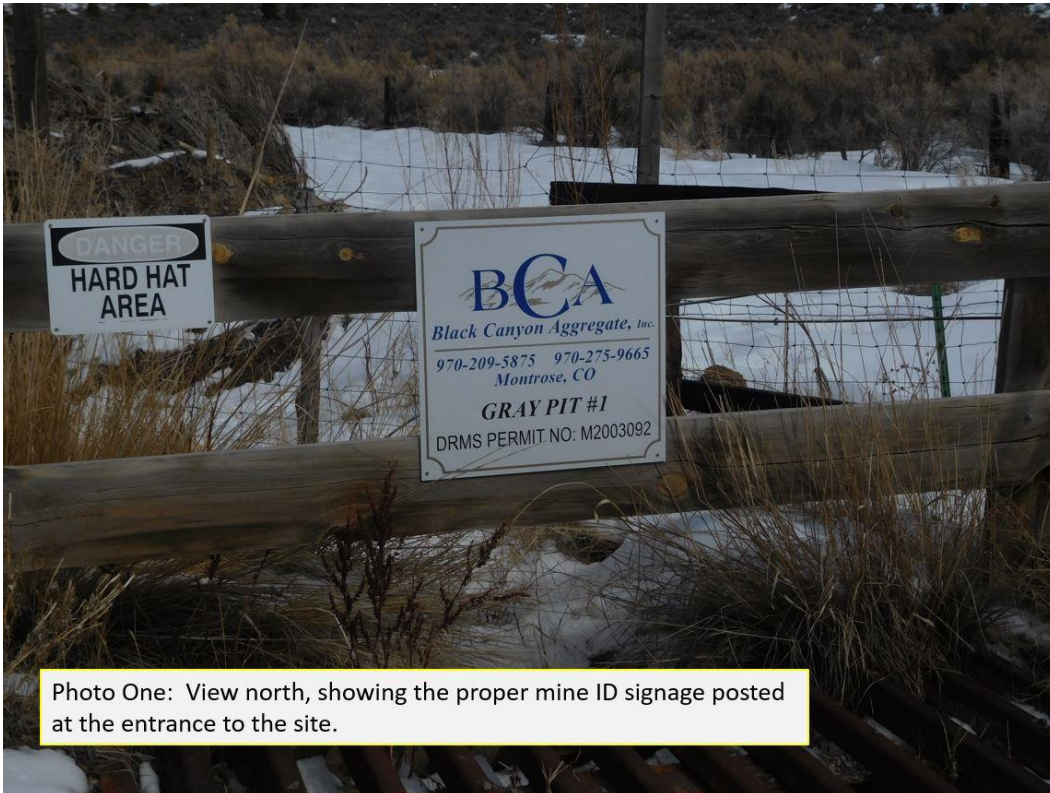
The proper mine identification was observed, however it is posted at the old entrance to the site. The sign can be seen in Photo One. The site was not active during the inspection and no mining related equipment was observed on site. The main pit floor can be seen in Photos Two and Three. The pit area is currently being used as stockpile area for material generated from this pit as well as the Gray Pit #2, which is a permitted site nearby. The pit floor as well as the stockpiles appear to be in good condition, stable and show no signs of settling, slumping or erosion.

Photo One: View north, showing the proper mine ID signage posted at the entrance to the site.

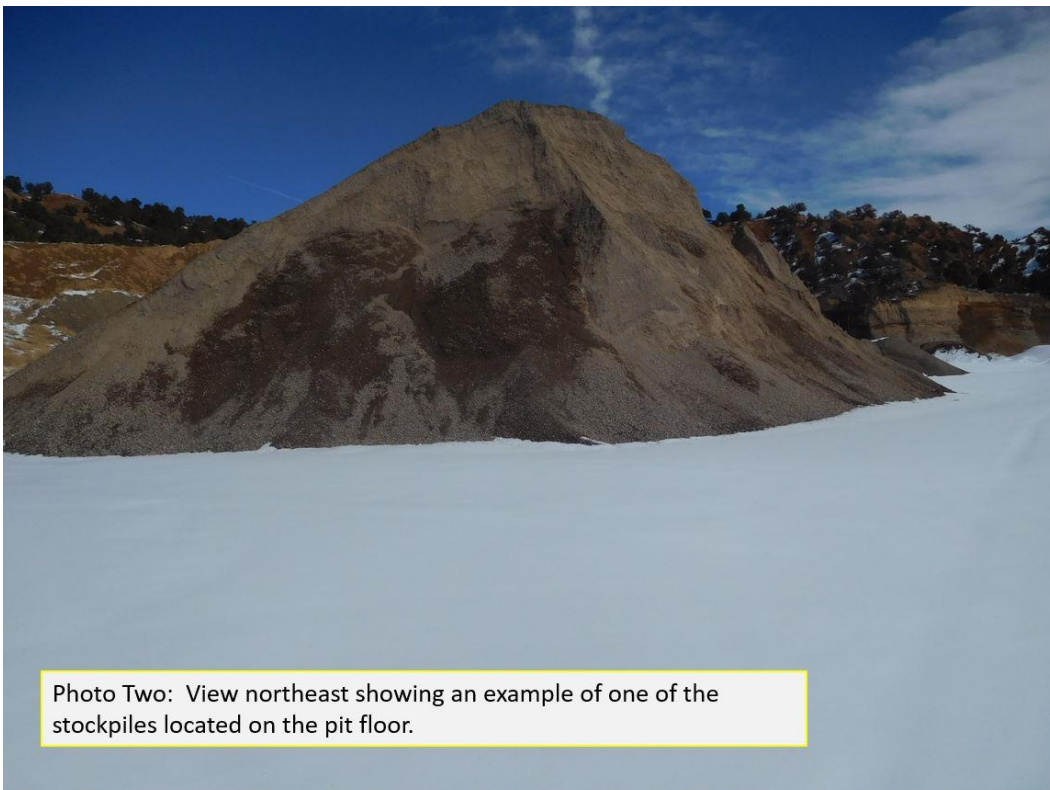
Photo Two: View northeast showing an example of one of the stockpiles located on the pit floor.

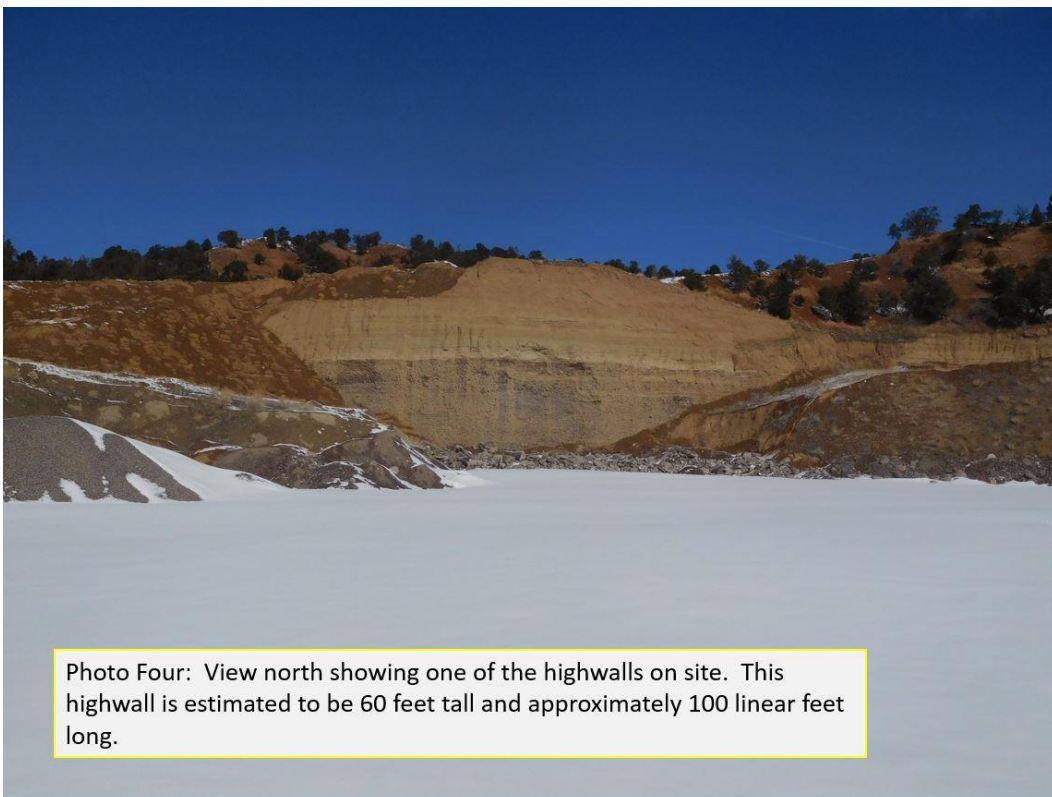
The main mining activity is centered on two areas. The first highwall is located in the main pit area, and is approximately 60 feet tall by 100 feet long. This highwall can be seen in Photo Four. The next area is surrounding the pond located at the east end of the pit. These highwalls are estimated at nearly 80 feet tall and nearly 200 Linear Feet. During the inspection, the highwalls were actively sloughing small amounts of material. The sloughing doesn't appear to pose any danger, however was noted. The area surrounding the pond can be seen in Photo Five.
