**MINERALS PROGRAM INSPECTION REPORT**  
**PHONE: (303) 866-3567**

<b>MINE NAME:</b> Colona Gravel Pit	<b>MINE/PROSPECTING ID#:</b> M-1994-005	<b>MINERAL:</b> Sand and gravel	<b>COUNTY:</b> Montrose
<b>INSPECTION TYPE:</b> Monitoring	<b>INSPECTOR(S):</b> Dustin M. Czaplá	<b>INSP. DATE:</b> March 21, 2019	<b>INSP. TIME:</b> 10:00
<b>OPERATOR:</b> Oldcastle SW Group, Inc. dba United Companies of Mesa County	<b>OPERATOR REPRESENTATIVE:</b> None	<b>TYPE OF OPERATION:</b> 112c - Construction Regular Operation	
<b>REASON FOR INSPECTION:</b> Normal I&E Program	<b>BOND CALCULATION TYPE:</b> None	<b>BOND AMOUNT:</b> \$165,351.00	
<b>DATE OF COMPLAINT:</b> NA	<b>POST INSP. CONTACTS:</b> None	<b>JOINT INSP. AGENCY:</b> None	
<b>WEATHER:</b> Cloudy	<b>INSPECTOR'S SIGNATURE:</b>

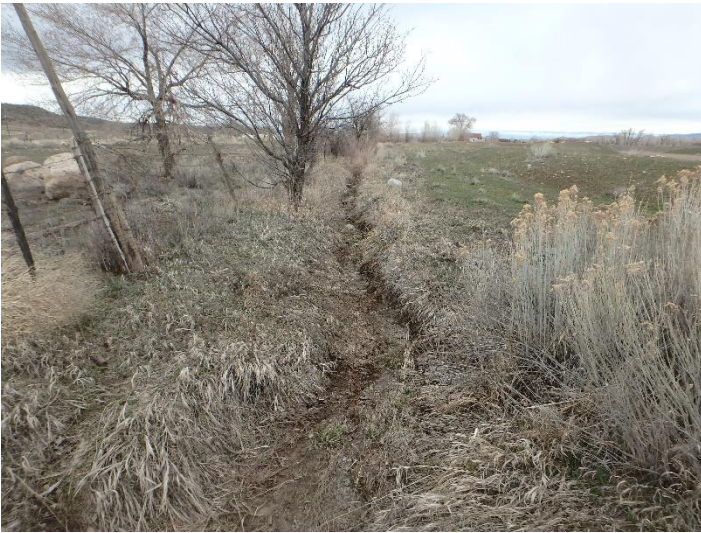
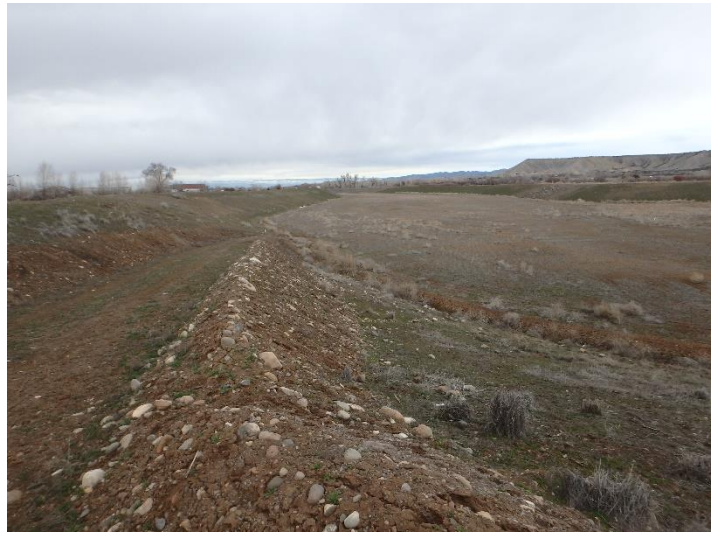
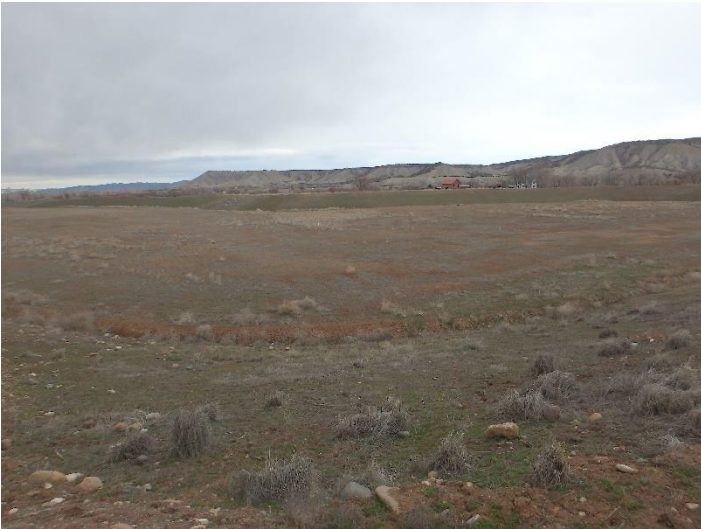
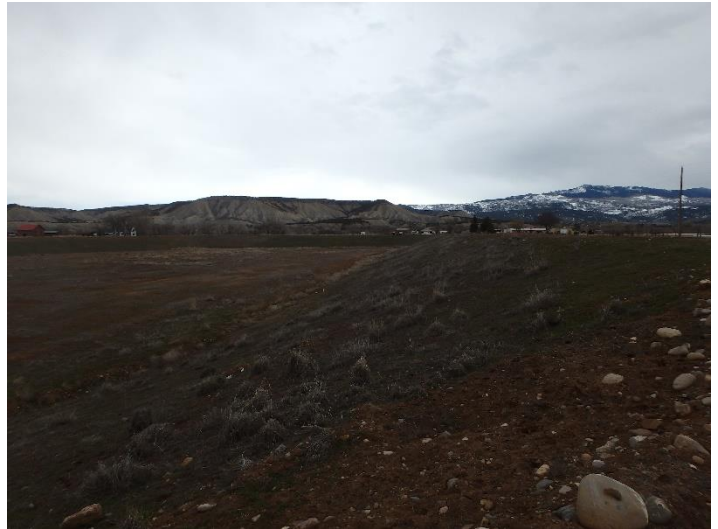
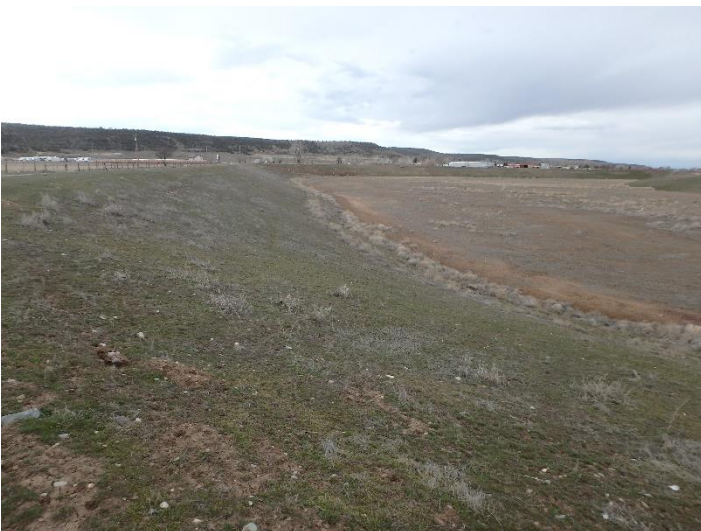
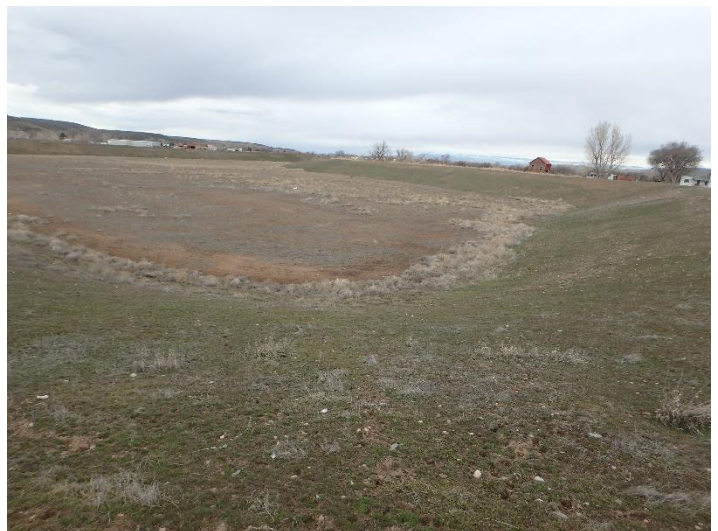
## **PHOTOGRAPHS**

The south pit area is in final reclamation. This inspection was conducted in order to observe and monitor conditions in the south pit area in order to address concerns related to groundwater infiltration through the highwalls and exposed groundwater in the pit floor. There were no seeps in the highwalls observed during this inspection. There was no exposed groundwater observed in the pit floor during this inspection. The irrigation ditch on the west side of the pit is not yet flowing for the irrigation season. The operator has constructed a ditch running along the base of the south and west highwall slopes in order to divert any seepage water around the south pit floor to the north pit area. No water was observed in the ditch.
