**COLORADO**  
Division of Reclamation,  
Mining and Safety  
Department of Natural Resources

<b>Permit Number:</b> C-1981-012 <b>Mine Name:</b> New Elk Mine <b>Operator:</b> New Elk Coal Company, LLC <b>Operator Address:</b> Mr. Louis Head 12250 Highway 12 Weston, CO 81091	<b>County:</b> Las Animas <b>Operation Type:</b> Underground <b>Permit Status:</b> Active <b>Ownership:</b> Private
	<b>Operator Representative Present:</b>  Vince Massarotti
<b>Operator Representative Signature: (Field Issuance Only)</b>

<b>Inspection Start Date:</b> March 21, 2019 <b>Inspection Start Time:</b> 07:40 <b>Inspection End Date:</b> March 21, 2019 <b>Inspection End Time:</b> 11:00		<b>Inspection Type:</b> Coal Partial Inspection <b>Inspection Reason:</b> Normal I&E Program <b>Weather:</b> Clear	
<b>Joint Inspection Agency:</b>  None		<b>Joint Inspection Contacts:</b>  	
<b>Post Inspection Agency:</b>  None		<b>Post Inspection Contacts:</b>  	
<b>Inspector(s):</b>  Robert D. Zuber, P.E.	<b>Inspector's Signature:</b>

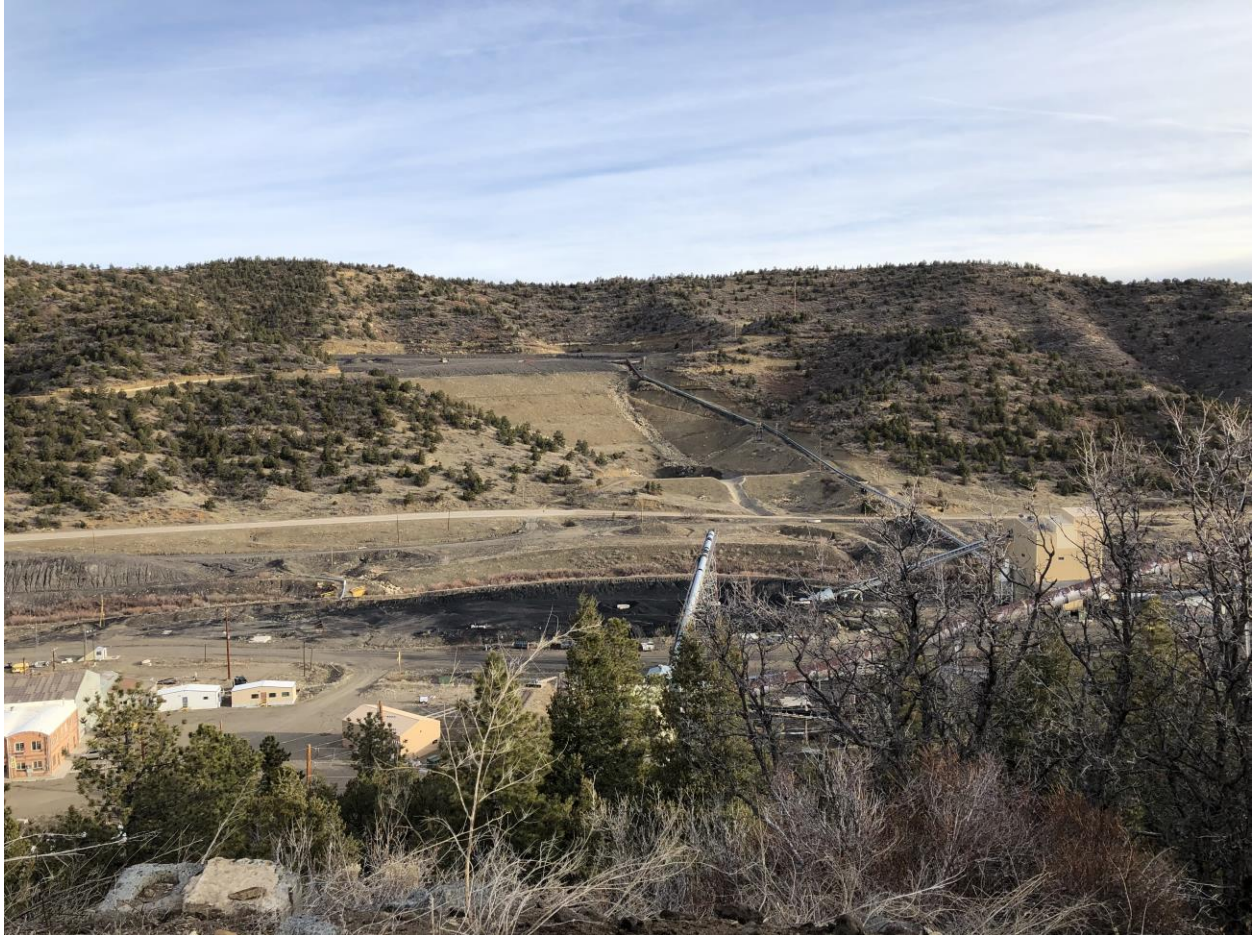
**RDA and facilities (taken from water tanks)**

No erosion was seen on the reclaimed portion of the RDA. The ditch between the upper and lower portions of the RDA is in good shape. No ponding or erosion were seen on the upper portion of the RDA, and the area is graded well. No signs of blowouts below the clear water ditches were seen.

No significant problems with roads were observed. The roads up the hills to the RDA and the water tanks were both in good shape and easily passable.

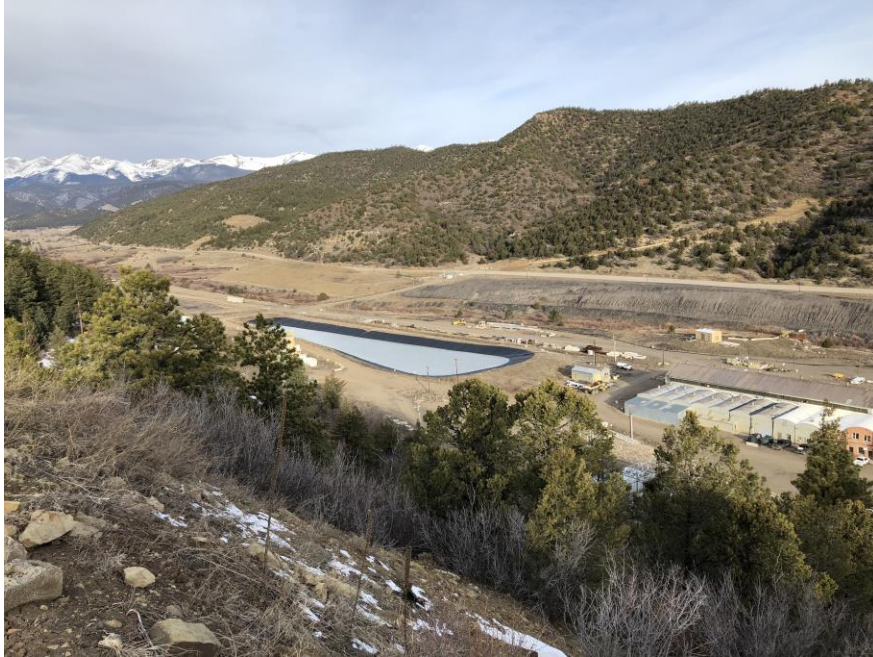
**Pond 001A and waste piles**

Ponds 001A, 004A, 006A, 007A, and 08 were inspected. None of them were discharging, but all held at least a small amount of water. The impounded water in Pond 08 appeared to be more than 13 feet below the primary spillway. There was very little water in Pond 007A and only a small amount in Pond 004A. Water was seen flowing into Pond 006A, and this was coming from Pond 008A (a pump was heard operating there and pipes run between these ponds). No significant issues were seen with the embankments or spillways of any ponds.

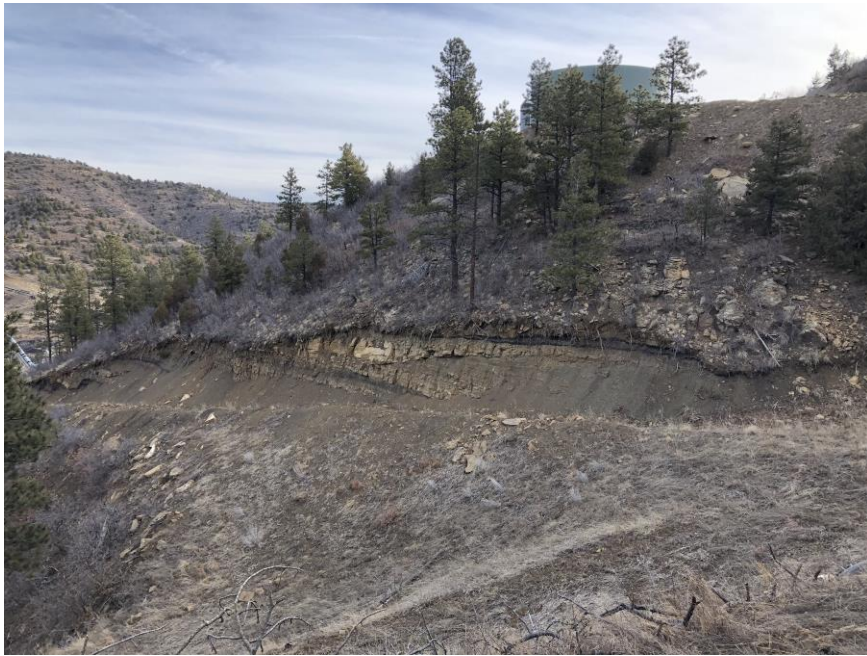
**Slope between Ditch D26 and water tanks**

No physical problems with ditches were identified. The hillside above Ditch C26 (below the water tanks) appeared stable. These ditches were found to be large enough per the specification in Table 20 of the PAP: D9, D39A.

- The hill below the water tanks was observed, and no erosion or other problems were seen.
- The retaining wall by the Bates Portals appears stable.
- No leaks or other problems were seen at any of the equipment storage areas.

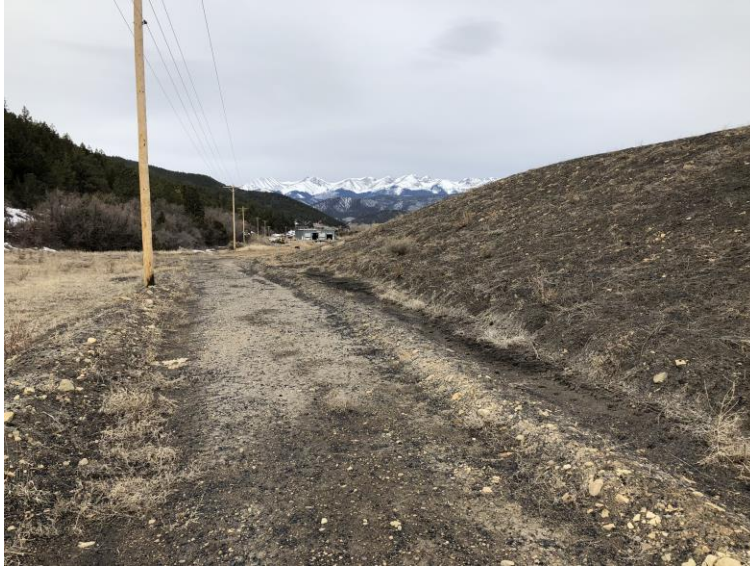
**Need for sediment removal from ring ditch around soil pile**

NECC staff need to remove sediment from the ring ditch around the subsoil pile at the soil storage area.

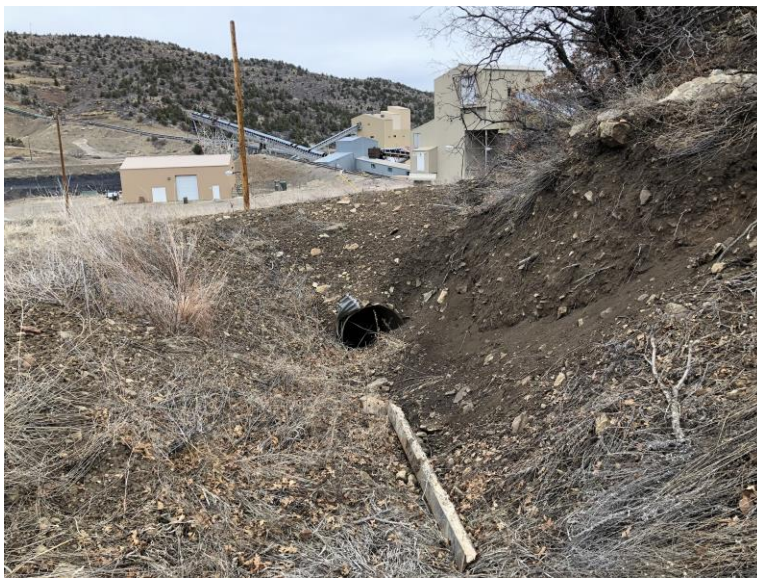
**Top of Culvert C12**

It still appears as though PAP maps and on-the-ground conditions are not completely in agreement (as noted in past reports). For example, Ditches D17A and D39AA do not exist, but they are shown on Map 13. Also, Culvert C12 is not located correctly and C50 does not appear to exist.

Some sediment removal is needed at the top of culvert C12.

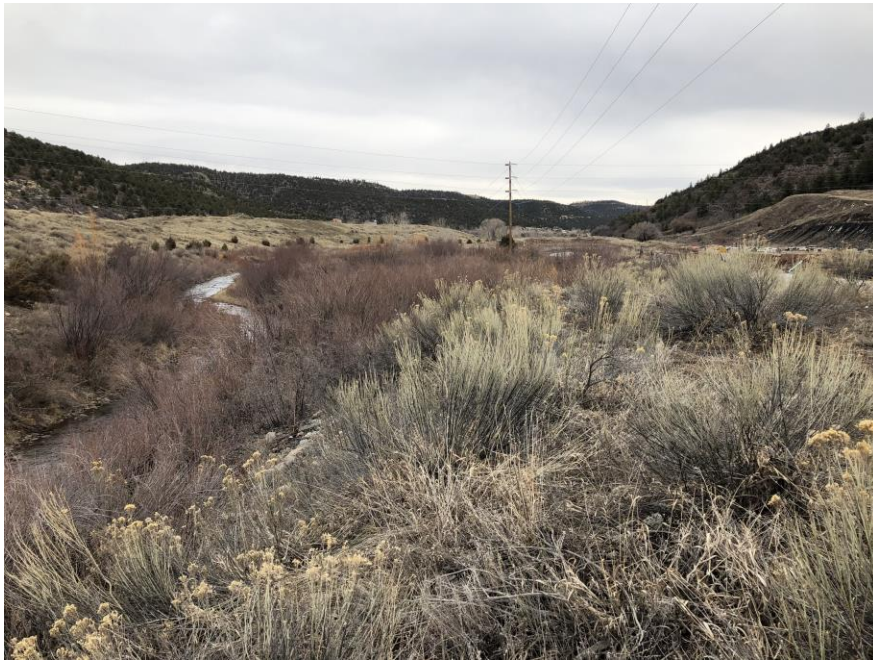
**Middle Fork of the Purgatoire River, below Pond 006A**

The Middle Fork of the Purgatoire River was inspected, and no eroding banks or signs of pollutant loading from the New Elk Mine were seen. Particular reaches that were inspected include below Pond 004A, near the prep plant, and beside Ponds 006A and 007A.

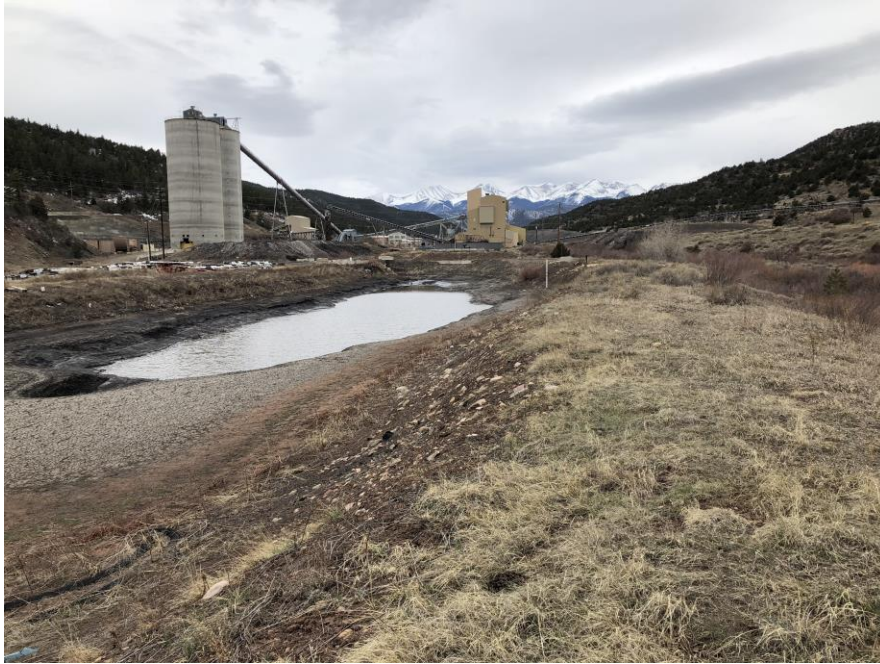
**Pond 007A**

Within the SAE by Pond 007A, BMPs appear to be functioning, and there was no discharge from this outfall. No problems were seen with the SAE east of DWDA#2, and the riprap below this area is stable.
