Permit Number: C-1996-084 Mine Name: Lorencito Canyon Mine Operator: New Elk Coal Company, LLC Operator Address: Mr. Louis Head 12250 Highway 12 Weston, CO 81091	County: Las Animas Operation Type: Surface Permit Status: Permanent Cessation Ownership: Private
	Operator Representative Present: Vince Massarotti
Operator Representative Signature: (Field Issuance Only)

Inspection Start Date: March 22, 2019 Inspection Start Time: 12:30 Inspection End Date: March 22, 2019 Inspection End Time: 14:40		Inspection Type: Coal Partial Inspection Inspection Reason: Normal I&E Program Weather: Cloudy	
Joint Inspection Agency: None		Joint Inspection Contacts: 	
Post Inspection Agency: None		Post Inspection Contacts: 	
Inspector(s): Robert D. Zuber, P.E.	Inspector's Signature:

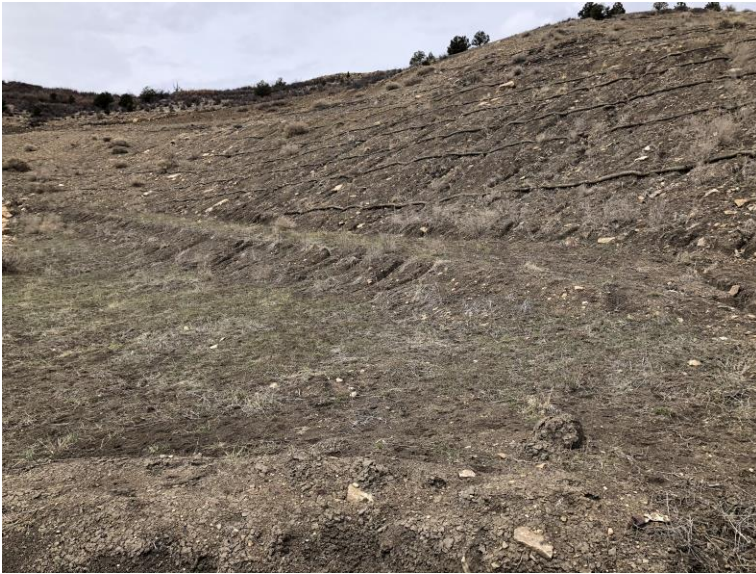
Hillside above Pond 6

The rills on the hillside above Pond 6 have not gotten worse, but should be treated. Vince indicated that he planned to put branches there soon. Branches have been placed recently in rills on the hillside above the pond cleaning dump area.

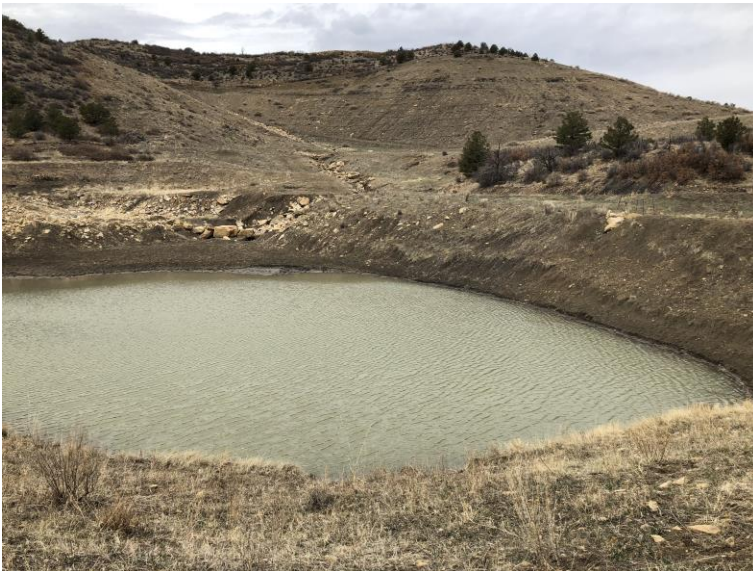
Pond 6 and quarry

The following ponds were inspected: 6, 7, 8, 9 and 9A. All ponds contained some water, except Pond 7. None of them were discharging. No problems were identified with embankments, spillways, or other features of the ponds, although the spillway at Pond 9 should be watched closely. It could be leaking, as water was seen at the downstream end of the spillway despite the water level in the pond being well below the spillway. Possibly this was a remnant of melting ice in the spillway.

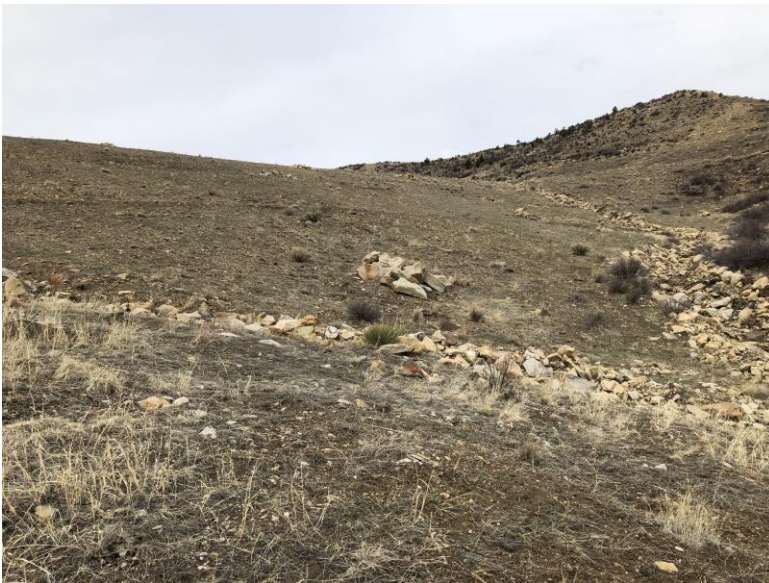
Fills 7, 8, and 9 were inspected. No new large rills or gullies were seen. The rills on Fill 7 are healing well, including the large one near the pond; branches are working to stabilize this feature.

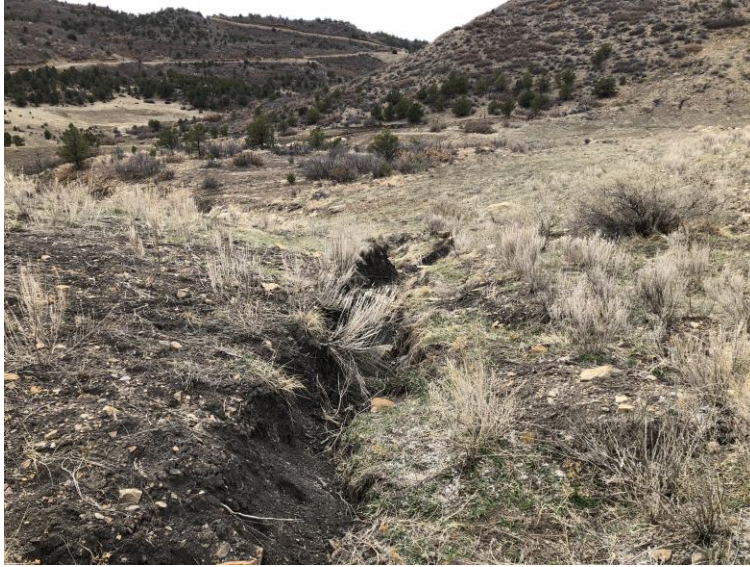
The following ditches (at least significant segments of them) were inspected: D5, D7, D9, D15, D71, D74, and D86. Rills in Ditch D7 should be repaired. Some bare spots were seen in some side ditches at fills (e.g., D74 at Fill 7), and these should be monitored for erosion problems. No problems were found with other ditches.

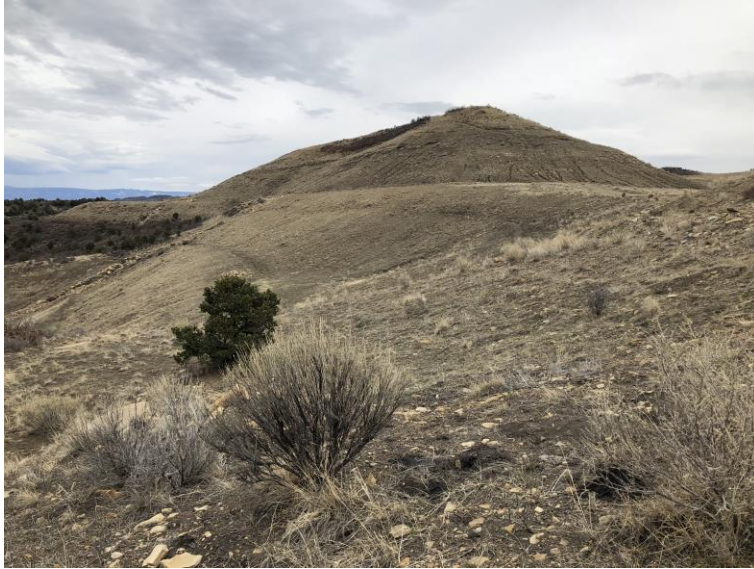
Fill 8 and “the knob”

The hill known as “the knob” looked to be generally stable, with no gullies.
