MINERALS PROGRAM INSPECTION REPORT
PHONE: (303) 866-3567

MINE NAME: Donley Rock Quarry	MINE/PROSPECTING ID#: M-2011-005	MINERAL: Sand and gravel	COUNTY: Montrose
INSPECTION TYPE: Monitoring	INSPECTOR(S): Lucas J. West	INSP. DATE: February 26, 2019	INSP. TIME: 14:30
OPERATOR: Montrose County	OPERATOR REPRESENTATIVE: Norm David	TYPE OF OPERATION: 112c - Construction Regular Operation	
REASON FOR INSPECTION: Normal I&E Program	BOND CALCULATION TYPE: None	BOND AMOUNT: \$0.00	
DATE OF COMPLAINT: NA	POST INSP. CONTACTS: None	JOINT INSP. AGENCY: None	
WEATHER: Clear	INSPECTOR'S SIGNATURE:

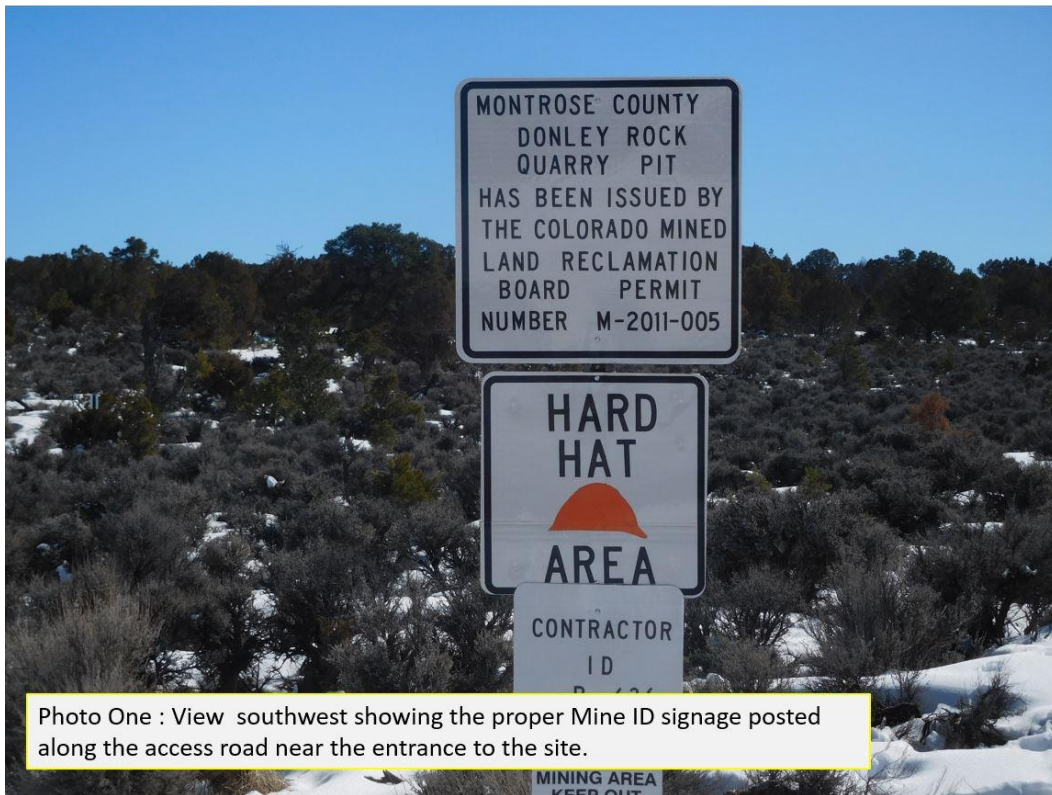
The site was not active during the day of the inspection and no mining related equipment present on the site. The proper mine identification signage was posted at the entrance to the site and can be seen in Photo One. The permit boundaries were clearly marked around the site with a series of t-posts. The main mining area consists of a small excavation from which dimensional stone is being excavated. The material is drilled and blasted periodically by a licensed blaster and the material is harvested as needed. The excavation area appears to be stable and is in good condition, no signs of sloughing or erosion were observed during the inspection. The area has created a small highwall that is approximately 8' tall by 15 linear foot. The rest of the area is left sloped during excavation and can be seen in Photo Two.

Photo One : View southwest showing the proper Mine ID signage posted along the access road near the entrance to the site.

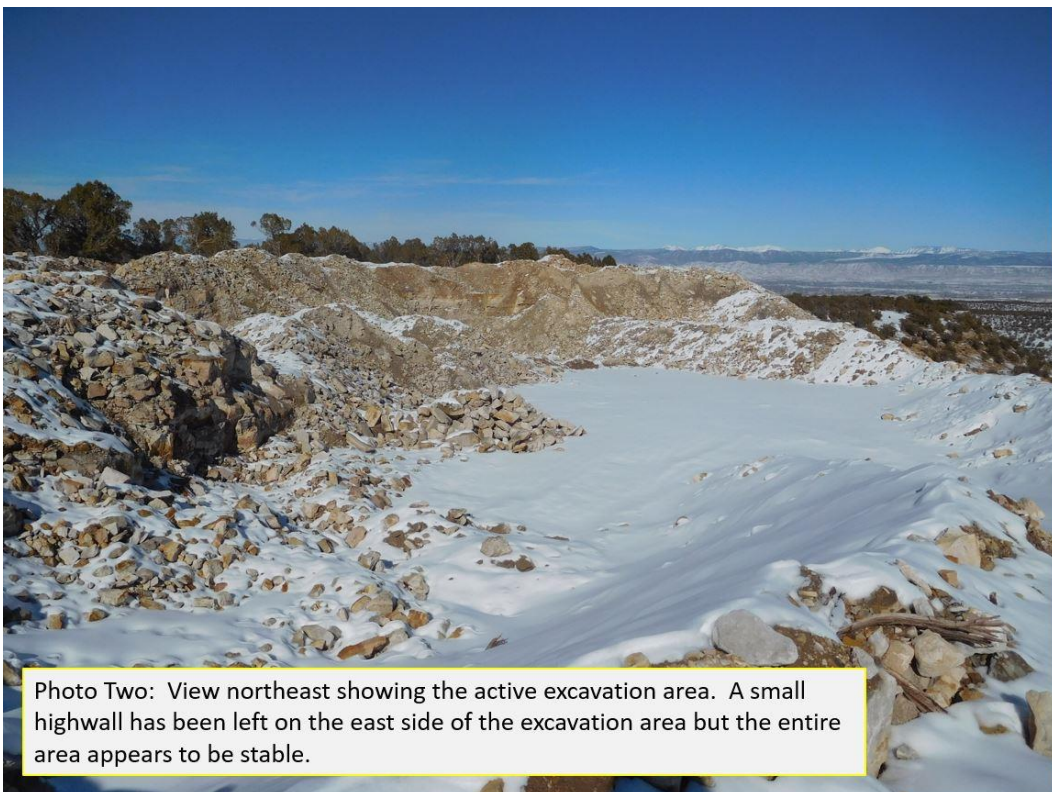
Photo Two: View northeast showing the active excavation area. A small highwall has been left on the east side of the excavation area but the entire area appears to be stable.

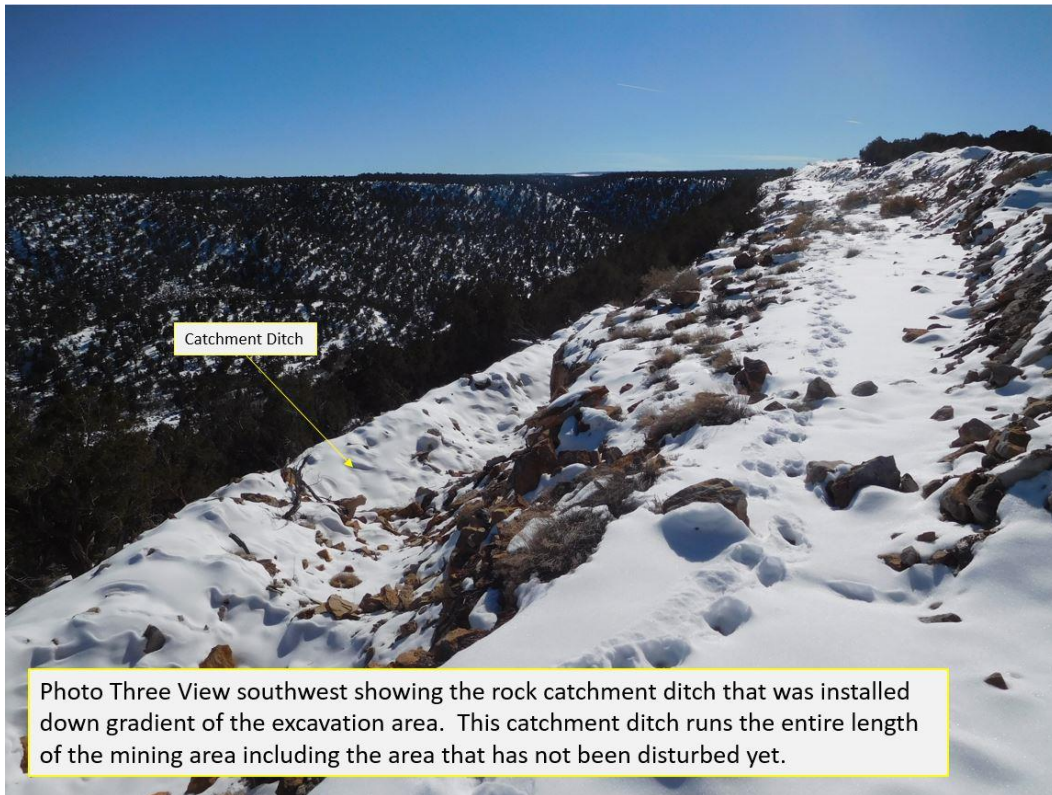
The main excavation area exhibits positive drainage and no impounded snowmelt or storm water was observed during the inspection. A large rock catchment ditch was installed on the down gradient side of the excavation to protect offsite areas from accidental rock fall from the excavation area. This ditch can be seen in Photo Three. It appears to be functioning as designed and no fugitive rocks were observed below the catchment ditch.
