COLORADO

MINERALS PROGRAM INSPECTION REPORT

MINE NAME: Branson Gravel Pit	MINE/PROSPECTING ID#: M-1997-100	MINERAL: Gravel	COUNTY: Las Animas
INSPECTION TYPE: Monitoring	INSPECTOR(S): Jared L. Ebert	INSP. DATE: March 19, 2019	INSP. TIME: 11:55
OPERATOR: Las Animas County	OPERATOR REPRESENTATIVE: Allen Winford	TYPE OF OPERATION: 112c - Construction Regular Operation

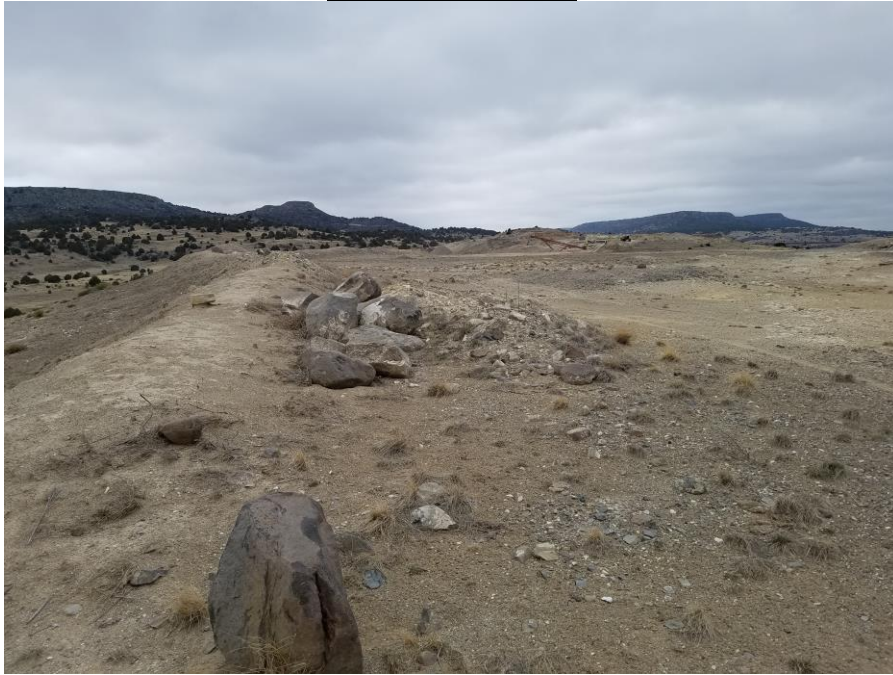
The permit area encompasses two small mesas bisected by a small draw. Mining appears to be complete on the eastern mesa. The top of the eastern mesa is gently sloped with a small berm of soil or excess mined material around the perimeter of the excavated area.

Overall, mining appears to be complete in the eastern mesa. Las Animas County is encouraged to spread any remaining topsoil material over the affected land and complete reclamation of this area.

Little to no vegetation has established in the eastern mining area.

Figure 1. From the southeast end of the eastern mining area looking west/northwest.

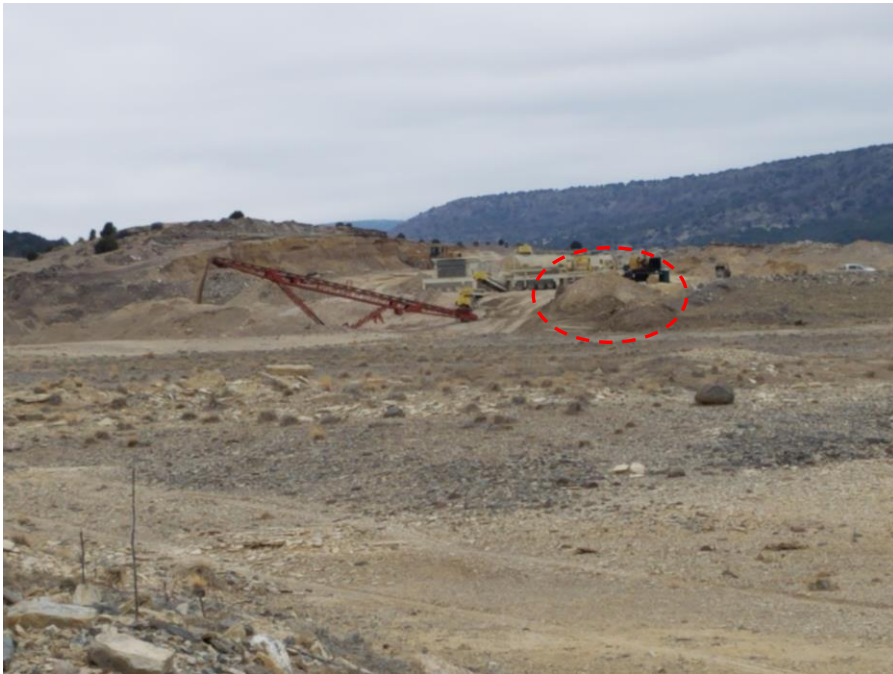
One topsoil stockpile was located very close to the processing equipment and the active mining area. Las Animas County must use caution and not affect this pile by the continued mining operation.

Figure 2. From the east end of the western mining area looking west. Topsoil stockpile circled in red.

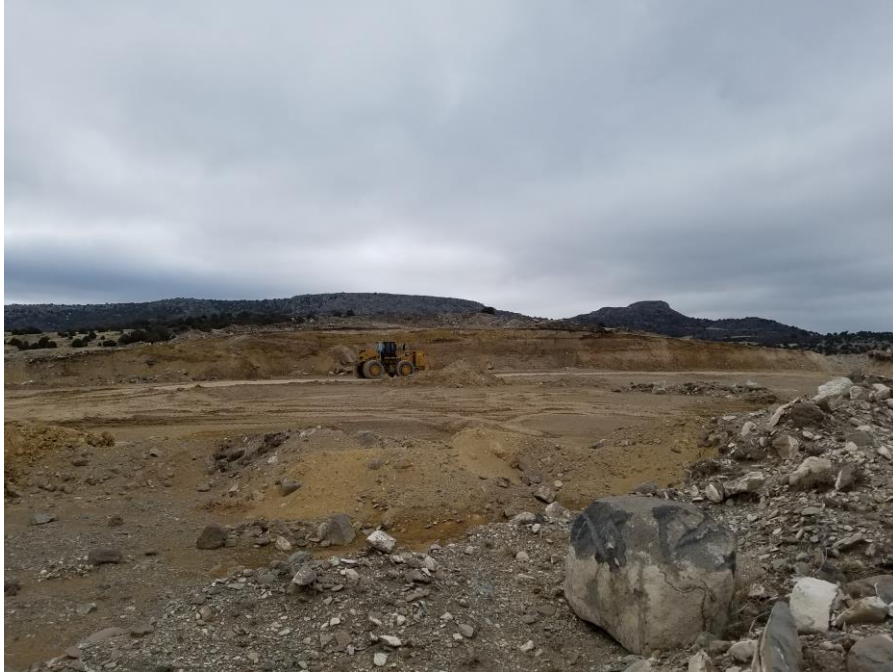
The western mesa is where active mining is occurring. A bowl shaped pit excavation has occurred on the western mesa. The active mining face consists of a near vertical highwall with a northern aspect at the top of the mesa. The remaining pit slopes are generally at the angle of repose.

Figure 3. From the north end of the western mining area looking south.

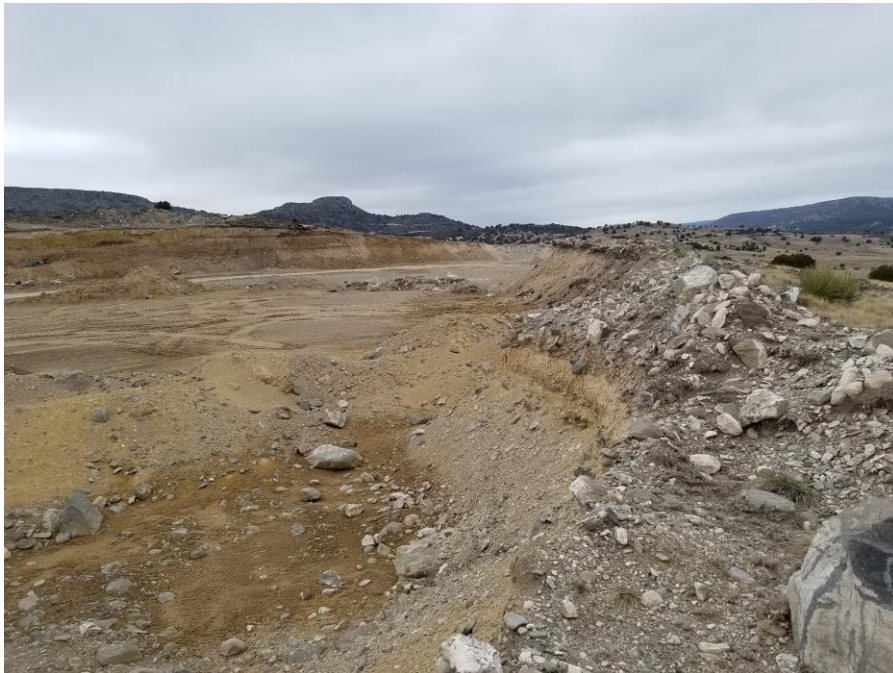
Figure 4. From the north end of the western mining area looking west.

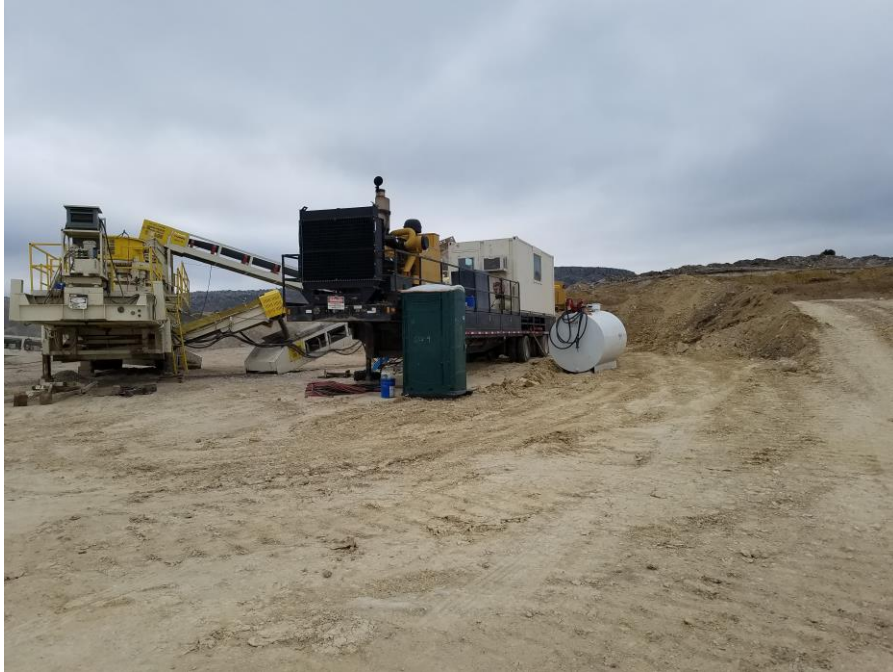
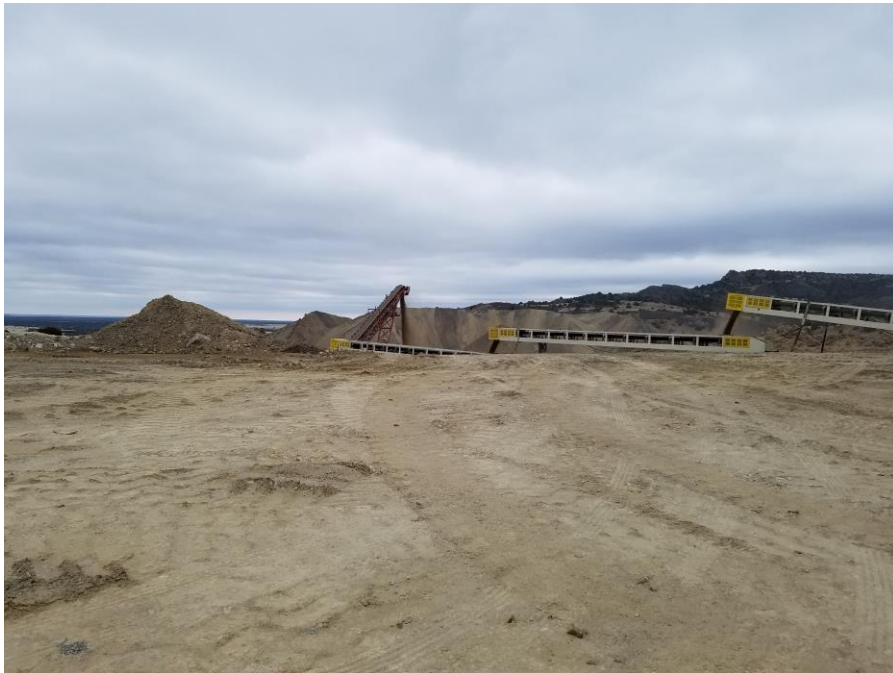
Mining appears to be advancing in accordance with the approved mining plan. Processing equipment was in place and functioning on the east side of the western mesa.

Figure 5. Processing equipment on the east side of the western mining area.

Figure 6. Processing equipment on the east side of the western mining area.
