MINERALS PROGRAM INSPECTION REPORT

MINE NAME: McCumber Hill Pit	MINE/PROSPECTING ID#: M-2000-151	MINERAL: Sand and gravel	COUNTY: Fremont
INSPECTION TYPE: Monitoring	INSPECTOR(S): Timothy A. Cazier	INSP. DATE: March 20, 2019	INSP. TIME: 14:10
OPERATOR: Fremont Paving & Redi-Mix, Inc.	OPERATOR REPRESENTATIVE: John Young	TYPE OF OPERATION: 112c - Construction Regular Operation	
REASON FOR INSPECTION: Normal I&E Program	BOND CALCULATION TYPE: Partial Bond	BOND AMOUNT: \$64,540.00	
DATE OF COMPLAINT: NA	POST INSP. CONTACTS: None	JOINT INSP. AGENCY: None	
WEATHER: Clear	INSPECTOR'S SIGNATURE:

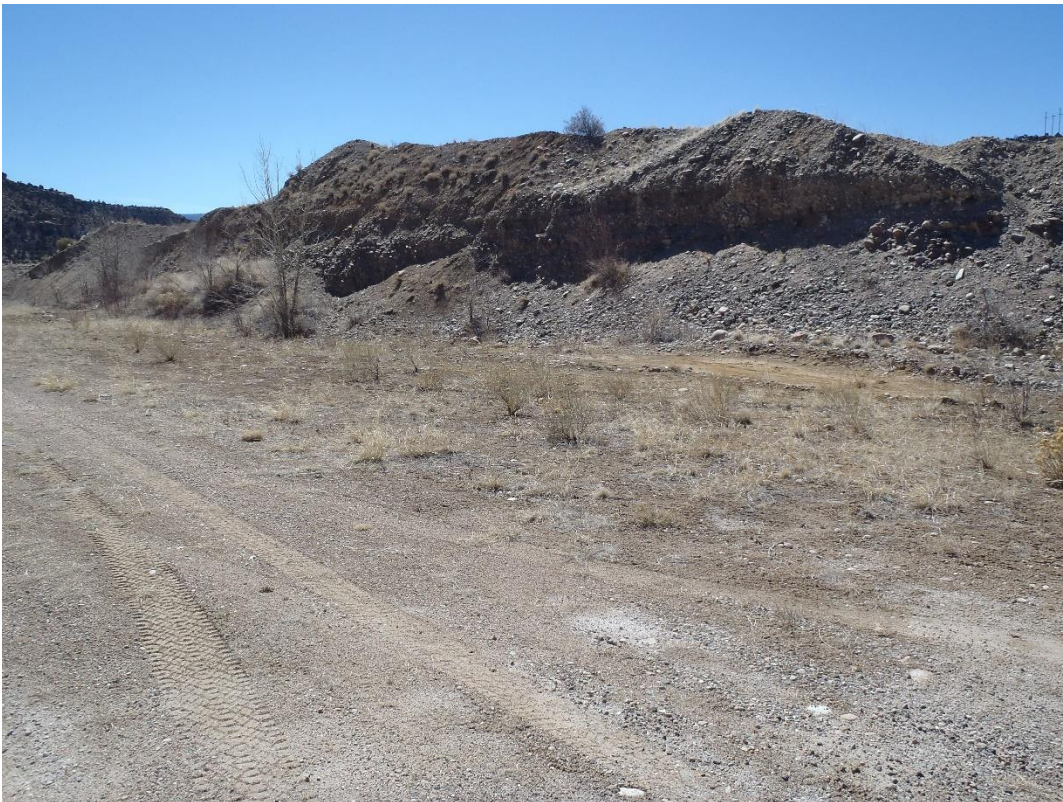
Gen. Compliance with Mine Plan: The operation appeared to be in compliance with the approved mine plan. Mining has only occurred in Phase 1. Google Earth was used to measure the disturbed area, which was estimated to be approximately 10.3 acres, based on June 1, 2018 imagery. Highwalls were estimated to vary between 12 and 15 feet in height. Only the internal highwalls are near vertical (see **Photo 1**). The external (east side) highwalls have been flattened and appeared stable (see **Photo 2**).

Photo 1. Internal highwalls near vertical (looking SW from north end of pit floor).

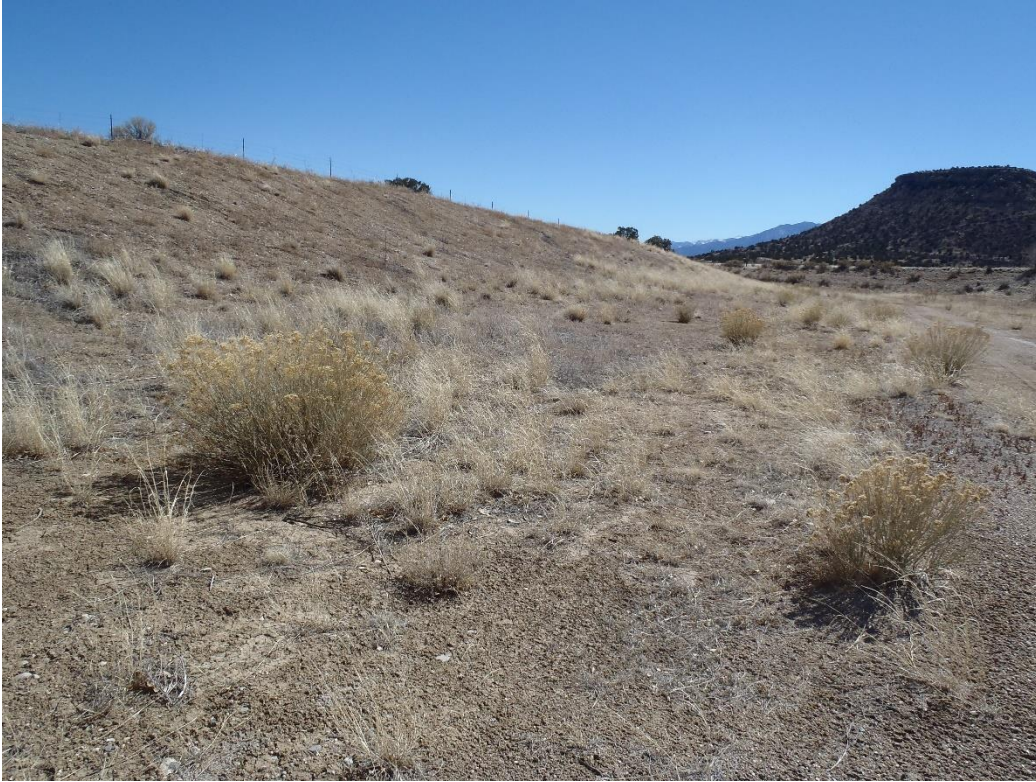
Backfilling and Grading: Sufficient backfill (push down) material was available for internal highwalls. The external highwalls had been flattened to acceptable slope between the May 20, 2014 inspection and the November 11, 2014 inspection.

Photo 2. External/east side (Phase 1) highwalls flattened and appeared stable.

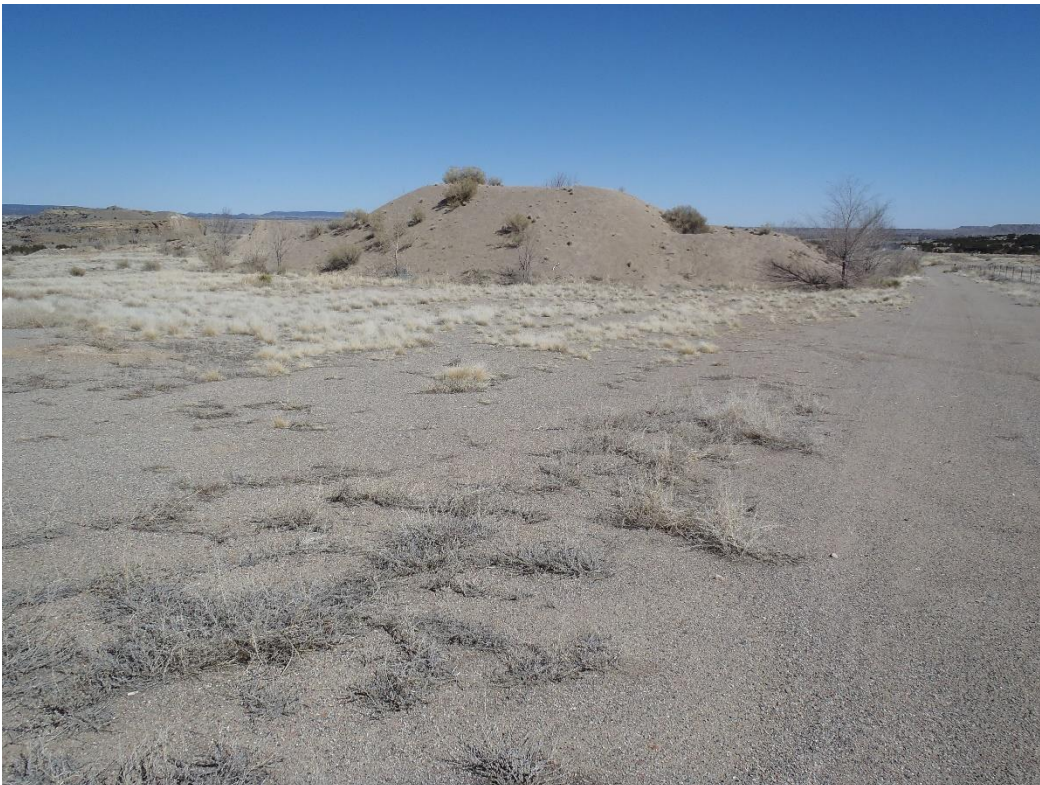
Processing Waste: A large stockpile of crusher fines (see **Photo 3**) was observed to the west of the pit and north of the access road running along the fence.

Photo 3. Crusher fines stockpile (SW of pit, looking ESE).

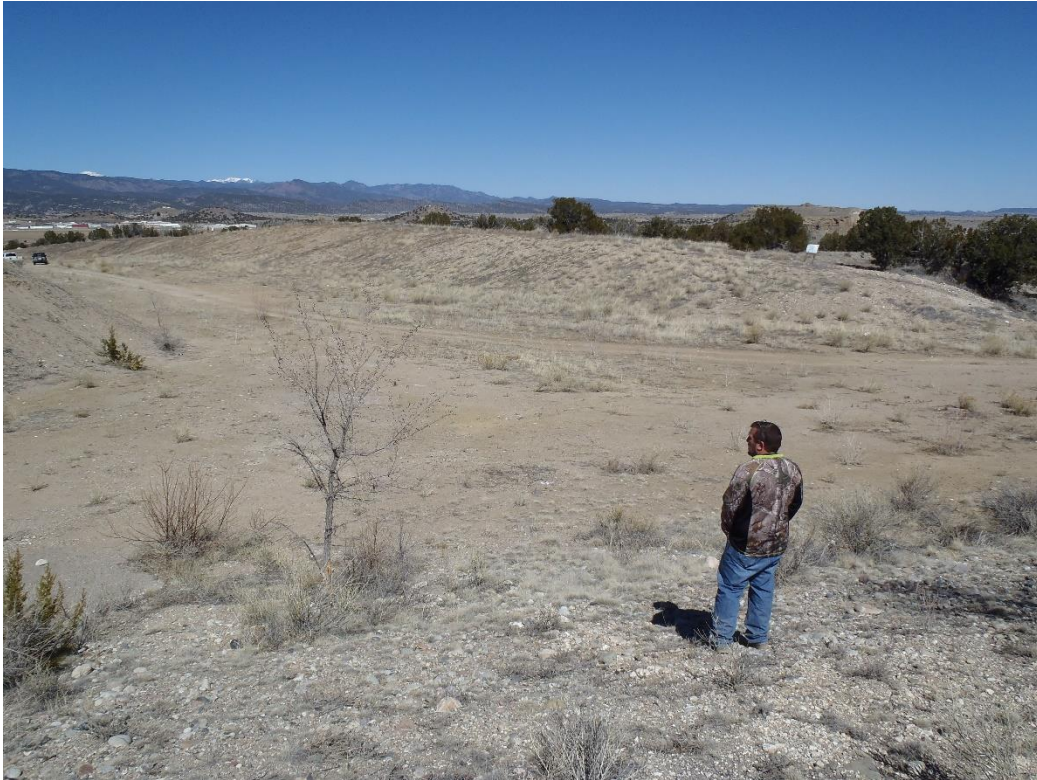
Reclamation Success: The only reclamation is that started on the east slopes (see **Photo 4**) as a result of the corrective action required by the DRMS in 2014 due to the unstable slopes observed at that time. Mr. Young pointed out the house west of the pit had been demolished.

Photo 4. Reclamation of east slopes (looking NE from access road south of pit).

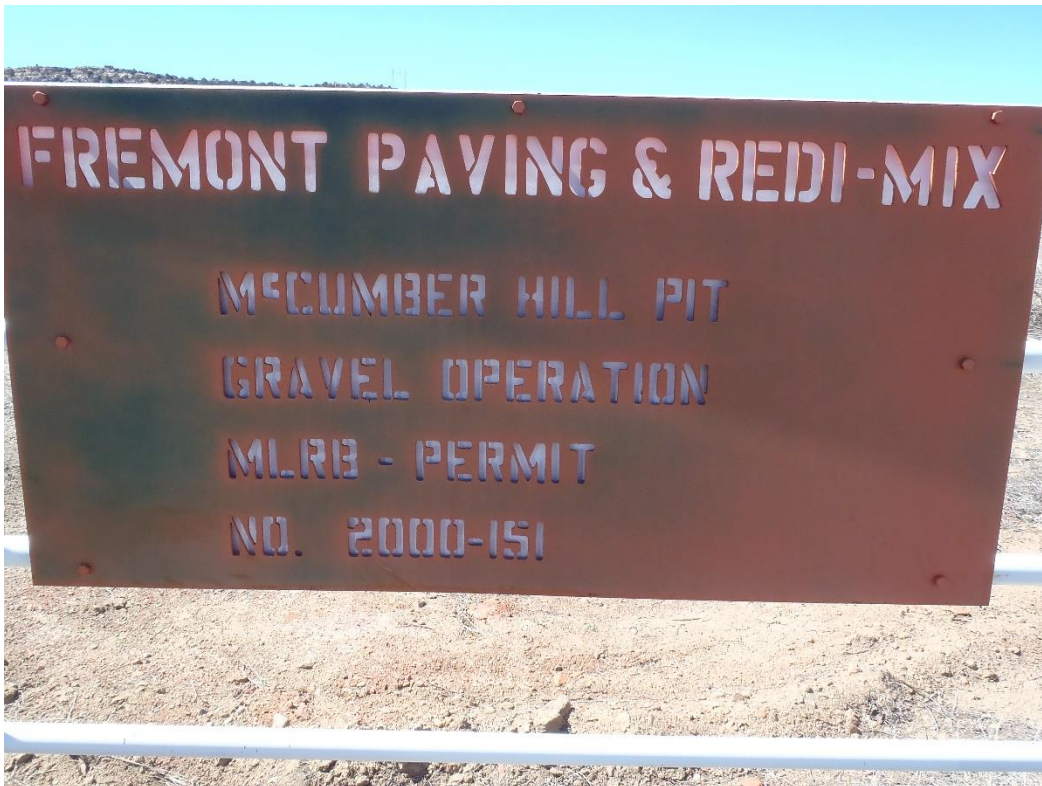
Signs and Markers: The permit sign was properly posted (see **Photo 5**) and boundary markers were observed to delineate the permit boundary (see **Photo 6**).

Photo 5. Permit sign at entrance.

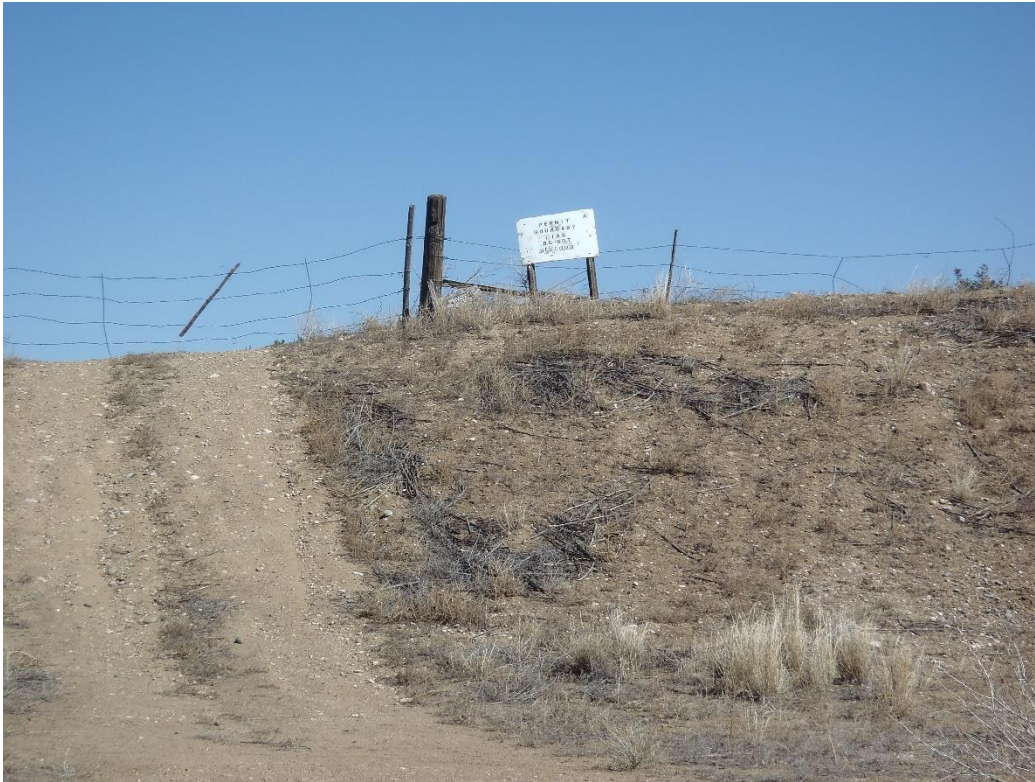
Photo 6. Fenced and marked boundary on east side (looking east).
