MINERALS PROGRAM INSPECTION REPORT**PHONE: (303) 866-3567**

MINE NAME: Yocam Pit	MINE/PROSPECTING ID#: M-1999-060	MINERAL: Gravel	COUNTY: Las Animas
INSPECTION TYPE: Monitoring	INSPECTOR(S): Jared L. Ebert	INSP. DATE: March 19, 2019	INSP. TIME: 14:00
OPERATOR: Las Animas County	OPERATOR REPRESENTATIVE: Ricky Torres	TYPE OF OPERATION: 112c - Construction Regular Operation

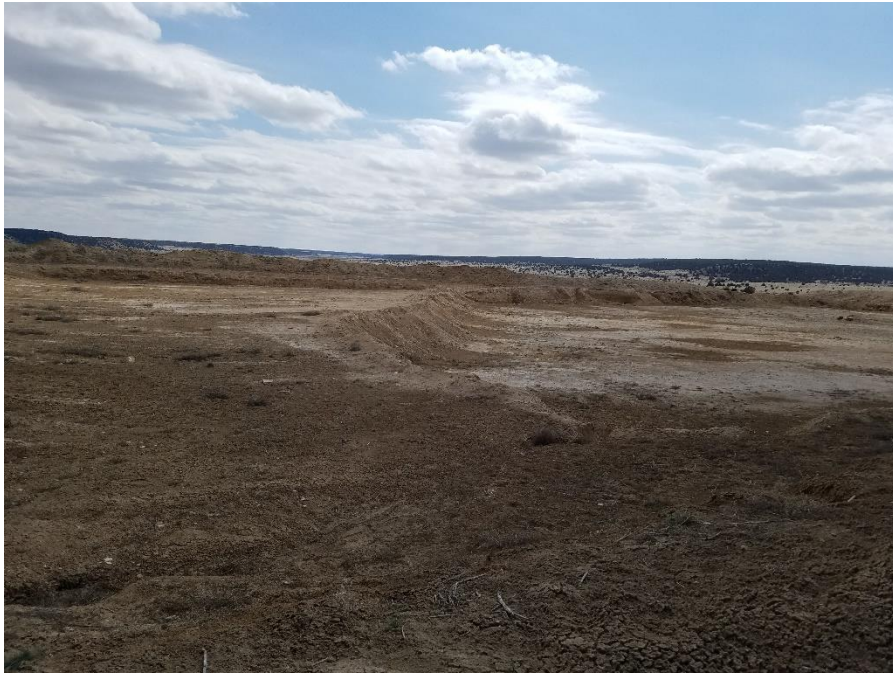
Figure 1. From the northeast corner of the active pit area looking south.

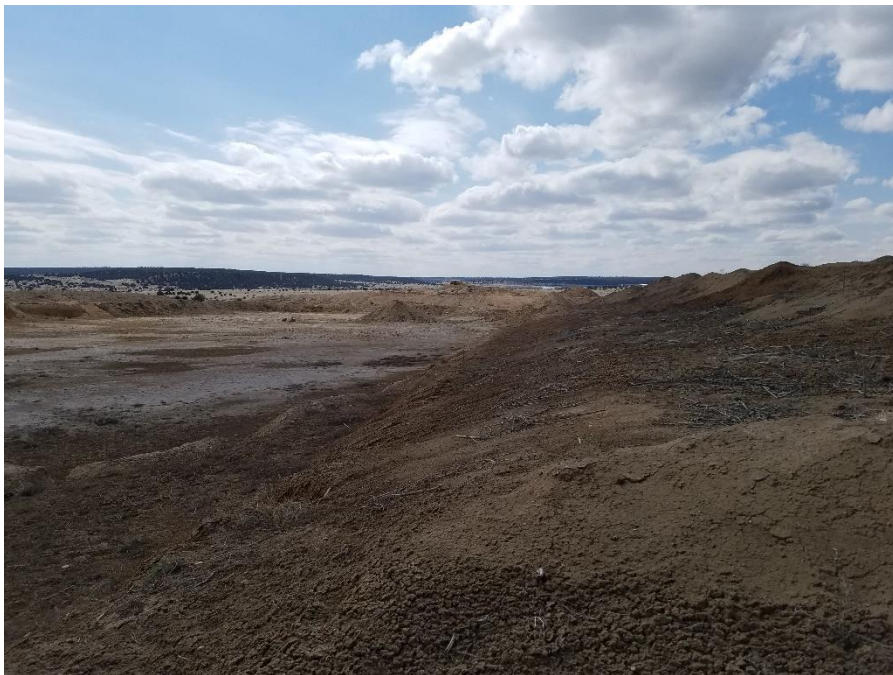
Figure 2. From the northeast corner of the active pit looking southwest.

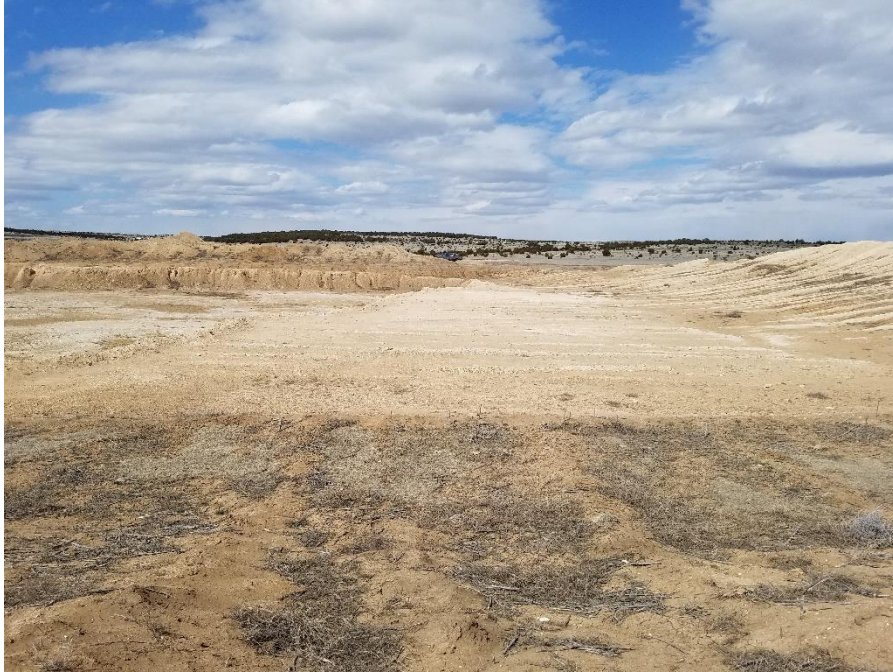
Figure 3. From the southeast corner of the active pit looking north.

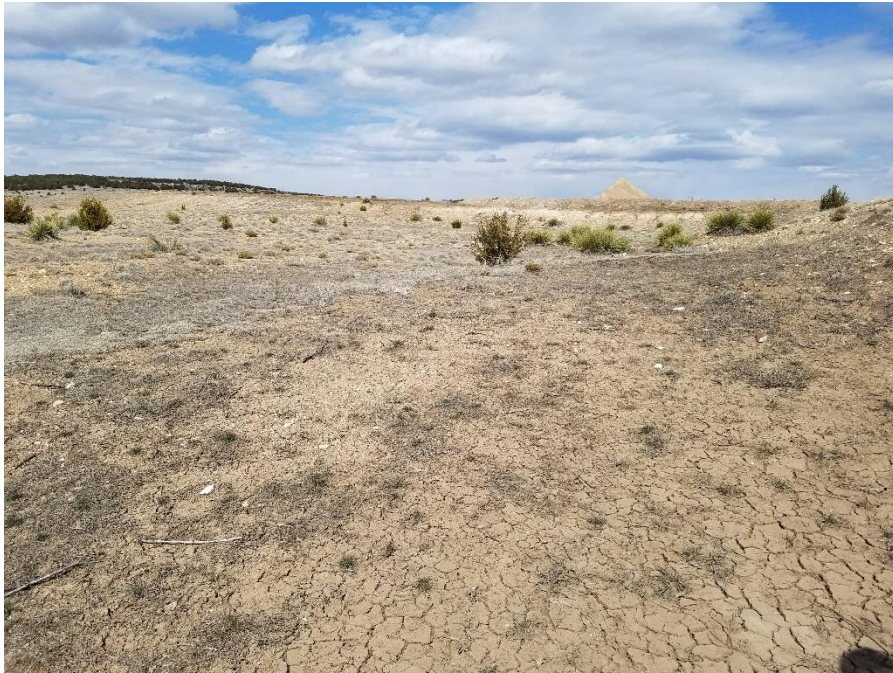
A portion of the affected land appears partially reclaimed northwest of the active pit area. Sparse vegetation has established in this area. However, according to Mr. Torres, they may continue mining in this area.

Figure 4. From the southwest corner of the active pit area looking northwest at partially reclaimed area.
