MINERALS PROGRAM INSPECTION REPORT

| MINE NAME: Goodrich Pit | MINE/PROSPECTING ID#: M-2019-005 and M-2017-005 | MINERAL: Aggregate and grave | COUNTY: Las Animas |
| INSPECTION TYPE: Preoperation Inspection | INSPECTOR(S): Jared L. Ebert | INSP. DATE: March 20, 2019 | INSP. TIME: 08:20 |

Goodrich Pit, M-2019-005

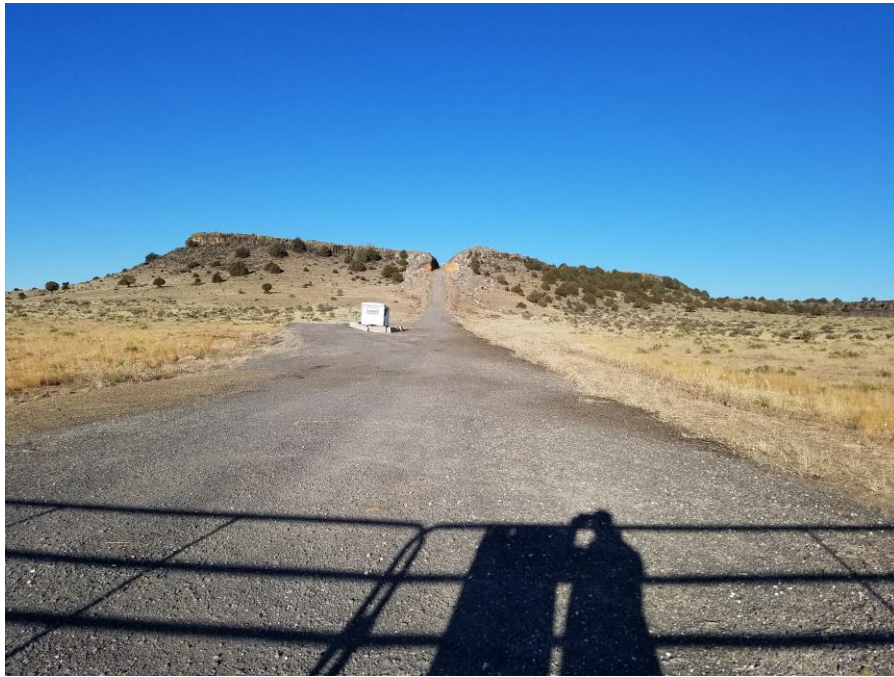
Figure 1. From the entrance looking west at the access road.

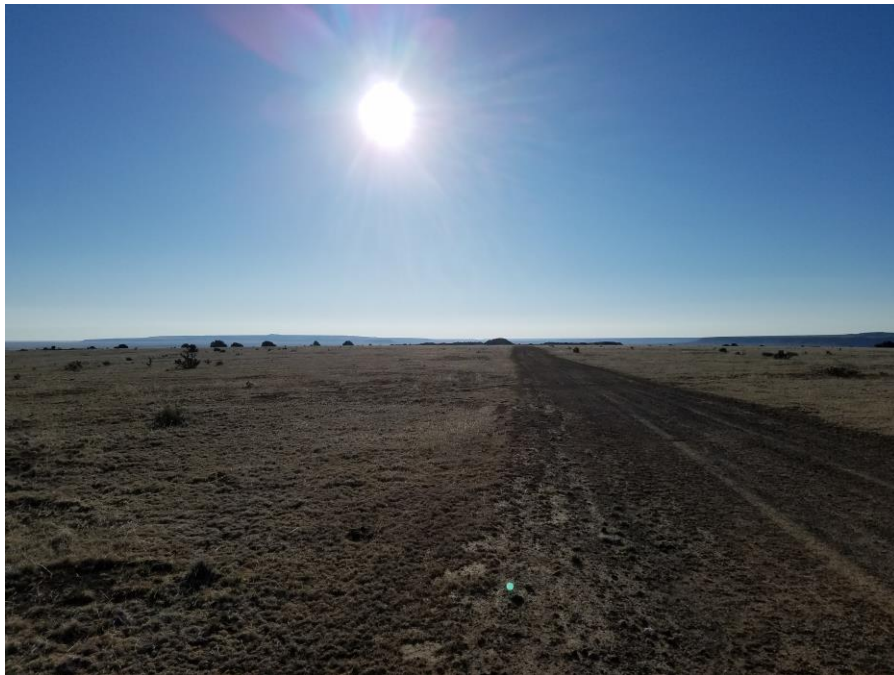
The proposed permit area encompasses the top of a portion of a mesa. Mining is proposed to continue west and then north of the currently affected land. The proposed expansion area was observed. This area is a relatively gentle sloped mesa top with native grass established. A small stock pond embankment was observed in the northwest corner of the proposed expansion area. This stock pond is not accounted for in the 112c application. The Division has issued an adequacy review letter for the 112c application and is awaiting the applicant's response. The Division is required to issue a decision on the application on May 6th, 2019.

Figure 2. From the west end of the expansion area looking east.

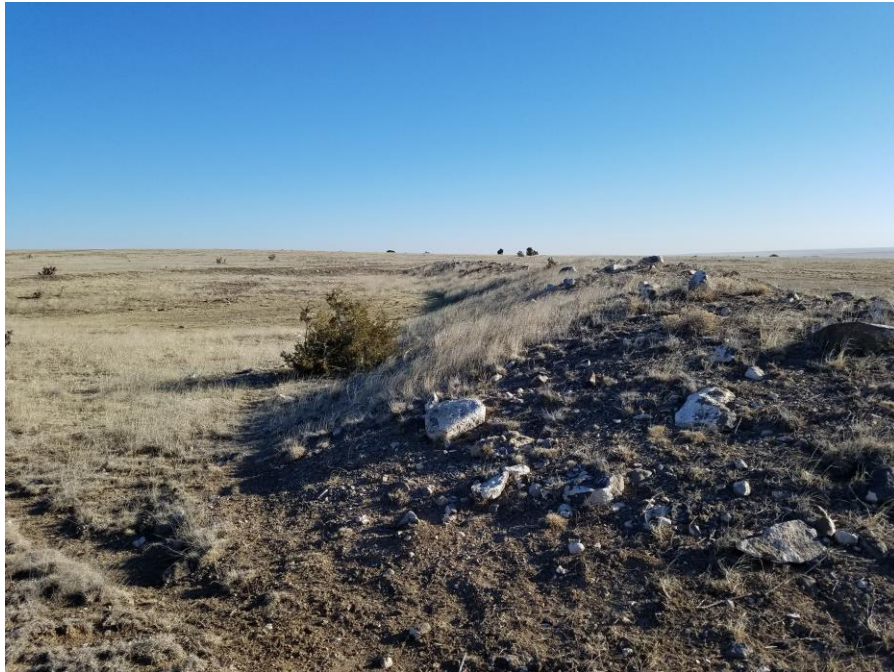
Figure 3. Stock water pond embankment in the northwest portion of the permit area.

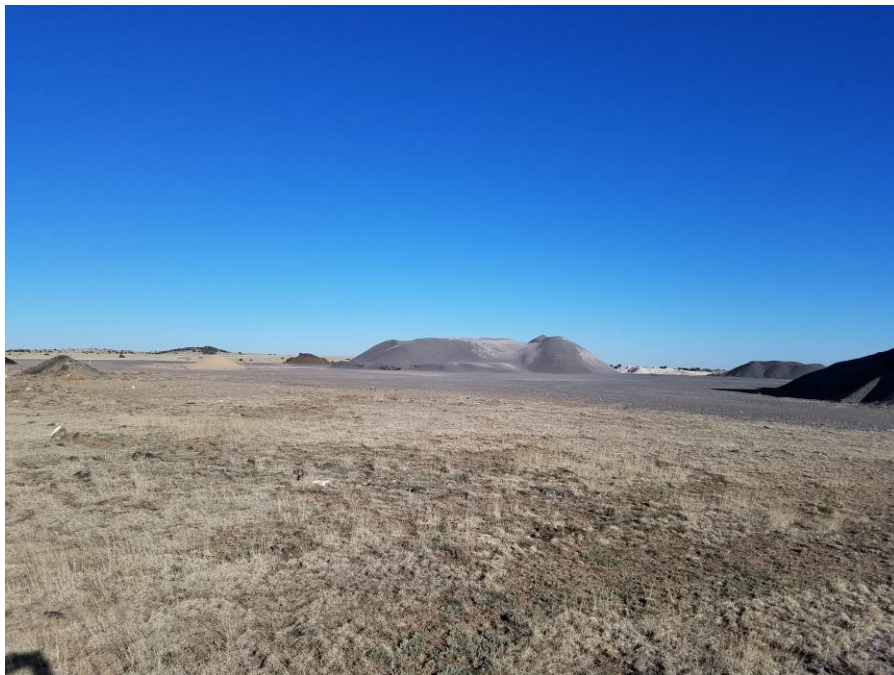
The Operator has affected about 18 acres of land not including the newly created access road. The affected land has been stripped of topsoil and the pit area is located in the northeast portion of the affected area. Topsoil and any additional overburden has been placed in stable berms primarily on the south side of the affected land.

Figure 4. Stockpile area on the west side of the affected area.

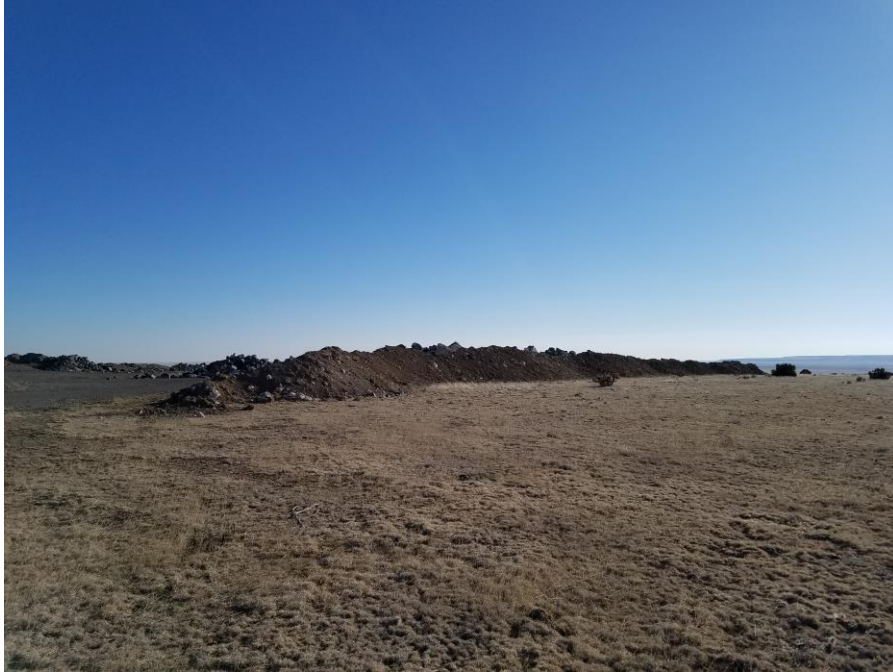
Figure 5. From the southwest corner of the affected land looking west.

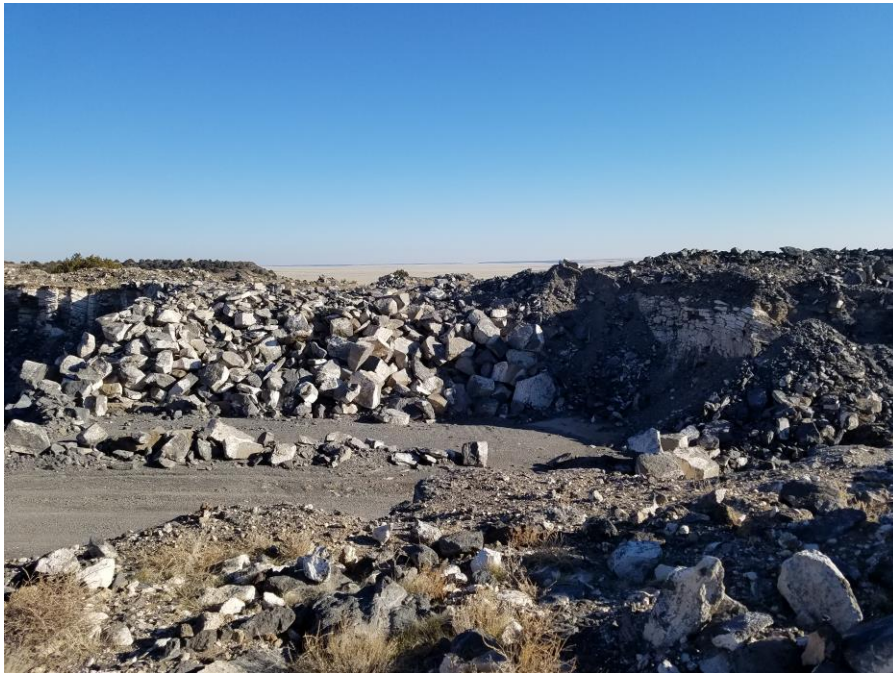
The Operator has begun excavation under the 111c permit that appears to be in the Phase 1 area shown on the proposed mining plan map submitted with the 112c permit application. A small pit excavation currently exists in the northeast portion of the affected area. A box cut with near vertical side slopes exists, and the Division estimates the length of the current highwall is about 570 feet and is about 25 feet in height.

Figure 6. From the southwest corner of the active pit looking north.

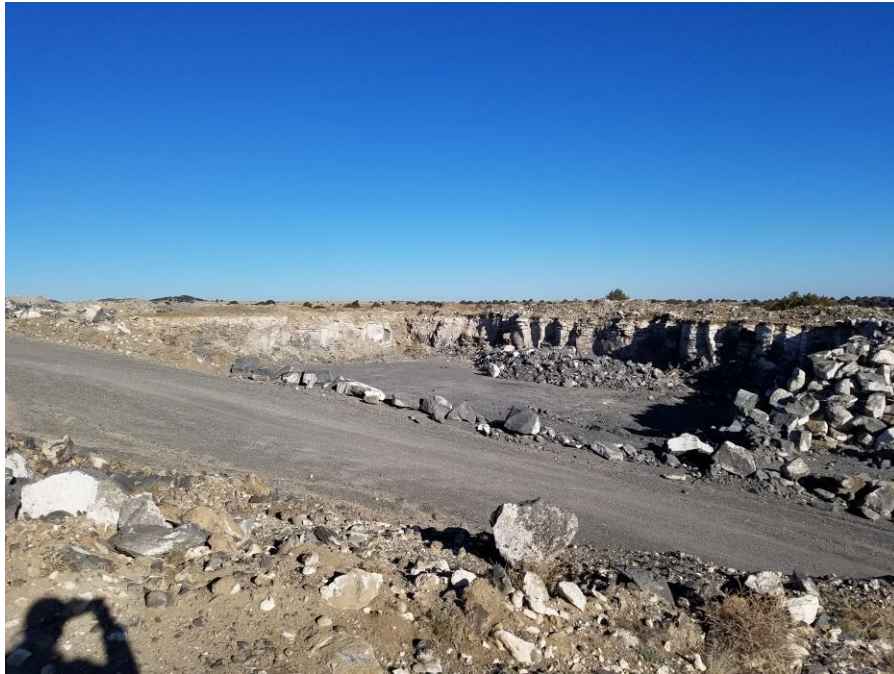
Figure 7. From the southeast corner of the active pit area looking northwest.
