**MINERALS PROGRAM INSPECTION REPORT****PHONE: (303) 866-3567**

MINE NAME: Valco T Pit	MINE/PROSPECTING ID#: M-2004-043	MINERAL: Sand and gravel	COUNTY: Las Animas
INSPECTION TYPE: Monitoring	INSPECTOR(S): Jared L. Ebert	INSP. DATE: March 20, 2019	INSP. TIME: 10:07
OPERATOR: Larry and Christine Tortorice	OPERATOR REPRESENTATIVE: None	TYPE OF OPERATION: 112c - Construction Regular Operation

Valco T Pit, M-2004-043

March 20, 2019 DRMS Inspection

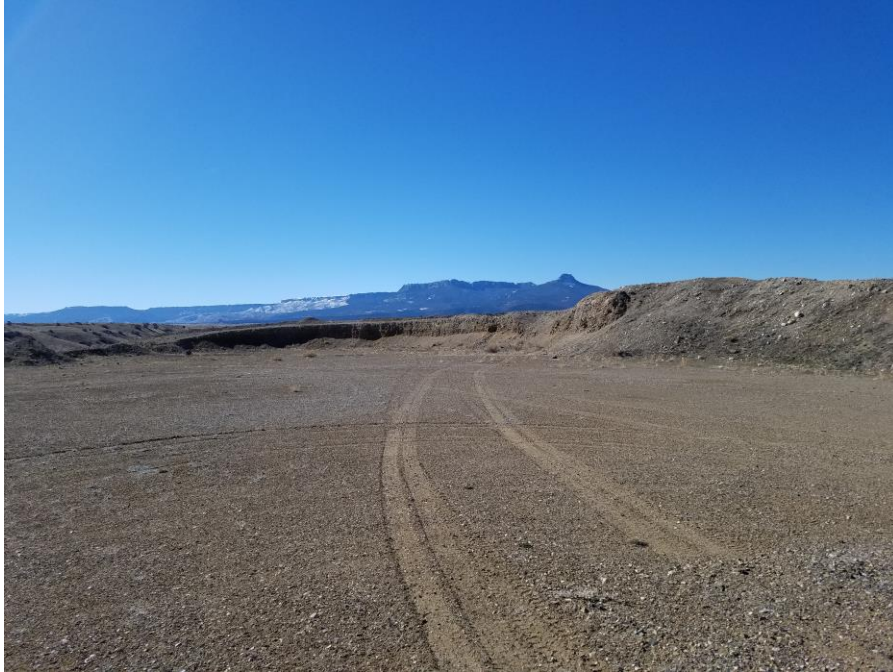
Figure 1. From the north end of the affected land looking south.

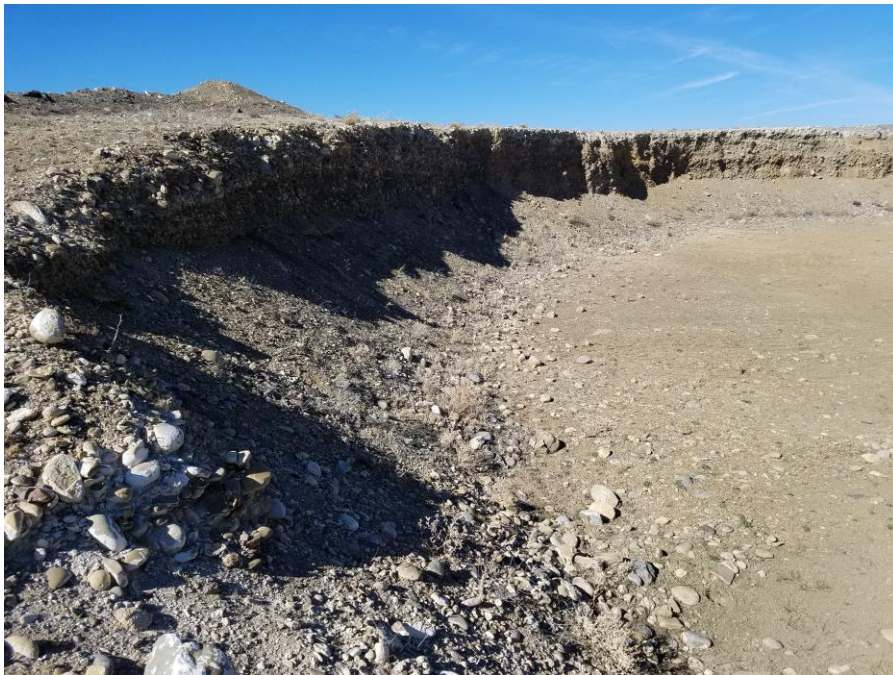
A highwall exists at the site that has a eastern and northern aspect. The highwall is about 10 feet in height and is nearly vertical. The highwall is about 970 feet in length and is partially bisected by a trail/road that lead to the top of the highwall. Otherwise, pit floor is relatively gentle.

Figure 2. From the southeast end of the highwall looking west.

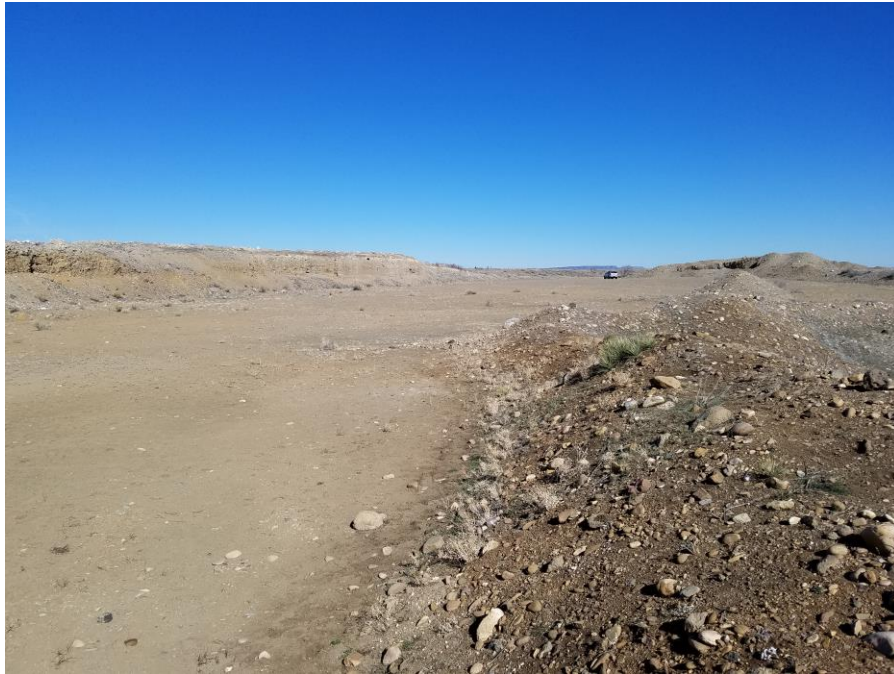
Figure 3. From the southeast end of the affected land looking north.

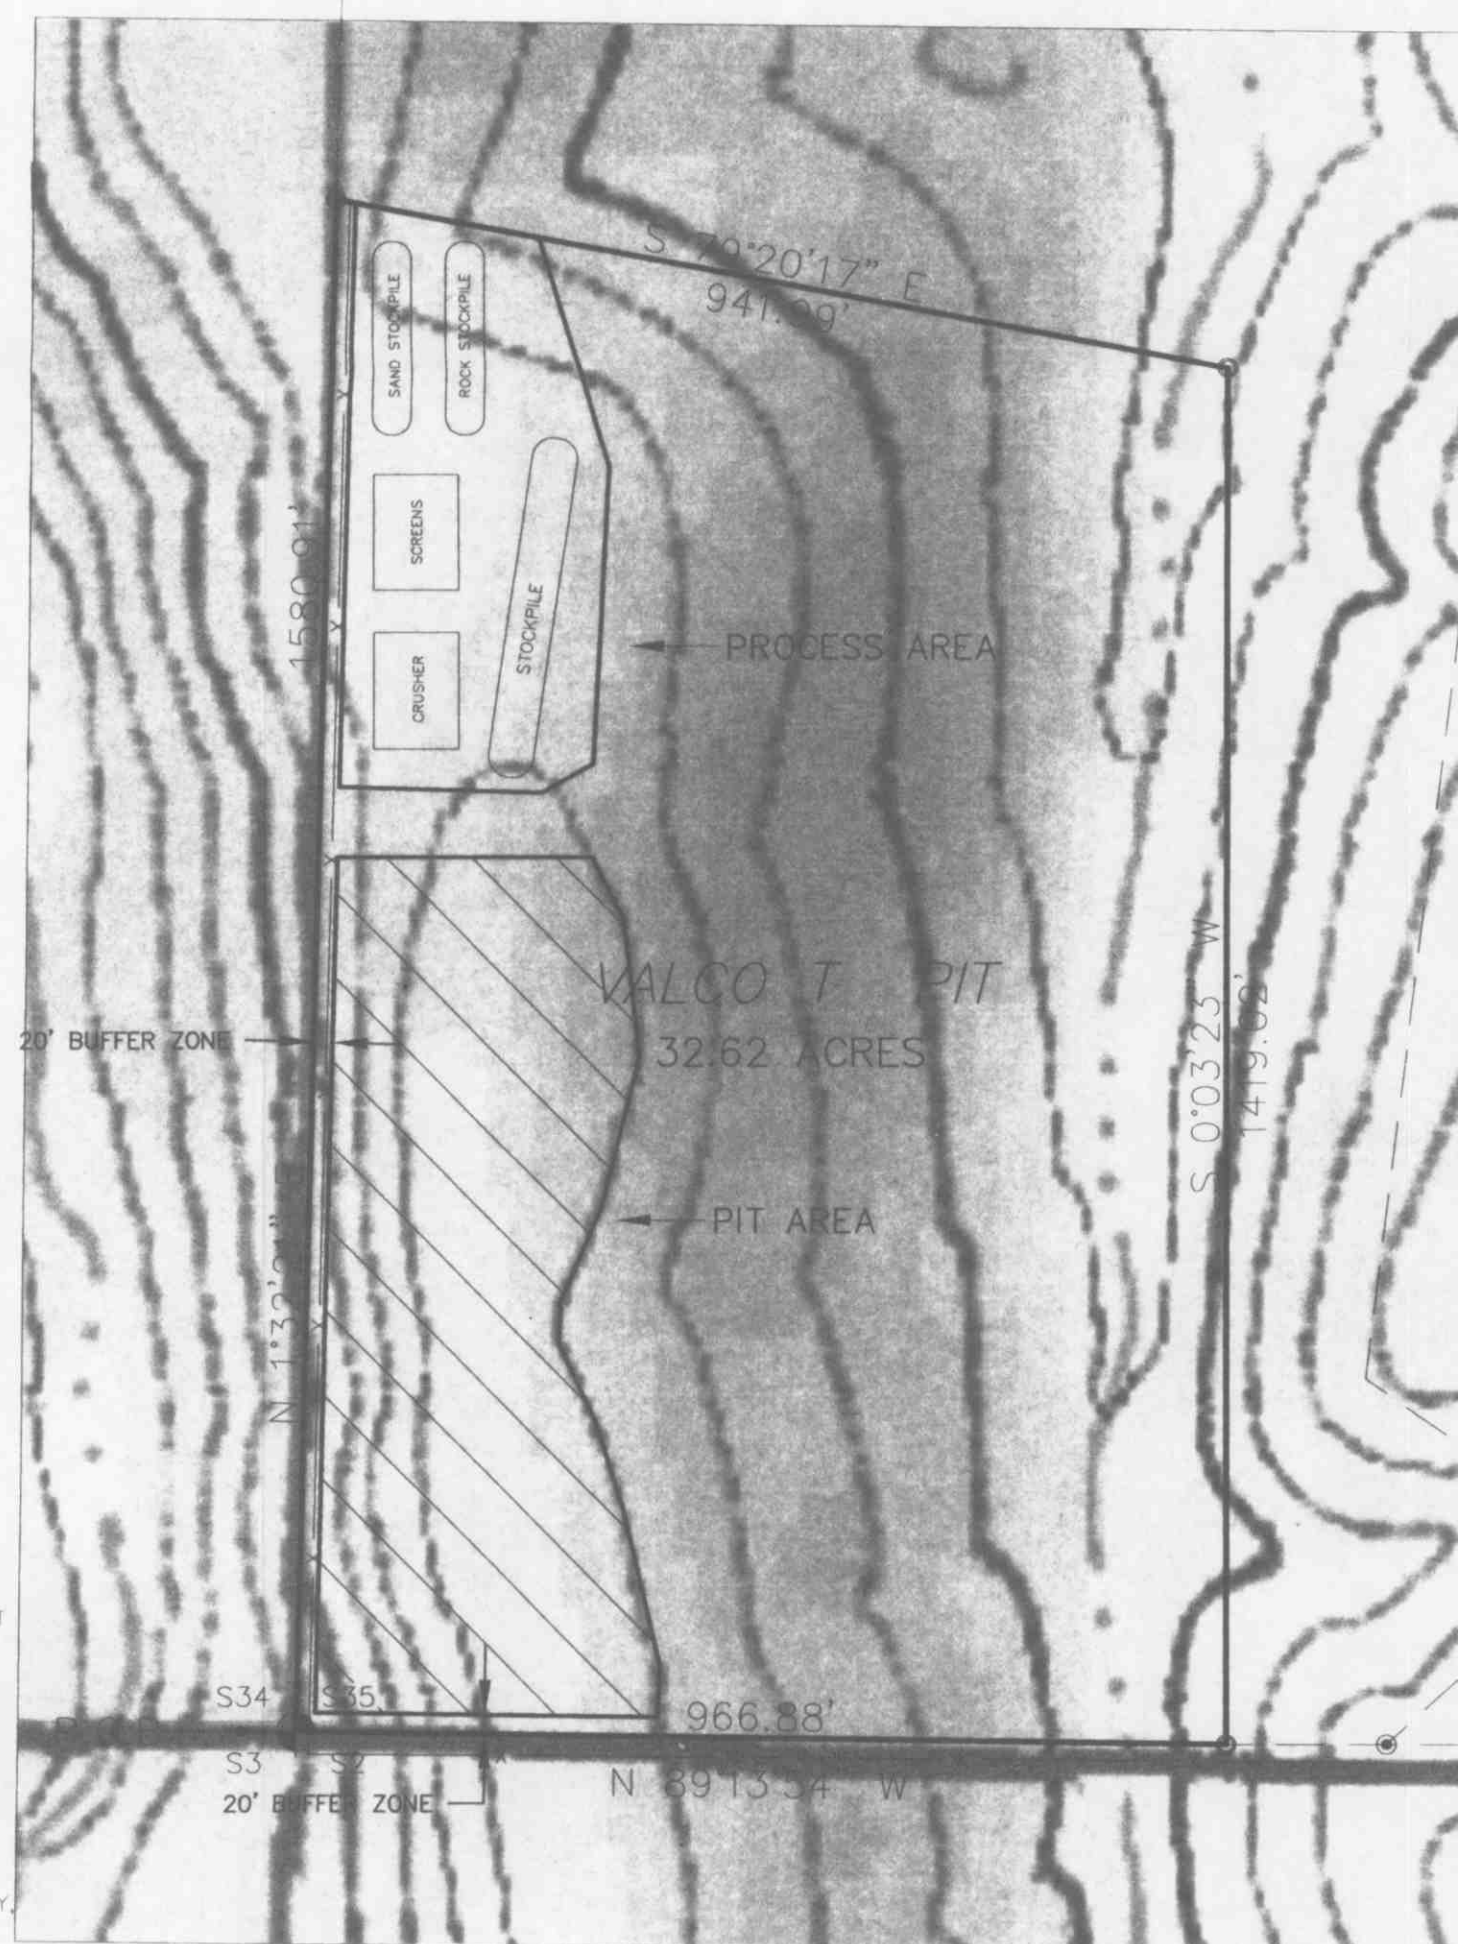
LAND SURVEY PLAT
VALCO T PIT - TORTORICE PROPERTY
A TRACT OF LAND LOCATED IN PART OF THE
W1/2SW1/4 OF SECTION 35, TOWNSHIP 32
SOUTH, RANGE 63 WEST OF THE 6TH P.M.,
COUNTY OF LAS ANIMAS, STATE OF COLORADO

PROBLEM: The affected area boundary markers are missing or incorrectly placed. This is a problem for failure to maintain boundary markers around the affected area as required by Section 3.1.12(2) of the rule.

Upon a review of the file for this site, two different permit boundaries are depicted on the various maps that were submitted with the original application in 2004. A map titled "Land Survey Plat, Mining Plan" depicts a surveyed permit boundary (a photocopy of this map is included with this report). This map depicts a 32.62-acre permit area. Several other maps such as the "Index Map" and the "Reclamation Map" depict a different shaped permit boundary (a photocopy of the Reclamation Map is included with this report). The reclamation plan map depicts a 38.28 acre permit boundary. The Division believes the "Land Survey Plat, Mining Plan" map accurately depicts the correct permit area and will therefore consider it the true depiction of the permit boundary as it is consistent with the approved acreage associated with this site. The Operator should use caution and stay within the approved permit boundary.

Only one boundary marker was observed, the northwest corner marker. The Division could not located any of the other boundary markers. This issue is cited as a problem at the beginning of this report.

CORRECTIVE ACTIONS: The Operator shall conduct a survey and replace the boundary markers in the correct location(s). The operator shall provide proof to the Division that this has been done by the corrective action date.
