Permit Number: C-1981-028 Mine Name: Keenesburg Strip Mine Operator: Coors Energy Company Operator Address: Mr. Danny Kipp P.O Box 467 Golden , CO 80402	County: Weld Operation Type: Surface Permit Status: Active Ownership: Private
	Operator Representative Present: Danny Kipp
Operator Representative Signature: (Field Issuance Only)

Inspection Start Date: March 27, 2019 Inspection Start Time: 08:00 Inspection End Date: March 27, 2019 Inspection End Time: 09:30		Inspection Type: Coal Partial Inspection Inspection Reason: Normal I&E Program Weather: Clear	
Joint Inspection Agency: None		Joint Inspection Contacts: 	
Post Inspection Agency: None		Post Inspection Contacts: 	
Inspector(s): Robert D. Zuber, P.E.	Inspector's Signature:

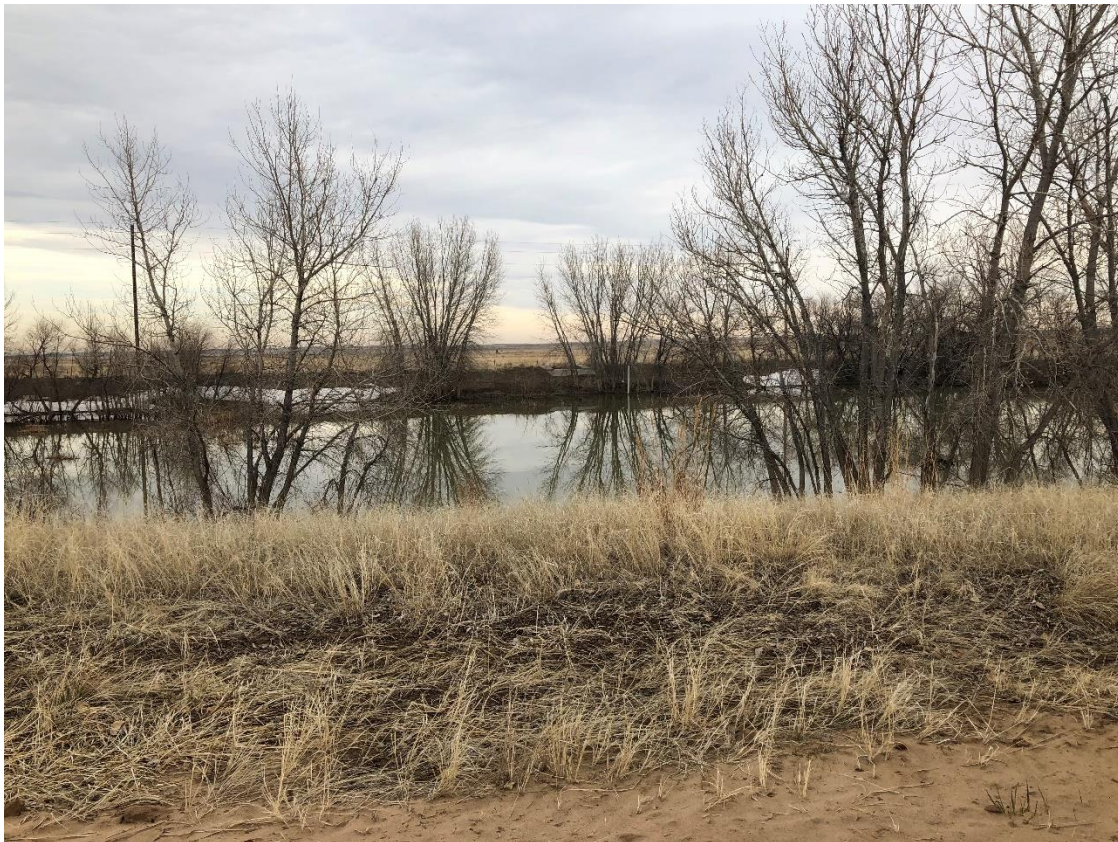
Water was observed in the two ponds. Neither pond was discharging during the inspection, and the water levels were well below the spillways. Danny estimate about a foot in the Dugout Pond. The water in Sediment Pond 2 looked to be approximately four to five feet deep. No problems were observed with the two ponds.

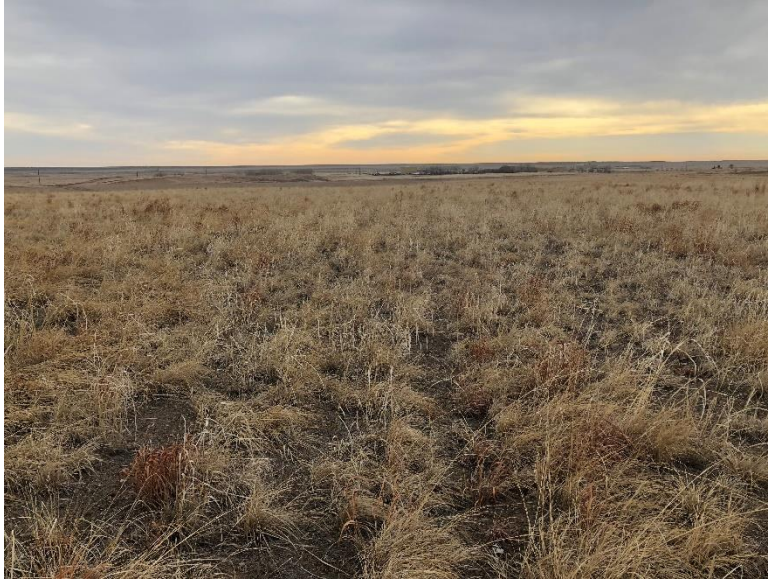
Area 32, looking east

No problems were seen with the reclaimed areas. In particular, the following parcels were inspected by driving through them, looking for erosion, and looking at the vegetation: 23, 25, 30, 31, 32, 33, and 34. Most of the areas showed very little emergence of green grass, although some was seen in Area 32 and a large amount was seen in Area 25. This may be cheat grass. No areas exhibited problems with erosion, large bare spots, or weeds.
