MINERALS PROGRAM INSPECTION REPORT
PHONE: (303) 866-3567

MINE NAME: Sunday Mine	MINE/PROSPECTING ID#: M-1977-285	MINERAL: Uranium and vanadium	COUNTY: San Miguel
INSPECTION TYPE: Monitoring	INSPECTOR(S): Lucas J. West	INSP. DATE: March 21, 2019	INSP. TIME: 09:49
OPERATOR: Pinon Ridge Mining LLC	OPERATOR REPRESENTATIVE: Michael Rutter	TYPE OF OPERATION: 112d-2 - Designated Mining Operation	
REASON FOR INSPECTION: Normal I&E Program	BOND CALCULATION TYPE: None	BOND AMOUNT: \$330,242.00	
DATE OF COMPLAINT: NA	POST INSP. CONTACTS: None	JOINT INSP. AGENCY: None	
WEATHER: Clear	INSPECTOR'S SIGNATURE:

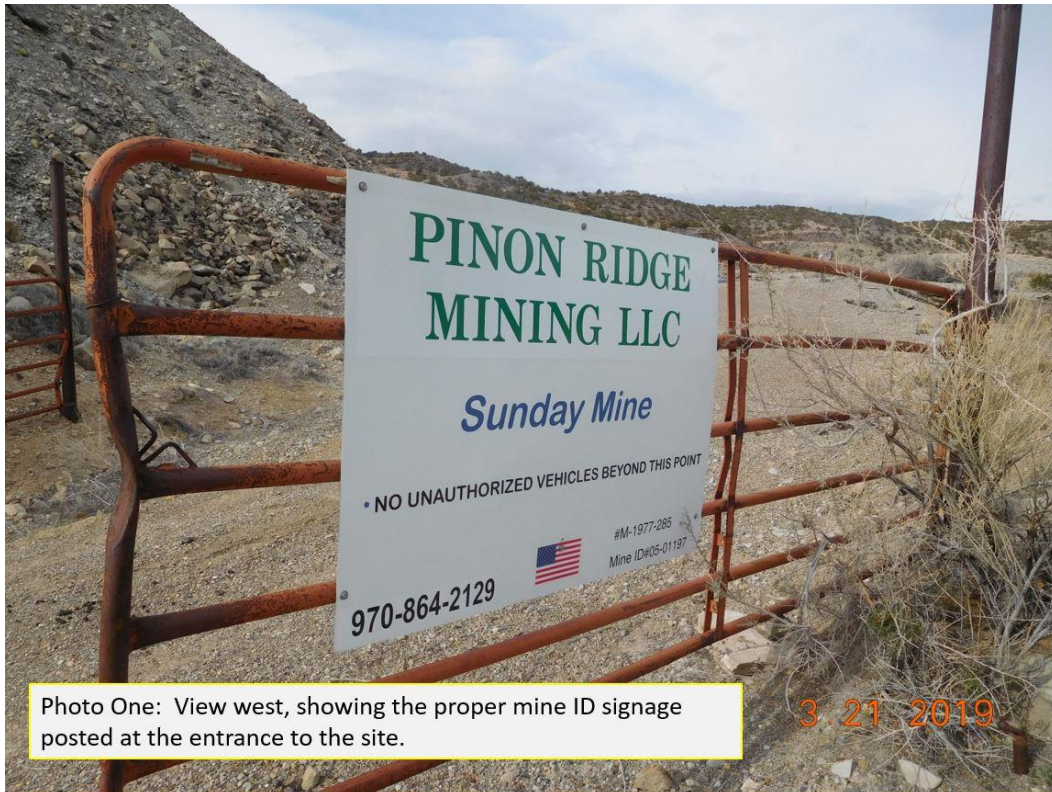
As seen in Photo One, the permit ID sign was observed at the entrance to the site. The permit boundary markers were also observed. Photo Two shows an example of the sediment catchment basins that are located on site as part of the storm water management plan. All storm water control devices are in good condition and appear to be functioning as designed. All diversion ditches appear to be functioning as designed and no significant erosion was observed throughout most of the site. In addition to the site's routine monitoring inspection, the purpose of this inspection was to have on site discussions regarding the pending technical revision and work to be conducted on site as outlined in the Divisions letter dated January 23, 2019. The revision will address the construction plans to address the areas of the temporary stockpile that have been identified. The Technical Revision outlining the plan for the corrective actions must be submitted no later than Tuesday April 23, 2019. Discussions with the Operator indicate that construction of an earthen cover will be the preferred action and the source of the material was observed.

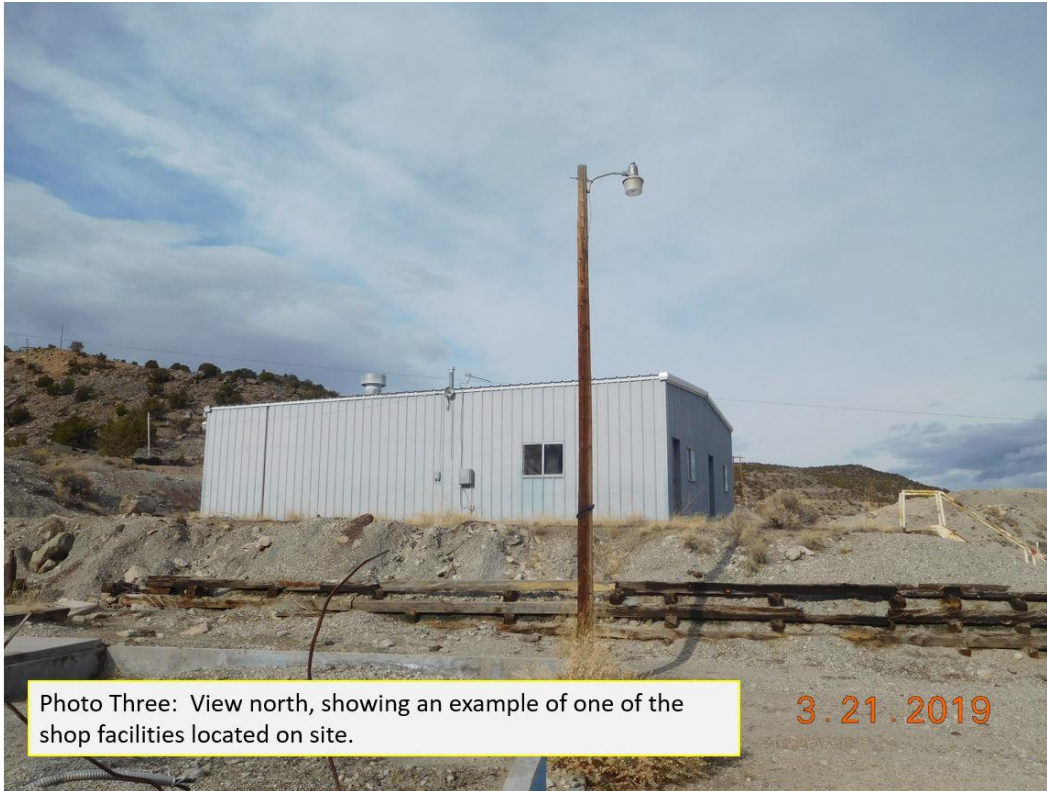
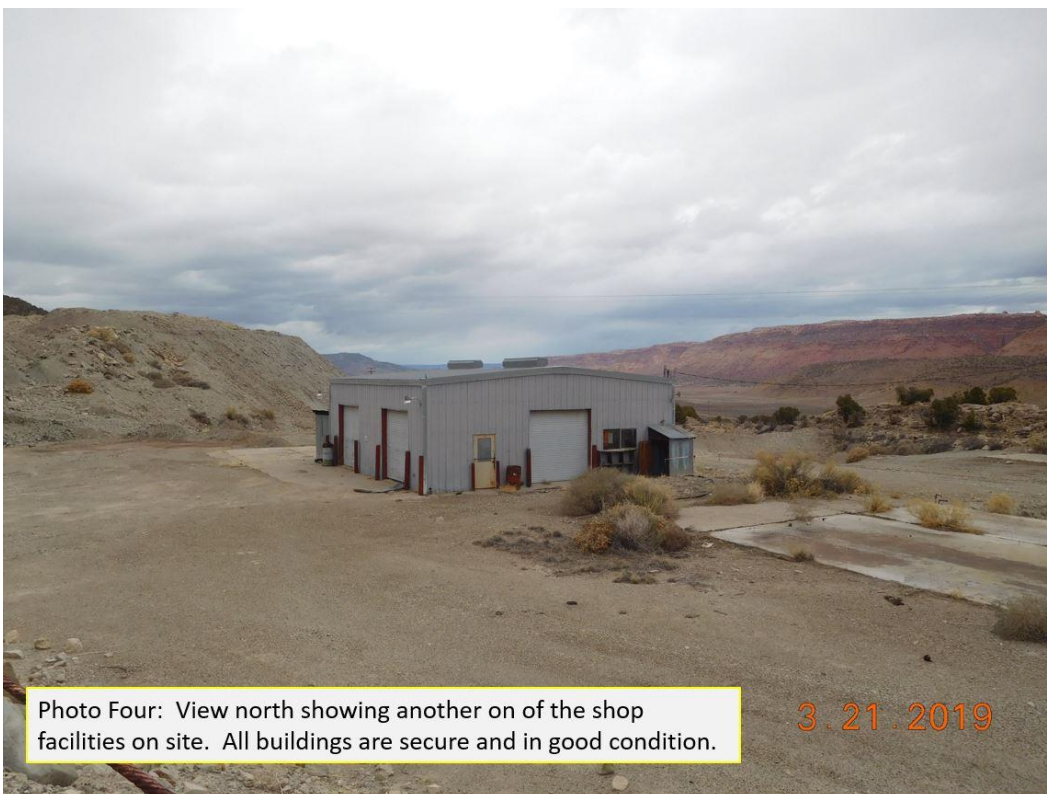
All work facilities were secure and seemed to be in good condition during the time of the inspection. No signs of vandalism or general site degradation were noted. Examples of the work facilities can be seen in Photos Three and Four. The portal located on site was also secured. The portal has been backfilled and closed off with steel grates that are in good condition as seen in Photo Five. Vent shaft S-2, located to the Northwest of the shop facilities is covered with a steel grate and has been secured. All loadouts, roads and pad areas that exist on site were observed and in good condition. Evidence of chemical weed treatment was observed and the operator expressed that weed management is ongoing throughout the whole Sunday Mine Complex.
