MINERALS PROGRAM INSPECTION REPORT
PHONE: (303) 866-3567

MINE NAME: North Bank Resources	MINE/PROSPECTING ID#: M-2006-018	MINERAL: Sand and gravel	COUNTY: Garfield
INSPECTION TYPE: Monitoring	INSPECTOR(S): Amy C. Yeldell	INSP. DATE: February 14, 2019	INSP. TIME: 10:45
OPERATOR: Oldcastle SW Group, Inc. dba United Companies of Mesa County	OPERATOR REPRESENTATIVE: Jason Burkey	TYPE OF OPERATION: 112c - Construction Regular Operation	
REASON FOR INSPECTION: Normal I&E Program	BOND CALCULATION TYPE: Complete Bond	BOND AMOUNT: \$231,576.00	
DATE OF COMPLAINT: NA	POST INSP. CONTACTS: None	JOINT INSP. AGENCY: None	
WEATHER: Cloudy	INSPECTOR'S SIGNATURE:

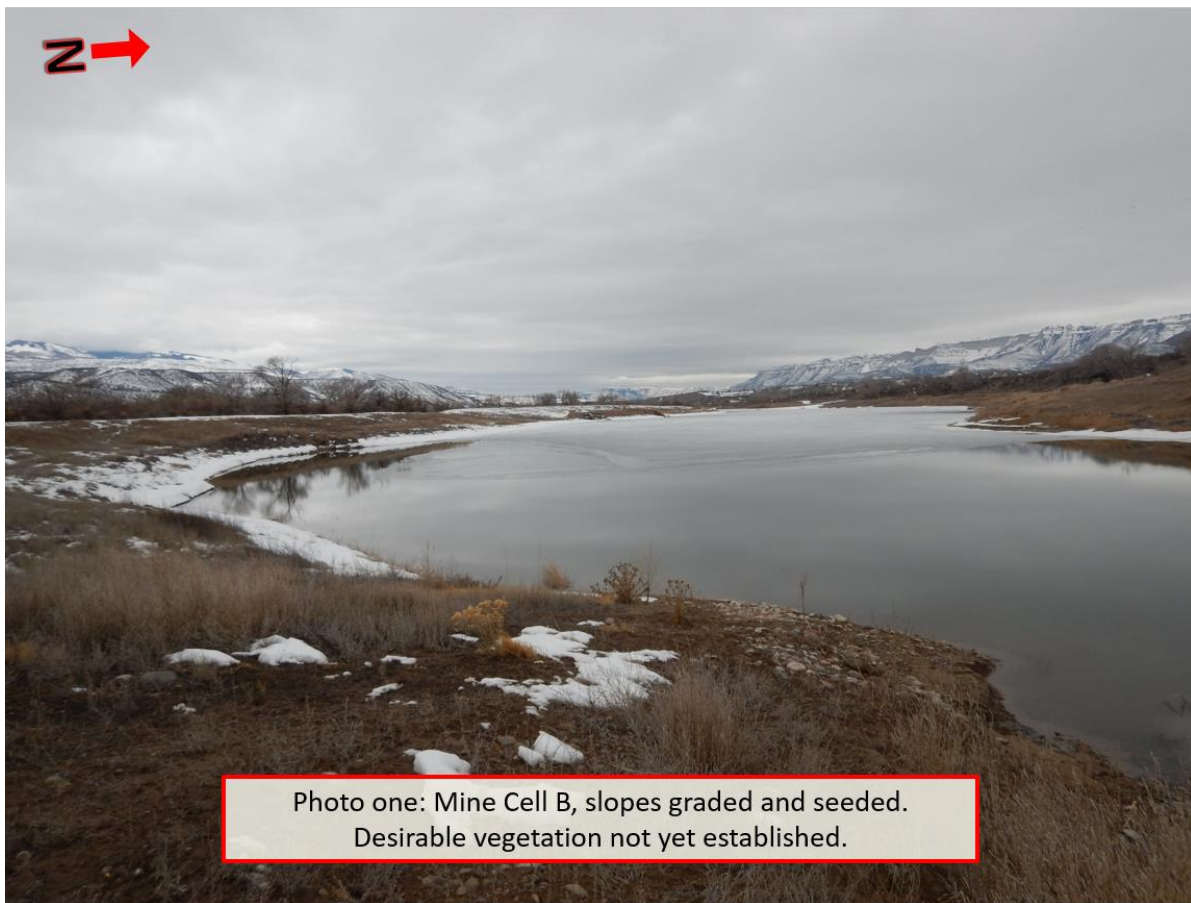
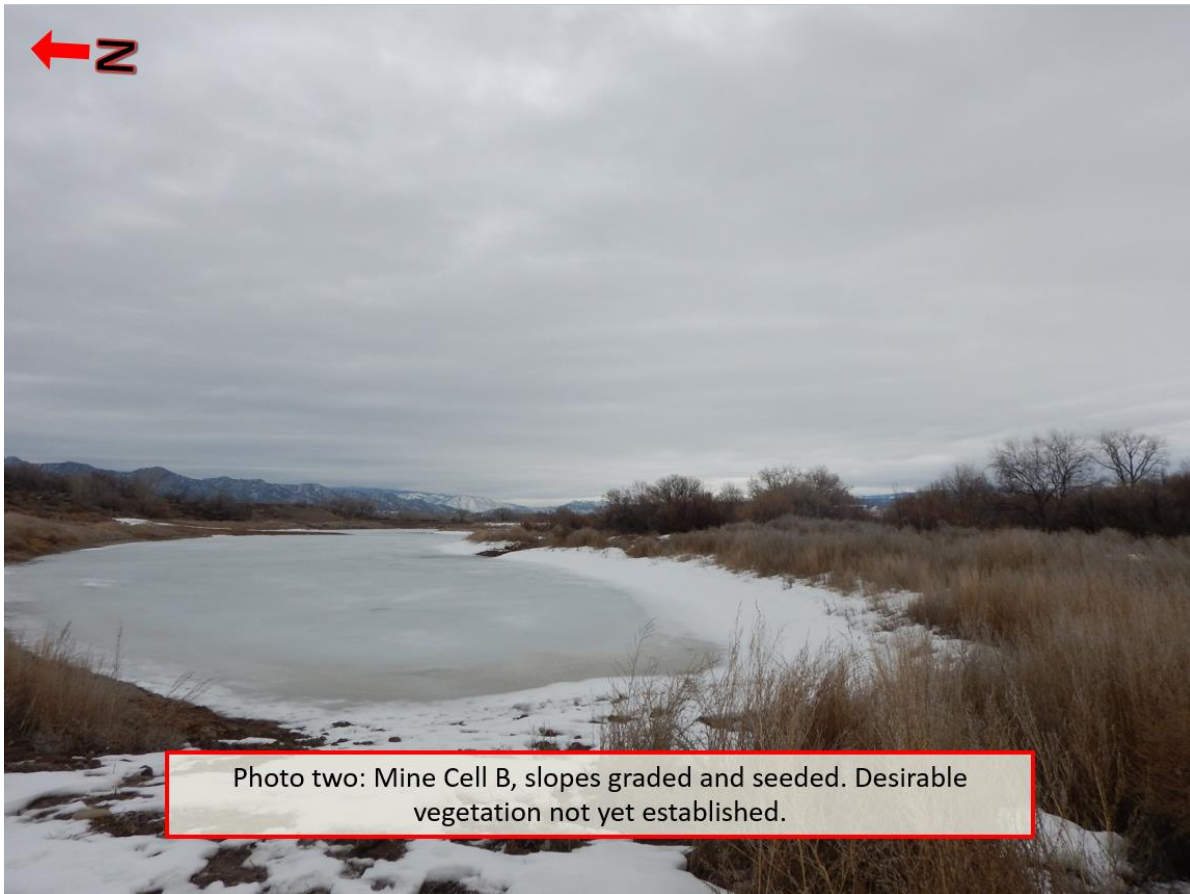
Mining in Cell B has concluded and this area is in final reclamation (see photos one and two). This area has been graded to a 3H:1V slope or less. Seeding has occurred however desirable vegetation at the required densities has yet to establish. Even though vegetation was dormant large amounts of dead Kochia plant matter (skeletons) were observed in addition to other noxious weed skeletons. There appeared to be limited undergrowth of grasses. Ms. Monger stated that the cottonwood stakes appeared to take hold last fall and should be resilient this spring. Vegetation success cannot be fully evaluated until spring/summer when it is no longer dormant.

The mine identification sign and affected area boundary markers are in place and in compliance with Rule 3.1.12. All stockpiles appear to be stable and free of visible erosion. The operator is encouraged to more aggressively manage annual and noxious weed species to increase reclamation success.

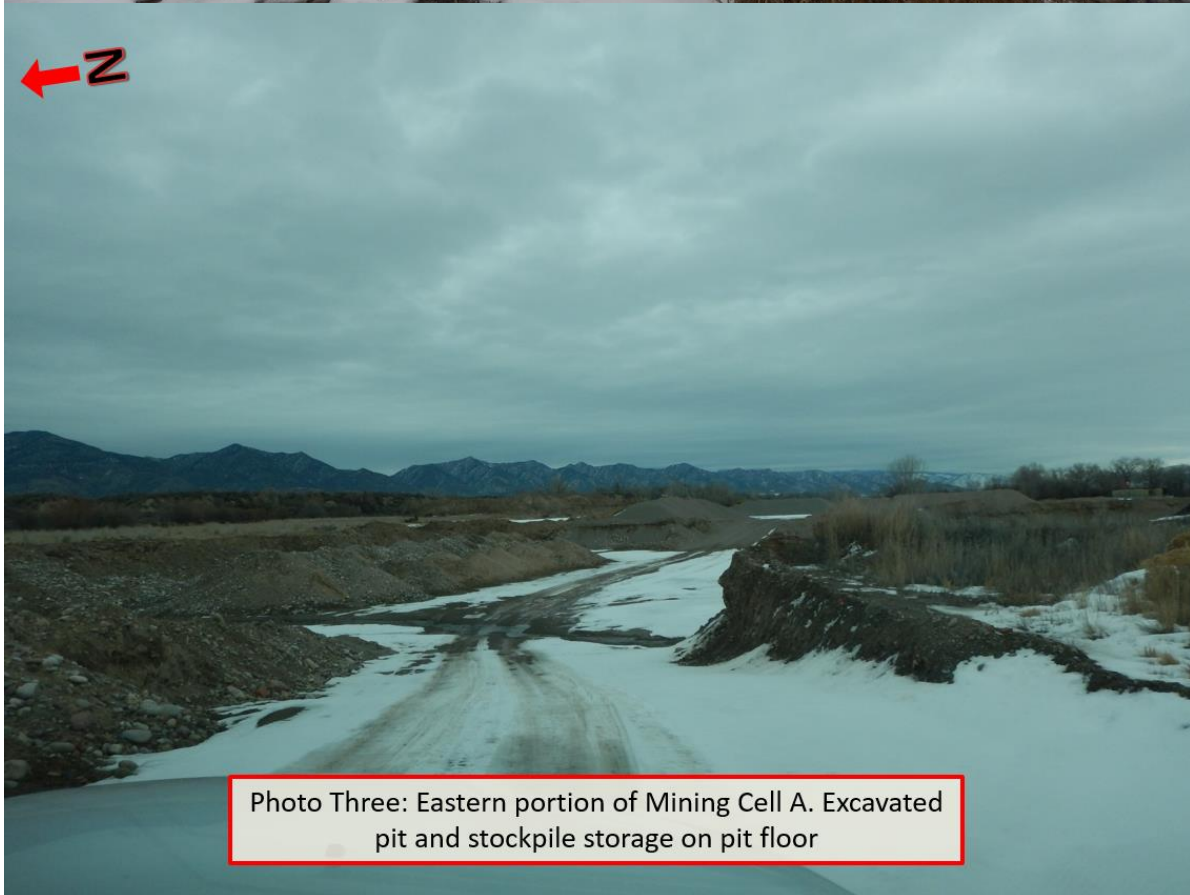
Mining is occurring in Cell A (the eastern half of the permit). The eastern portion of Mine Cell A consists of an excavated pit and a stockpile storage area (photo three). This disturbed area is estimated to be approximately 25 acres. Stockpile storage is primarily on the northern half. This area appears to have been minimally excavated (no more than 10 feet beyond topsoil salvage) and will most likely be above the groundwater table once pumping ceases. The southern half is a dewatered pit that is approximately 20 ft. deep with perimeter highwalls that are sloped 1H:1V (photo four). There is a gas pad in the southeastern most corner of Mine Cell A. Adjacent to the pad is a fuel tank in a secondary containment and the dewatering pump.

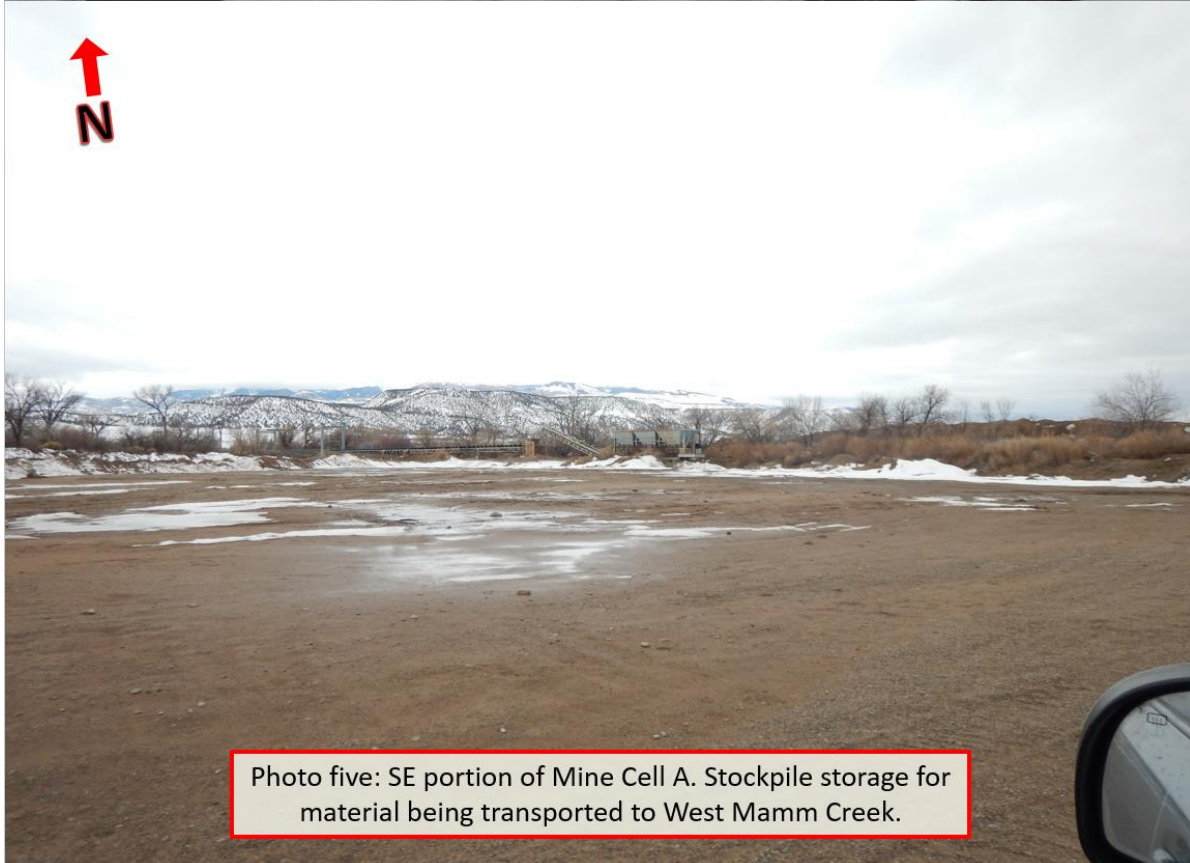
The western portion of Mine Cell A serves more as a storage area. Processed material is stockpiled prior to being transported via the conveyor to the Mamm Creek Sand and Gravel Pit (M-2000-113) for sales (photo five). There is a small excavated pond on the southeastern side of this mining area. The northwestern area has an excavated highwall to increase floor storage space. Excavations in this area are above the water table. Topsoil and overburden are stored on the north bluff in both sections of Mine Cell A.
