**COLORADO**Division of Reclamation,
Mining and Safety

MINERALS PROGRAM INSPECTION REPORT**PHONE: (303) 866-3567**

MINE NAME: Carnation Mine	MINE/PROSPECTING ID#: M-1977-416	MINERAL: Uranium and vanadium	COUNTY: San Miguel
INSPECTION TYPE: Monitoring	INSPECTOR(S): Lucas J. West	INSP. DATE: March 21, 2019	INSP. TIME: 10:58
OPERATOR: Pinon Ridge Mining LLC	OPERATOR REPRESENTATIVE: Michael Rutter	TYPE OF OPERATION: 110d - Designated Limited Impact	
REASON FOR INSPECTION: Normal I&E Program	BOND CALCULATION TYPE: None	BOND AMOUNT: \$40,245.00	
DATE OF COMPLAINT: NA	POST INSP. CONTACTS: None	JOINT INSP. AGENCY: None	
WEATHER: Clear	INSPECTOR'S SIGNATURE:

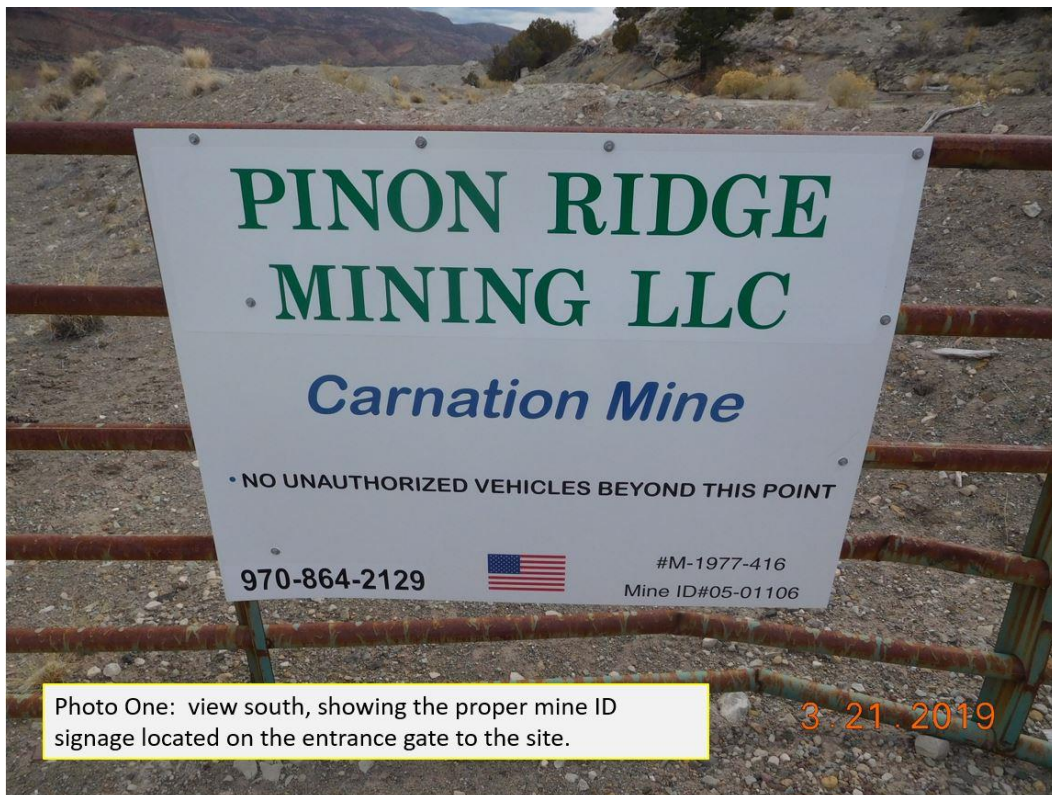
As seen in Photo One, the permit ID sign was observed at the entrance to the site. The permit boundary markers were also observed and all disturbances were confined within the permitted area. Evidence that the diversion ditches and storm water control devices are functioning as designed and no significant erosion was observed throughout the site. The lower permit area was also in good condition with no signs of significant erosion. The lower area has begun to revegetate itself and appears to be in good condition.

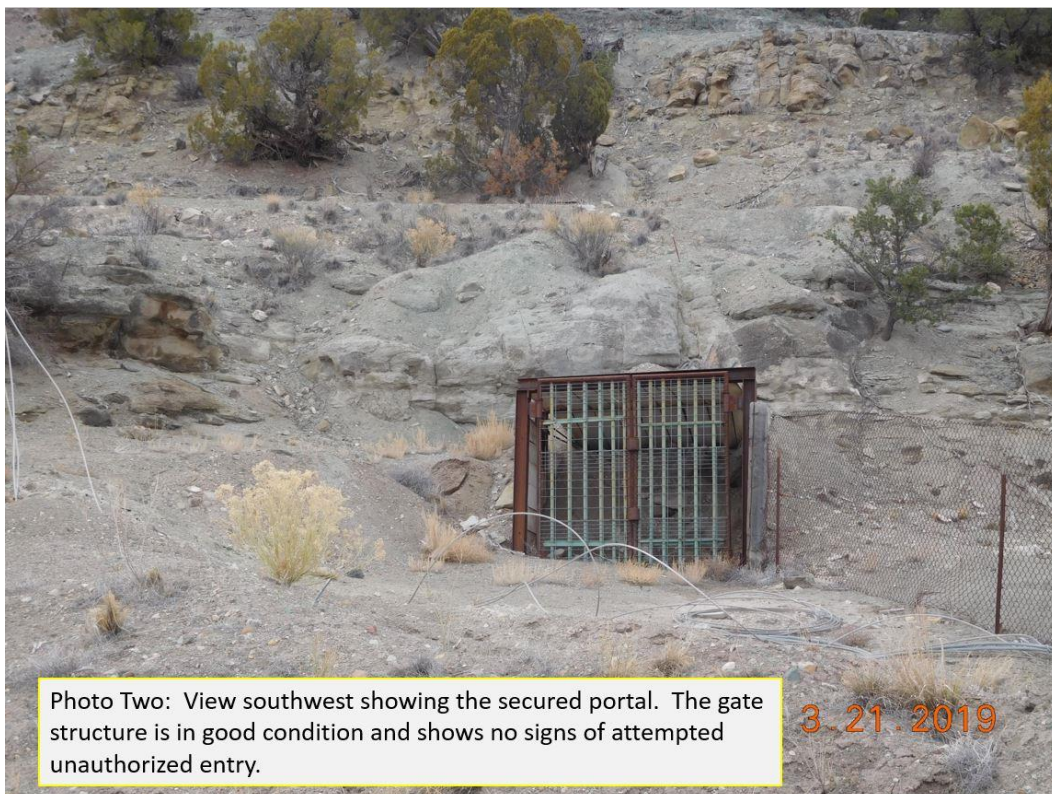
The portal located on site was also secured, it has been backfilled, closed off with steel grates as well as encompassed by a small berm as seen in Photo Two. No fuel storage containers were observed on site.

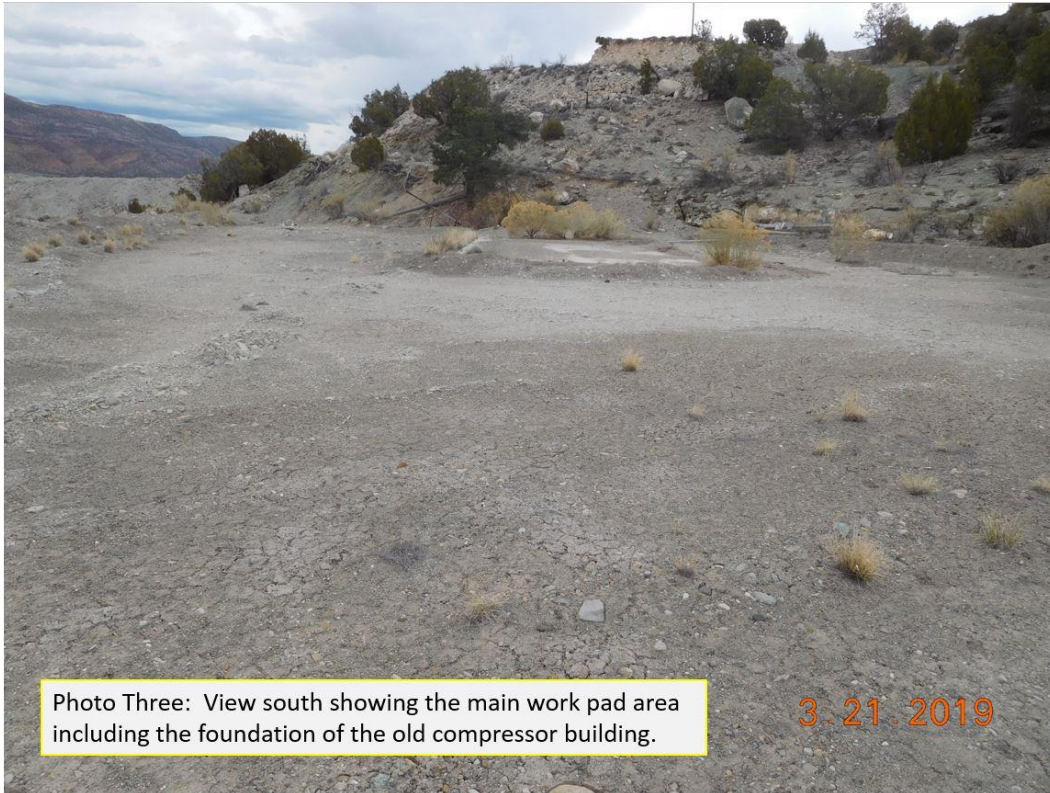
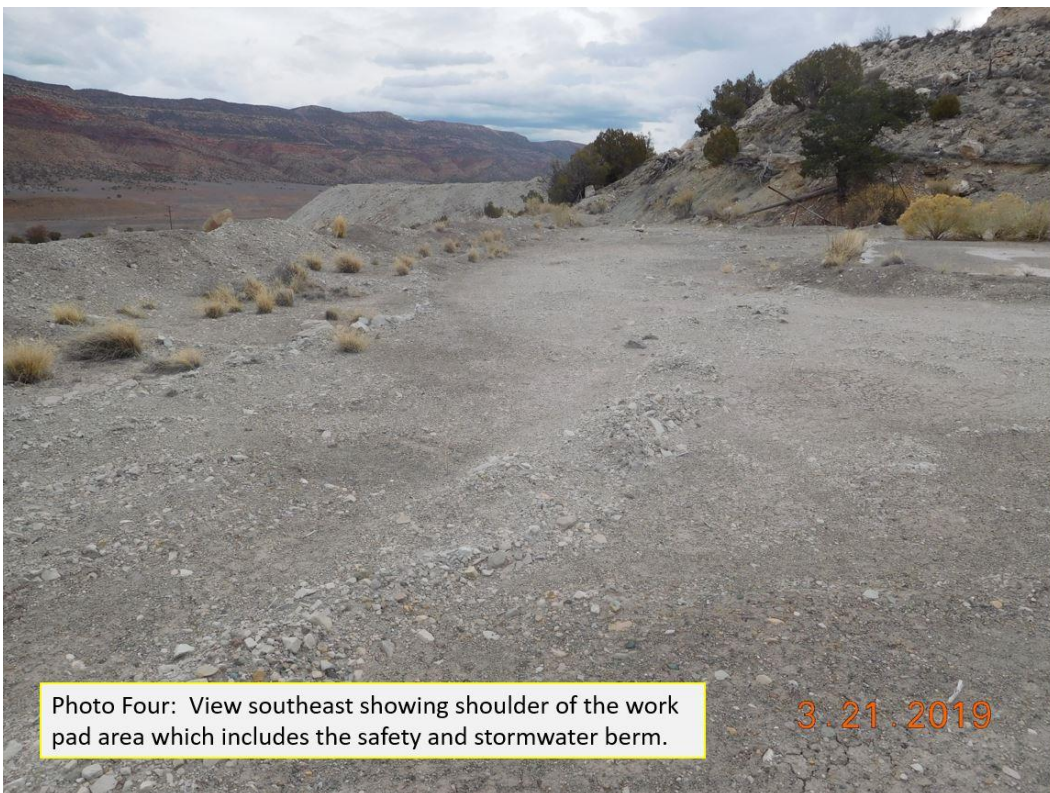
The main pad and work area was in good condition as seen in Photos Three and Four, evidence of weed management during the growing season was observed. The whole site exhibits positive drainage and no erosional issues were observed at this time. A concrete slab foundation is located on the portal pad measuring approximately 20 x 30 ft. with an adjacent utility pole and line. The foundation, utility pole and wire are slated to be removed during final reclamation. The portal pad area has begun to revegetate itself with volunteer species. On site discussions with the Operator centered on the immediate reclamation tasks that could be completed while still retaining the potential use of the portal for ventilation of the underground workings or a secondary escape way. Those tasks include the grading and sloping of the pad, removal of the old compressor building foundation and some revegetation work.
