**COLORADO**Division of Reclamation,
Mining and Safety

MINERALS PROGRAM INSPECTION REPORT**PHONE: (303) 866-3567**

| MINE NAME: St Jude Mine | MINE/PROSPECTING ID#: M-1978-039-HR | MINERAL: Uranium and vanadium | COUNTY: San Miguel |
| INSPECTION TYPE: Monitoring | INSPECTOR(S): Lucas J. West | INSP. DATE: March 21, 2019 | INSP. TIME: 11:30 |

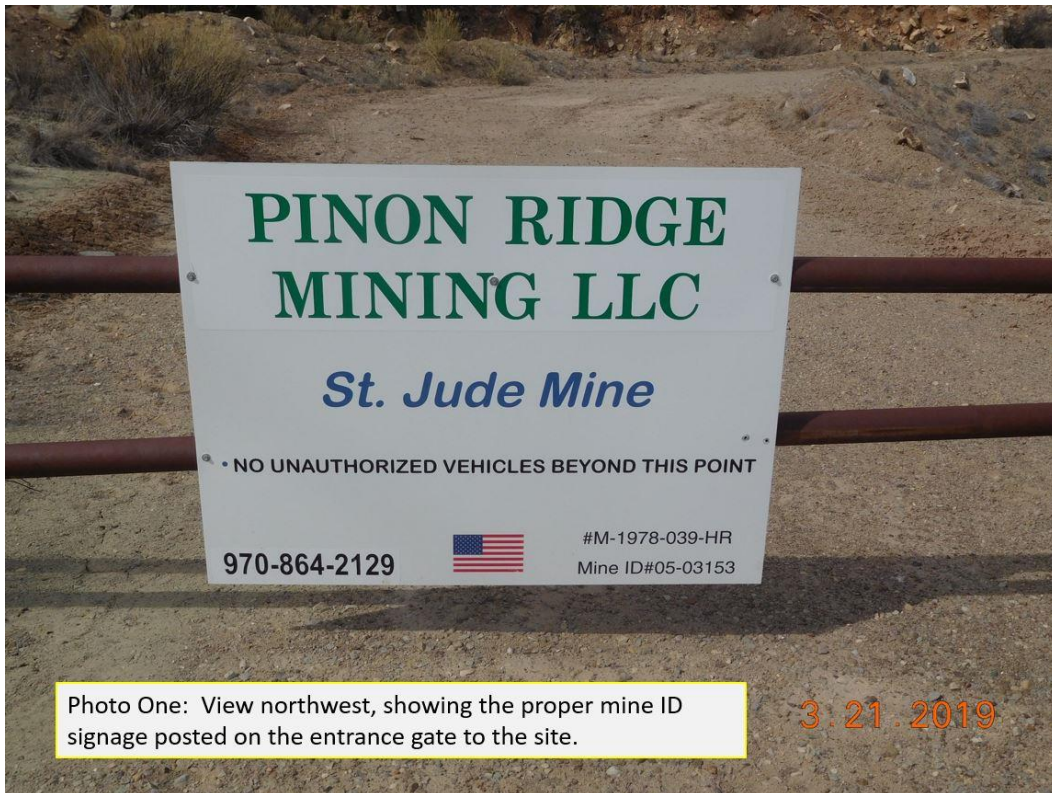
As seen in Photo One, the permit ID sign was observed at the entrance to the site. The permit boundary markers were also observed. All disturbances are contained within the permitted areas. The remote vent shaft sites were not inspected at this time. The diversion ditches and storm water control devices appear to be functioning as designed and no significant erosion was observed throughout the site. The main work area, adjacent to the portal and shops, appeared to be stable and in good condition. The portal located on this site has been backfilled and secured. Photo Two shows the earthen cover placed over the portal. No evidence of vandalism or attempted unauthorized entry to the portal was observed during the inspection.

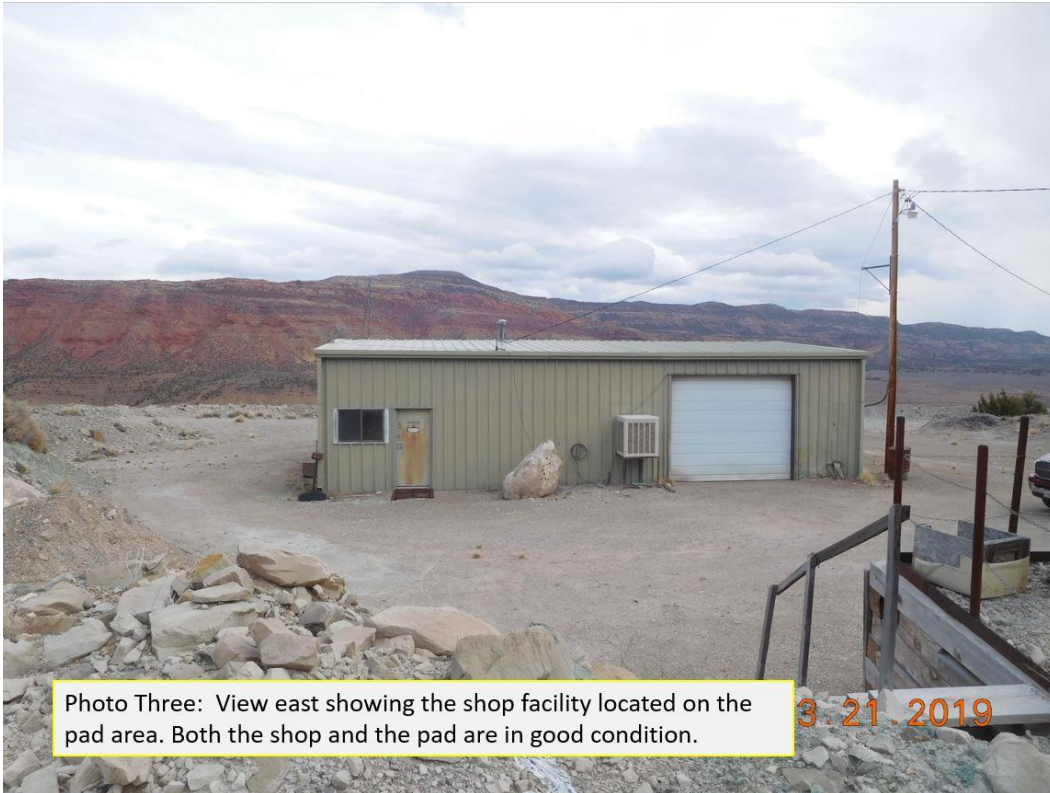
All work and shop facilities onsite were secured and appeared to be in good condition. An example of the facilities can be seen in Photo Three. No fuel storage containers were observed on site. Various other debris was observed on site however it was stored in an orderly fashion and was not a concern at this time. The waste rock dump storage area was observed, and appears to be stable and in good condition. The waste rock stored in the area can be seen in Photo Four.
