MINERALS PROGRAM INSPECTION REPORT
PHONE: (303) 866-3567

MINE NAME: Topaz Mine	MINE/PROSPECTING ID#: M-1980-055-HR	MINERAL: Uranium and vanadium	COUNTY: San Miguel
INSPECTION TYPE: Monitoring	INSPECTOR(S): Lucas J. West	INSP. DATE: March 21, 2019	INSP. TIME: 12:10
OPERATOR: Pinon Ridge Mining LLC	OPERATOR REPRESENTATIVE: Michael Rutter	TYPE OF OPERATION: 112d-3 - Designated Mining Operation	
REASON FOR INSPECTION: Normal I&E Program	BOND CALCULATION TYPE: None	BOND AMOUNT: \$99,893.00	
DATE OF COMPLAINT: NA	POST INSP. CONTACTS: None	JOINT INSP. AGENCY: None	
WEATHER: Clear	INSPECTOR'S SIGNATURE:

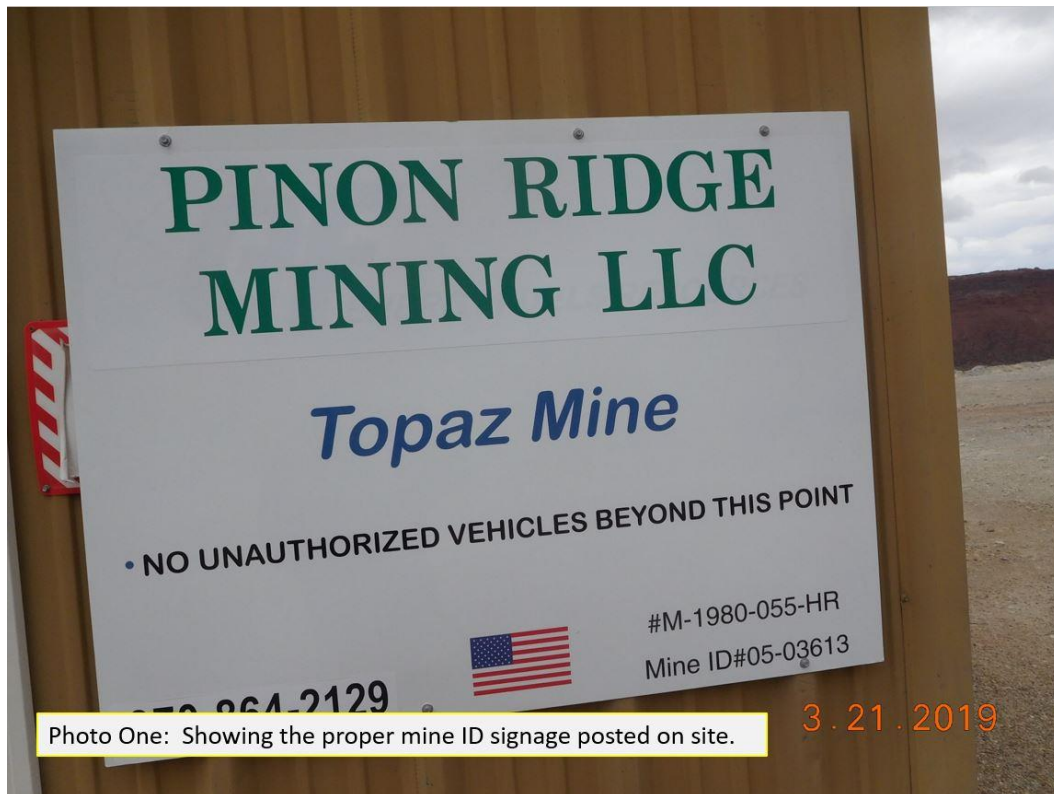
As seen in Photo One, the permit ID sign was observed near the entrance to the site. The permit boundary markers were also observed. Evidence that the diversion ditches and storm water control devices are functioning as designed and no significant erosion was observed throughout the site.

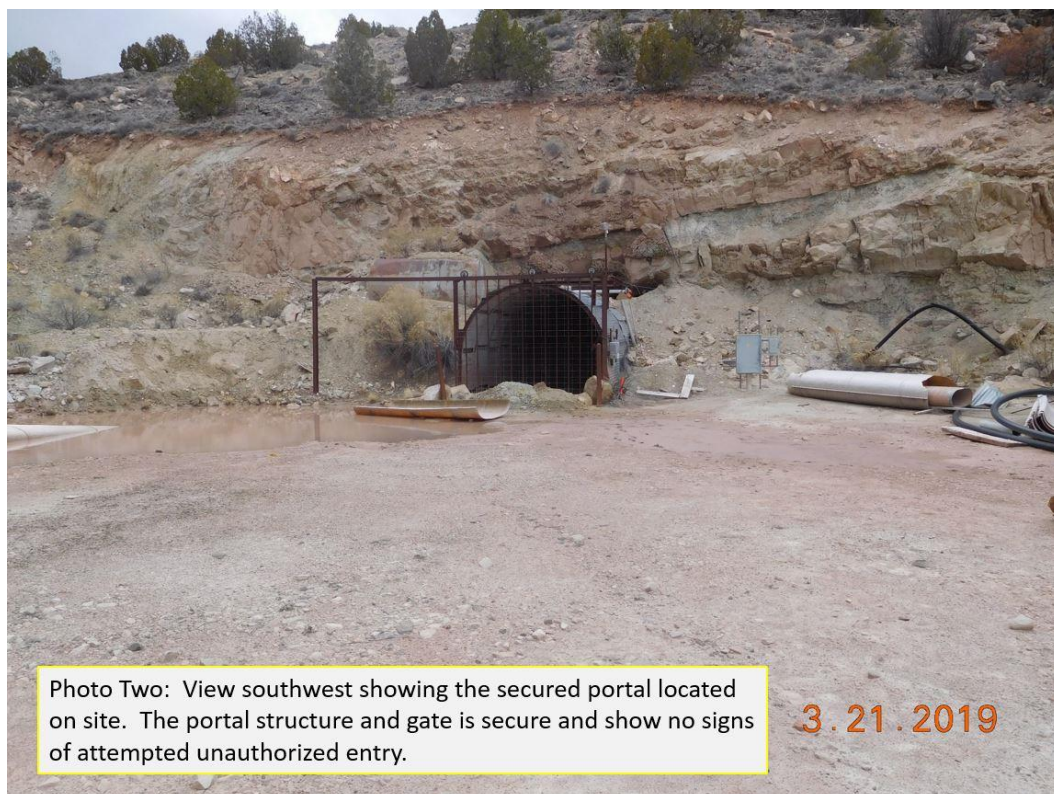
All work and shop facilities onsite were secured and appeared to be in good condition. The portal located on site was also secured, it has been backfilled, closed off with steel grates as well as encompassed by a small berm as seen in Photo Two. Some mining related equipment including vent tubing and steel scaffolding is being stored on site. The items that are stored are in a neat and orderly fashion and not considered a problem at this time. No fuel storage containers were observed on site. Various other debris was observed on site however it was stored in an orderly fashion and was not a concern at this time.

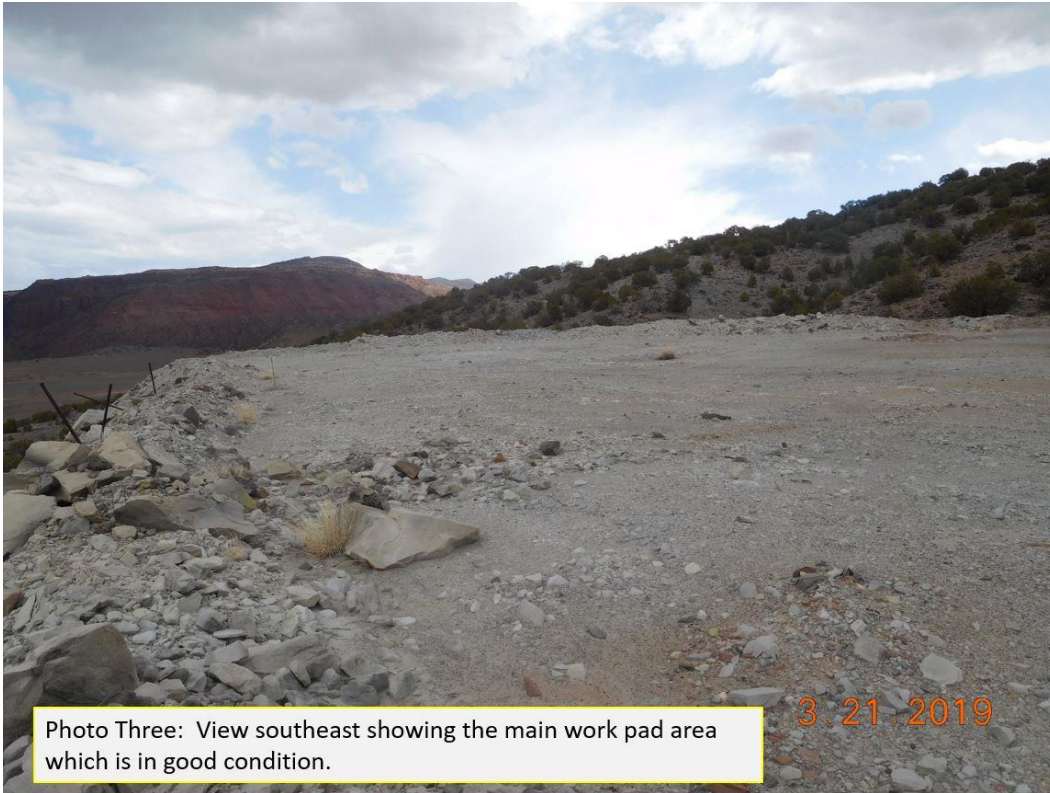
The main pad and work area was in good condition as seen in Photos Three and Four, evidence of weed management during the growing season was observed. Some areas around the perimeter of the pad area have begun to revegetate themselves with volunteer species. The whole site exhibits positive drainage and no erosional issues were observed at this time.
