MINERALS PROGRAM INSPECTION REPORT**PHONE: (303) 866-3567**

MINE NAME: West Sunday	MINE/PROSPECTING ID#: M-1981-021	MINERAL: Uranium and vanadium	COUNTY: San Miguel
INSPECTION TYPE: Monitoring	INSPECTOR(S): Lucas J. West	INSP. DATE: March 21, 2019	INSP. TIME: 11:45
OPERATOR: Pinon Ridge Mining LLC	OPERATOR REPRESENTATIVE: Michael Rutter	TYPE OF OPERATION: 112d-3 - Designated Mining Operation	
REASON FOR INSPECTION: Normal I&E Program	BOND CALCULATION TYPE: None	BOND AMOUNT: \$85,036.00	
DATE OF COMPLAINT: NA	POST INSP. CONTACTS: None	JOINT INSP. AGENCY: None	
WEATHER: Clear	INSPECTOR'S SIGNATURE:

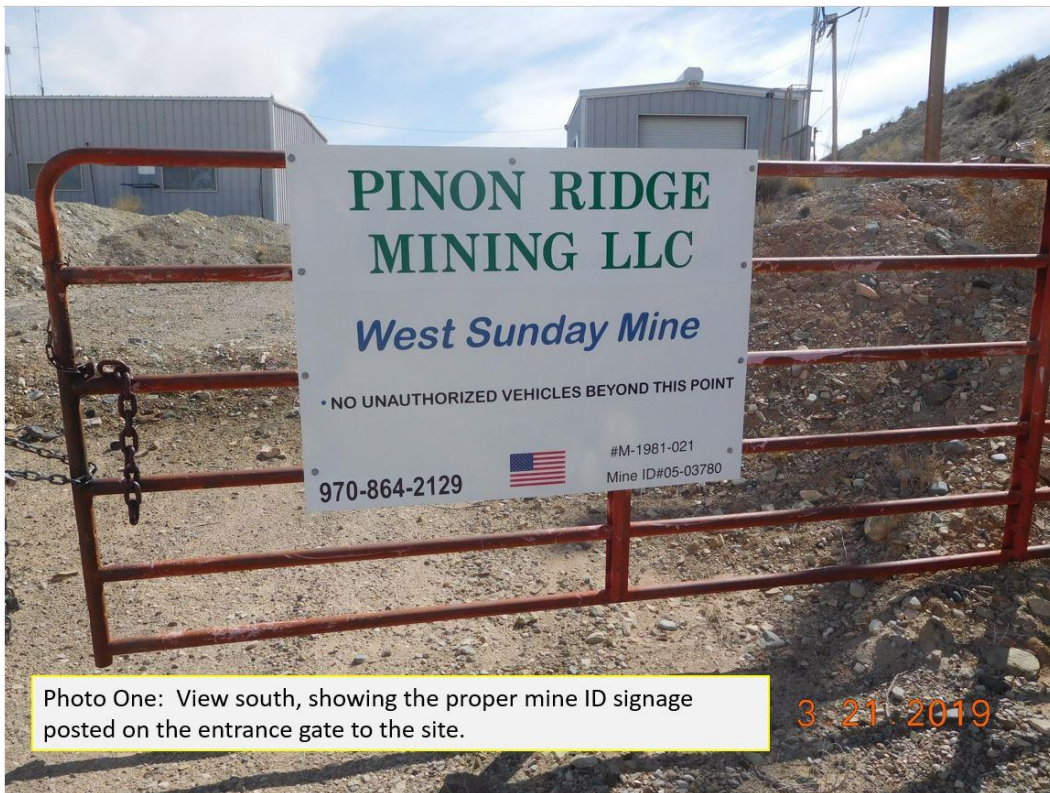
As seen in Photo One, the permit ID sign was observed at the entrance to the site. The permit boundary markers were also observed. The remote vent shaft sites were not inspected at this time. Evidence that the diversion ditches and storm water control devices are functioning as designed was observed and no significant erosion was observed throughout the site.

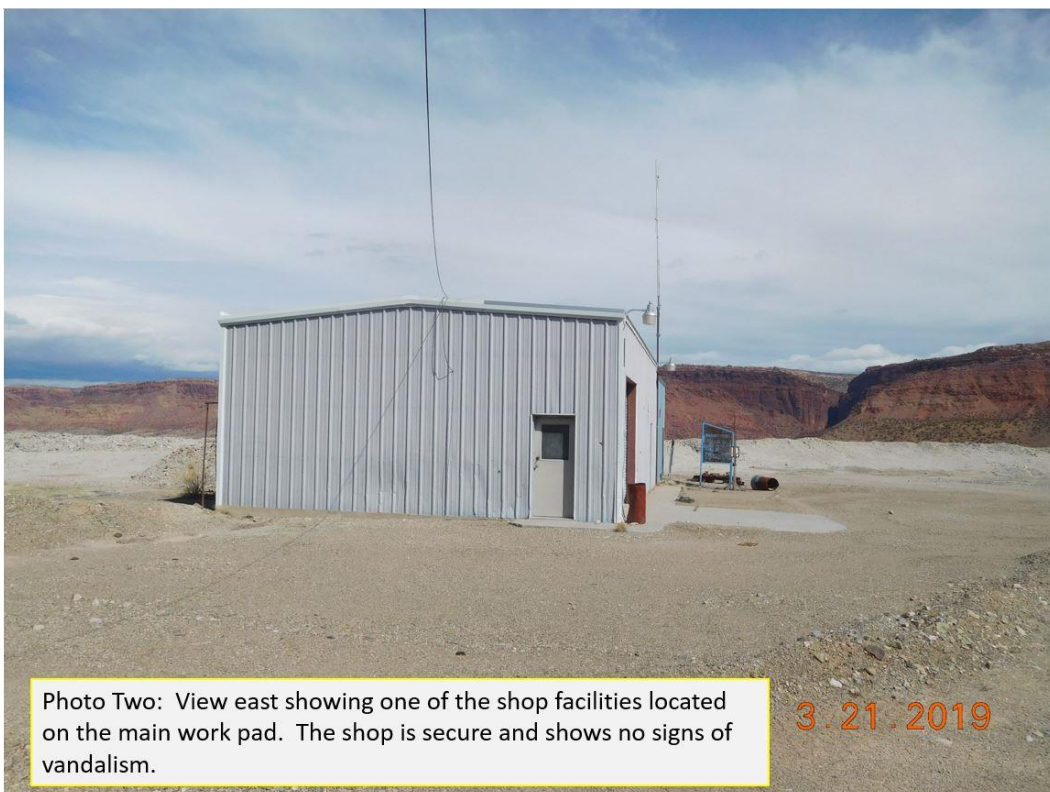
All work and shop appeared to be in good condition as seen in Photos Two and Three. The shop and storage facility in Photo Two was discovered to be unsecure, with the bay door opened. According to the operator there appeared to be no signs of theft or damage to the structure. The office facility was secured, and no signs of attempted unauthorized entry were noted on that facility. The portal located on site was also secured, it has been backfilled, closed off with steel grates as well as encompassed by a small berm as seen in Photo Four. Two fuel storage containers were observed on site but were empty and appear to have not been utilized in some time. Various other debris was observed on site however it was stored in an orderly fashion and was not a concern at this time.
