MINERALS PROGRAM INSPECTION REPORT
PHONE: (303) 866-3567

MINE NAME: Stewart Pit II	MINE/PROSPECTING ID#: M-2009-010	MINERAL: Sand, gravel, borrow	COUNTY: Kit Carson
INSPECTION TYPE: Monitoring	INSPECTOR(S): Elliott R. Russell	INSP. DATE: March 21, 2019	INSP. TIME: 11:30
OPERATOR: McCormick Excavation & Paving, LLC	OPERATOR REPRESENTATIVE: None	TYPE OF OPERATION: 112c - Construction Regular Operation

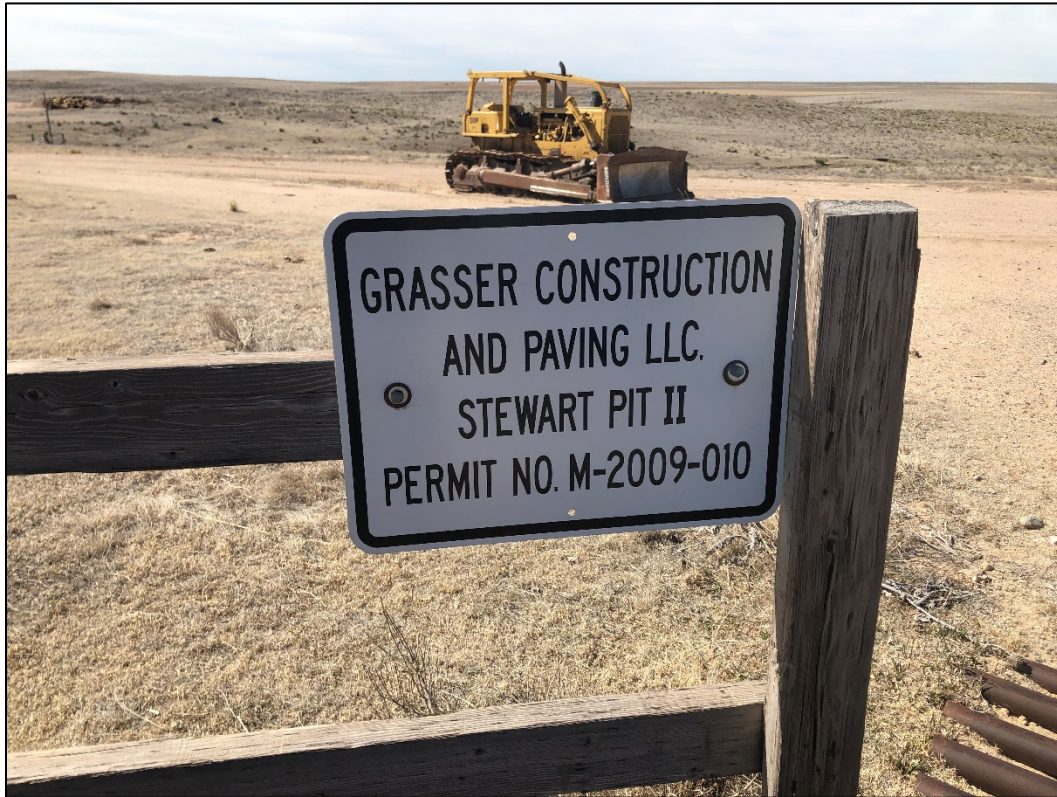
PROBLEM: The mine identification sign identified the incorrect operator. This is a problem for failure to post a mine identification sign in accordance with Rule 3.1.12(1).

Signs and Markers: The permit sign was properly posted at the entrance to the site, however, it still identifies the previous Operator "Grasser Construction and Paving, LLC." of the site. This sign will need to be updated to reflect the current permittee. This has been cited as a compliance problem, requiring corrective action.

Photo 1. Mine identification sign; looking west.

CORRECTIVE ACTIONS: The operator shall, at the entrance of the mine site, post a sign which shall be clearly visible from the access road with the following: the name of the operator, a statement that a reclamation permit for the operation has been issued by the Colorado Mined Land Reclamation Board; and the permit number. The operator shall submit photo documentation that a proper sign has been posted by the corrective action date.

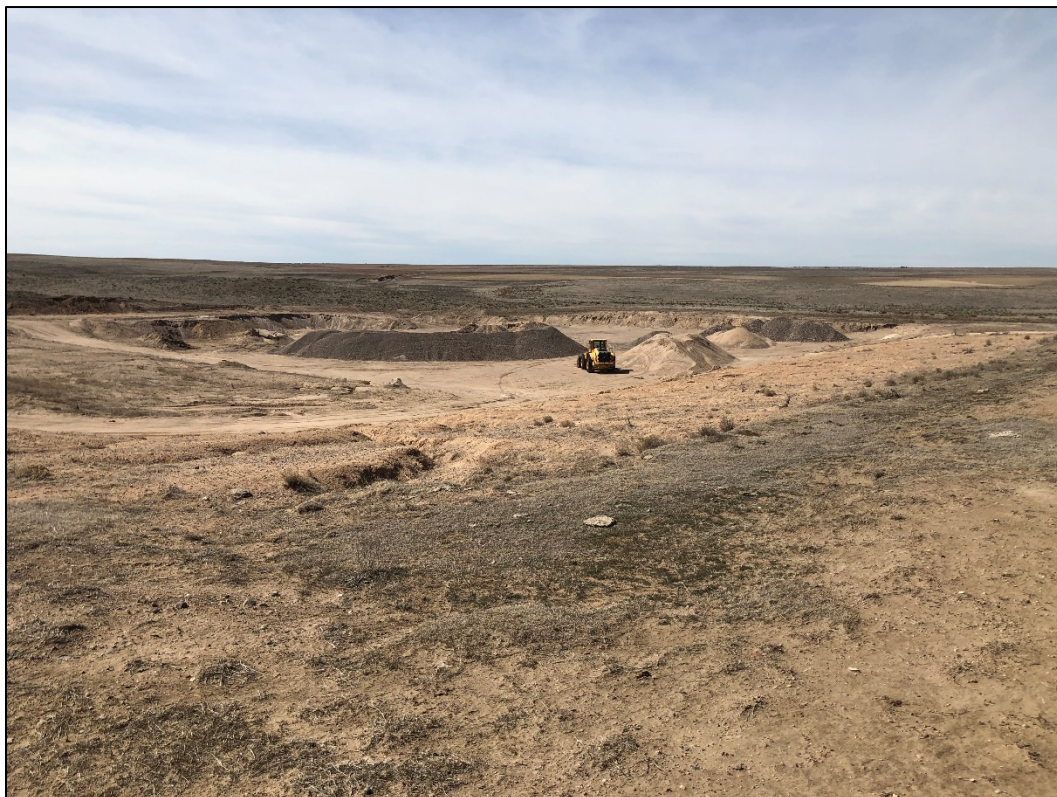
Photo 2. Overview of the Stewart Pit II (north portion of the site); looking southwest.

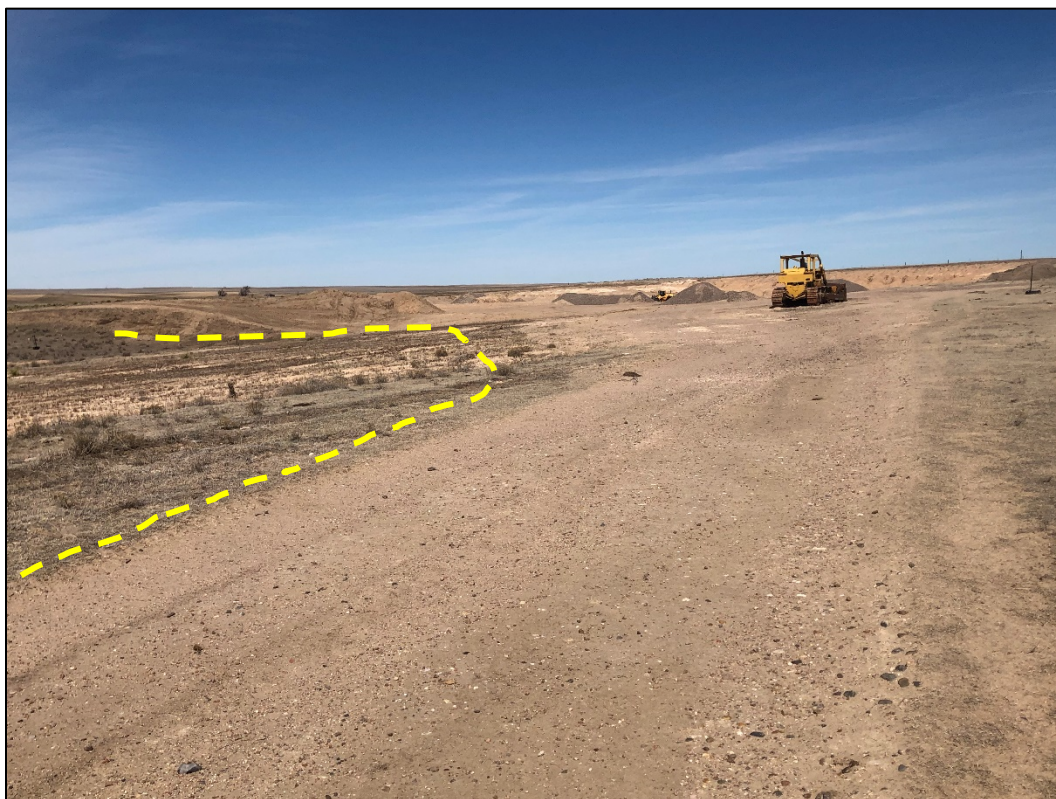
PROBLEM: Sediment is not being controlled at the site. This is a problem at this time for failure to protect the affected land from erosion pursuant to C.R.S. 34-32.5-116(4)(j).

Sediment Control: The operation spans a small drainage between the Stewart Pit (south) and Stewart Pit II (north). The Operator needs to ensure sediment is controlled at the southern portion of the Stewart Pit II area and the access road between the two mining areas (see **Photo 3**). The use of Best Management Practices (BMPs) is needed to prevent off-site sedimentation in this area. The Operator may want to construct a stormwater berm or install silt fencing along the western edge of the disturbance. This has been cited as a compliance problem requiring corrective action.

Photo 3. Access road from the northern to southern portion of the site, western edge of disturbance is in need of stormwater/sediment BMPs (yellow dashed line); looking northwest.

CORRECTIVE ACTIONS: The operator shall provide photo documentation to the Division verifying sediment control BMPs have been implemented and that the site has have been reconstructed and stabilized to prevent sedimentation and erosion damage by the corrective action date.

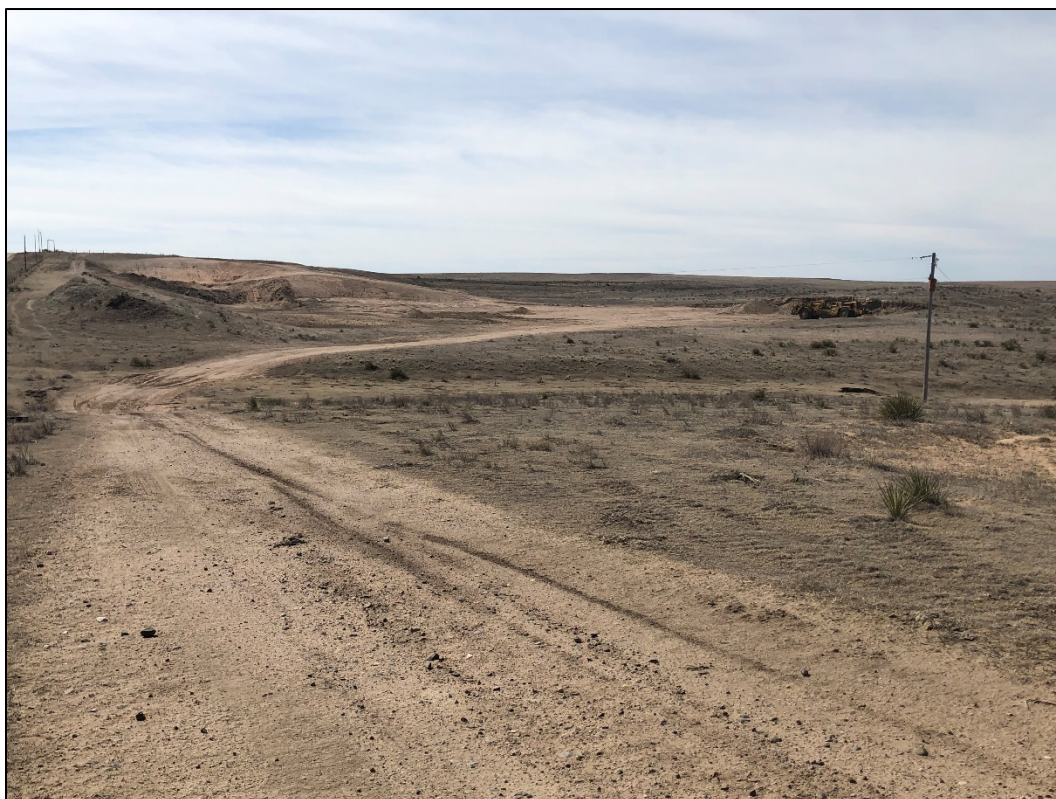
Photo 4. Overview of the Stewart Pit (southern portion of the site); looking southwest.

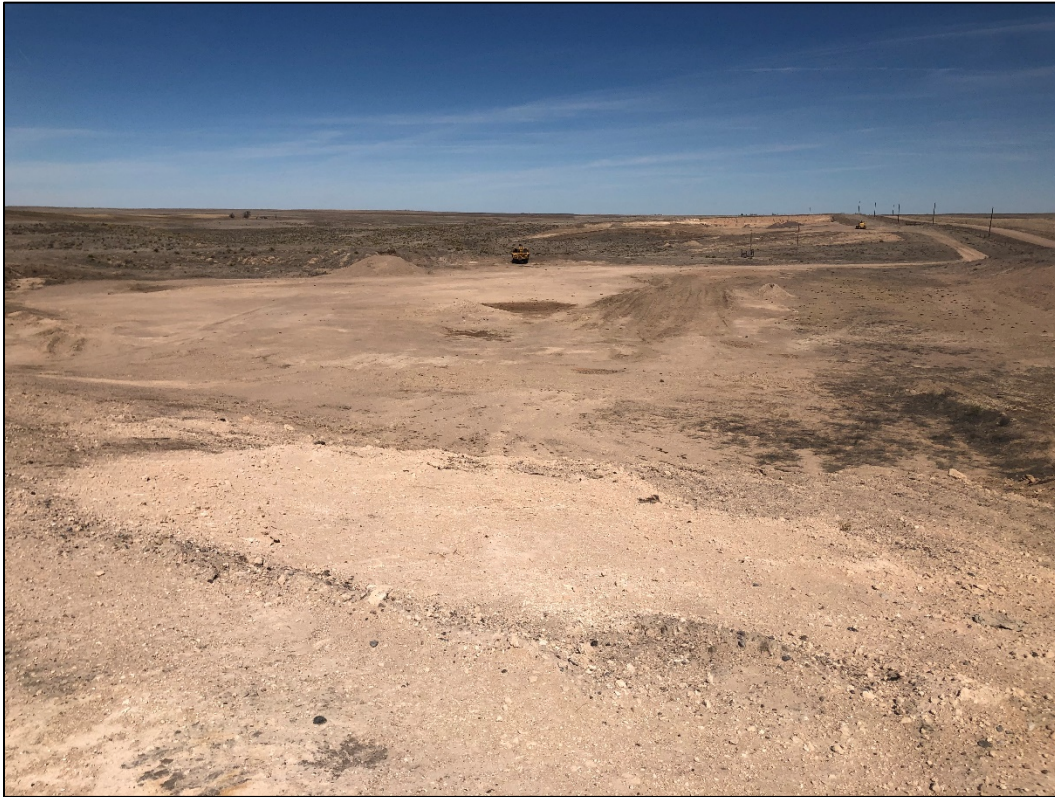
Photo 5. Overview of the Stewart Pit (southern portion of the site); looking north.

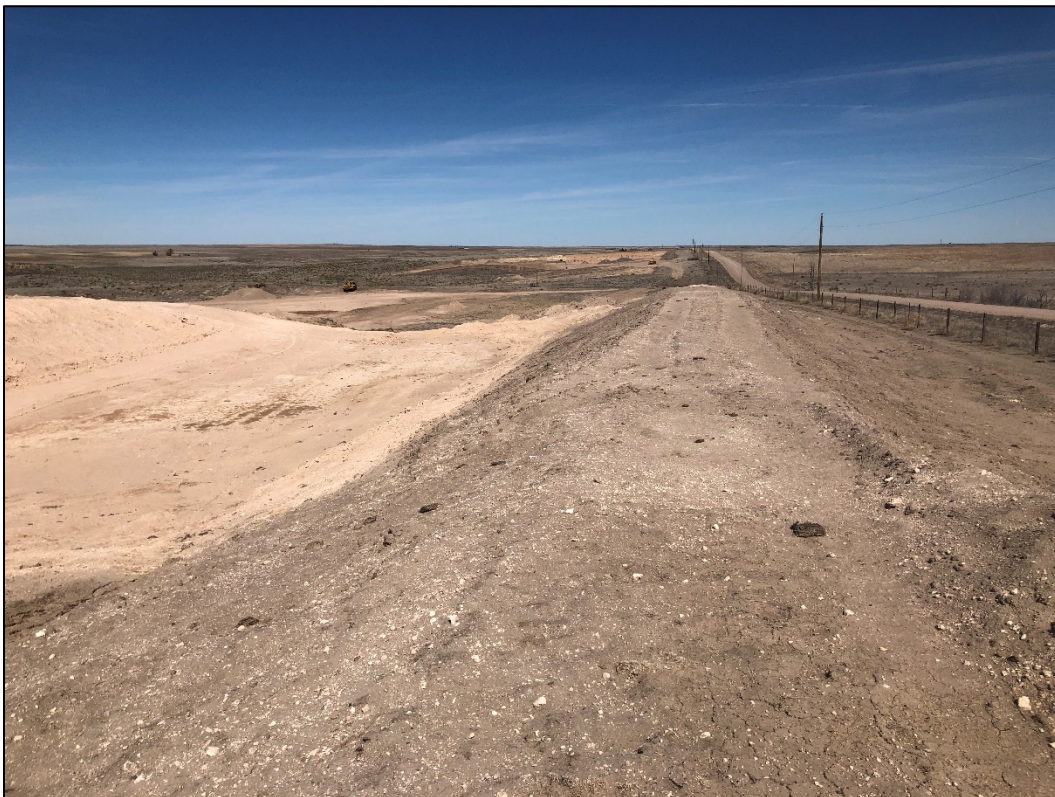
Topsoil: Topsoil appeared to have been adequately salvaged and is stored around the site in various.

Photo 6. Topsoil stockpile located along eastern boundary of the Stewart Pit (southern portion of the site); looking north.
