**MINERALS PROGRAM INSPECTION REPORT**  
**PHONE: (303) 866-3567**

<b>MINE NAME:</b> Goddard Pit #1	<b>MINE/PROSPECTING ID#:</b> M-2018-050	<b>MINERAL:</b> Sand, gravel, clay	<b>COUNTY:</b> Sedgwick
<b>INSPECTION TYPE:</b> Monitoring	<b>INSPECTOR(S):</b> Elliott R. Russell	<b>INSP. DATE:</b> March 20, 2019	<b>INSP. TIME:</b> 14:00
<b>OPERATOR:</b> Town of Julesburg	<b>OPERATOR REPRESENTATIVE:</b> None	<b>TYPE OF OPERATION:</b> 111 - Construction by Government Agency	
<b>REASON FOR INSPECTION:</b> Normal I&E Program	<b>BOND CALCULATION TYPE:</b> None	<b>BOND AMOUNT:</b> NA	
<b>DATE OF COMPLAINT:</b> NA	<b>POST INSP. CONTACTS:</b> None	<b>JOINT INSP. AGENCY:</b> None	
<b>WEATHER:</b> Clear	<b>INSPECTOR'S SIGNATURE:</b>

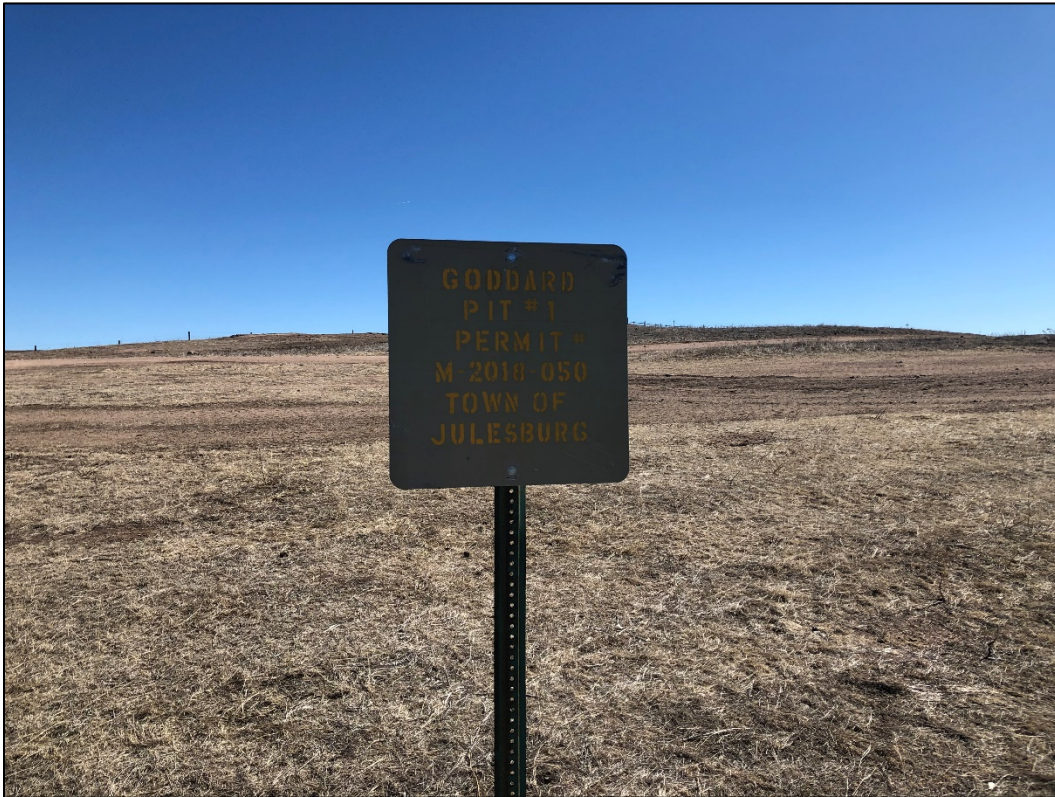
Signs and Markers: The mine identification sign was posted the mine site. The site was delineated fence lines.

**Photo 1.** Permit identification sign; looking south.

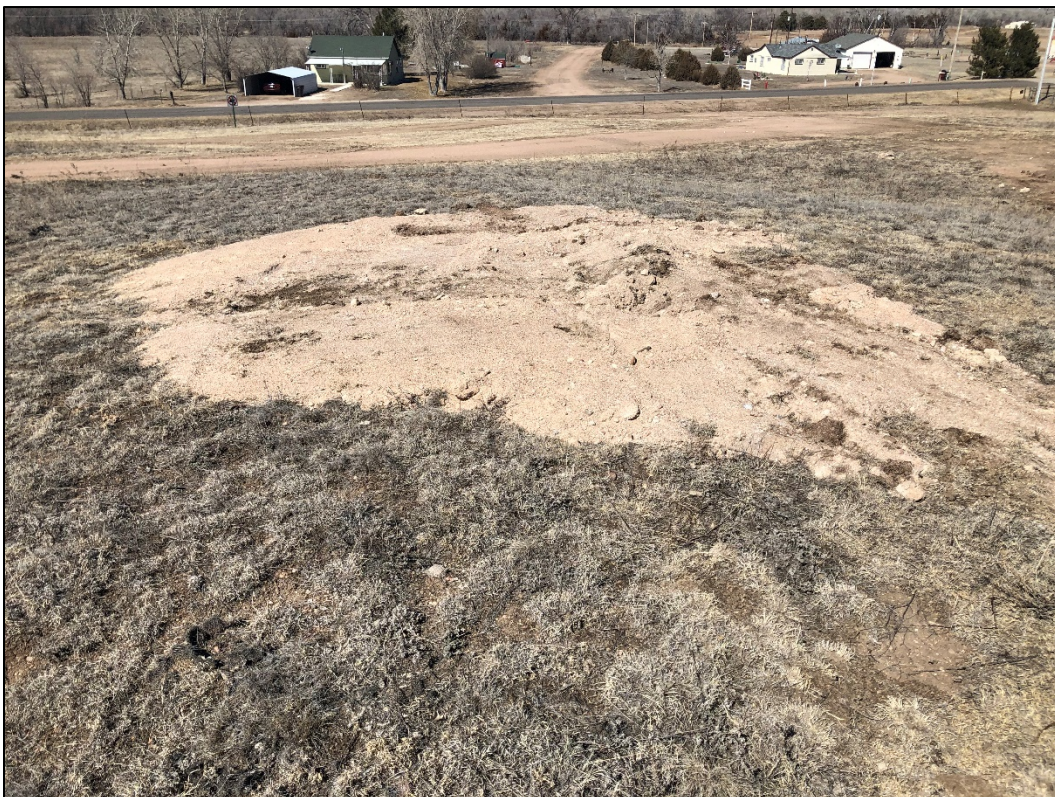
The Division cited two compliance problems following the January 17, 2019 inspection. The site didn't have a permit identification sign and there was an open test pit. The Operator promptly resolved these problems by supplying photographic documentation of the corrective action to the Division on January 29, 2019.

**Photo 2.** Backfilled test pit; looking north.

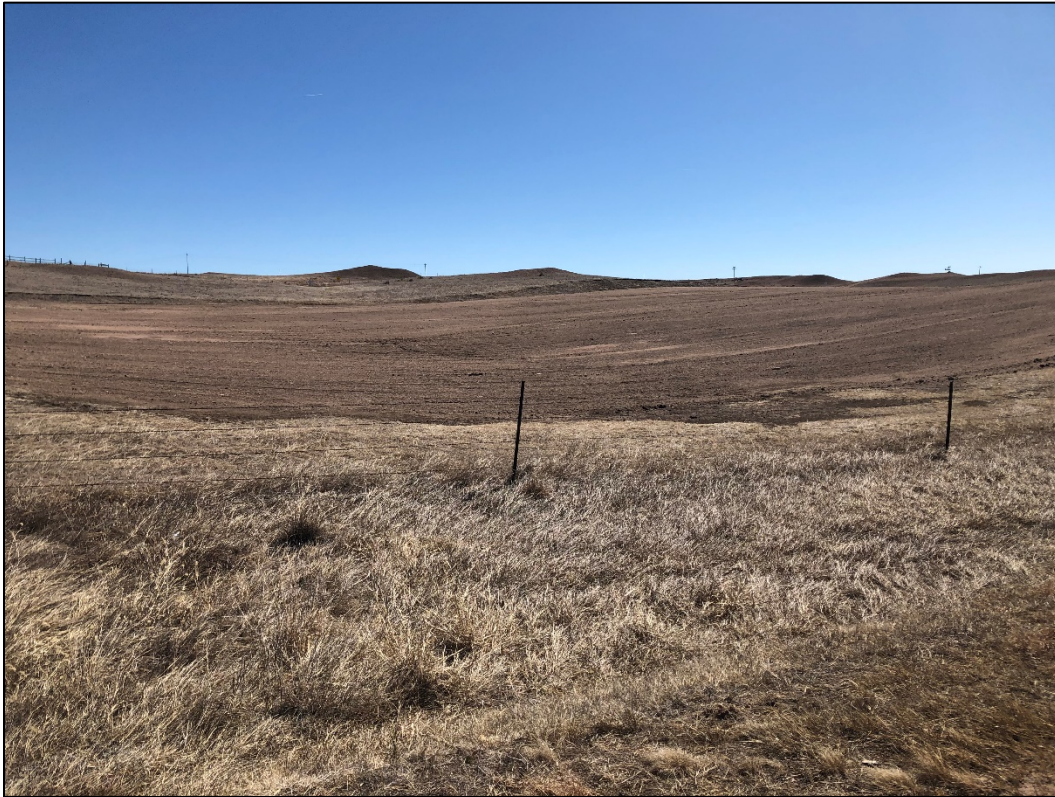
Sediment Control: It appears erosion control measures are needed at the site to prevent off-site sedimentation. The site has been graded to what appeared to be the original contour, however, since vegetative cover has yet to establish, there is a high chance for erosion. There are two drainages within the affected lands (identified in this report as the eastern and western drainages) which lead northwest to the northern permit boundary. Utilization of silt fencing, straw bales, erosion control blankets, straw wattles, and/or contour furrows may help prevent erosion and off-site sedimentation.

**Photo 3.** Eastern drainage area needing erosion control BMPs; looking south.

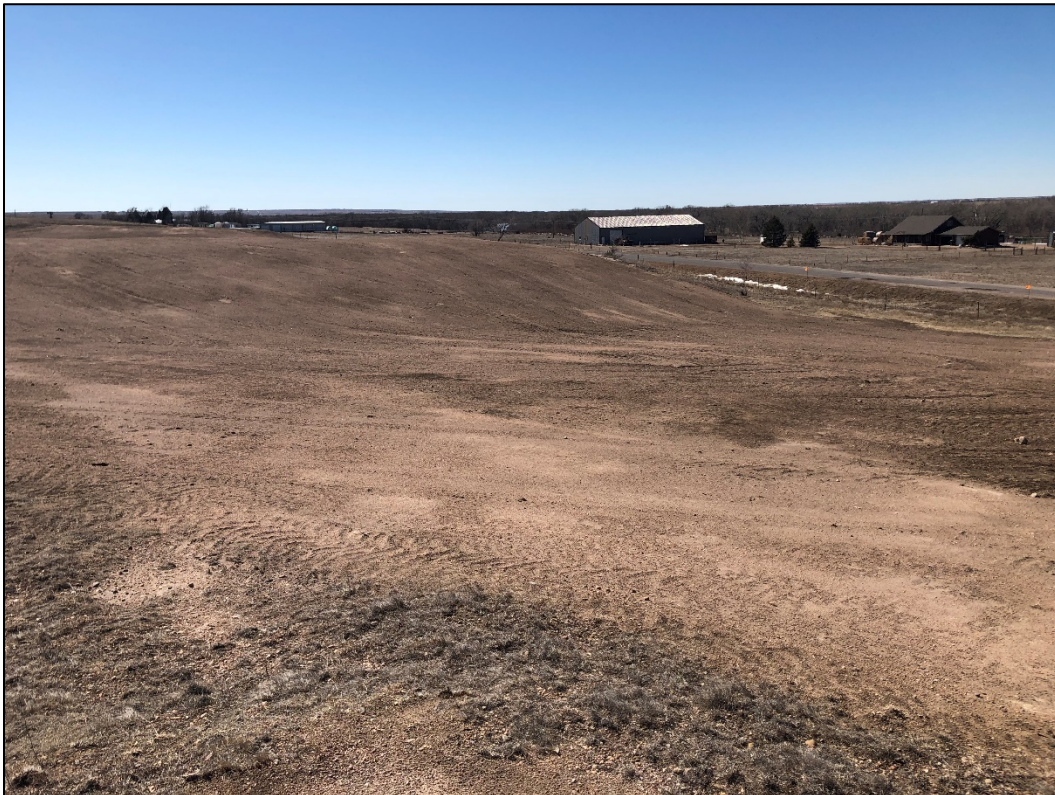
**Photo 4.** Eastern drainage area needing erosion control BMPs; looking west.

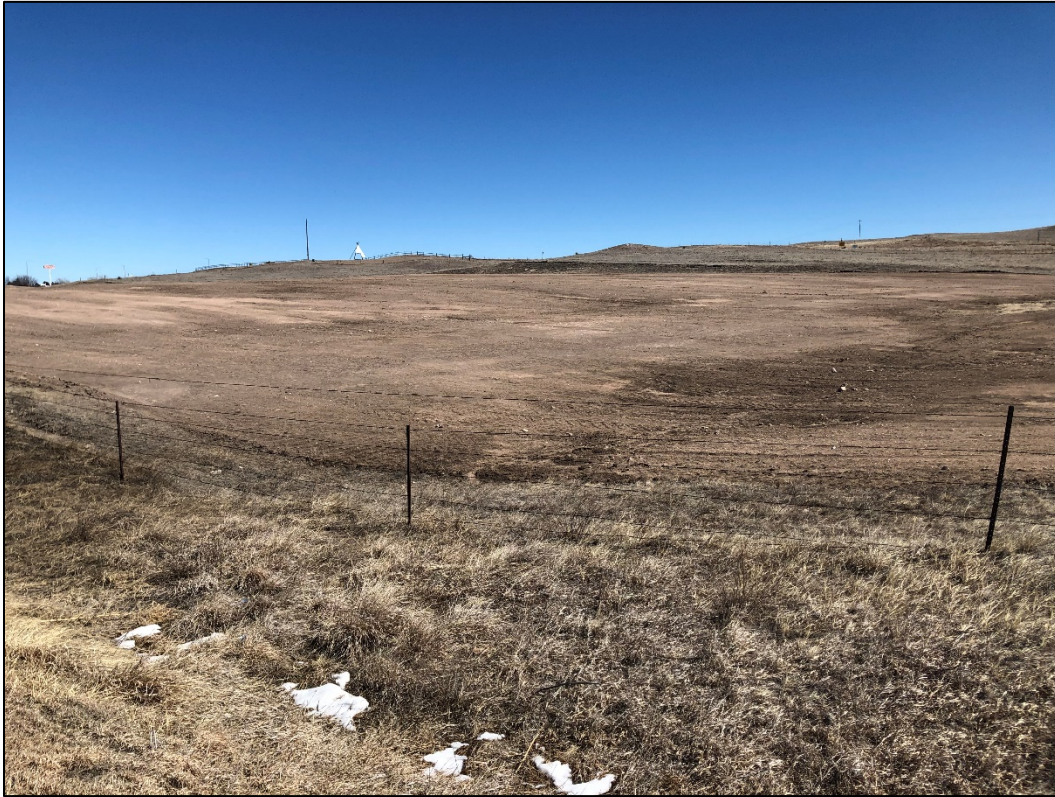
**Photo 5.** Western drainage area needing erosion control BMPs; looking southeast.

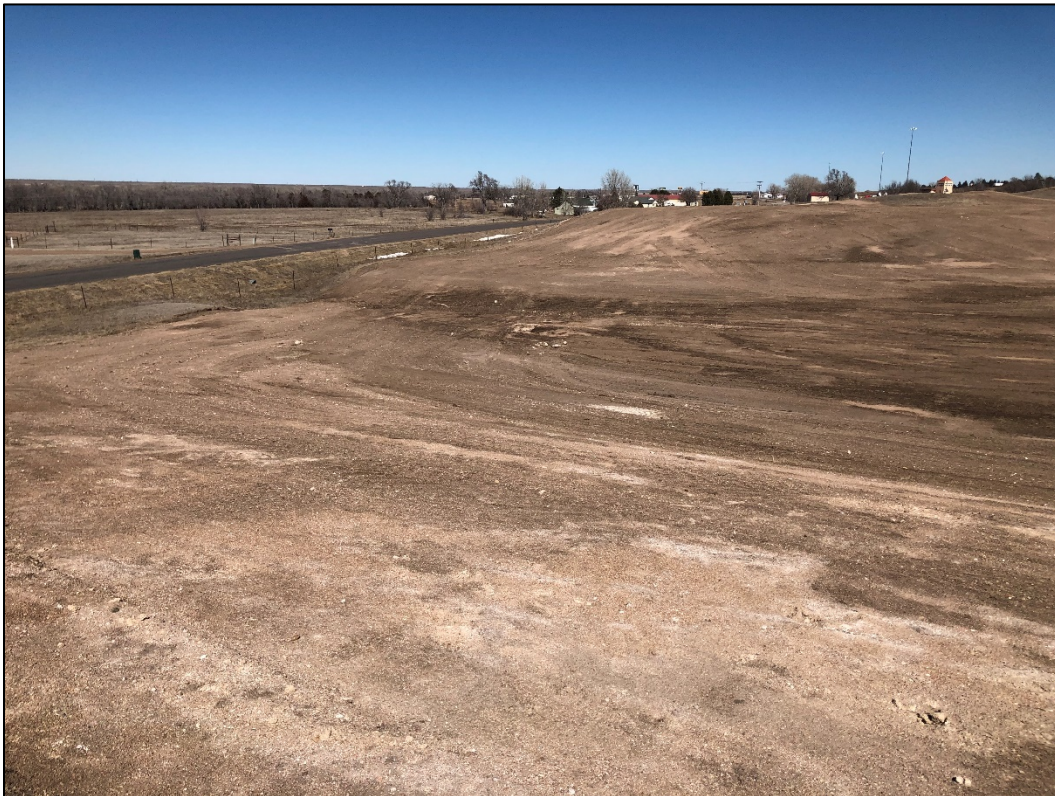
**Photo 6.** Western drainage area needing erosion control BMPs; looking northeast.
