**MINERALS PROGRAM INSPECTION REPORT**  
**PHONE: (303) 866-3567**

<b>MINE NAME:</b> Chambers Pit	<b>MINE/PROSPECTING ID#:</b> M-1979-205	<b>MINERAL:</b> Sand and gravel	<b>COUNTY:</b> Garfield
<b>INSPECTION TYPE:</b> Monitoring	<b>INSPECTOR(S):</b> Amy C. Yeldell	<b>INSP. DATE:</b> February 14, 2019	<b>INSP. TIME:</b> 10:15
<b>OPERATOR:</b> Oldcastle SW Group, Inc. dba United Companies of Mesa County	<b>OPERATOR REPRESENTATIVE:</b> Jason Burkey	<b>TYPE OF OPERATION:</b> 112c - Construction Regular Operation	
<b>REASON FOR INSPECTION:</b> Normal I&E Program	<b>BOND CALCULATION TYPE:</b> Complete Bond	<b>BOND AMOUNT:</b> \$212,000.00	
<b>DATE OF COMPLAINT:</b> NA	<b>POST INSP. CONTACTS:</b> None	<b>JOINT INSP. AGENCY:</b> None	
<b>WEATHER:</b> Cloudy	<b>INSPECTOR'S SIGNATURE:</b>

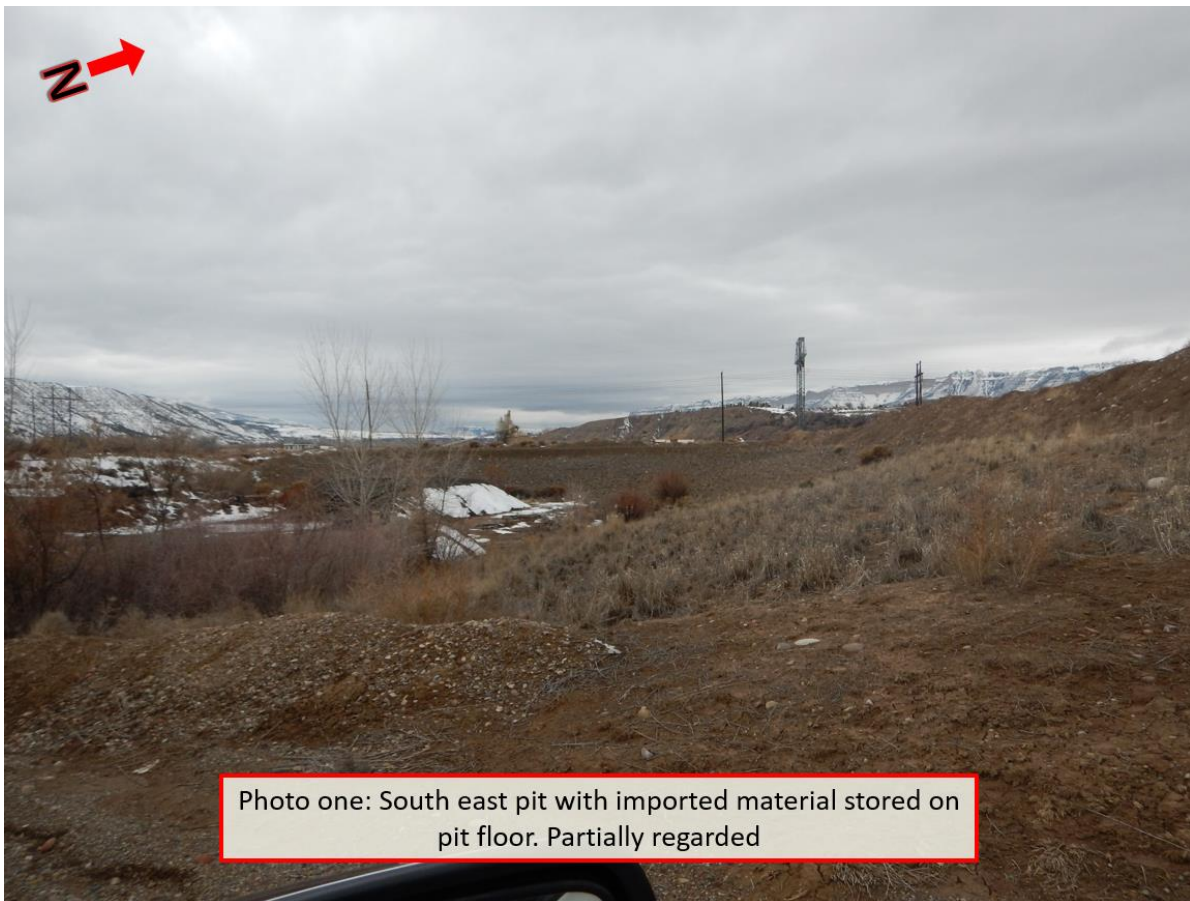
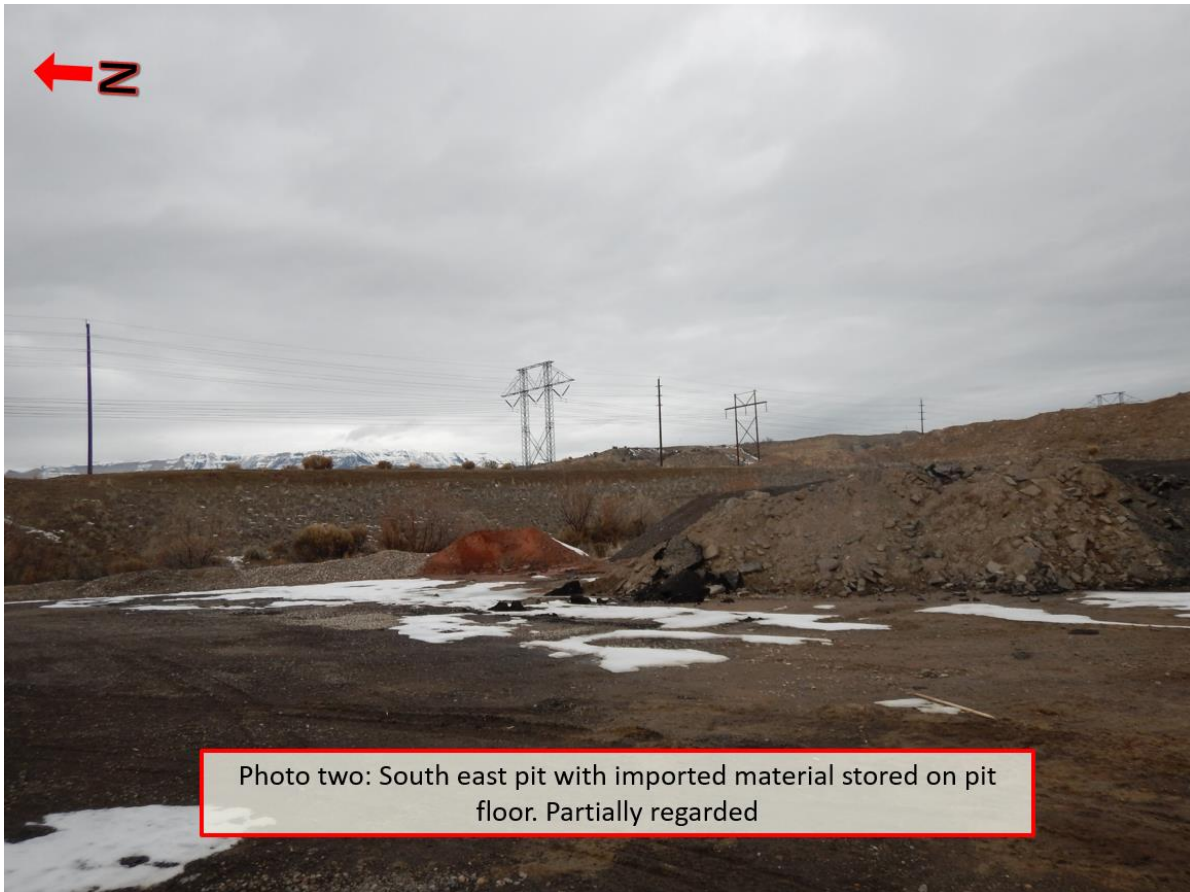
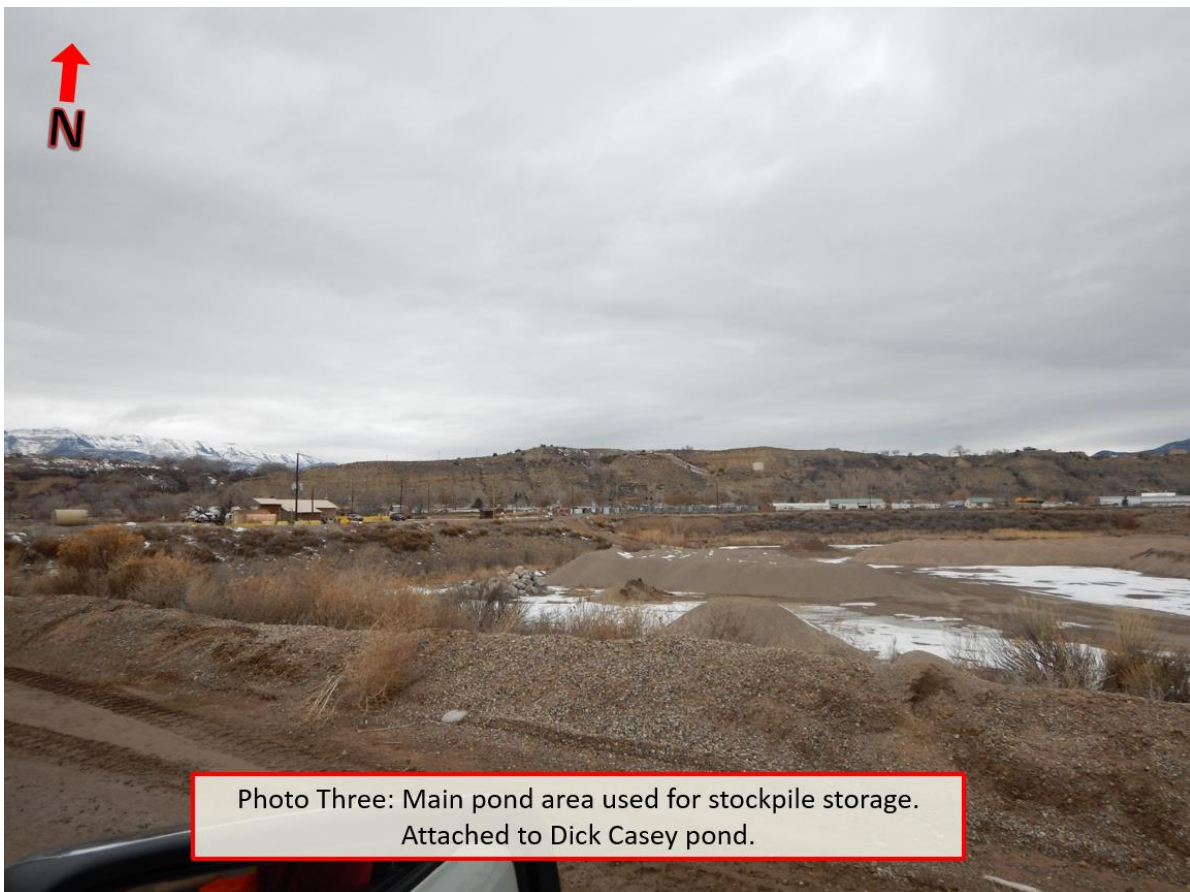
Main: (photos one through four)

There is a scale house and scale located just north of the central reclaimed pond. A dewatering pond is located adjacent to the scale. The central lake appears to be fully reclaimed and the operator may like to request an acreage reduction.

The site is completely mined out and used just for stockpile storage. Slopes around the pit floor storage area require additional grading. The current mining plan calls for joining the Chambers Pit lake with the Dick Casey lake. Topsoil for this pit is mostly located at the Glen Pit (M-2005-075).

The phase in the southeast corner of the pit is separate from the Dick Casey Pit. On this pit floor there is recycled asphalt and concrete stockpiled. The operator is reminded of Rule 3.1.5(9) regarding use of inert fill for reclamation purposes.

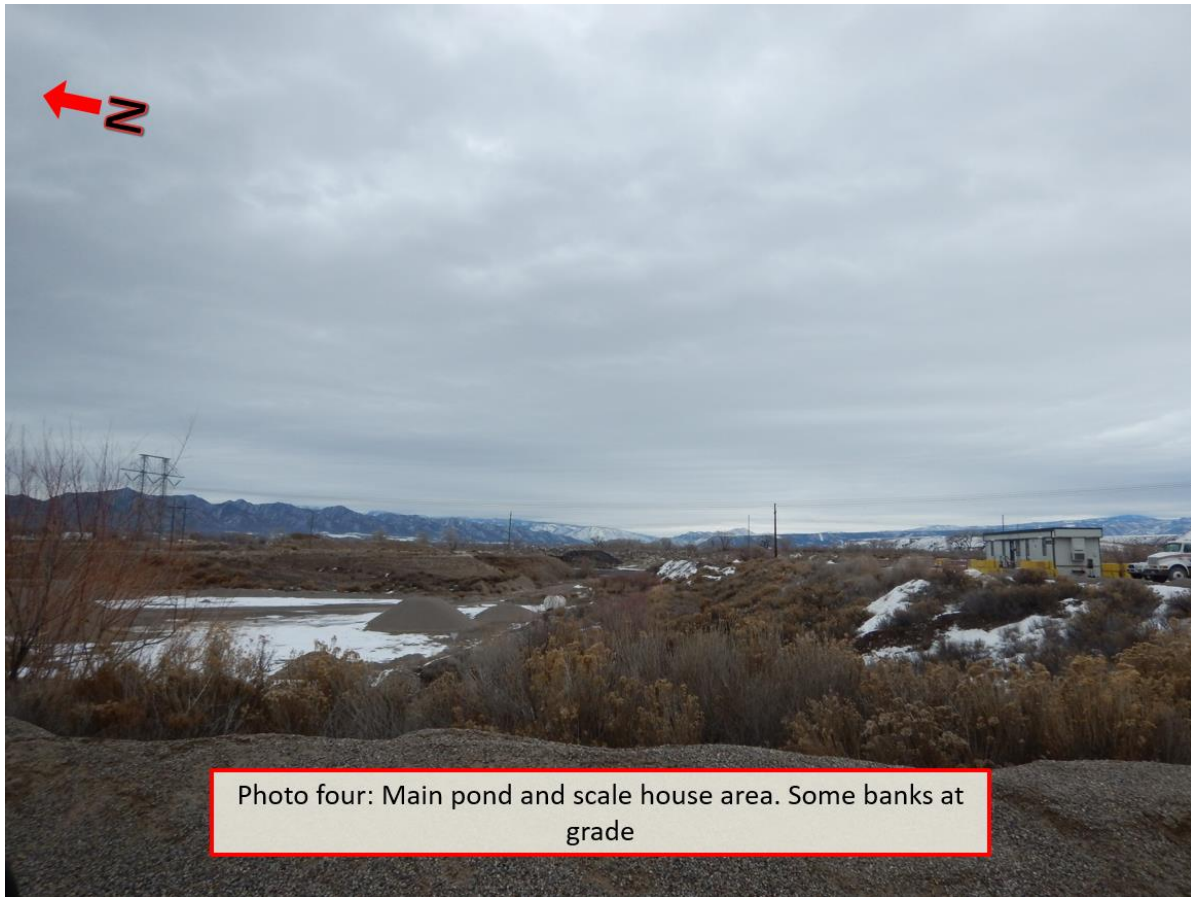
Photo four: Main pond and scale house area. Some banks at grade

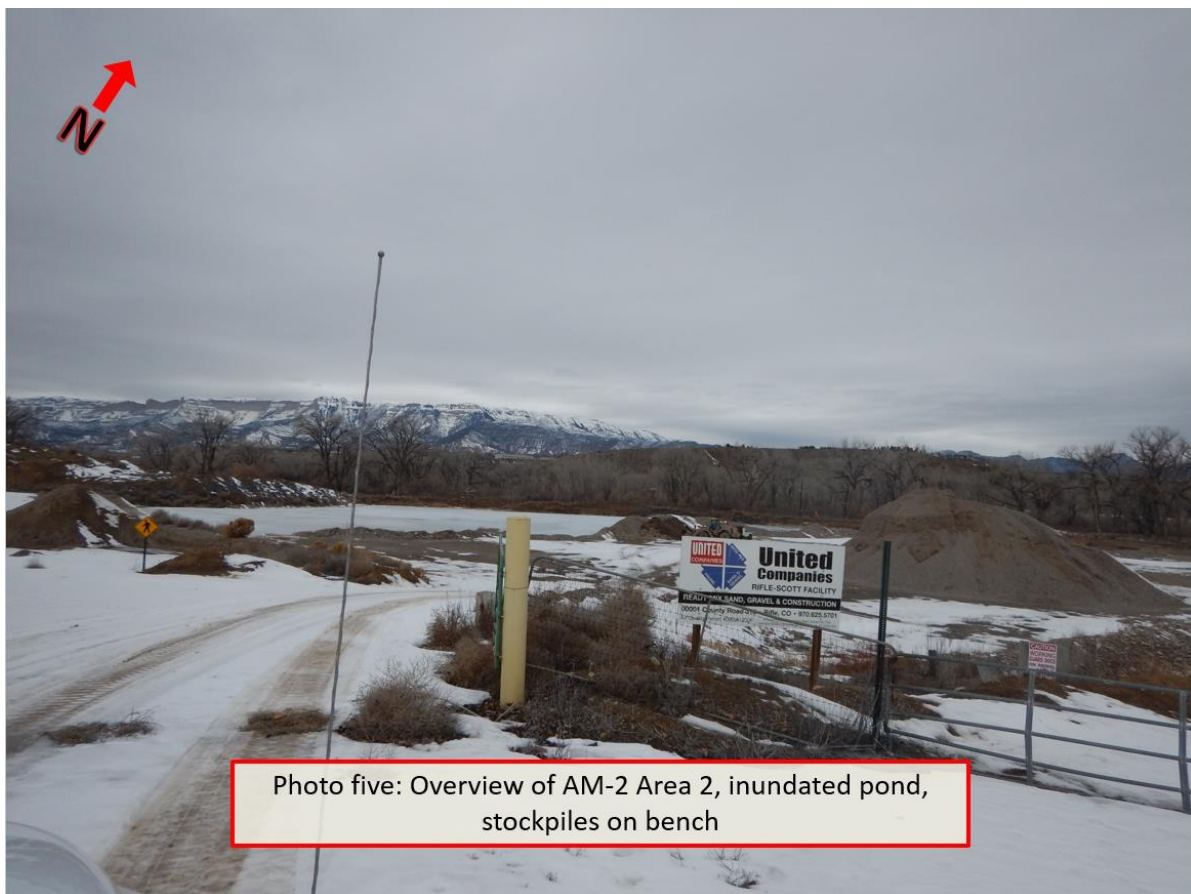
The east Scott Pit lake is where active mining is taking place. There is one large stockpile in the pad area of the east side of this phase that is approximately 2-3 acres. A large topsoil and overburden pile is located in the southwest corner of the east phase. There is a 20'H x 5"W dewatering ditch around the entire phase with a 1H:1V highwall all the way around it. The west side of the east phase remains an inundated pond.

Photo five: Overview of AM-2 Area 2, inundated pond, stockpiles on bench

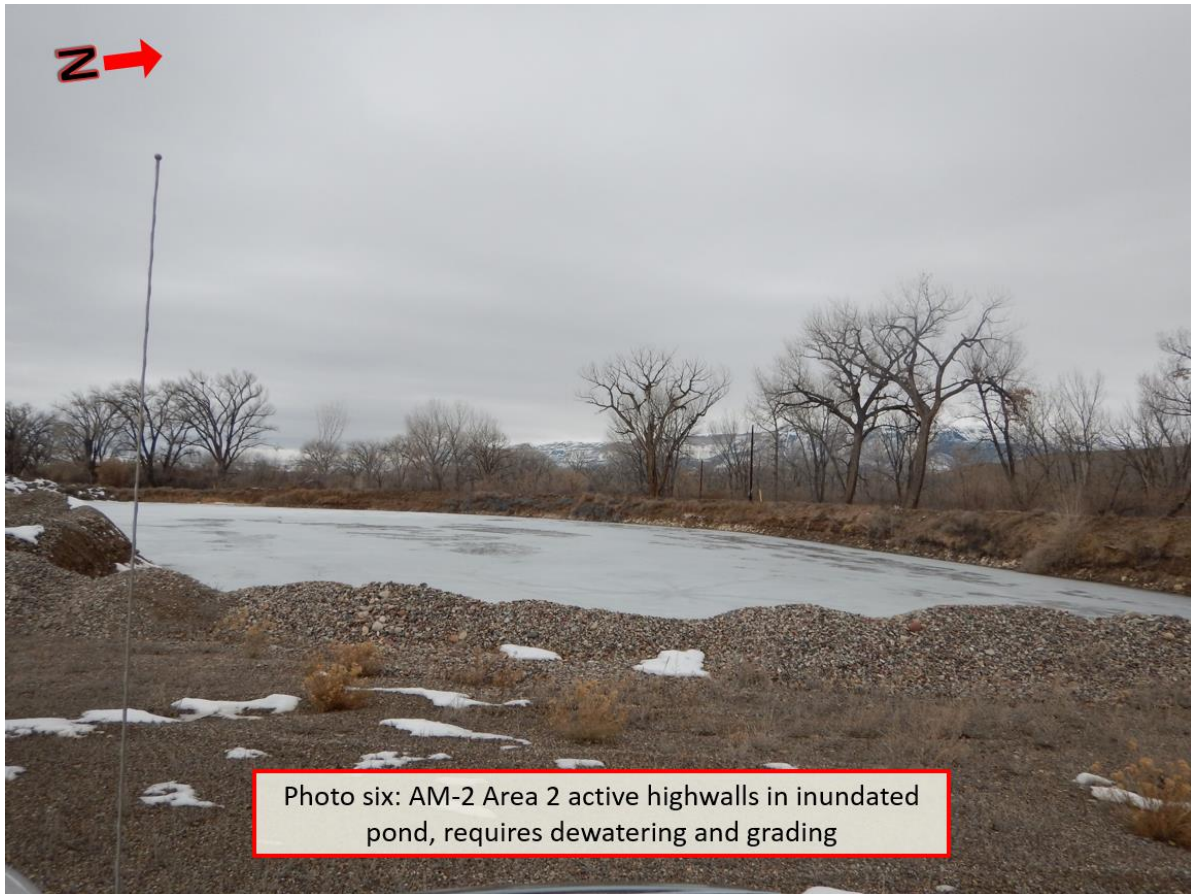
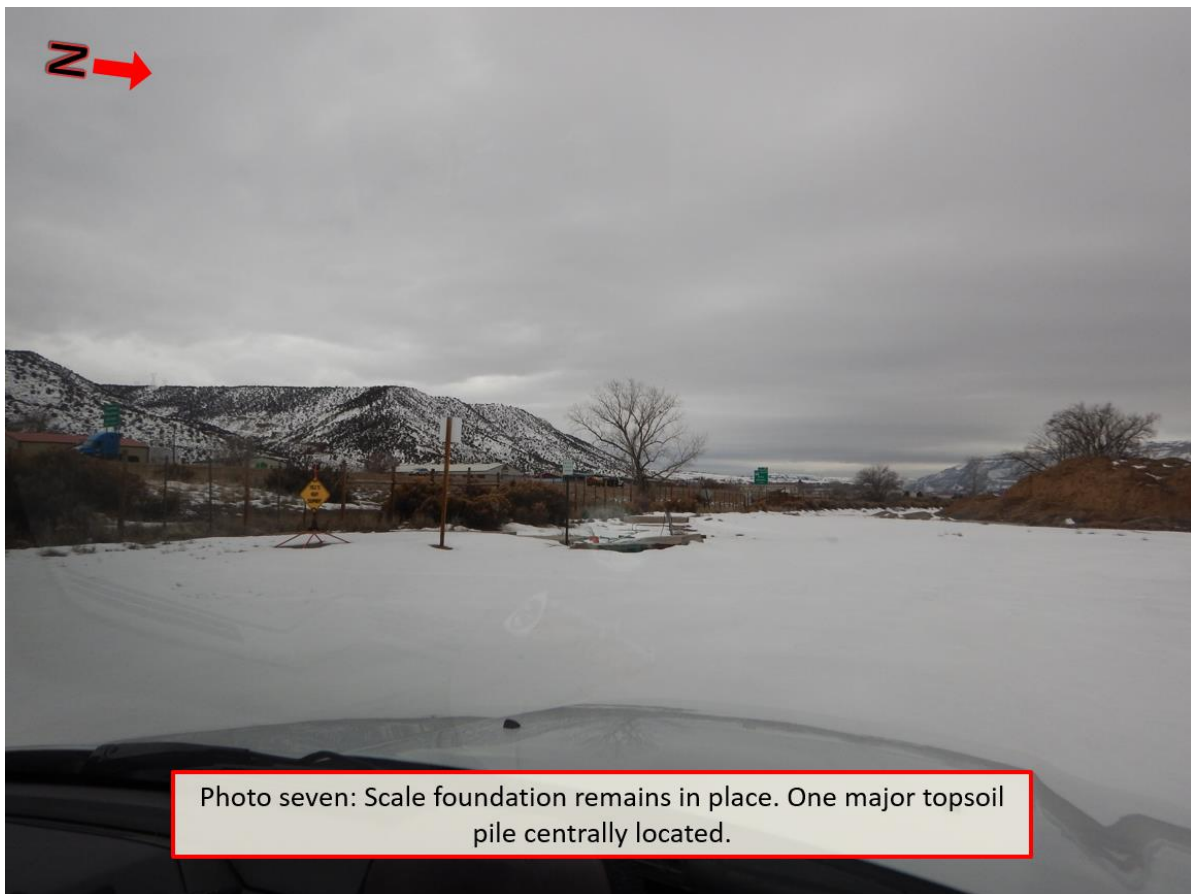
AM-2 Scotts Pit Expansion Area: (photos five through seven)

The Scott Pit area permit boundary is delineated by t-posts fences and the Colorado River. No fuel is stored in this location. A loader was present for transporting material to Mamm Creek (M-2000-113). The western phase is fully reclaimed. The access road remains a graveled surface. The scale house and scale have been removed but the concrete footers remain in place.
