MINERALS PROGRAM INSPECTION REPORT

MINE NAME: Dolezal Gravel Pit	MINE/PROSPECTING ID#: M-1996-073	MINERAL: Gravel	COUNTY: Sedgwick
INSPECTION TYPE: Monitoring	INSPECTOR(S): Elliott R. Russell	INSP. DATE: March 20, 2019	INSP. TIME: 12:15
OPERATOR: Sedgwick County	OPERATOR REPRESENTATIVE: Rick Furrow	TYPE OF OPERATION: 110c - Construction Limited Impact

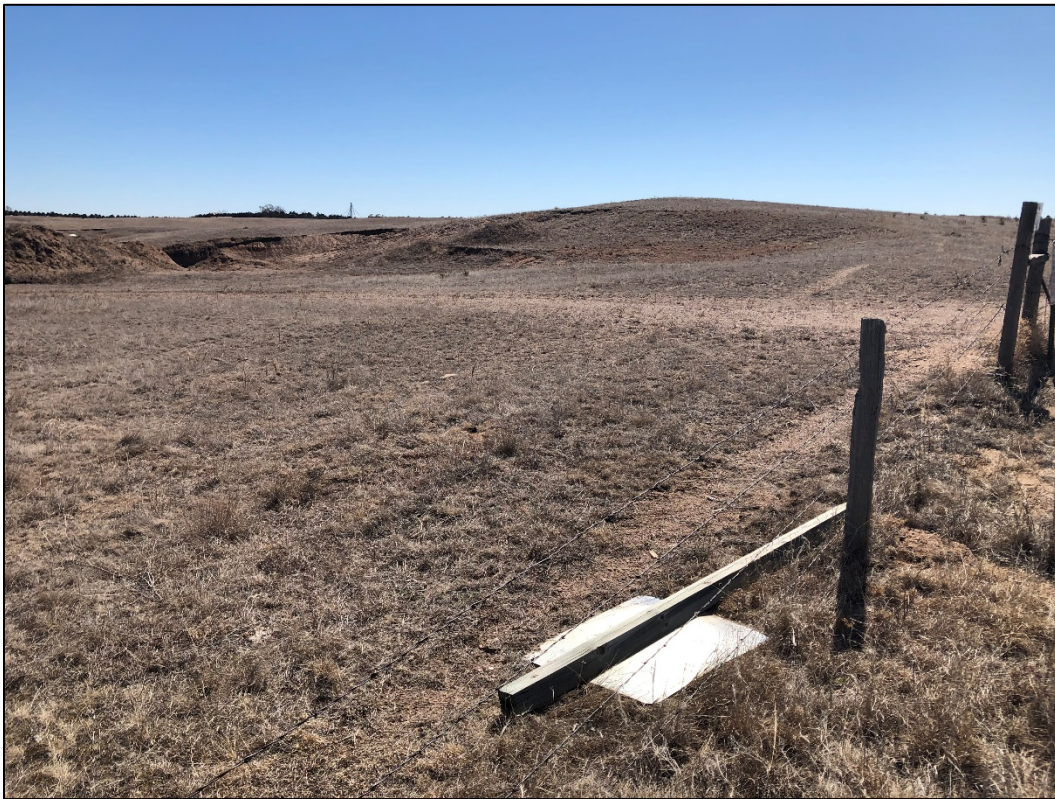
PROBLEM: The mine identification sign was not posted at the entrance of the mine site. This is a problem for failure to post a mine identification sign as required by Rule 3.1.12(1).

Signs and Markers: The permit sign was not properly posted at the entrance to the site. This has been cited as a compliance problem requiring corrective action. Boundary markers (t-posts and tires) were observed to delineate the permit boundary.

Photo 1. Mine identification sign has fallen over at the entrance to the site; looking southeast.

CORRECTIVE ACTIONS: The operator shall, at the entrance of the mine site, post a sign which shall be clearly visible from the access road with the following: the name of the operator, a statement that a reclamation permit for the operation has been issued by the Colorado Mined Land Reclamation Board; and the permit number. The operator shall submit photo documentation that a proper sign has been posted by the corrective action date.

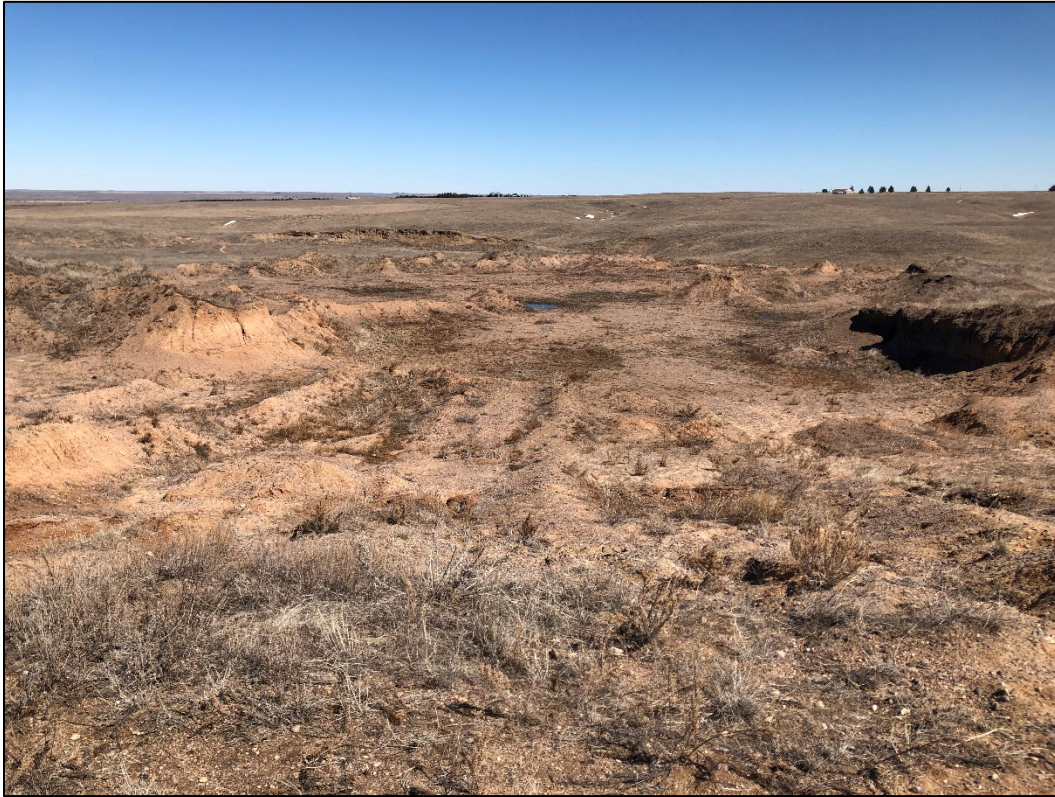
Photo 2. Active (southern) portion of the pit overview; looking northeast.

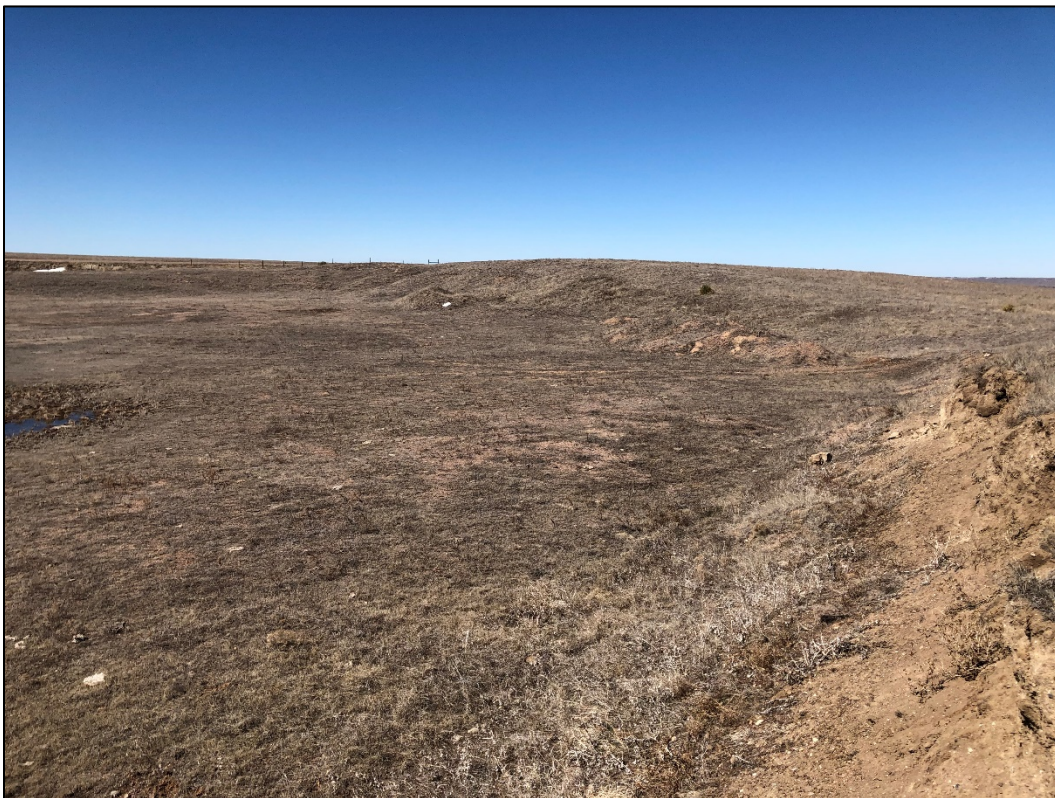
Photo 3. Older (northern) portion of the site; looking northwest.

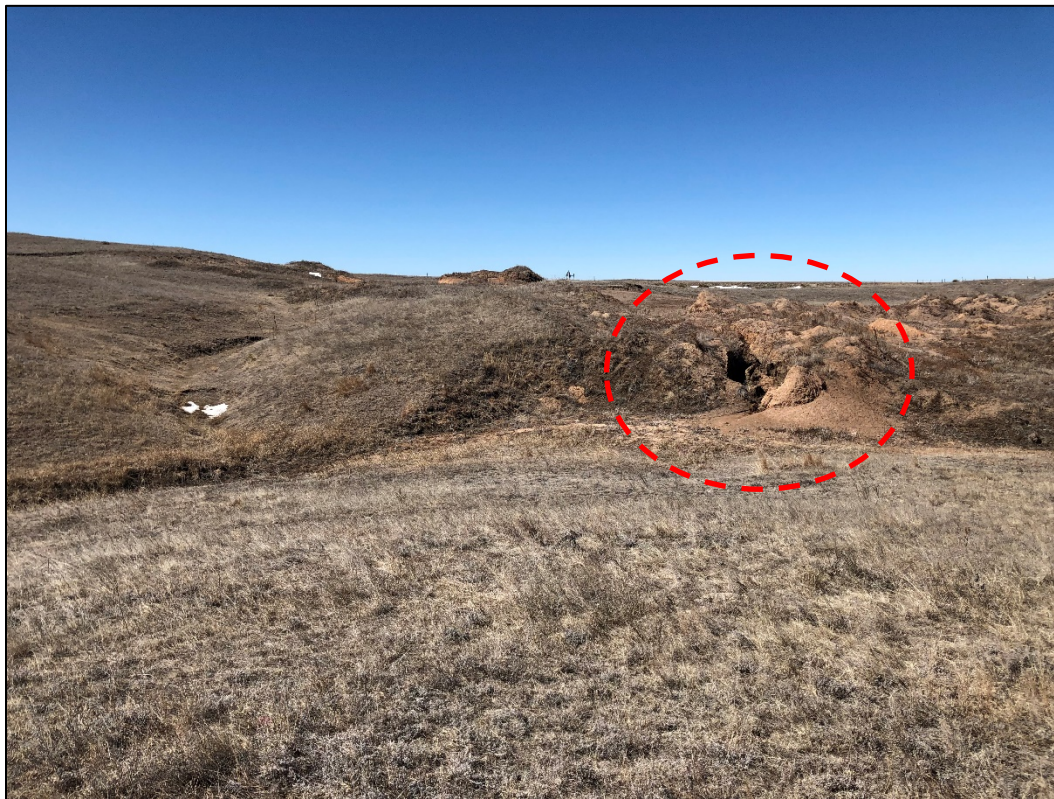
PROBLEM: Erosion gullies and ruts were observed on-site and storm water was not being adequately controlled. This is a problem at this time for failure to protect the affected land from erosion pursuant to C.R.S. 34-32.5-116(4)(j).

Sediment Control: The operation is located on the west side of a small dry wash. Within the permitted area, there are several small drainages which flow east toward the dry wash. The Operator needs to ensure storm water is controlled at the site along the eastern boundary to prevent erosion and sediment from entering the dry wash. The use of Best Management Practices (BMPs) is needed to prevent off-site sedimentation in this area.

Photo 4. Area where storm water is currently allowed to leave the eastern permit boundary and enter the dry wash; looking west.

CORRECTIVE ACTIONS: The operator shall provide photo documentation to the Division verifying erosion gullies and ruts have been repaired, and that the site has have been reconstructed and stabilized to prevent erosion damage by the corrective action date.

The Operator may want to regrade the site and construct storm water berms along around the small drainages or along the eastern permit boundary. This has been cited as a compliance problem requiring corrective action.
