MINERALS PROGRAM INSPECTION REPORT**PHONE: (303) 866-3567**

MINE NAME: Kinnie Gravel Pit	MINE/PROSPECTING ID#: M-1997-061	MINERAL: Gravel	COUNTY: Sedgwick
INSPECTION TYPE: Monitoring	INSPECTOR(S): Elliott R. Russell	INSP. DATE: March 20, 2019	INSP. TIME: 11:20
OPERATOR: Sedgwick County	OPERATOR REPRESENTATIVE: Rick Furrow	TYPE OF OPERATION: 110c - Construction Limited Impact	
REASON FOR INSPECTION: Normal I&E Program	BOND CALCULATION TYPE: None	BOND AMOUNT: NA	
DATE OF COMPLAINT: NA	POST INSP. CONTACTS: None	JOINT INSP. AGENCY: None	
WEATHER: Clear	INSPECTOR'S SIGNATURE:

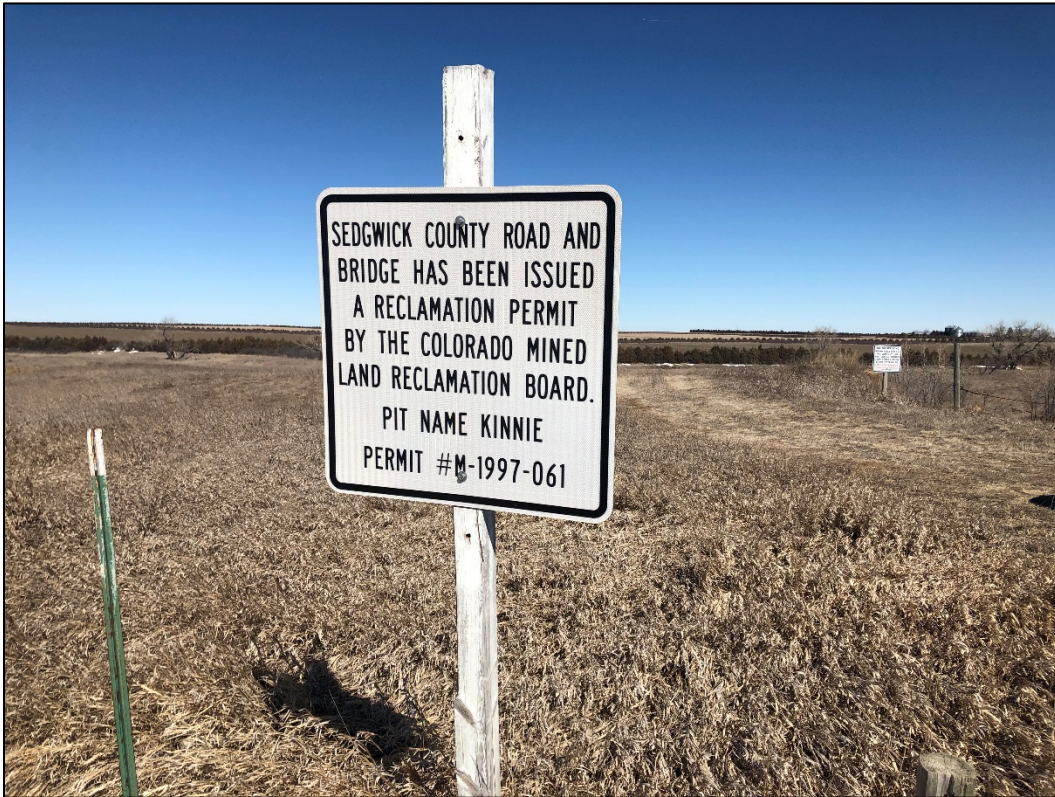
Signs and Markers: The permit sign was properly posted and boundary markers (t-posts) were observed to delineate the permit boundary.

Photo 1. Mine identification sign; looking north.

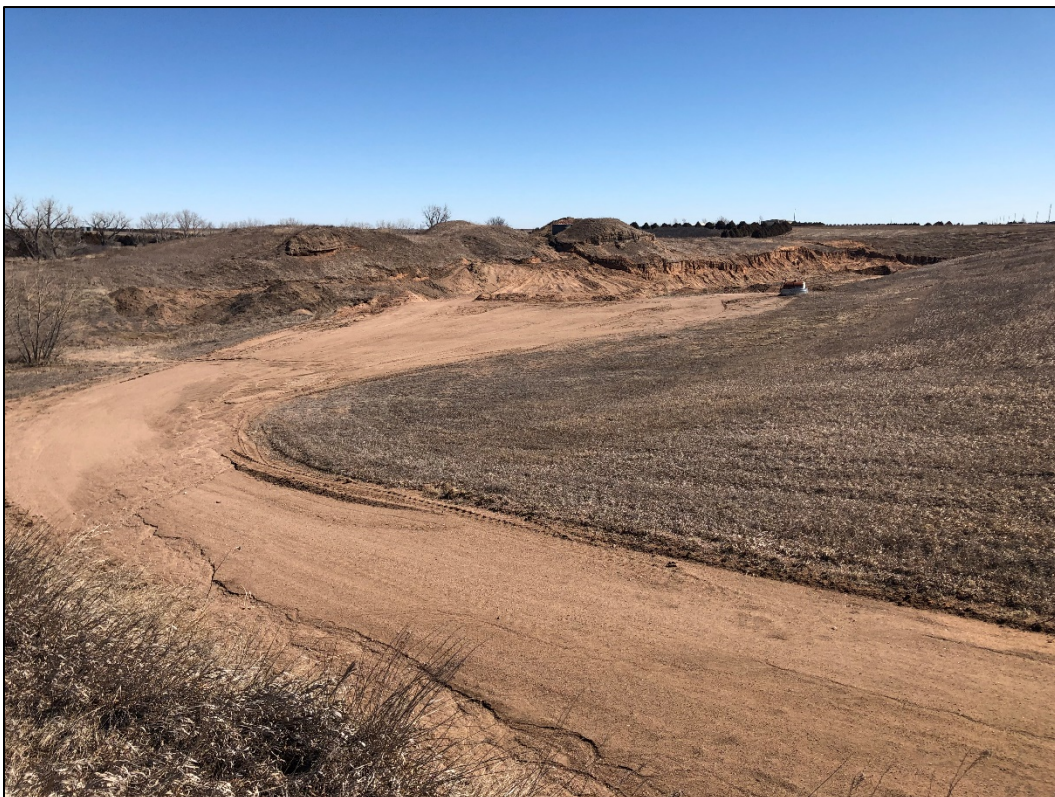
Photo 2. Pit overview; looking northeast from the access road.

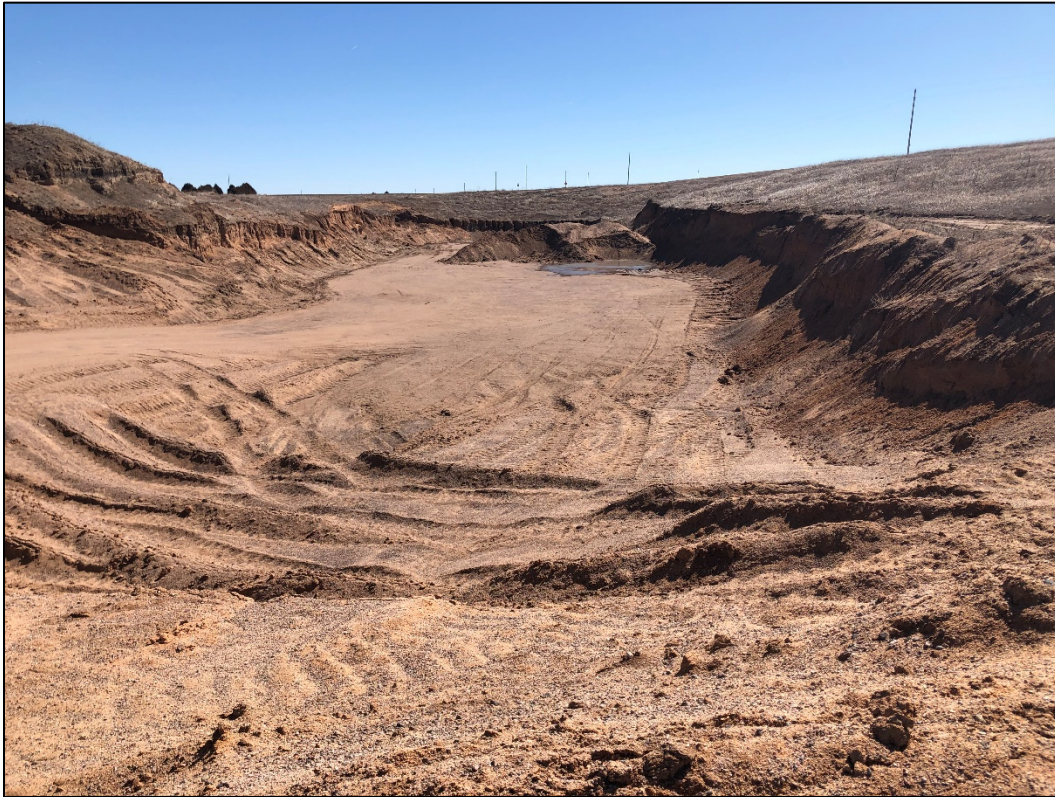
Photo 3. Pit area; looking east.

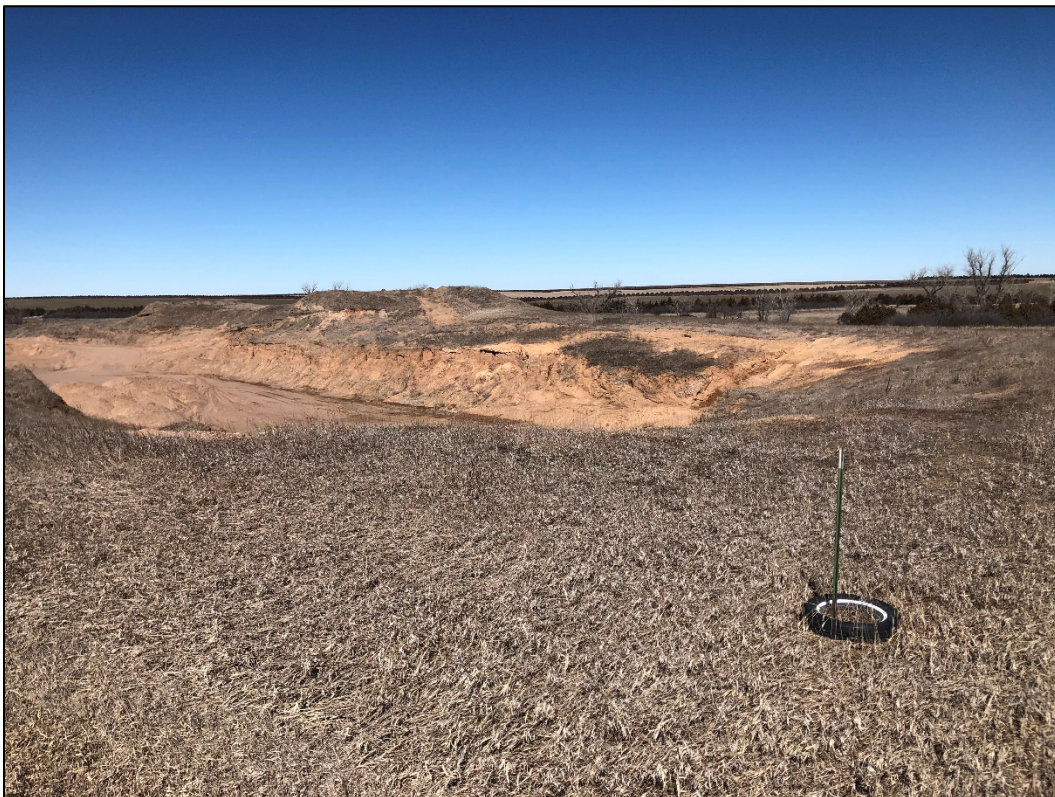
Photo 4. Pit overview; looking northwest from the southeast boundary corner.
