MINERALS PROGRAM INSPECTION REPORT
PHONE: (303) 866-3567

MINE NAME: Skold Pit	MINE/PROSPECTING ID#: M-1998-032	MINERAL: Gravel	COUNTY: Sedgwick
INSPECTION TYPE: Monitoring	INSPECTOR(S): Elliott R. Russell	INSP. DATE: March 20, 2019	INSP. TIME: 10:45
OPERATOR: Sedgwick County	OPERATOR REPRESENTATIVE: Rick Furrow	TYPE OF OPERATION: 110c - Construction Limited Impact	
REASON FOR INSPECTION: Normal I&E Program	BOND CALCULATION TYPE: None	BOND AMOUNT: NA	
DATE OF COMPLAINT: NA	POST INSP. CONTACTS: None	JOINT INSP. AGENCY: None	
WEATHER: Clear	INSPECTOR'S SIGNATURE:

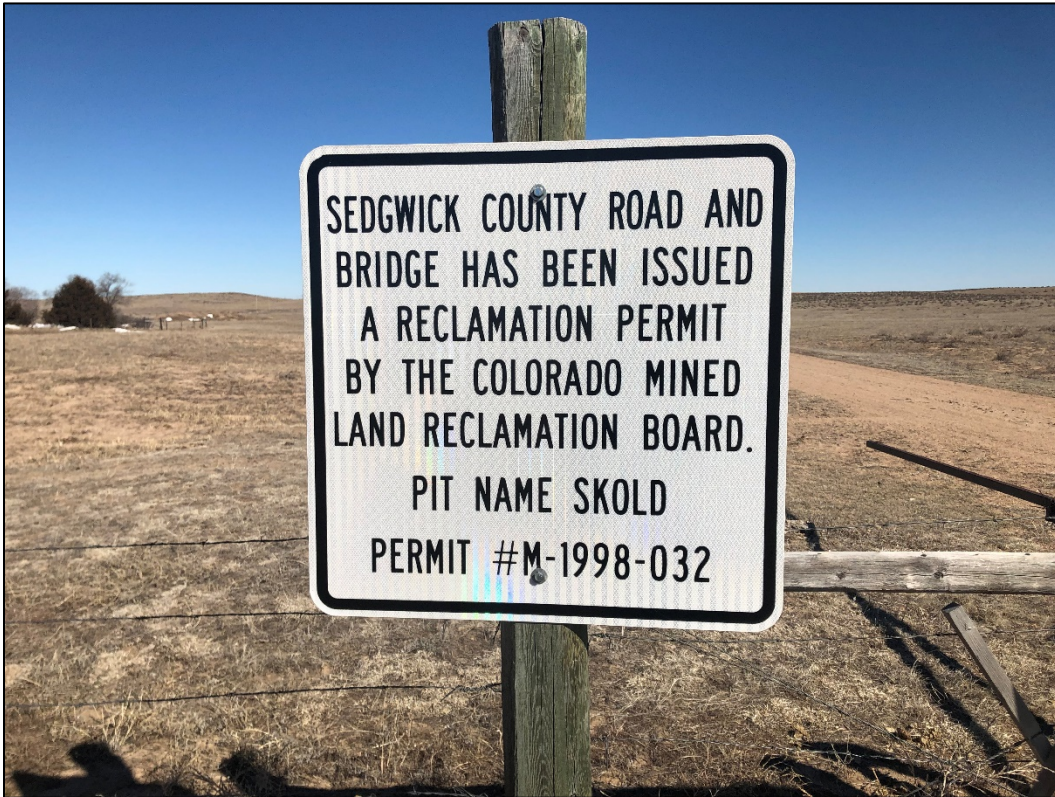
Signs and Markers: The permit sign was properly posted and boundary markers (concrete blocks) were observed to delineate the permit boundary.

Photo 1. Mine identification sign; looking north.

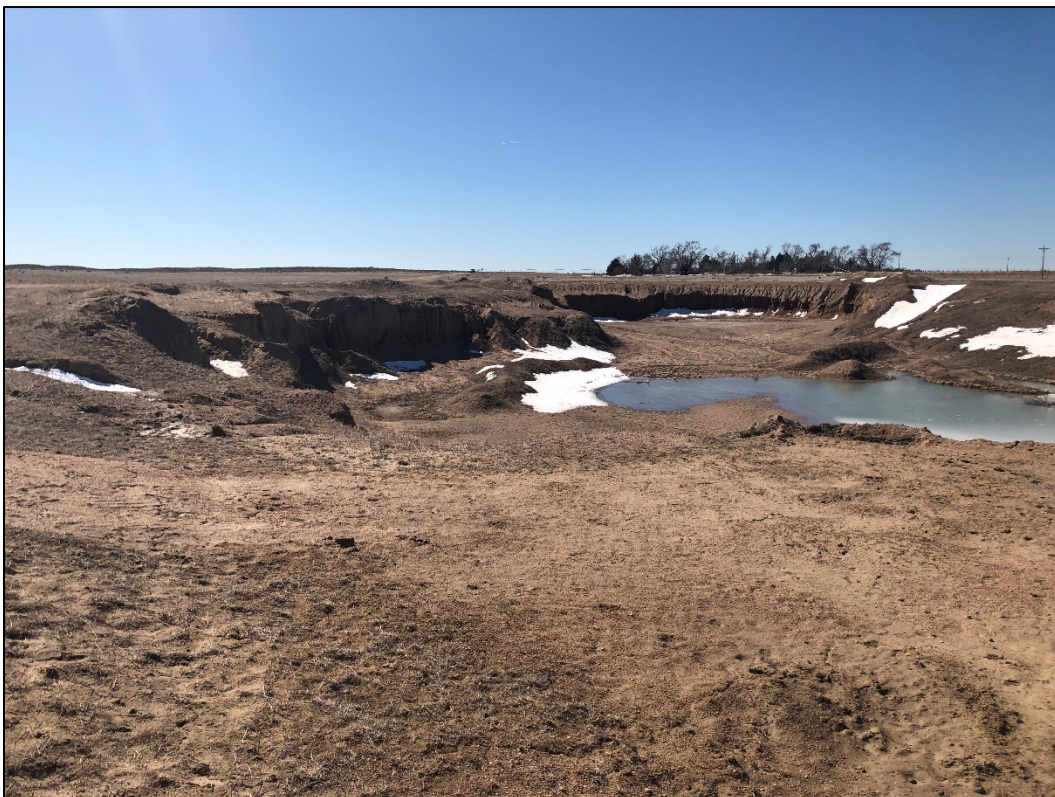
Photo 2. Pit overview; looking south.

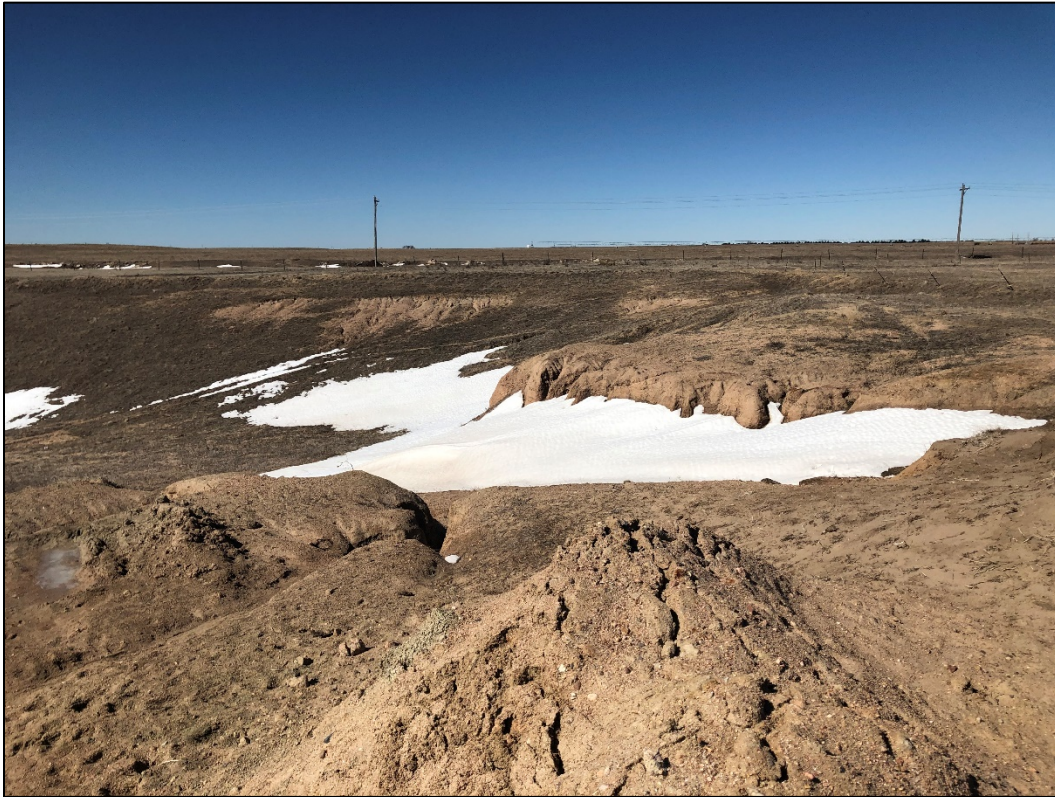
Photo 3. Northern area of the pit; looking west.

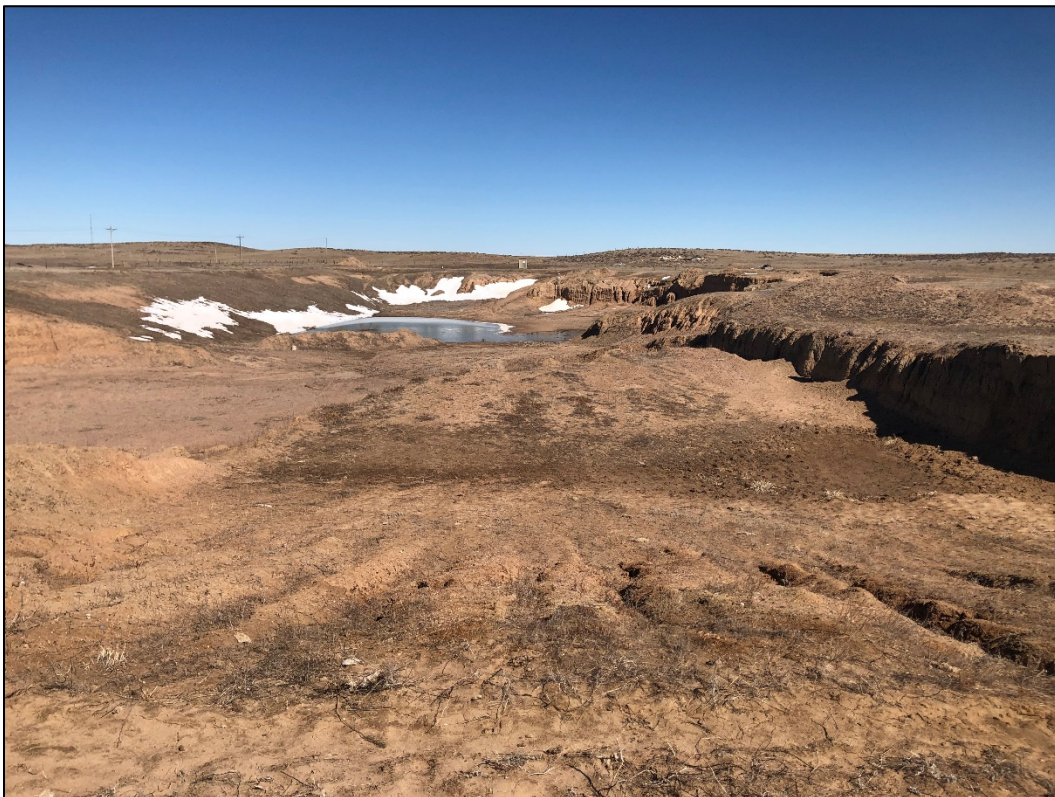
Photo 4. Pit overview; looking north.

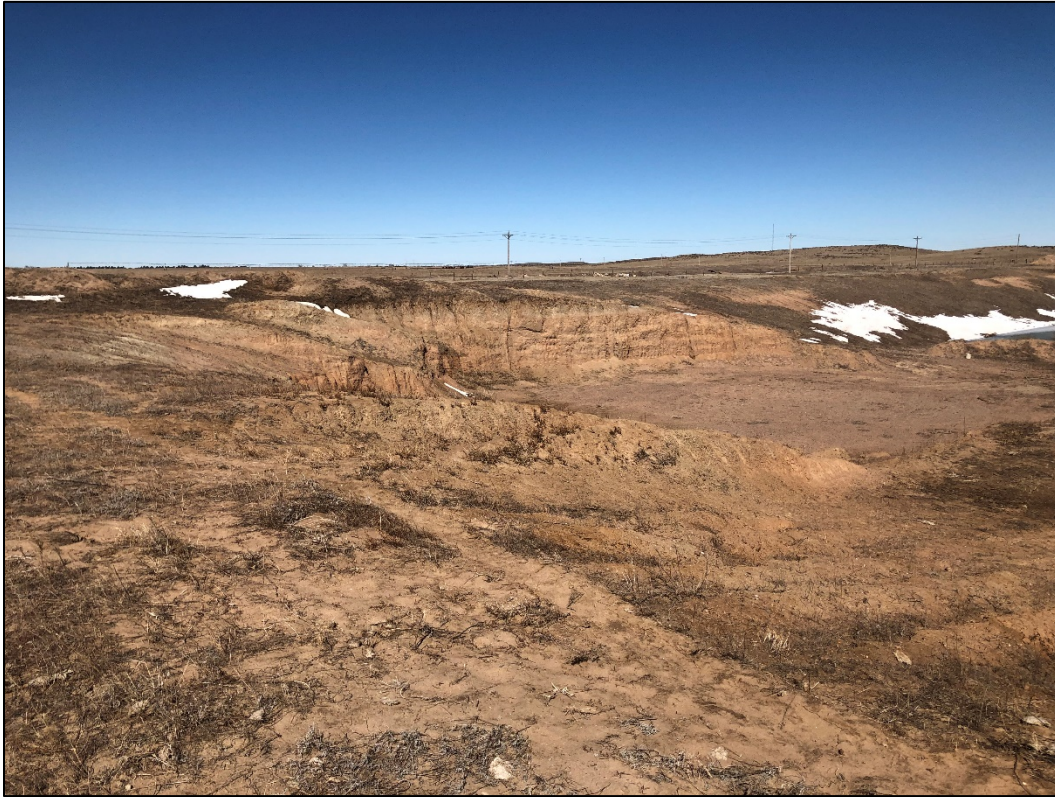
Photo 5. Southern area of the pit; looking west.
