MINERALS PROGRAM INSPECTION REPORT
PHONE: (303) 866-3567

MINE NAME: Larson Pit	MINE/PROSPECTING ID#: M-2007-012	MINERAL: Gravel, sand, clay	COUNTY: Phillips
INSPECTION TYPE: Monitoring	INSPECTOR(S): Elliott R. Russell	INSP. DATE: March 20, 2019	INSP. TIME: 09:45
OPERATOR: Gregory Larson	OPERATOR REPRESENTATIVE: None	TYPE OF OPERATION: 112c - Construction Regular Operation

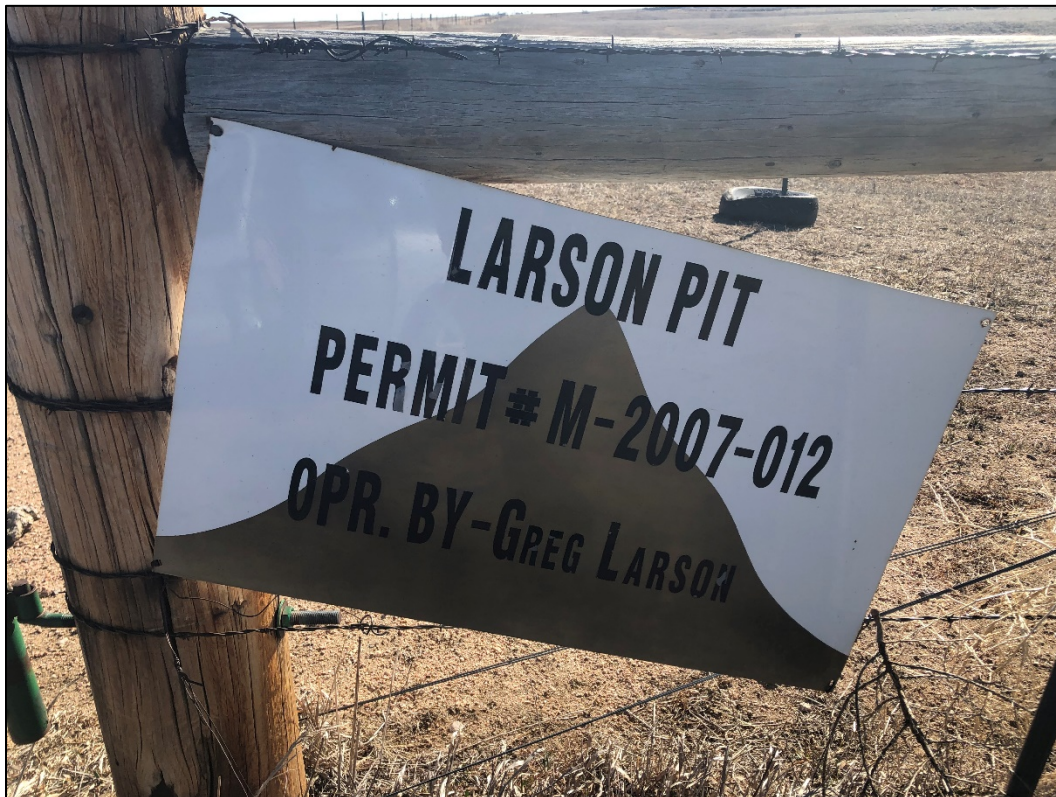
Signs and Markers: The permit sign was properly posted and boundary markers, delineating the permit boundary, were observed.

Photo 1. Mine identification sign; looking east.

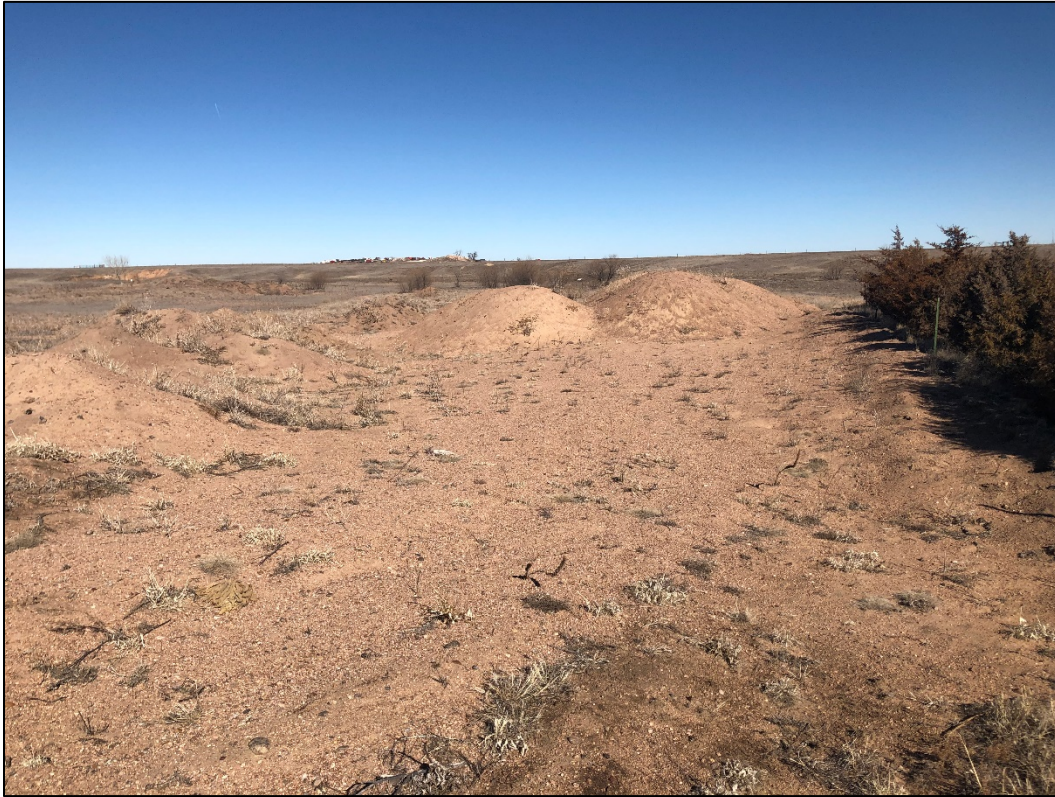
Photo 2. East portion of disturbance within Mining Area 2; looking northwest.

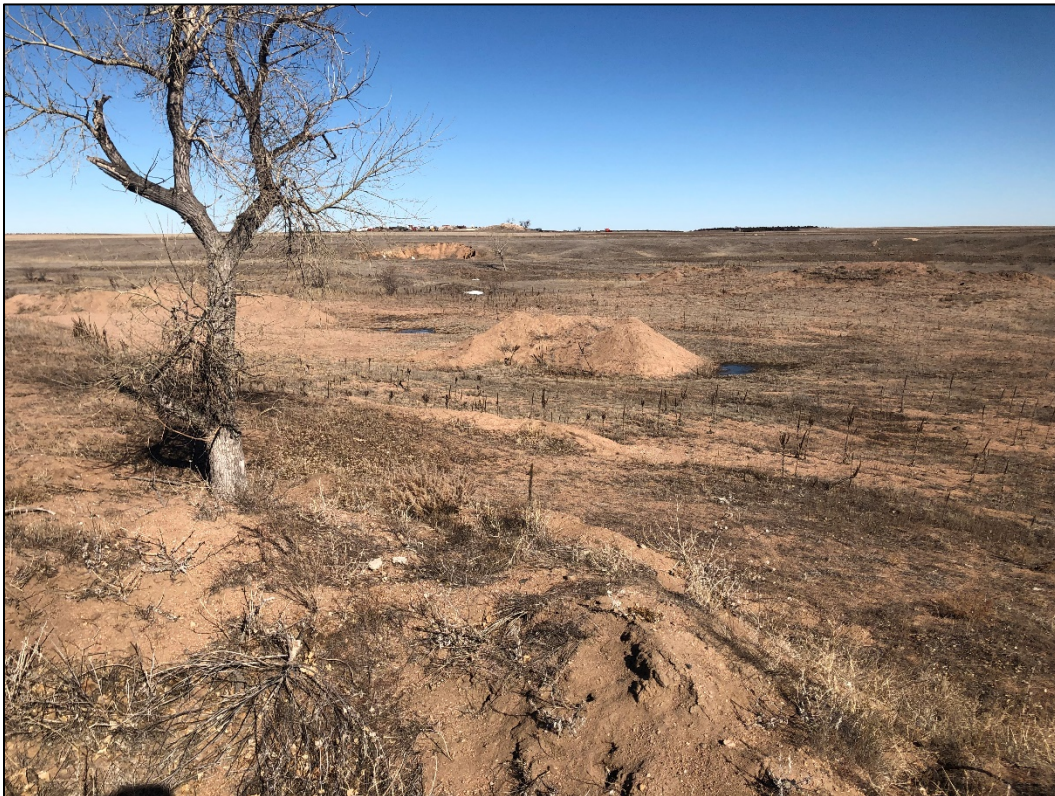
Photo 3. Southwest portion of disturbance within Mining Area 2; looking northwest.

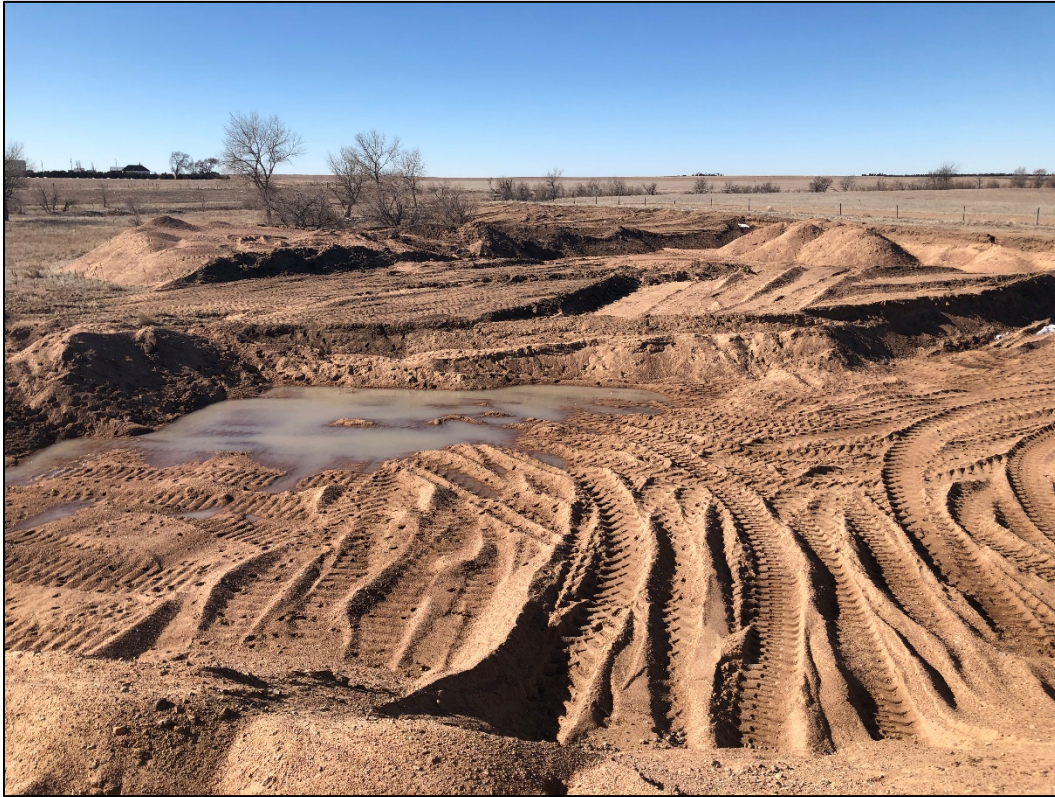
Gen. Compliance With Mine Plan: The operation has affected approximately 6 acres in Mining Area 2 and approximately 7 acres in Mining Area 1. Under the current Mine Plan and financial warranty held (\$28,889), the operation is currently approved to affect only Mining Area 2. As the operation has advanced into Mining Area 1, the operation is no longer in compliance with the approved Mine Plan and financial warranty. This has been cited as a compliance problem requiring corrective action. The Operator is reminded that he is required to contact the Division and post additional financial warranty prior to advancing the operation into an un-bonded phase.

Photo 4. South portion of disturbance within Mining Area 1; looking southwest.

CORRECTIVE ACTIONS: The operator shall submit a Technical Revision, with the required \$216 revision fee, to update and clarify the current approved mine plan to reflect existing and proposed activities by the corrective action date.

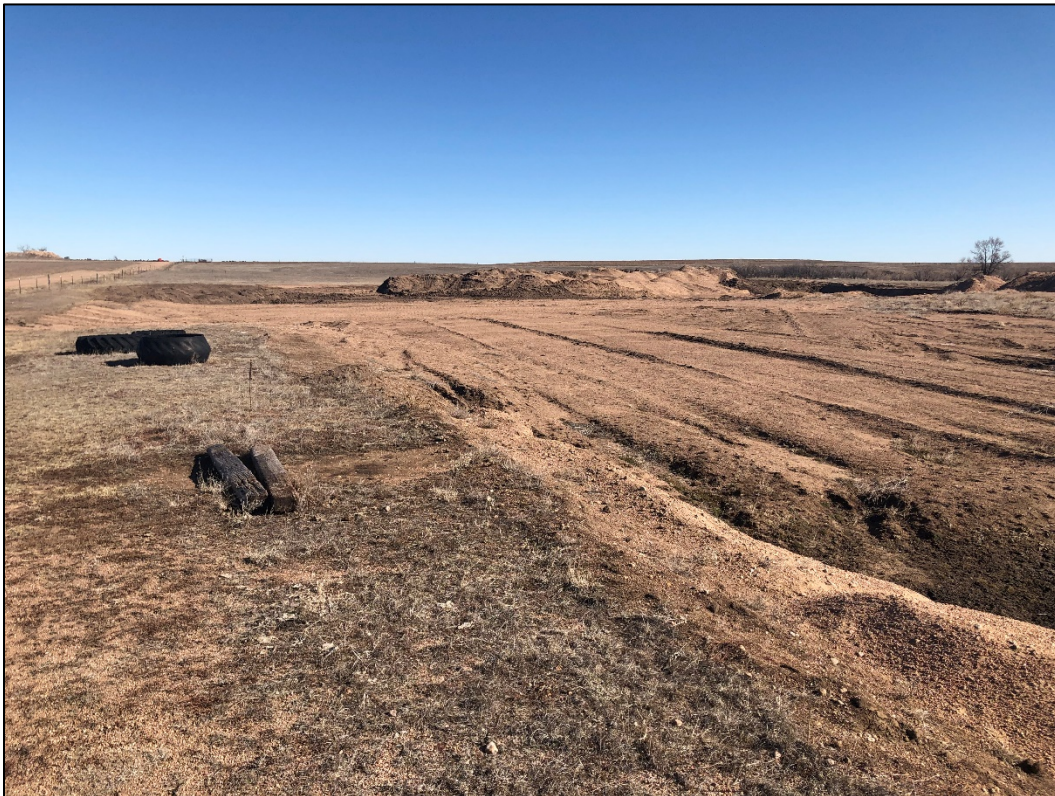
Photo 5. North portion of disturbance within Mining Area 1; looking north.

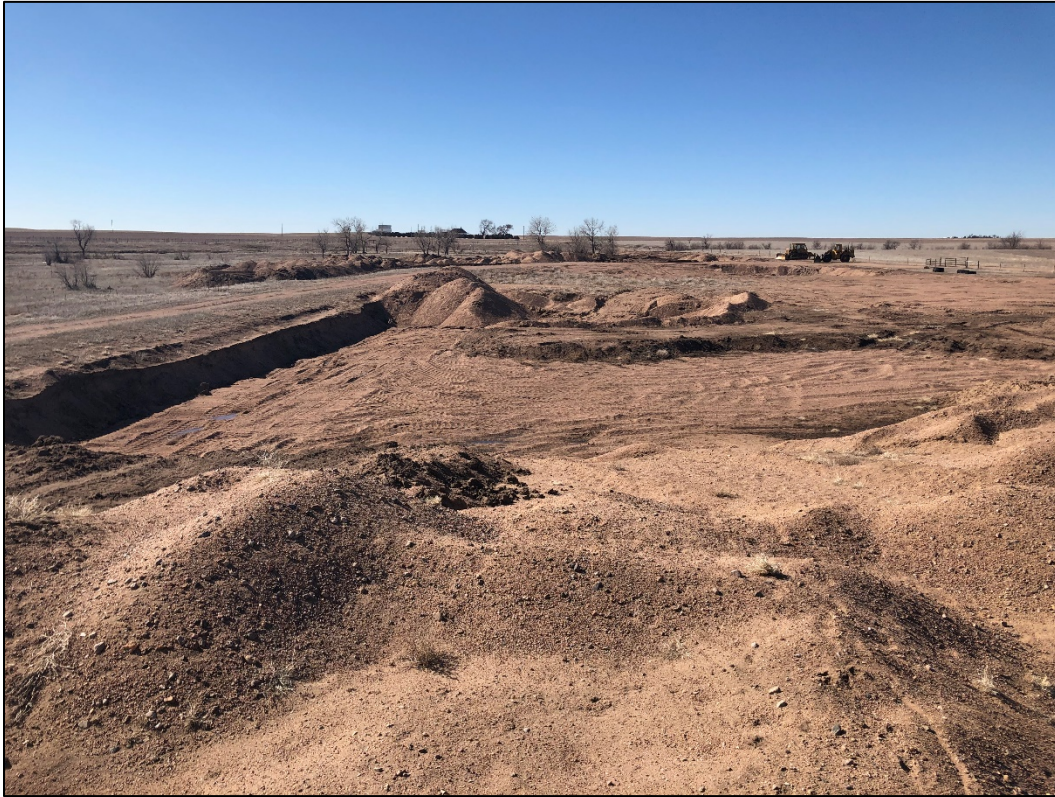
Photo 6. North portion of disturbance within Mining Area 1; looking south.
