MINERALS PROGRAM INSPECTION REPORT
PHONE: (303) 866-3567

MINE NAME: La Veta Town Gravel Pit	MINE/PROSPECTING ID#: M-2016-018	MINERAL: Sand and gravel	COUNTY: Huerfano
INSPECTION TYPE: Monitoring	INSPECTOR(S): Patrick Lennberg	INSP. DATE: March 28, 2019	INSP. TIME: 10:50
OPERATOR: Town of La Veta	OPERATOR REPRESENTATIVE: None	TYPE OF OPERATION: 110c - Construction Limited Impact	
REASON FOR INSPECTION: Normal I&E Program	BOND CALCULATION TYPE: None	BOND AMOUNT: \$0.00	
DATE OF COMPLAINT: NA	POST INSP. CONTACTS: None	JOINT INSP. AGENCY: None	
WEATHER: Clear	INSPECTOR'S SIGNATURE:

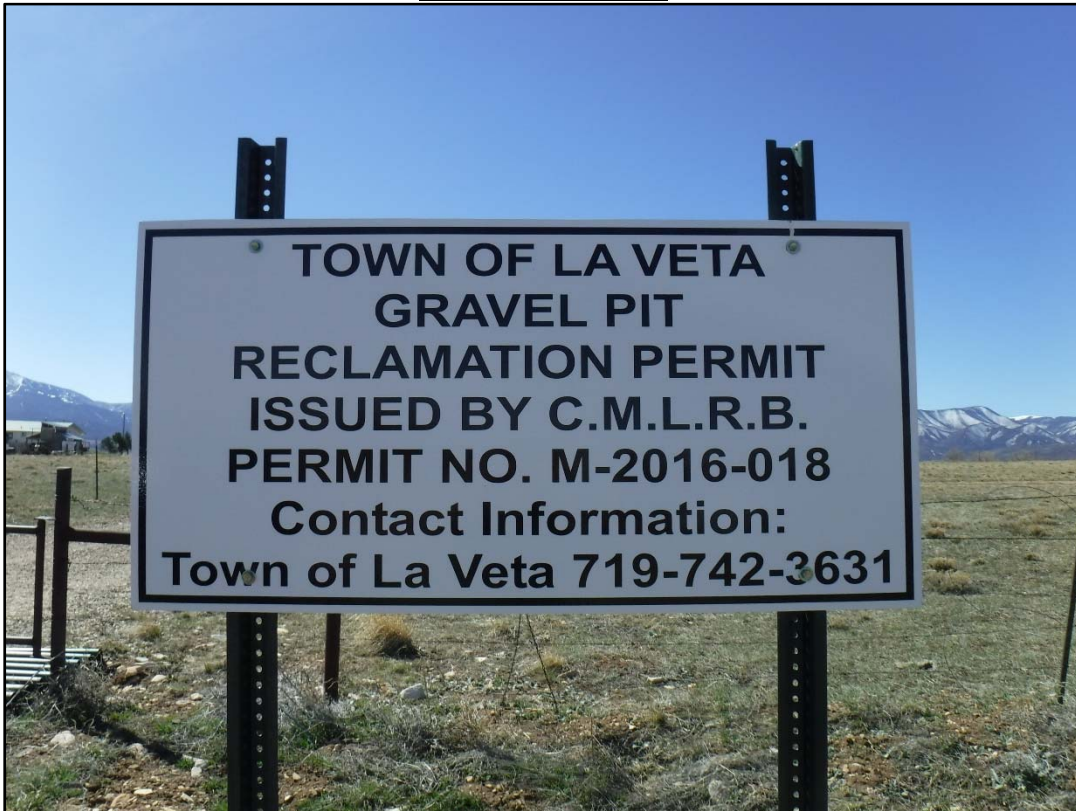
The La Veta Town Gravel Pit is located approximately 3.5 miles northwest of La Veta, Colorado just south of Highway 160 on County Road 451. The La Veta Town Gravel Pit is a 9.75 acre pit for the removal of sand and gravel for road maintenance and repair. The site is surrounded by rangeland and the post-mining land use is rangeland. A mine sign was observed as required by Rule 3.1.12.

Photo 1: Mine sign at entrance

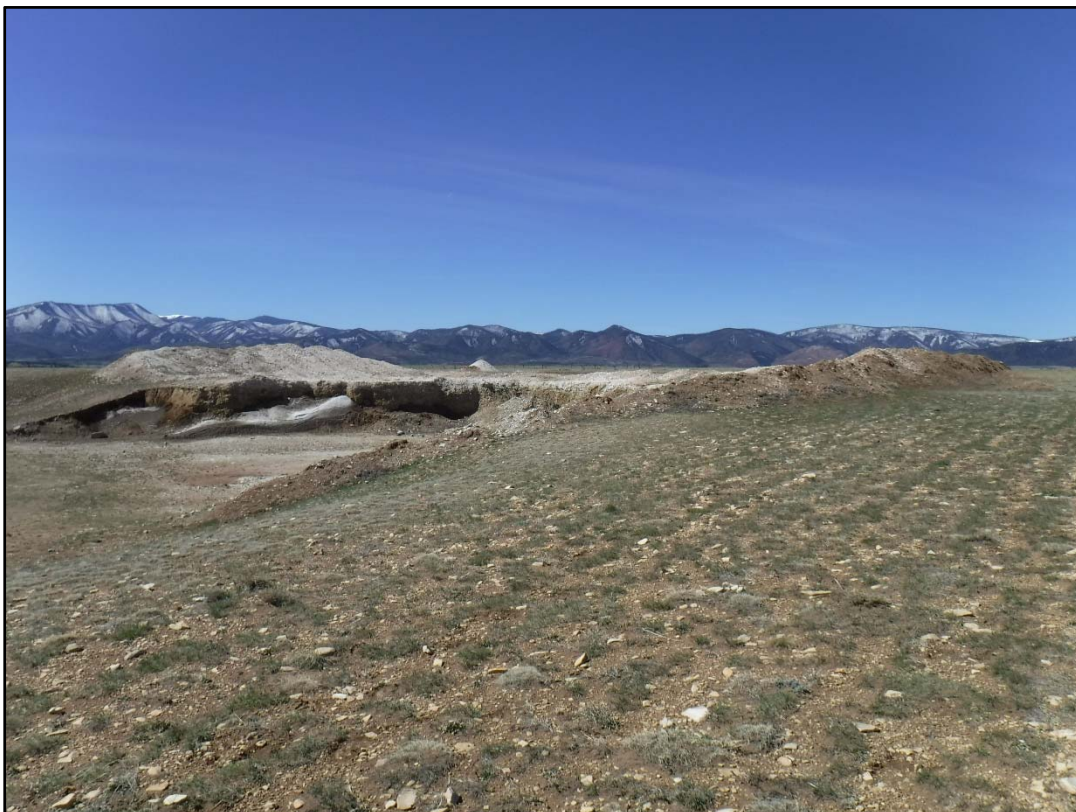
Photo 2: Pit area looking southwest

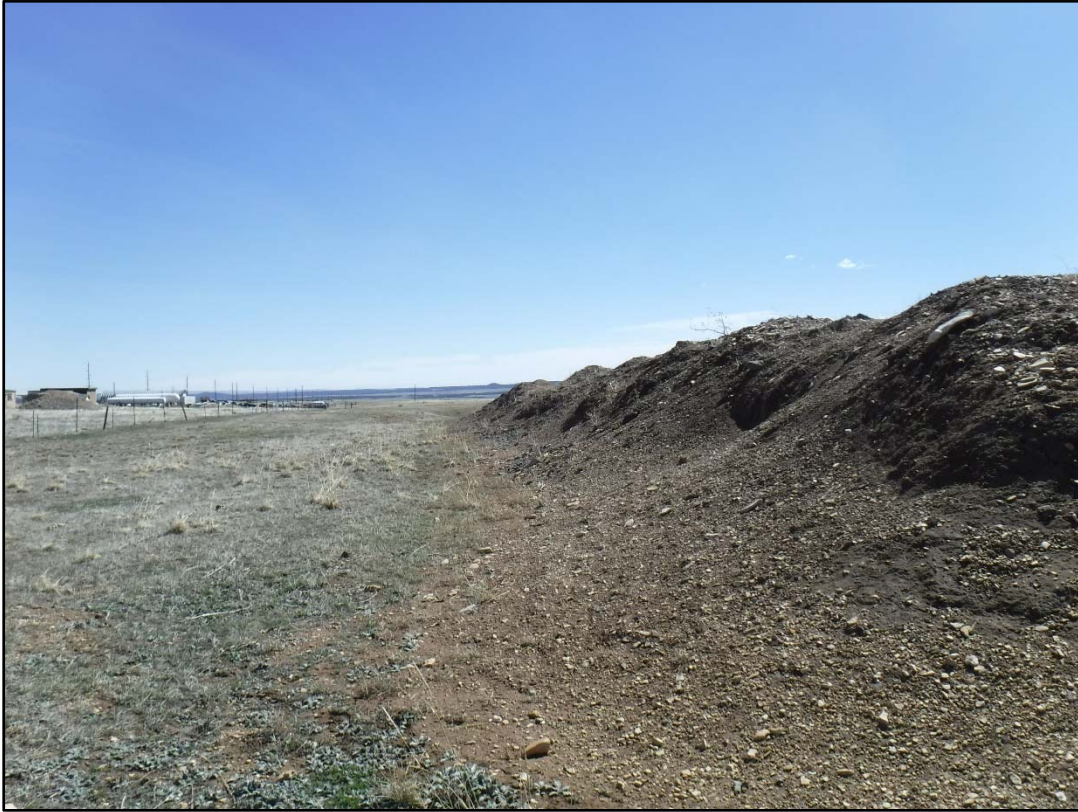
Photo 3: Topsoil stockpile along north edge of pit area

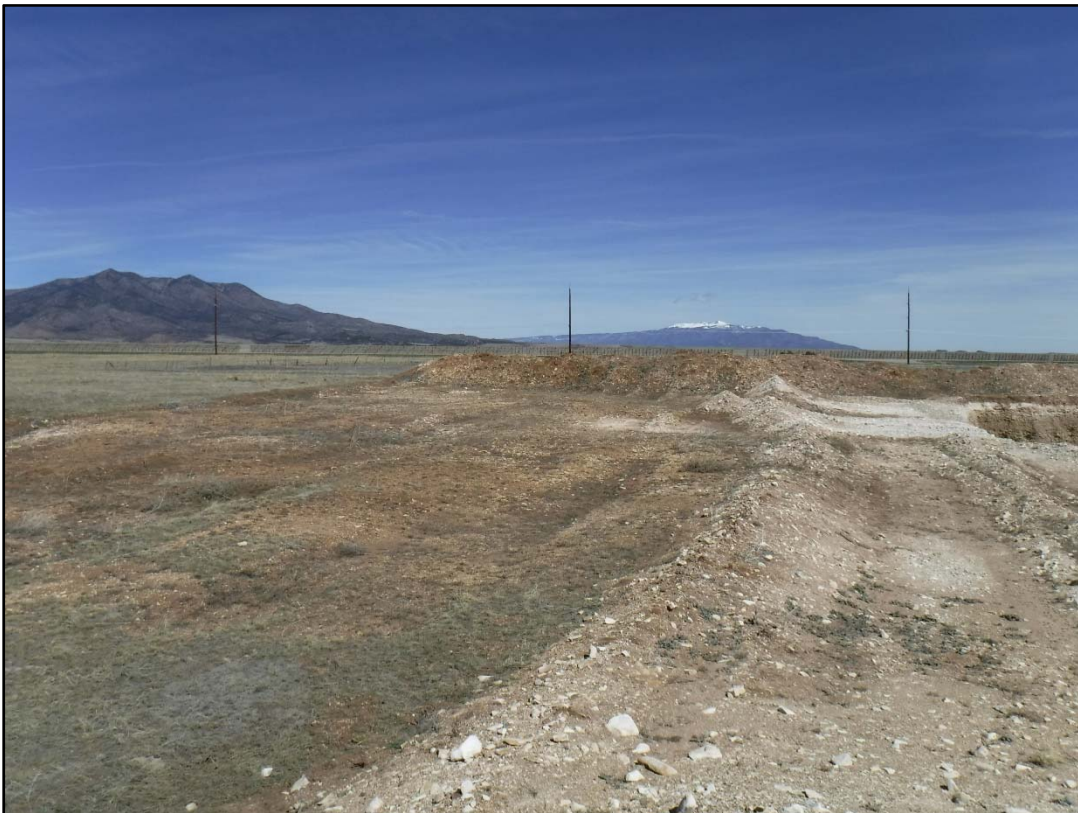
Photo 4: Area stripped of topsoil ahead of mining

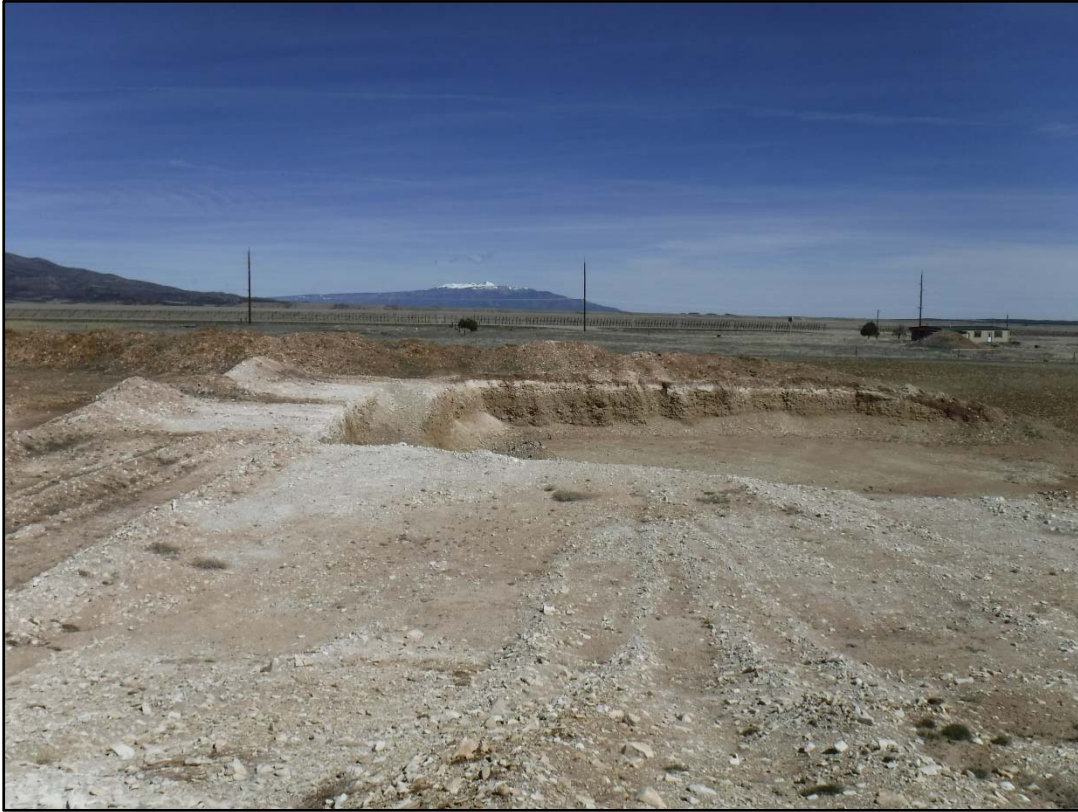
Photo 5: Pit area looking to the north

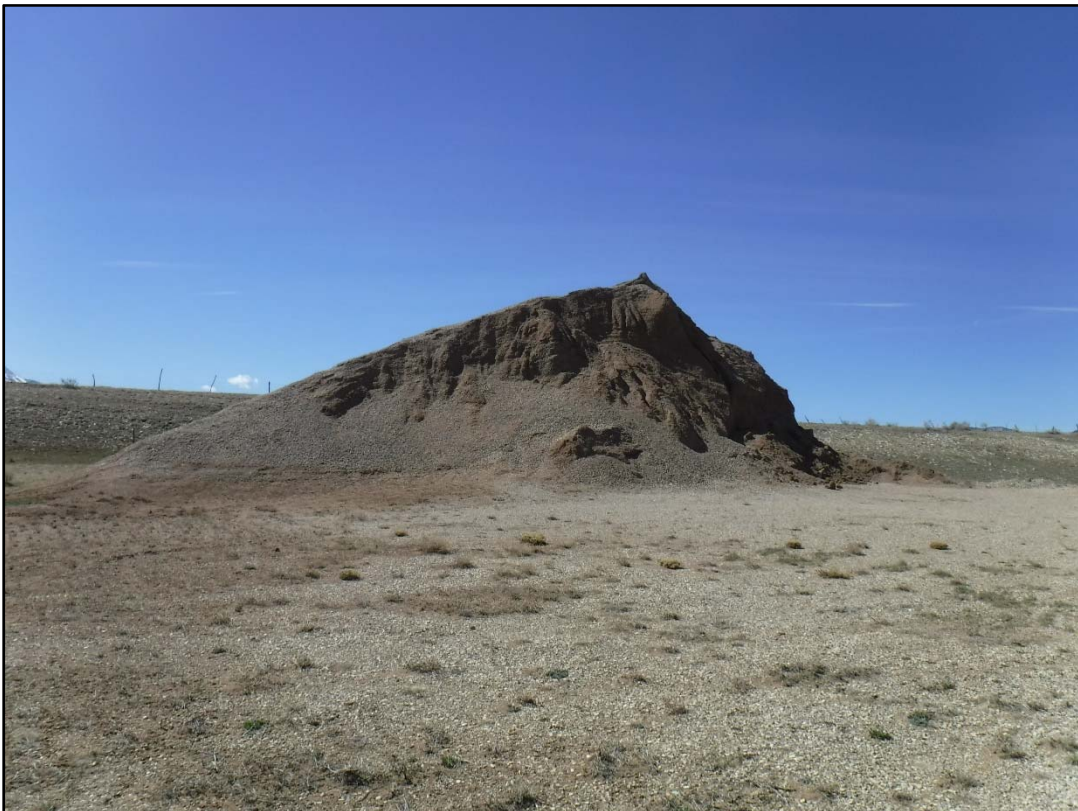
Current mining activity is progressing west from the former boundary of an old gravel pit. When the pit was first approved the Town of La Veta contracted with Colorado Crushing to produce road base material. This road base material was stockpiled in the southeastern portion of the permit area, where a stockpile of material still remains. Pit run material is being extracted from the current pit face. The pit was not active during the inspection. The property owner is storing some vehicles and parts in areas of the old pit outside the permit boundary. Topsoil stockpile are located at the perimeter of disturbed area and appears stable with some vegetation growing. When activity resumes at the site, the plan is to continue extraction moving to the west. The pit is about 15 to 20 feet deep. No groundwater was observed during the inspection.

Photo 6: Remaining road base material stockpile

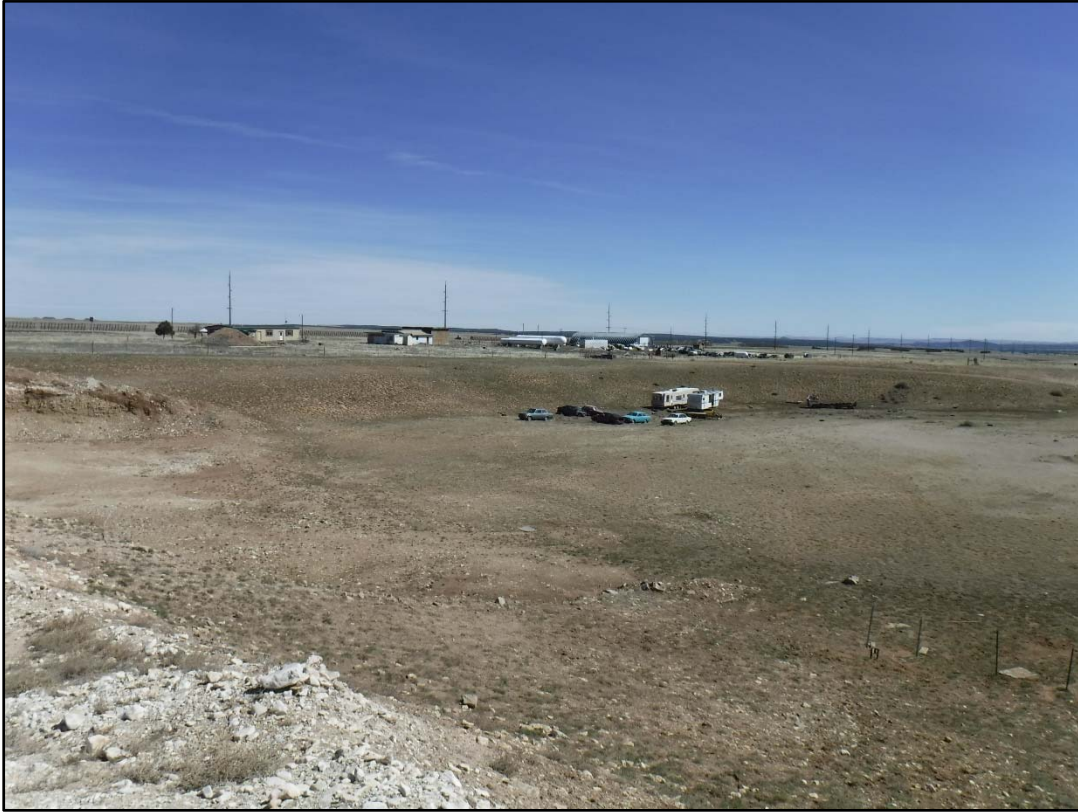
Photo 7: Vehicles stored on the permit boundary

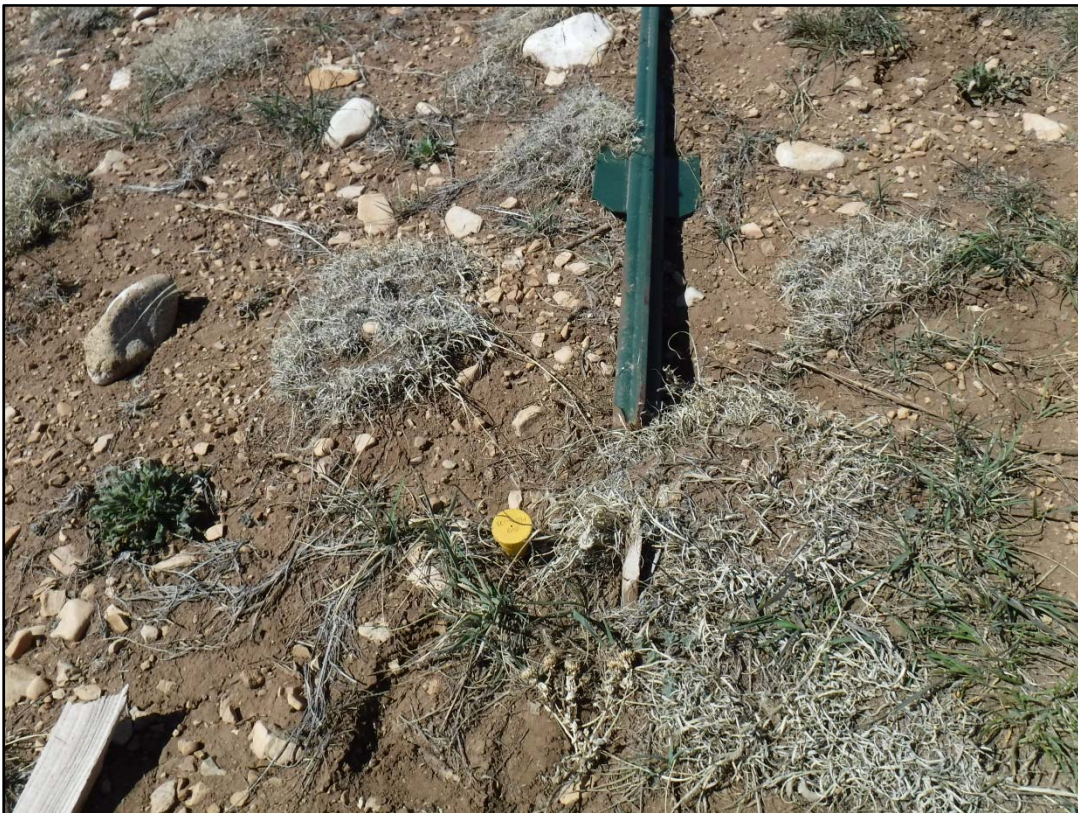
The Division was able to GPS all permit boundary markers. All current mining is within the permit boundaries.

Photo 8: Typical boundary marker
