MINERALS PROGRAM INSPECTION REPORT
PHONE: (303) 866-3567

MINE NAME: Gunnison River Gravel Pits	MINE/PROSPECTING ID#: M-2009-048	MINERAL: Sand and gravel	COUNTY: Mesa
INSPECTION TYPE: Surety-Related Inspection	INSPECTOR(S): Amy C. Yeldell	INSP. DATE: April 4, 2019	INSP. TIME: 10:00
OPERATOR: Whitewater Building Materials Corporation	OPERATOR REPRESENTATIVE: Mark Gardner	TYPE OF OPERATION: 112c - Construction Regular Operation	
REASON FOR INSPECTION: Priority	BOND CALCULATION TYPE: Partial Bond	BOND AMOUNT: \$88,767.00	
DATE OF COMPLAINT: NA	POST INSP. CONTACTS: None	JOINT INSP. AGENCY: None	
WEATHER: Clear	INSPECTOR'S SIGNATURE:

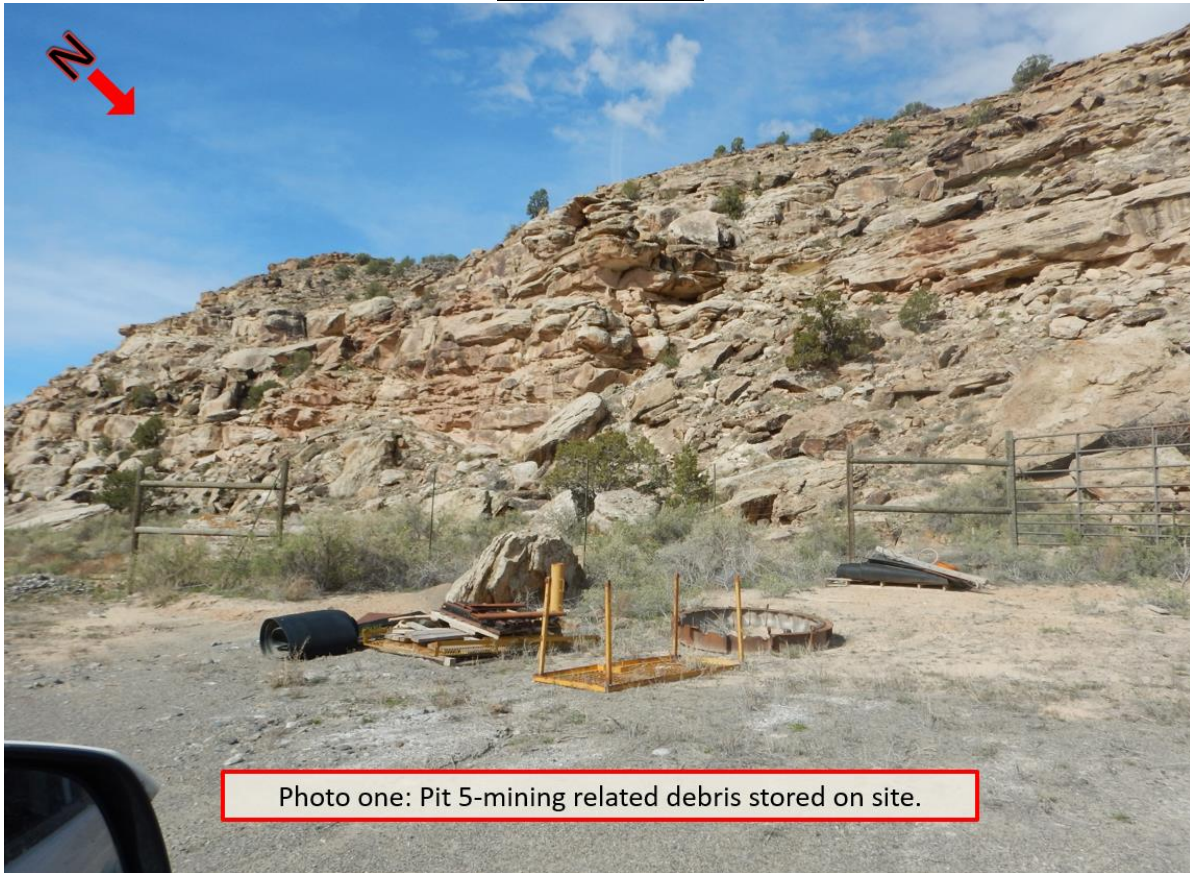
The site was inactive at the time of the inspection. The previous operator has removed their scale and house, Whitewater intends to bring in their own scale and house in near future. No other mining related equipment was on site. There was a small file of spare parts and miscellaneous metal near the mine road in Pit 5.

Photo one: Pit 5-mining related debris stored on site.

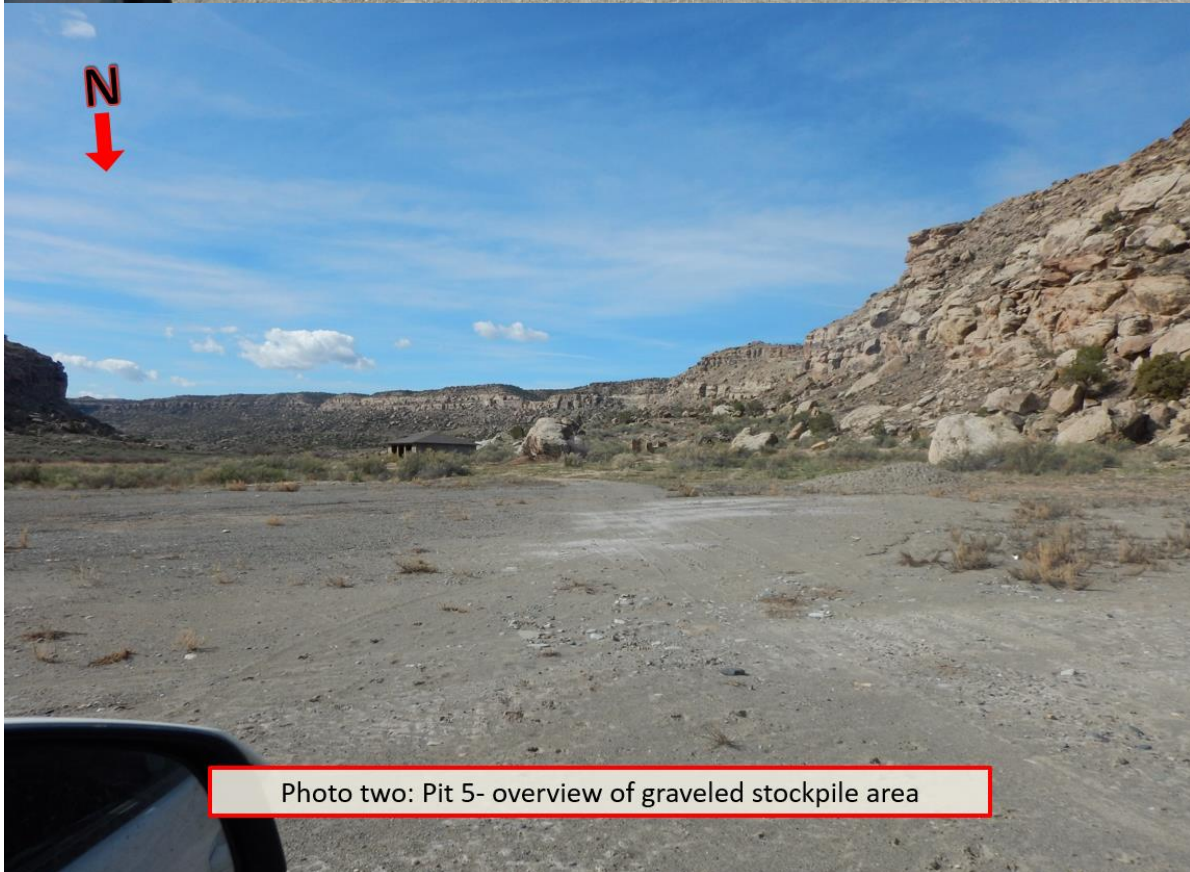
All previous mining took place in Pit 5 (photos one through four). Nearly the entire 10.5 ac phase has been affected and the current pond is approximate a half an acre. Prior to the previous operator leaving all active highwalls were reduced to a 3H:1V slope and topsoil was reapplied to those banks around the pond. The stockpile area remains a compacted gravel surface that if not mined out in the future would need to be ripped, topsoiled and revegetated.

Photo two: Pit 5- overview of graveled stockpile area

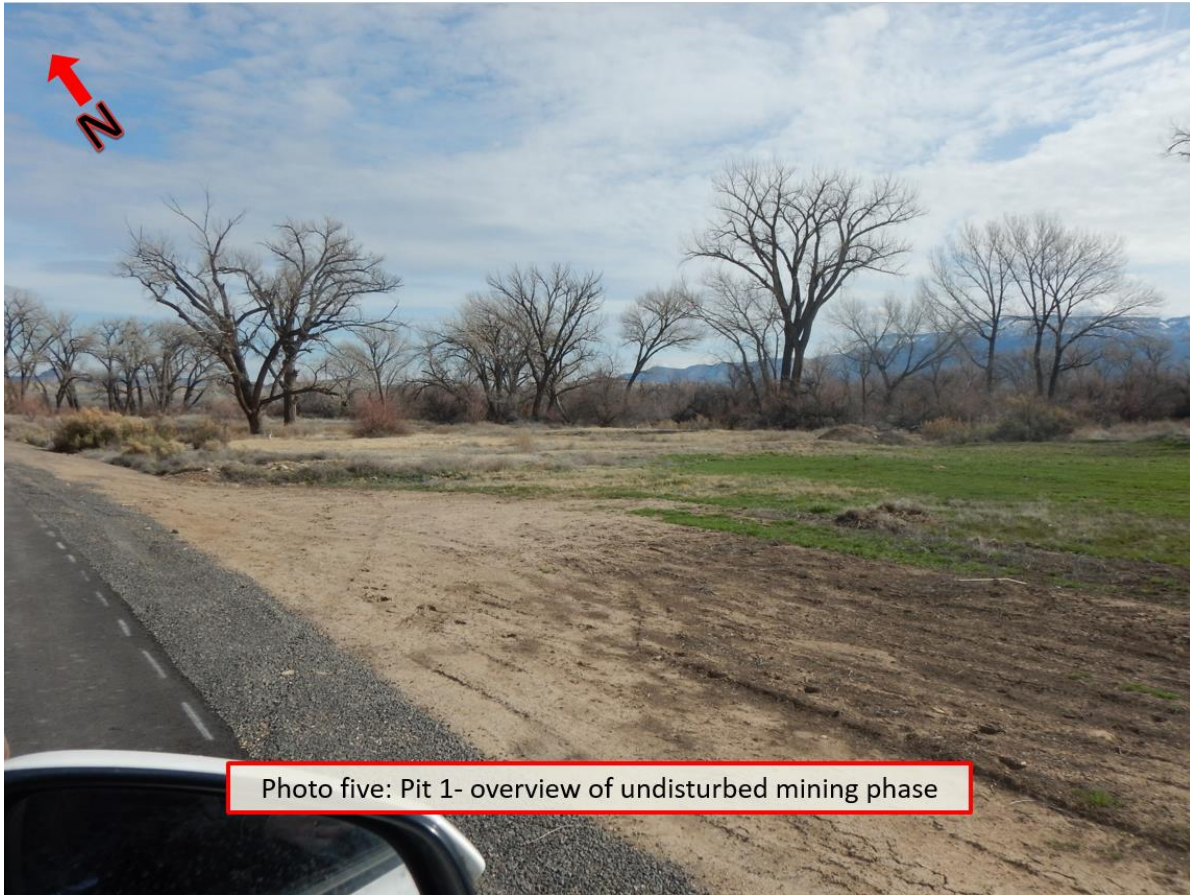
Pit 1 remains undisturbed (see photo five). In discussions with Mr. Gardner he has indicated that the landowner wishes for them to completely mine out Pit 1 prior to resuming mining activities in Pit 5.
