MINERALS PROGRAM INSPECTION REPORT
PHONE: (303) 866-3567

MINE NAME: Cresson Project	MINE/PROSPECTING ID#: M-1980-244	MINERAL: Gold	COUNTY: Teller
INSPECTION TYPE: Monitoring	INSPECTOR(S): Elliott R. Russell	INSP. DATE: February 14, 2019	INSP. TIME: 09:00
OPERATOR: Cripple Creek & Victor Gold Mining Company	OPERATOR REPRESENTATIVE: Justin Bills and Katie Blake	TYPE OF OPERATION: 112d-3 - Designated Mining Operation	
REASON FOR INSPECTION: Citizen Complaint	BOND CALCULATION TYPE: None	BOND AMOUNT: \$208,491,188.00	
DATE OF COMPLAINT: NA	POST INSP. CONTACTS: None	JOINT INSP. AGENCY: None	
WEATHER: Clear	INSPECTOR'S SIGNATURE:

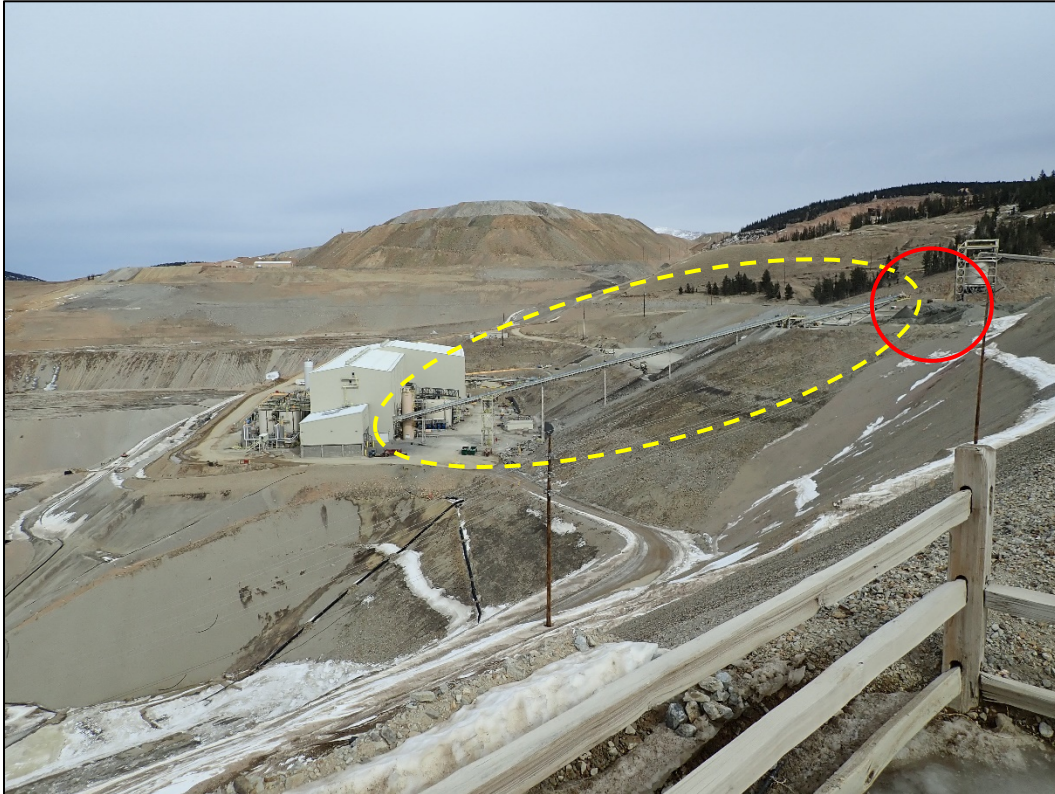
Photo 1. High Grade Mill, tailings conveyor (dashed yellow oval) and stockpile (red circle); looking northeast.

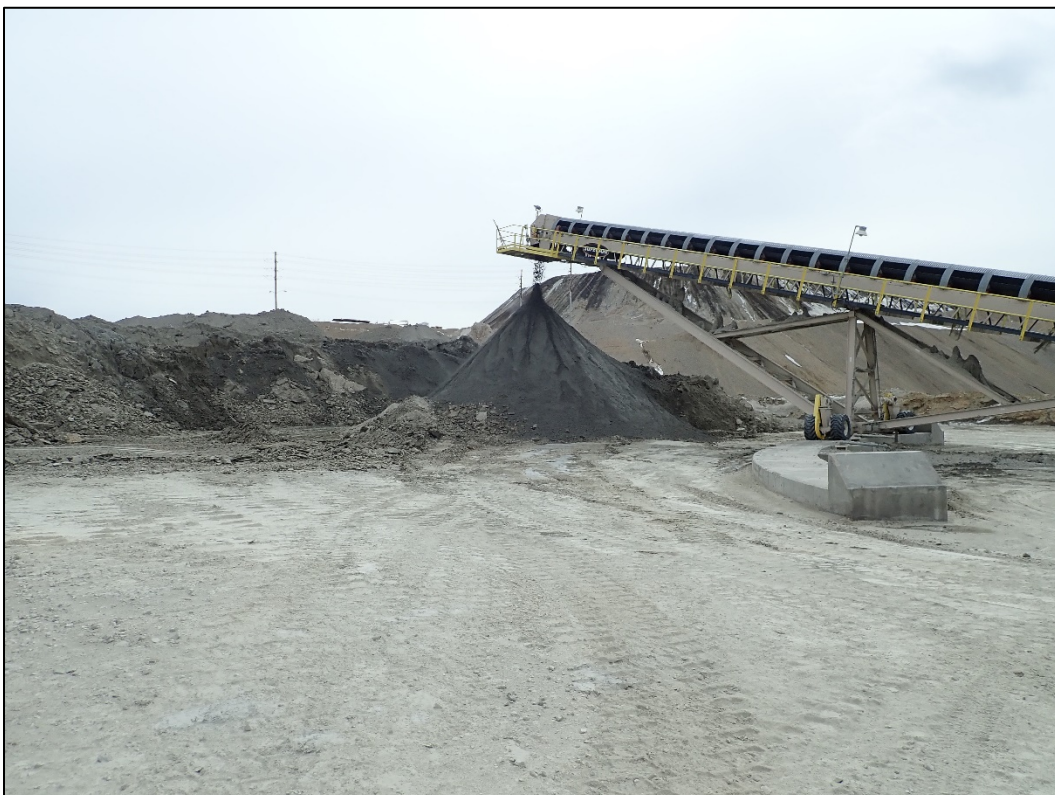
Photo 2. High Grade Mill tailings stockpile area; looking southwest.

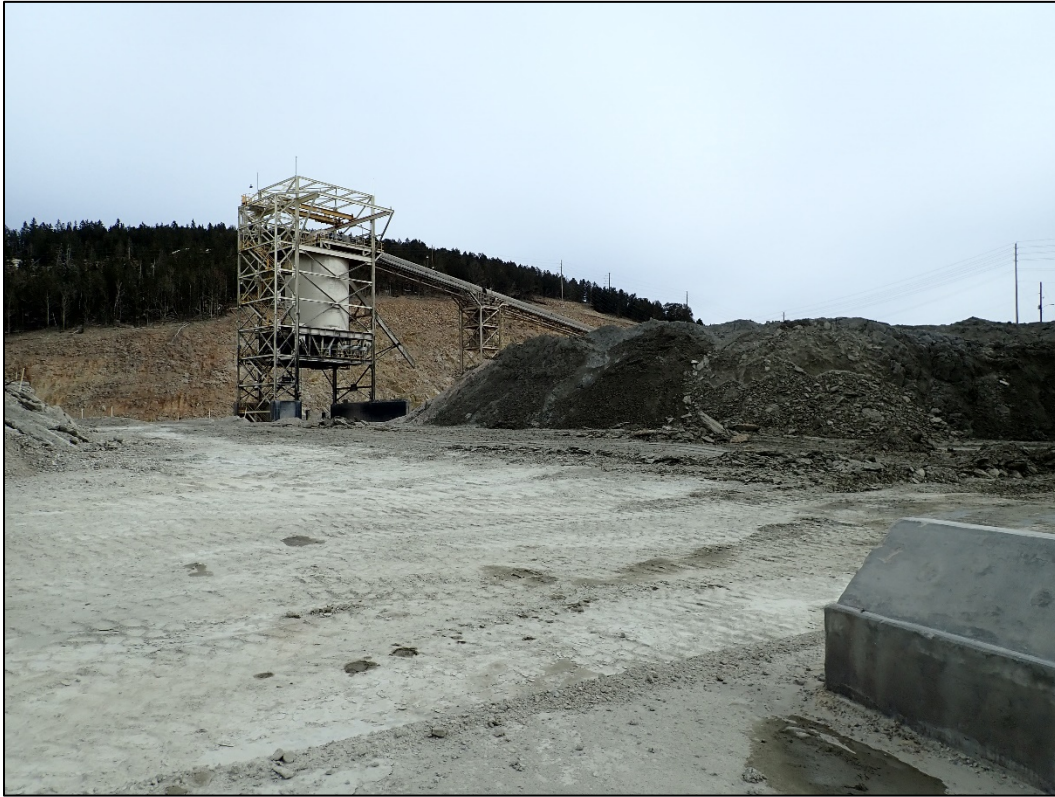
Photo 3. High Grade Mill tailings stockpile area and the crushed ore Load-Out-Bin; looking east.

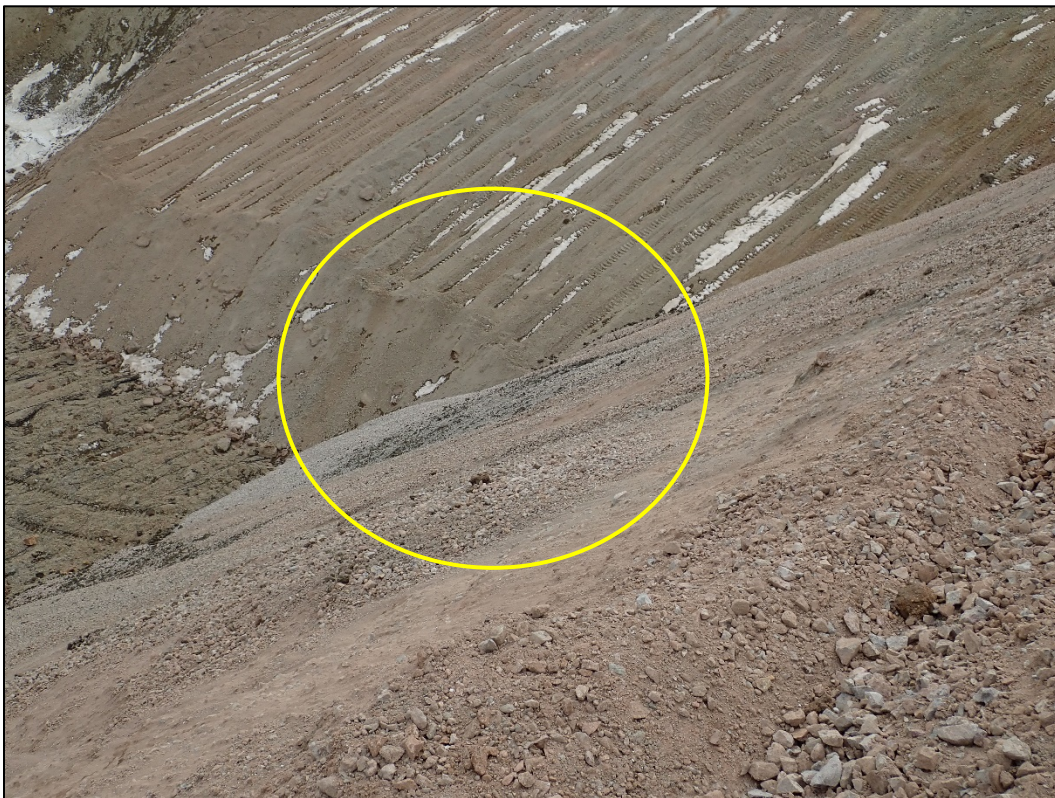
Although the High Grade Mill (HGM) tailings were not being transported and dumped on a lift within the Squaw Gulch Valley Leach Facility (SGVLF, a.k.a. VLF2) at the time of the inspection, the Division still inspected the HGM tailings process. From the HGM, tailings are transported uphill by conveyer belt and stockpiled near the Load-Out-Bin (LOB) by a radial stacker (**Photos 1-3**). The Operator has been transporting HGM tailings in a manner that helps reduce the chance of spilling the tailings out of the back of one of a 240 ton haul trucks. This method is referred to as "pancaking" where a haul truck gets loaded with approximately half capacity of crushed ore from the LOB, backs up to the HGM tailings stockpile where a front-end loader loads a couple of buckets of tailings, then goes back to the LOB to finish the load with crushed ore. Pancaking results in having the HGM tailings encapsulated within the crushed ore and helps to prevent spilling tailings while in transport to VLF2. Pancaking also assists with blending the HGM tailings with crushed ore on the dump face of a lift within VLF2 when dumping. The Division observed an internal face of the 9,850' lift where pancaked HGM tailing had been dump and blended on the slope (**Photo 4**).

The Permit requires the Operator to keep the overall ratio of the HGM tailings placed in VLF2 to a mixture of 10% tailings to 90% ore due to geotechnical concerns. This ratio is for the entire valley leach facility and not just each haul truck. The Operator confirmed that on occasion, when the HGM tailings stockpile is at full capacity and the LOB is shut down for maintenance, tailings are transported without crushed ore to a staging stockpile located near the active dump face. Once crushed ore is being hauled again to the VLF, a bulldozer helps blend the staged HGM tailings with each truck load of dumped ore onto the lift face. The Division has observed in the past and is aware of this occasional activity.

Photo 4. Dumped High Grade Mill tailings (yellow circle) and crushed ore on an internal face of the 9,850' lift; looking south.

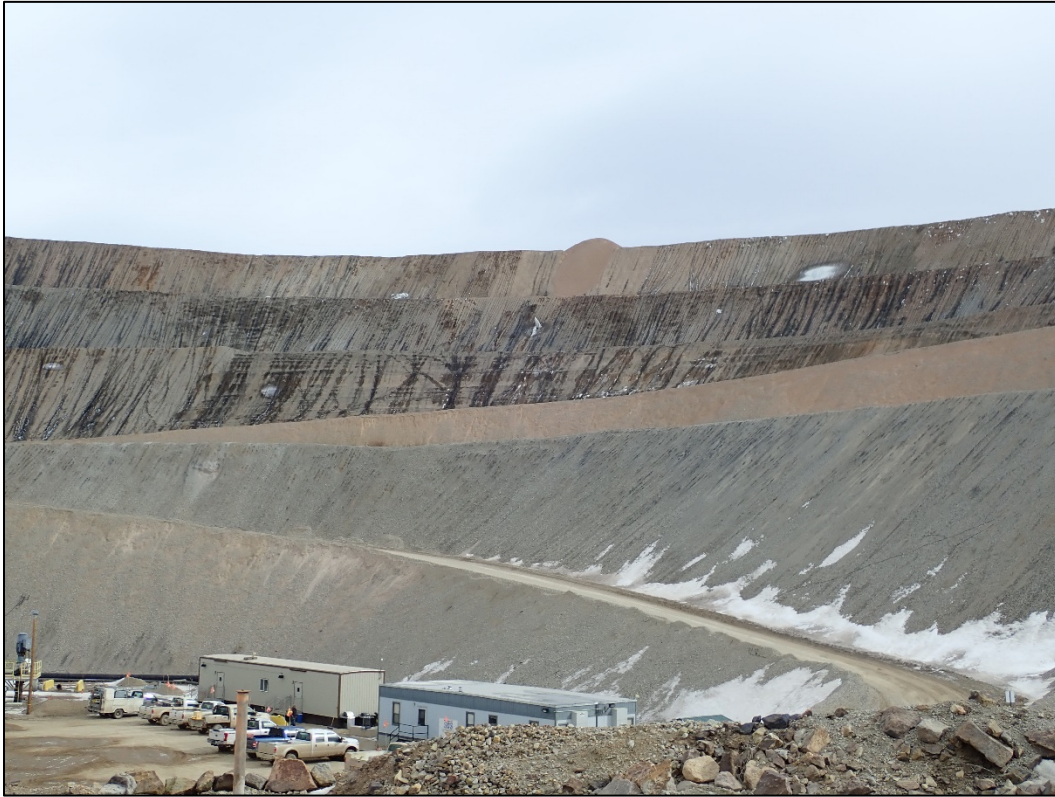
The Permit requires the Operator to not dump HGM tailings within 25 feet of the final outside face of a valley leach facility (VLF) due to geotechnical concerns and final reclamation slope grading. The Permit does not limit the Operator from placing tailings on the active dump face while creating and advancing a lift. The Division observed the final outside slopes beneath the current active lift and didn't find any evidence of HGM tailings at the surface (**Photo 5**). The Operator confirmed that they have been following the commitment to not placing HGM tailings within 25 feet of the final outside face of the VLF.

Photo 5. Final outside face of VLF2; looking northeast.

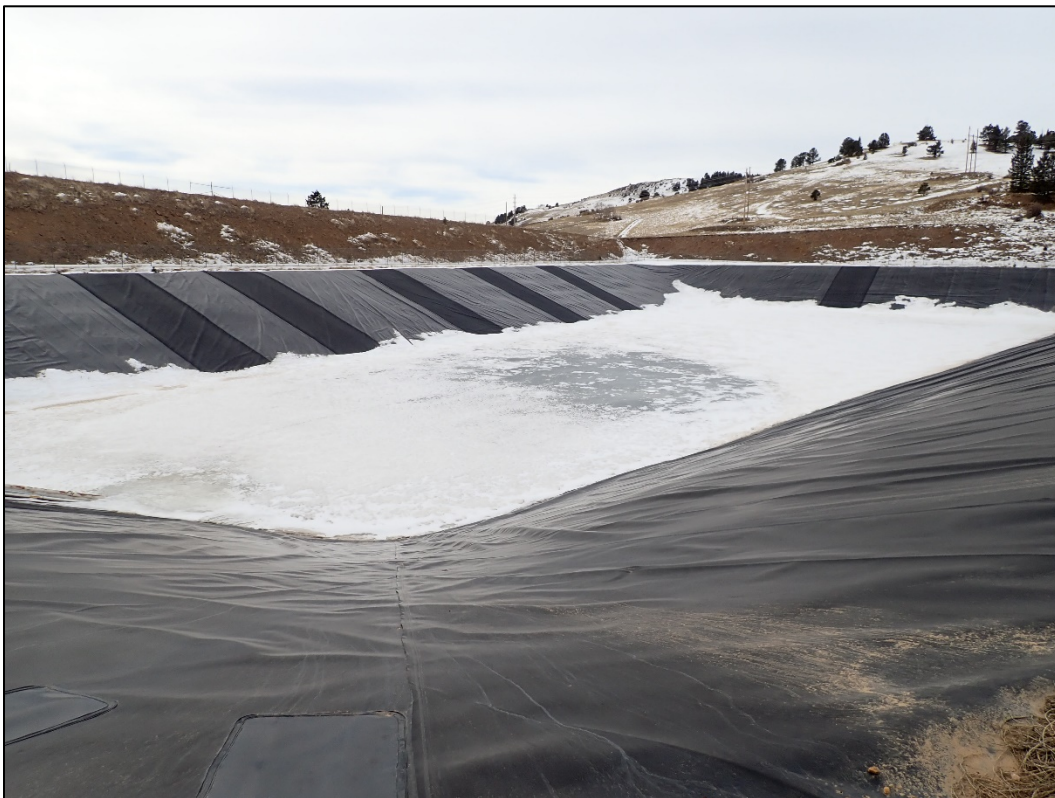
The Division inspected various portions of VLF1 while inspecting the High Volume Solution Collection Systems (HVSCS) and Low Volume Solution Collection Systems (LVSCS) of the four VLF1 phases (Phase I, Phase II/III, Phase IV, and Phase V), and Leak Detection Systems (LDS) of VLF1. No ponded solution was observed while inspecting VLF1. The Division also observed the External Storage Pond (ESP) which contained several feet of frozen precipitation (**Photo 6**). The Low Volume Solution Collection of the ESP was within normal operating levels.

Photo 6. External Storage Pond; looking southwest.

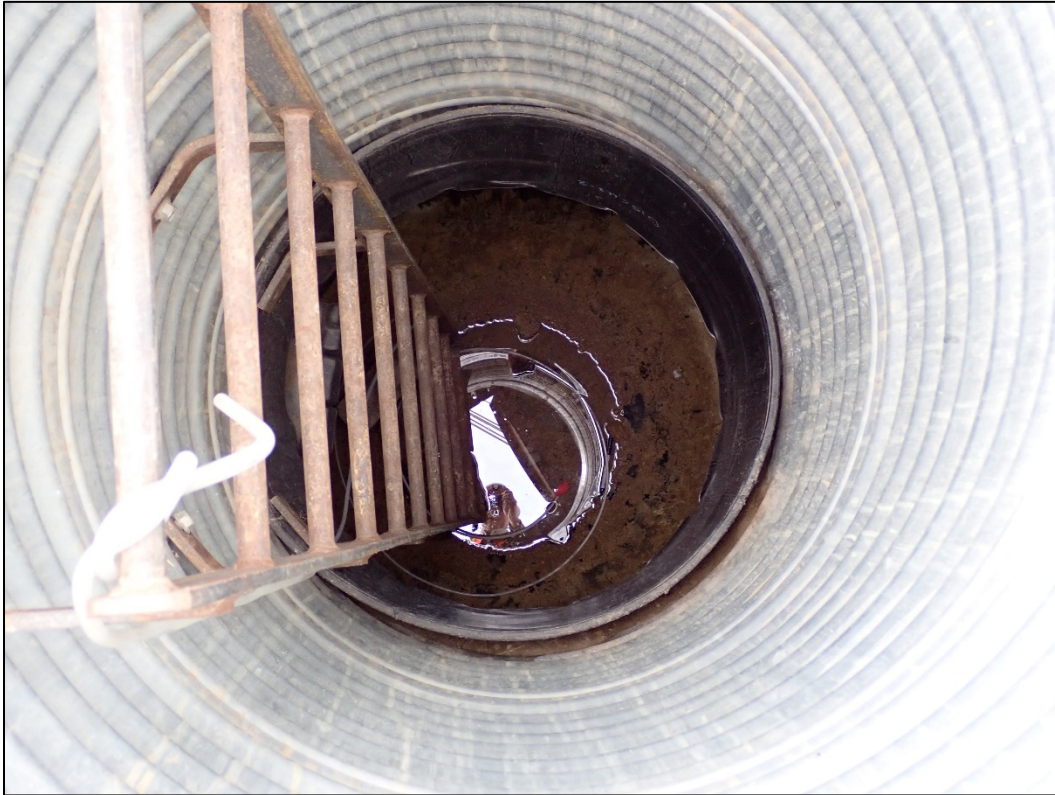
All of VLF1 LDS sumps were inspected and were dry except LDS-6, which contained a small amount of water (**Photo 7**). The Operator stated this LDS was sampled on November 28, 2018. The Division expressed concerns that LDS-6 was not completely pumped out after the November sampling event in order for the Operator to determine each week if the water in the sump was new and needed to be sampled again. The Operator stated that their sampling pump could not completely remove all of the water from the sumps, however stated they would work on a solution, such as using an absorbent blanket or placing a small removable bucket beneath the sump inlet, to remove the small amounts of water remaining after a sample is taken.

Photo 7. VLF1 LDS-6; looking down.

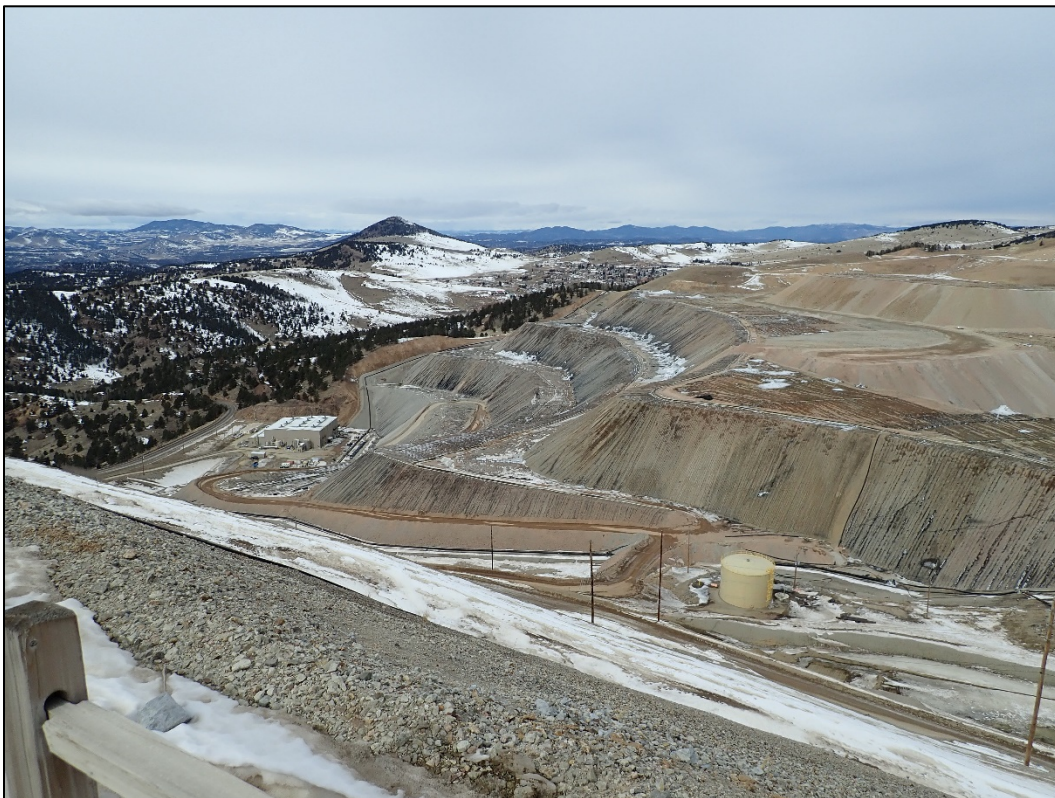
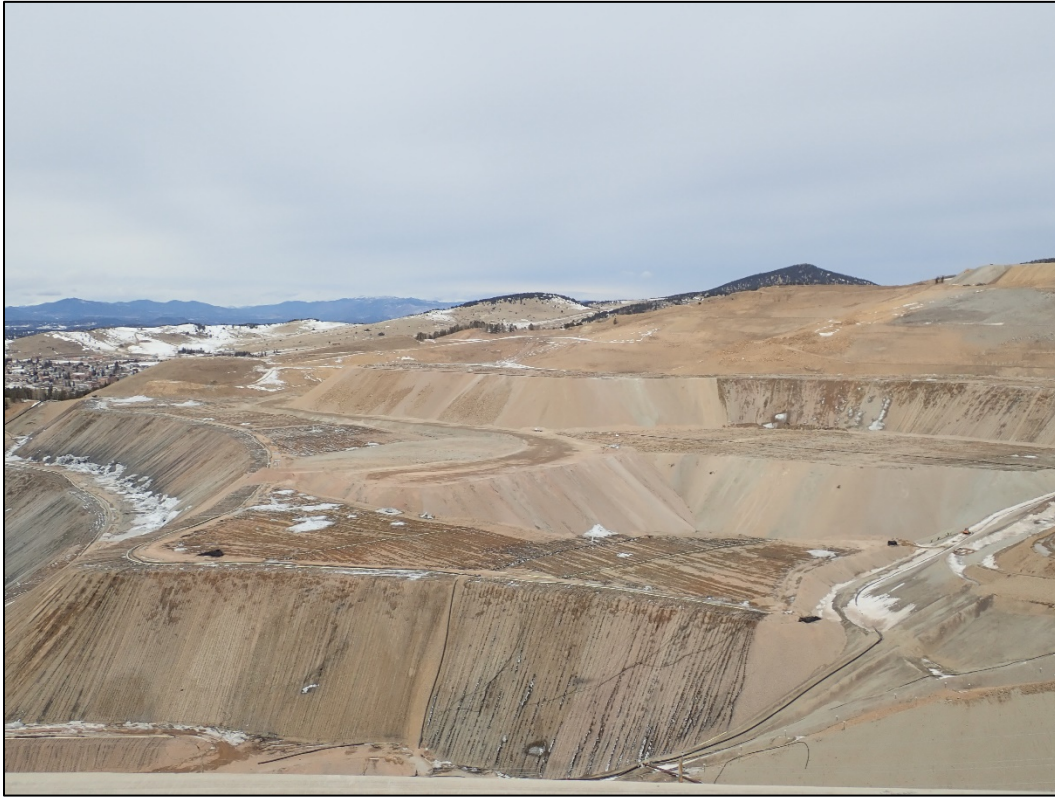
The Division observed VLF2 from a lookout point on the north side of VLF1 (**Photos 8 and 9**). The Division also inspected various portions of VLF2 while inspecting the High Volume Solution Collection System (HVSCS), Low Volume Solution Collection System (LVSCS), Leak Detection Systems (LDS), and the Underdrain of VLF2. No ponded solution was observed while inspecting VLF2.

Photo 8. Overview of VLF2; looking northwest.

Photo 9. Overview of VLF2; looking north.

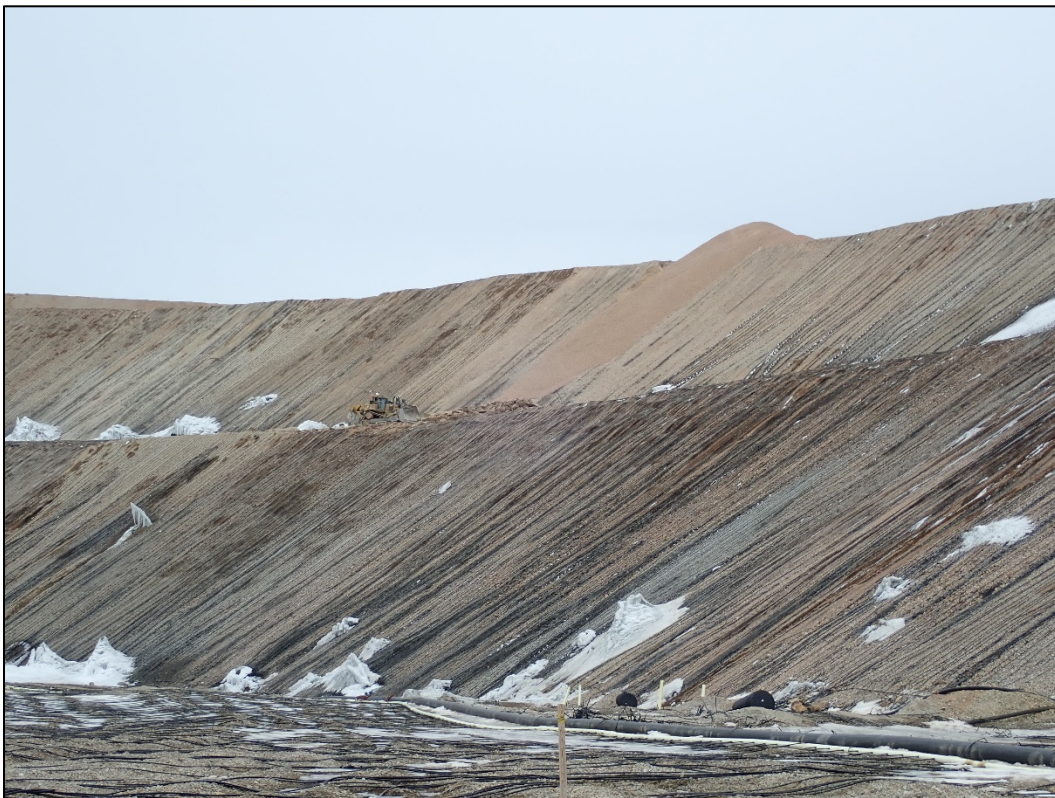
The washout located on the crest of the final outside slope of the 9,850' lift, previously observed during the December 20, 2018 DRMS inspection, was actively being backfilled during this inspection (**Photo 10**).

Photo 10. VLF2 9,850' lift washout being repaired; looking north.

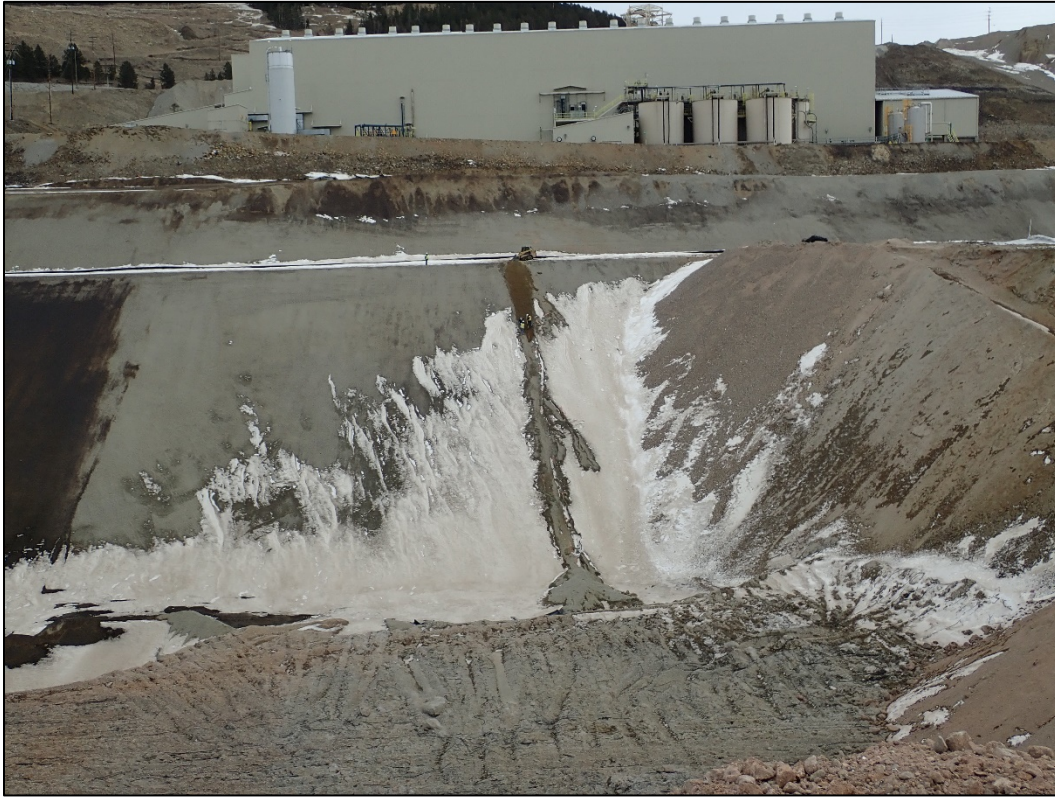
The Division also observed an area where a small washout displaced Drain Cover Fill (DCF) southwest of the 2018 liner repair area (**Photo 11**). A Newfields QA/QC personnel was observing the replacement of DCF to ensure the repair work was being done in accordance with the permit.

Photo 11. VLF2 Drain Cover Fill being repaired; looking southeast.
