**COLORADO**Division of Reclamation,  
Mining and Safety

**MINERALS PROGRAM INSPECTION REPORT****PHONE: (303) 866-3567**

<b>MINE NAME:</b> Schwartzwalder Mine	<b>MINE/PROSPECTING ID#:</b> M-1977-300	<b>MINERAL:</b> Uranium	<b>COUNTY:</b> Jefferson
<b>INSPECTION TYPE:</b> Monitoring	<b>INSPECTOR(S):</b> Amy Eschberger, Michael Cunningham	<b>INSP. DATE:</b> March 22, 2019	<b>INSP. TIME:</b> 10:00
<b>OPERATOR:</b> Colorado Legacy Land, LLC	<b>OPERATOR REPRESENTATIVE:</b> Paul Newman, Cliff Yeckes, Liz Busby	<b>TYPE OF OPERATION:</b> 112d-2 - Designated Mining Operation

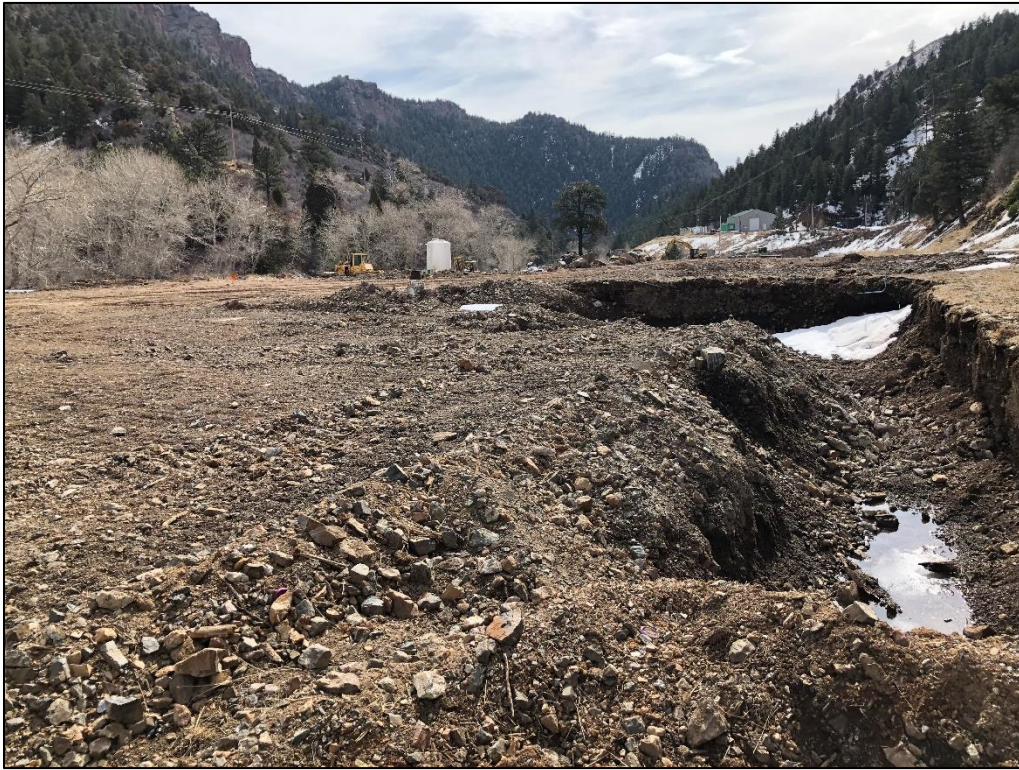
**Photo 1.** View looking southeast across the contaminated alluvial fill material on the canyon floor that is being extracted for reclamation.

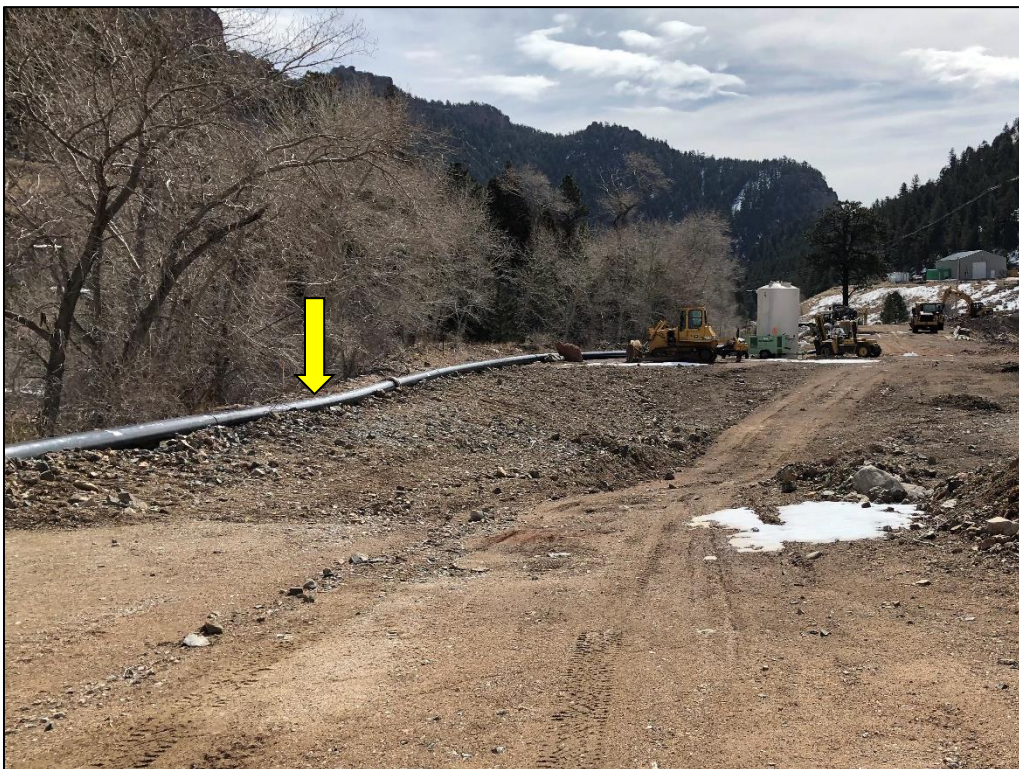
**Photo 2.** View looking southeast across the mine site, showing the creek diversion pipeline (indicated) which conveys upgradient "clean" water around the mine to discharge into Ralston Creek downgradient of the mine site.

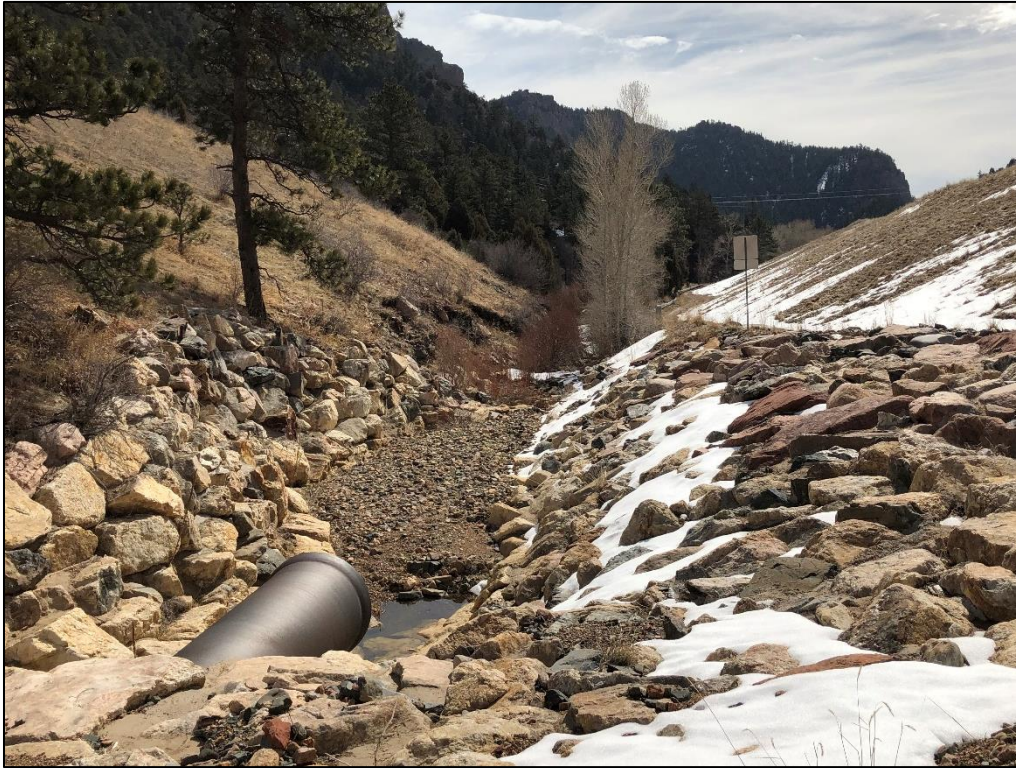
**Photo 3.** View looking downstream from upgradient cutoff wall in Ralston Creek, showing creek dry during inspection (besides a small pool of snow melt).

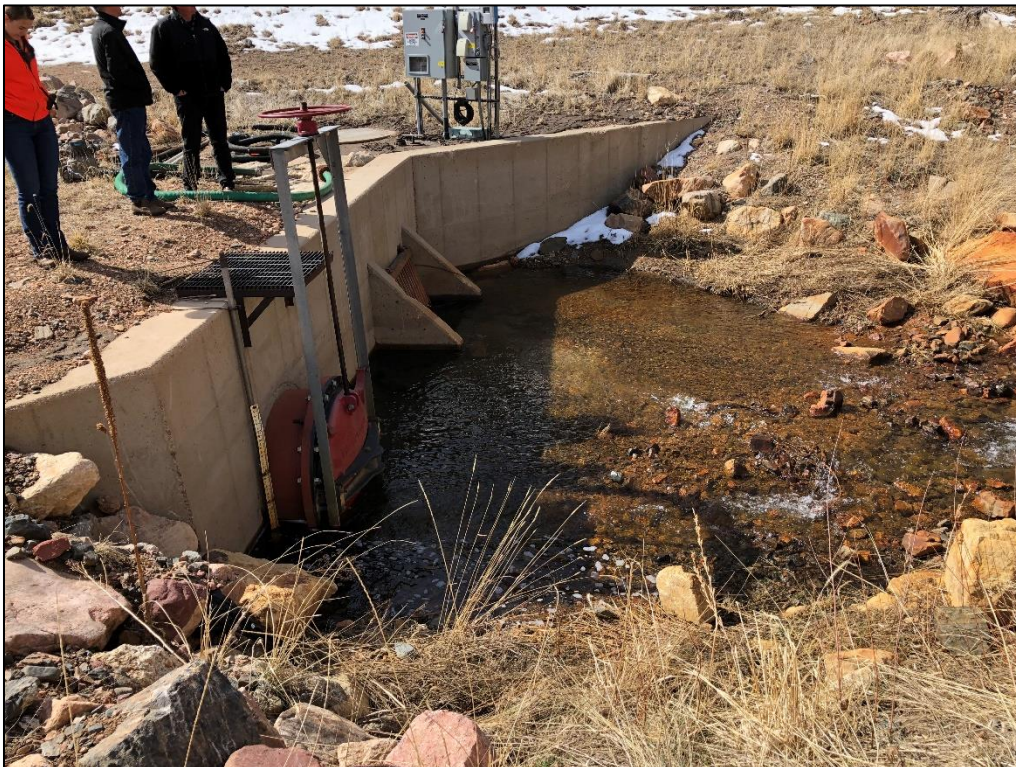
The Division inspected the upgradient cutoff wall and observed that all flows in Ralston Creek were being routed through the by-pass pipeline. The Division inspected the creek and adjacent areas upstream from the cutoff wall, and identified two areas of ponded water outside of the creek channel, between the creek and the North Waste Rock Pile (NWRP). Ponded water was observed in the ditch beside Glencoe Valley Road where the road is located east of the creek along the toe of the NWRP. The water pooled in this ditch was green in color due to extensive algae growth and appeared to be fairly stagnant. The other area of ponded water was observed between the green-colored water and the creek, further west from the road. The water pooled at this location was red in color due to staining of the underlying ground and vegetation. The red-colored water was flowing at an estimated rate of 1-2 gpm, and eventually joined the creek just upstream of the headgate/cutoff wall. The green-colored water appeared to be isolated from the creek. The Division believes the ponded water may be impacted due to its coloration and algae growth.

**Photo 4.** View looking at upgradient cutoff wall/head gate in Ralston Creek, showing creek flowing at time of inspection.

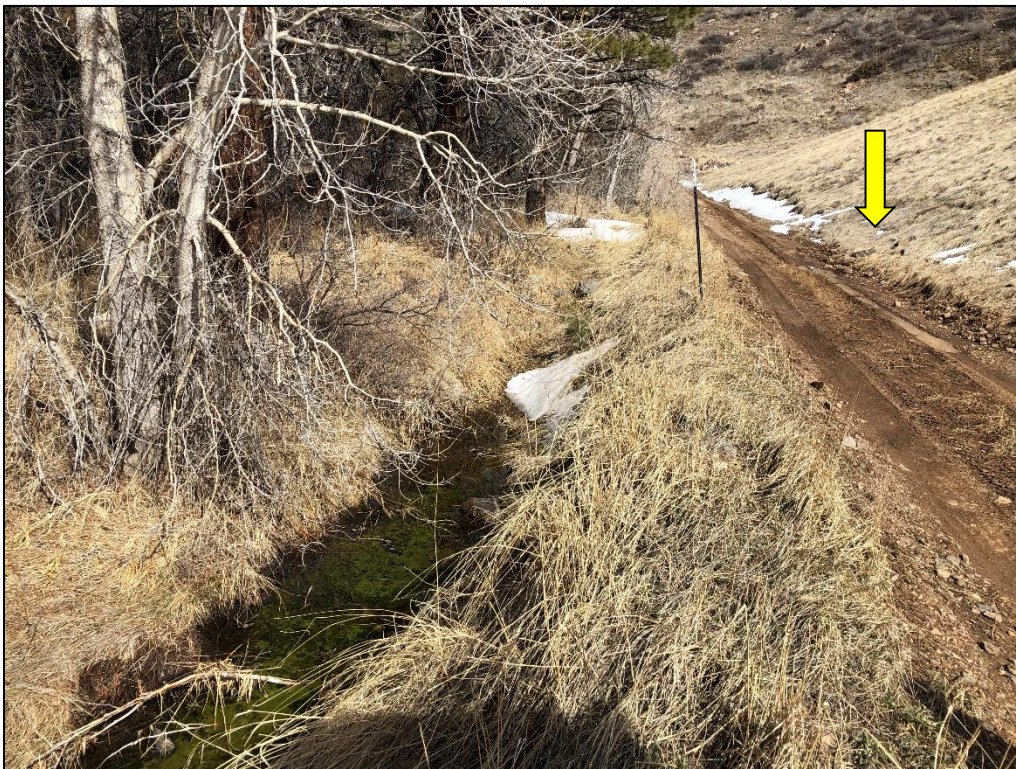
**PROBLEM #1:** Failure to minimize disturbance to the prevailing hydrologic balance of the affected land and of the surrounding area and to the quality of water in surface and groundwater systems both during and after the mining operation and during reclamation, as required by Hard Rock Rule 3.1.6(1).

**Photo 5.** View of standing water observed in ditch adjacent to Glencoe Valley Road (at right) near toe of North Waste Rock Pile (indicated). This water was green in color due to extensive algae growth, and appeared to be fairly stagnant.

**CORRECTIVE ACTIONS:** By the corrective action date, the operator shall sample the ponded water observed during the inspection between Ralston Creek and the North Waste Rock Pile (detailed in the report) and submit the results to the Division along with any additional relevant monitoring data. This report shall include an analysis of the data, comparing it to data obtained from the upgradient and downgradient monitoring locations, identification and quantification of the contaminant source(s), and a plan of action to prevent contaminated surface and groundwater from leaving the affected lands. If the plan of action involves changes to the approved mining and/or reclamation plans, it should be submitted as a Technical Revision or Amendment application with the appropriate fee.

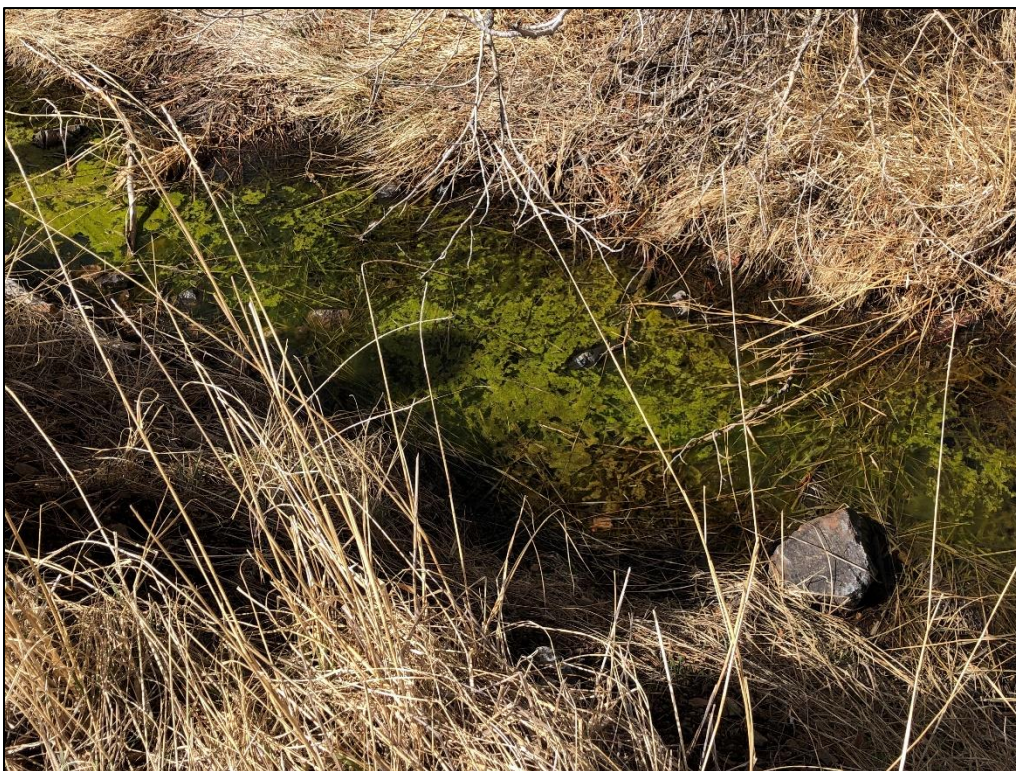
**Photo 6.** Closer view of standing water shown in Photo 5. Note green color of water due to extensive algae growth.

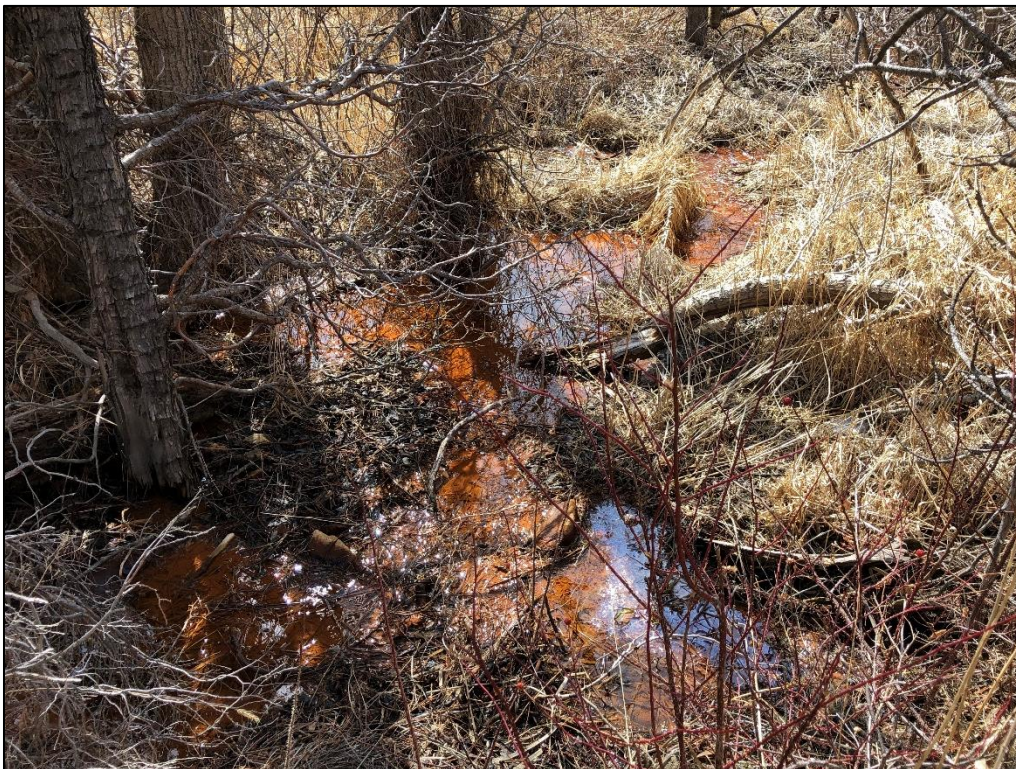
**Photo 7.** View of standing water observed in area between creek and green-colored standing water (shown in Photos 5 and 6). This water was bright red in color due to staining of the underlying ground and vegetation.

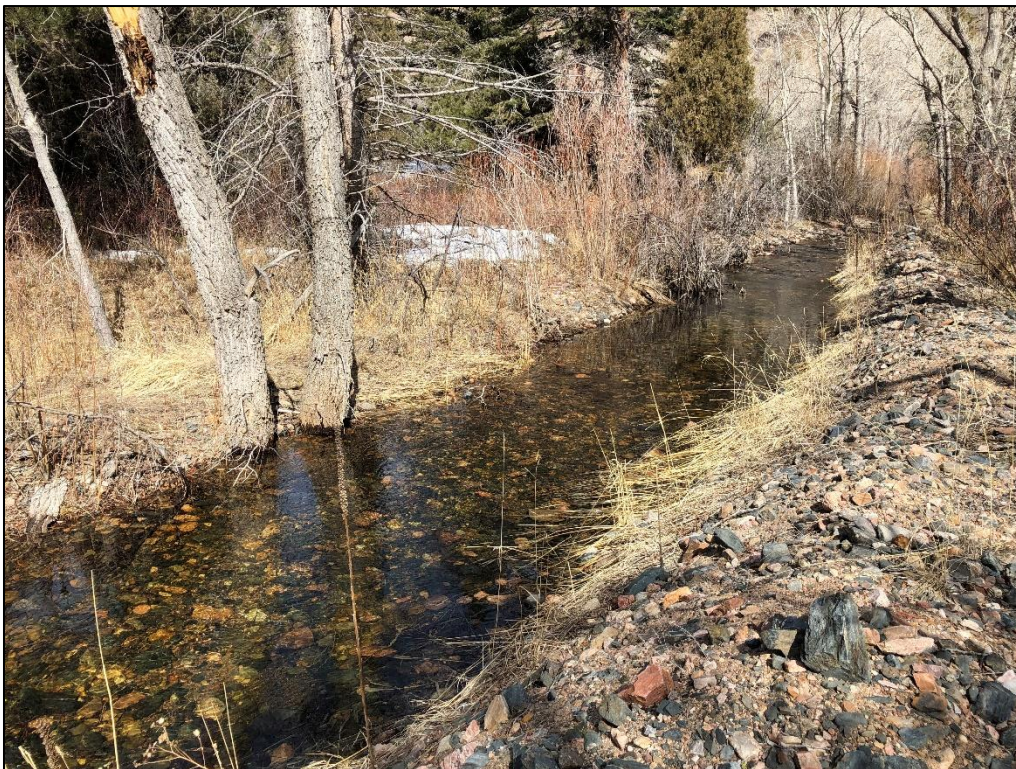
**Photo 8.** View of Ralston Creek upstream from the cutoff wall. Note water in creek is clear with no significant algae growth or red staining.

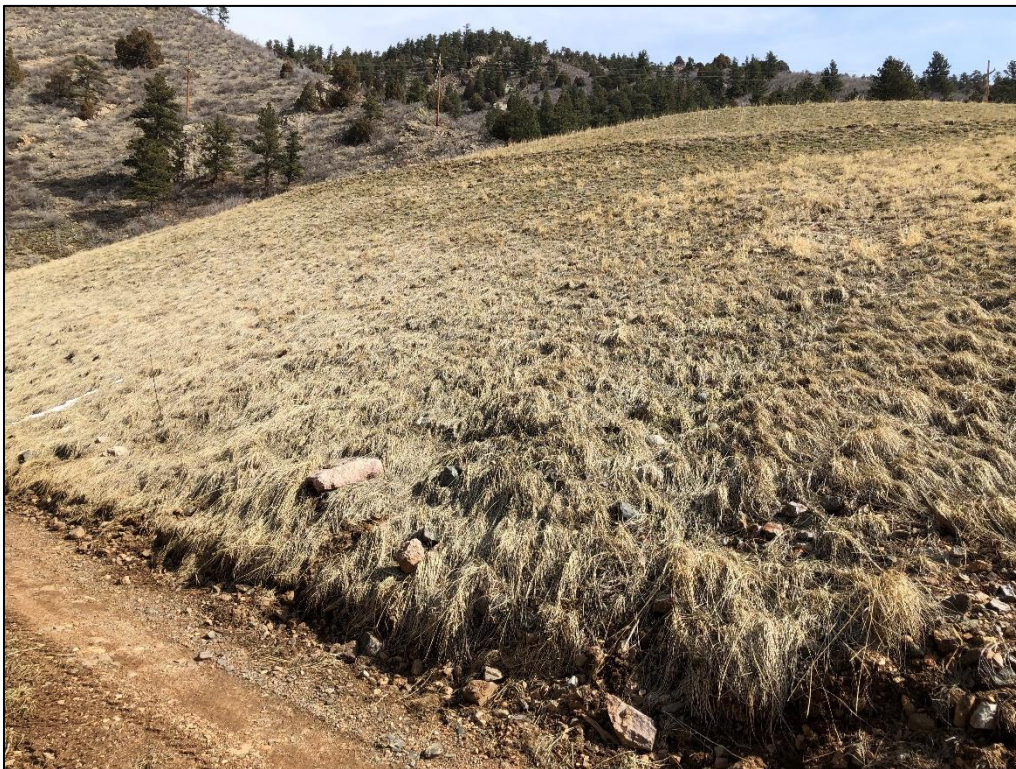
**Photo 9.** View looking across southwest side of North Waste Rock Pile. Note pile is stable with good grass cover.

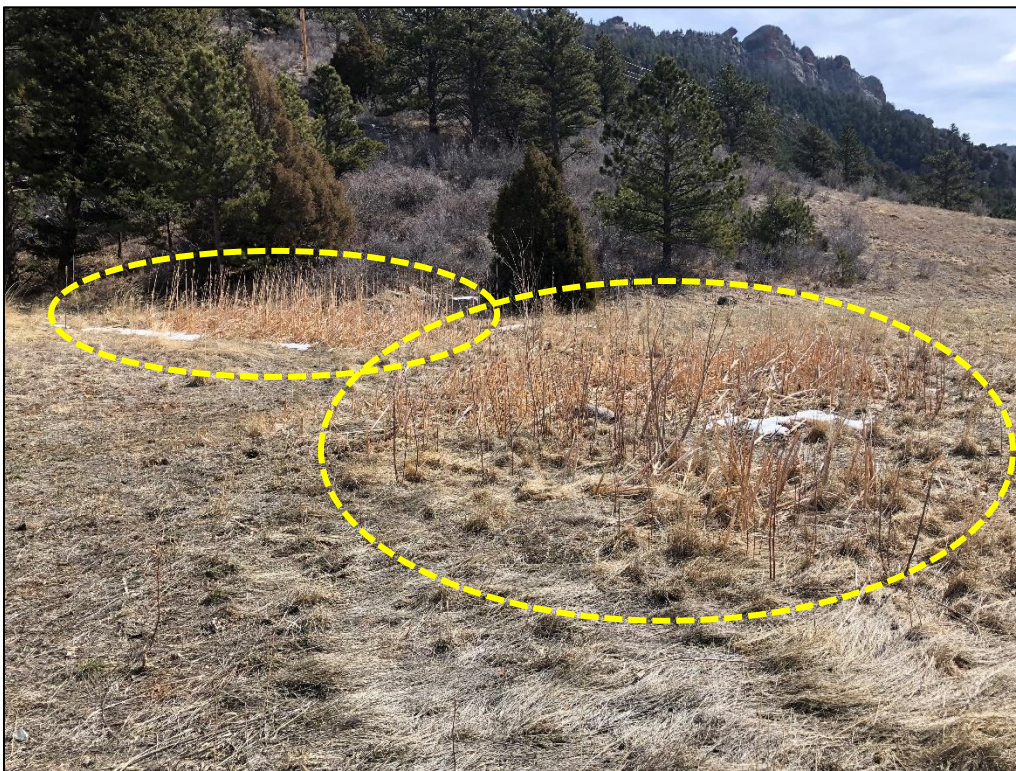
During the current inspection, no standing water was observed on top of the NWRP. However, the Division did observe hydrophytic vegetation (mainly cattails) growing in a few small areas near the center top surface of this

**Photo 10.** View looking across the top of the North Waste Rock Pile, showing the small areas (circled) with hydrophytic vegetation growing (mainly cattails) indicating prolonged saturated conditions.

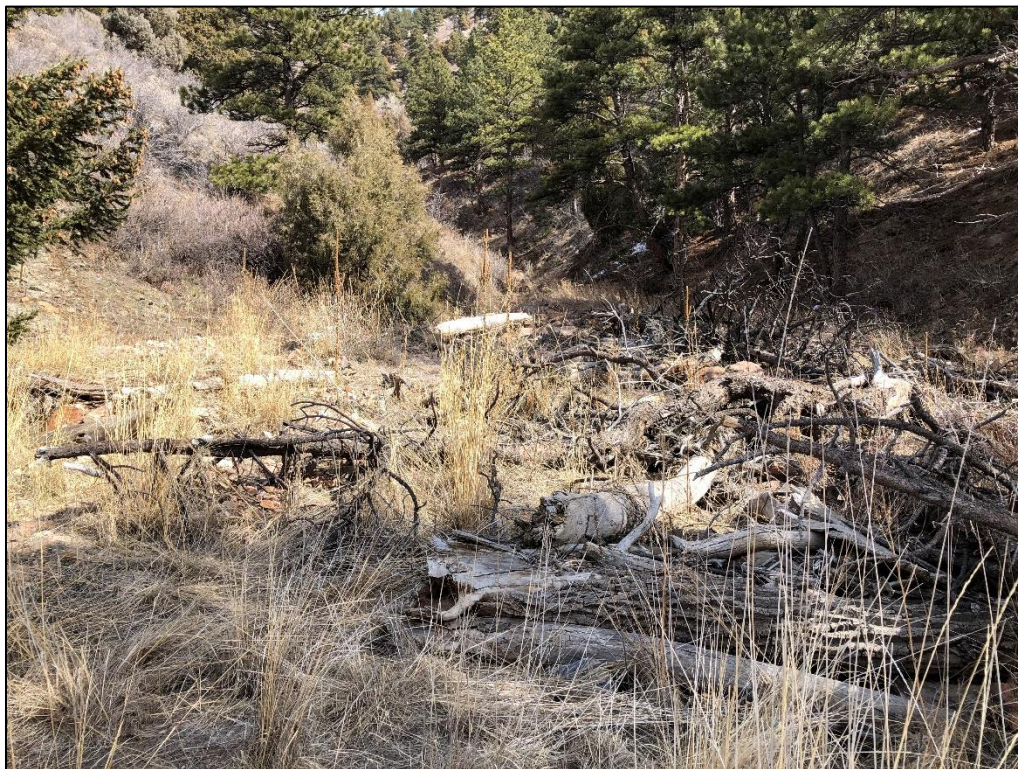
**Photo 11.** View from top of North Waste Rock Pile looking north up the gulch in which the pile was placed. Note the woody debris piled in the foreground, which appears to have been deposited by a high flow event(s).

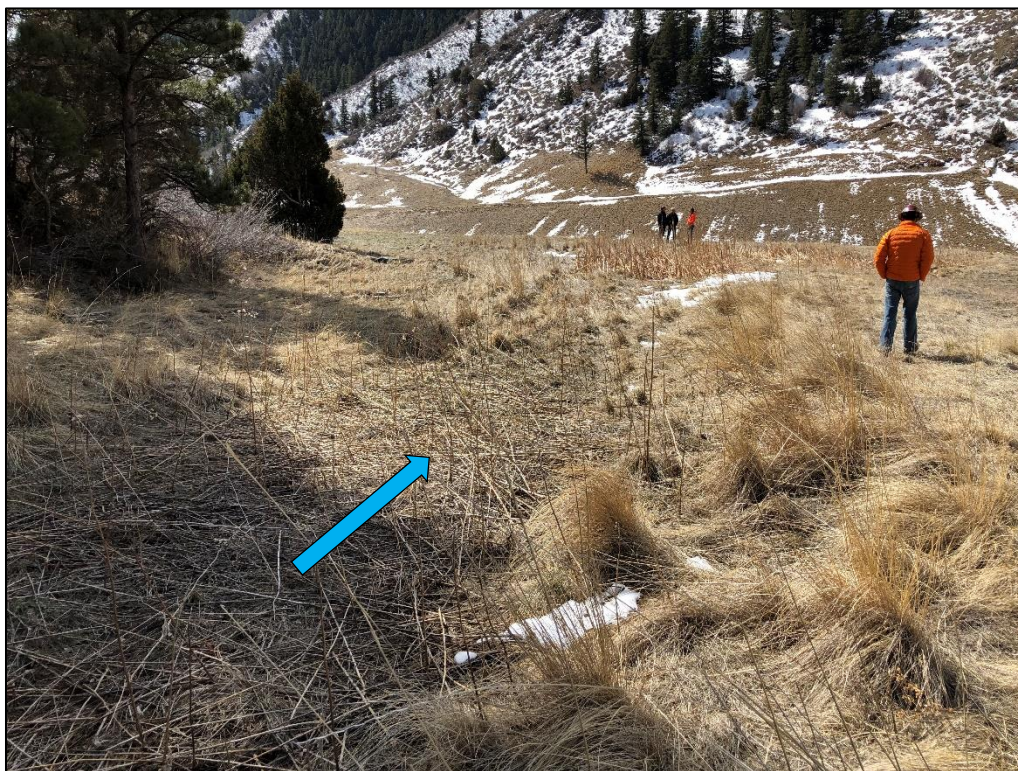
**PROBLEM #2:** A detailed construction schedule has not been provided to the Division as required by Hard Rock Rule 6.4.21(15) for installation of the surface water control structures approved in Technical Revision No. 23 (TR-23) for the waste rock piles, which are designated Environmental Protection Facilities. At the time of this inspection, these structures have not been installed at the site, and no alternative plan for controlling runoff of

pile. The NWRP was placed in a gulch that is typically dry most of the year, except during high precipitation events and spring runoff. The Division observed a pathway of flattened grass and woody debris where water has flowed from the gulch across the top of the NWRP. No erosion problems were observed on the sides of the pile. It appears that water mostly pools at the top of the pile, particularly in the area where hydrophytic vegetation is present.

**Photo 12.** View looking across top of North Waste Rock Pile, showing pathway of flattened vegetation where stormwater appears to flow from the gulch across the top of the pile (general flow direction indicated with blue arrow).

**CORRECTIVE ACTIONS:** By the corrective action date, the operator shall submit a detailed construction schedule for installation of the surface water control structures approved in TR-23 for the waste rock piles. Any proposed revisions to the approved plan must include a detailed construction schedule, and be submitted in the form of a Technical Revision or Amendment application by the corrective action date with the appropriate fee.

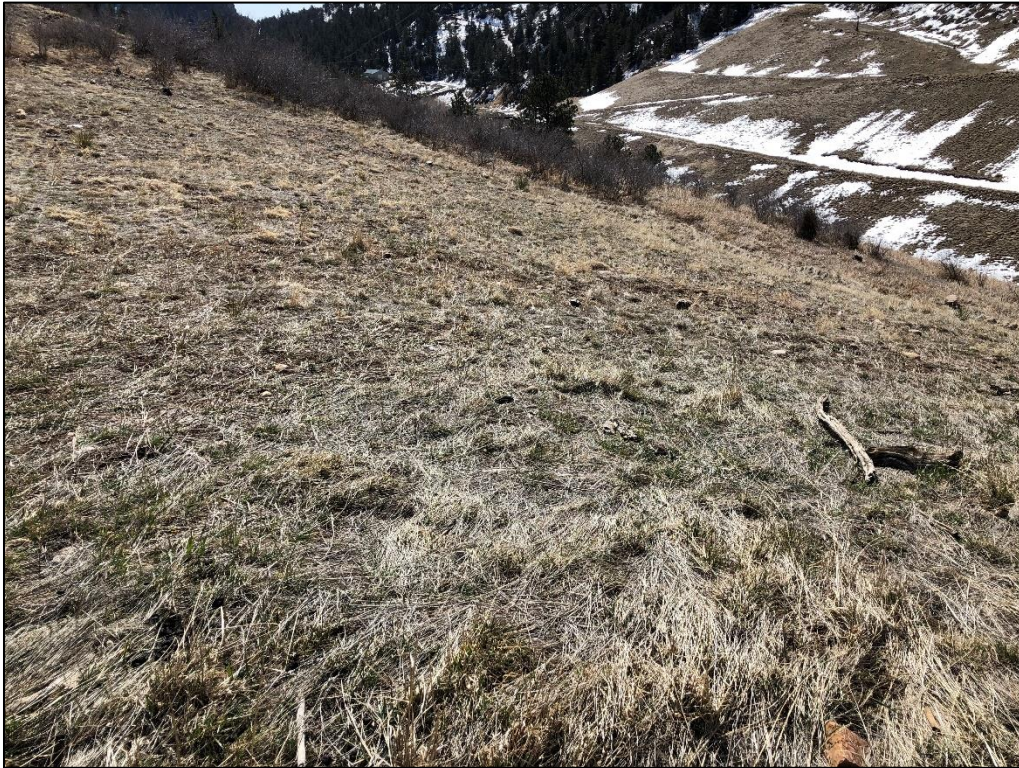
**Photo 13.** View looking down south side of North Waste Rock Pile from top of pile, showing no erosion problems.

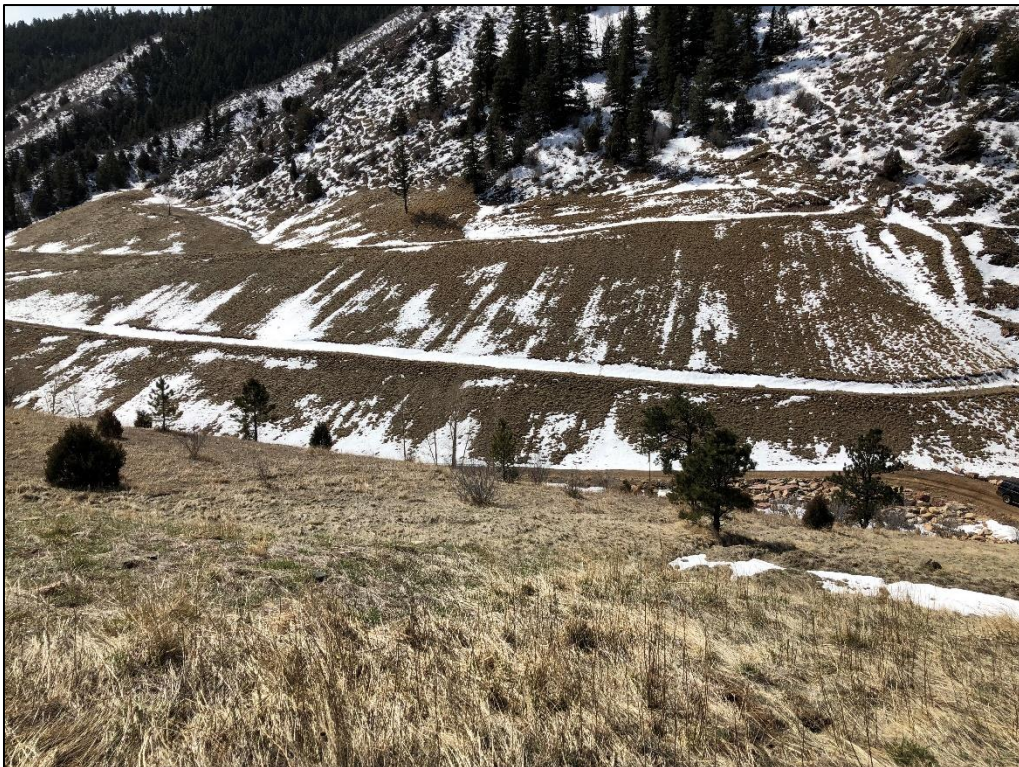
During the inspection, the Division also observed the South Waste Rock Pile (SWRP) from the top of the NWRP. This pile appeared to be stable with good grass cover. It should be noted, TR-23 authorized the operator to place additional material (excavated alluvial fill) on top of the existing waste rock piles. At this time, excavated alluvial fill is being placed in the other approved on-site disposal location, the CV Glory Hole inside the Minnesota Adit, and not on top of the waste rock piles. According to TR-23, the operation will place material on the SWRP until capacity is reached prior to placing material on the NWRP. **The operator should be advised, no additional material is to be placed on the NWRP until the issues identified in this report regarding potential seeps and insufficient surface water management of this pile have been addressed.** No excavation activities were occurring at the site during the inspection. The operator anticipates recommencing with excavation activities after spring runoff (April/May). During this construction season, the operator will also continue working to install the new submersible pump via the Jeffrey Air Shaft and associated pipelines (as approved in TR-27).

**Photo 14.** View looking southeast from top of North Waste Rock Pile, showing South Waste Rock Pile (in distance) located south of the creek. This pile appeared to be stable with good grass cover.
