## Airport Gravel Pit, M-1983-039

**MINERALS PROGRAM INSPECTION REPORT****PHONE: (303) 866-3567**

<b>MINE NAME:</b> Airport Gravel Pit	<b>MINE/PROSPECTING ID#:</b> M-1983-039	<b>MINERAL:</b> Sand and gravel	<b>COUNTY:</b> Las Animas
<b>INSPECTION TYPE:</b> Monitoring	<b>INSPECTOR(S):</b> Jared L. Ebert	<b>INSP. DATE:</b> March 19, 2019	<b>INSP. TIME:</b> 10:00
<b>OPERATOR:</b> Las Animas County	<b>OPERATOR REPRESENTATIVE:</b> John Lucero	<b>TYPE OF OPERATION:</b> 112c - Construction Regular Operation

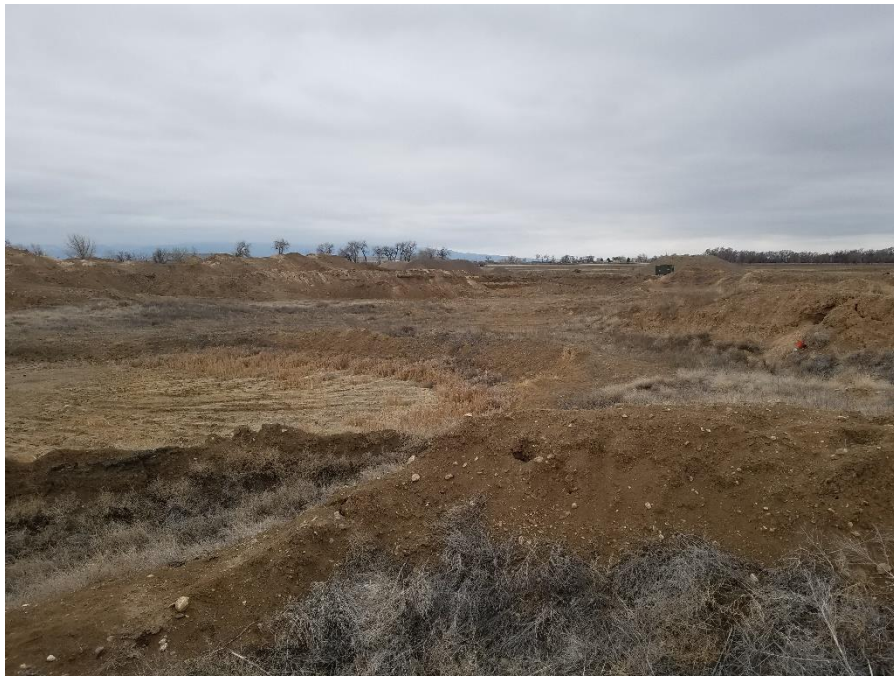
The active mine area on the southeast portion of the site consists of a shallow pit ranging in depth from five to fifteen feet deep with near vertical pit slopes. There appears to be plenty of room to backfill and grade the pit highwalls.

**Figure 1. From the northwest corner of the active pit area.**

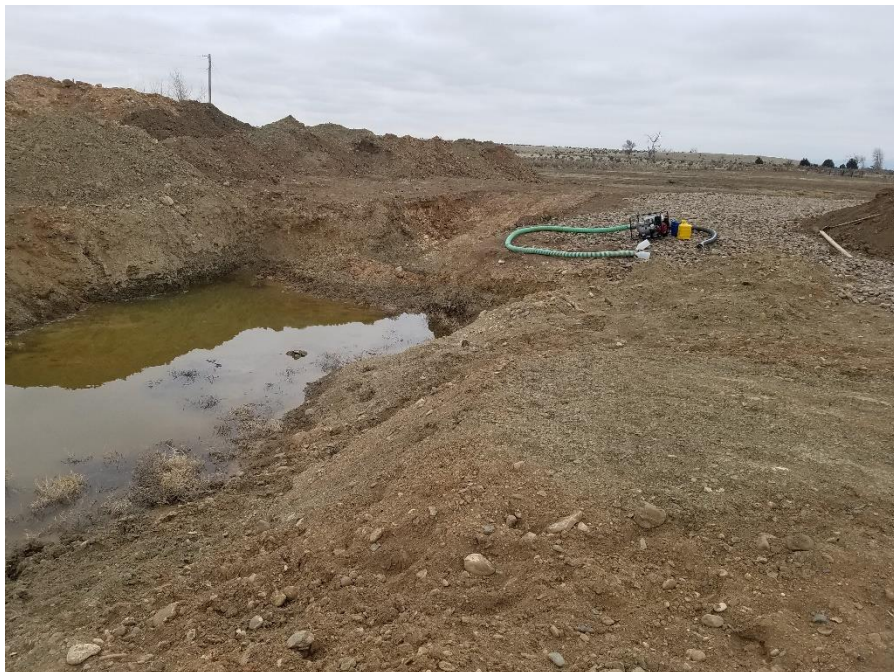
**PROBLEM:** The Division has no evidence that the operator has a valid well permit, substitute water supply plan, or approved water augmentation plan for the exposed groundwater at the site. This is a problem related to 34-32.5-116(4)(h) of the Colorado Revised Statutes and 3.1.6(1)(a) of the Construction Materials Rules and Regulations governing injury to existing water rights.

A smaller pit basin east of the active pit area has been excavated below the groundwater table. A submersible pump was staged next to the exposed groundwater and according to Mr. Lucero the County uses this water to fill water tankers. A crushed rock access road with a looped turn around has been constructed to provide access to this fill point. The Division does not have evidence on-file that Las Animas County has an approved well permit and/or substitute water supply plan for this activity. This issue is cited as a problem at the beginning of this report. Las Animas County will need to provide DRMS with evidence they are using this water in compliance with the Colorado Division of Water Resources or they will need to backfill this pit area above the groundwater table by the corrective action due date.

**Figure 2. Exposed groundwater and pump.**

**CORRECTIVE ACTIONS:** The operator shall demonstrate that the operation is in compliance with the Office of the State Engineer, show evidence that the operator is taking measures to bring the site into compliance with the SEO, or backfill the pits to at least two feet above the groundwater surface by the corrective action date specified.

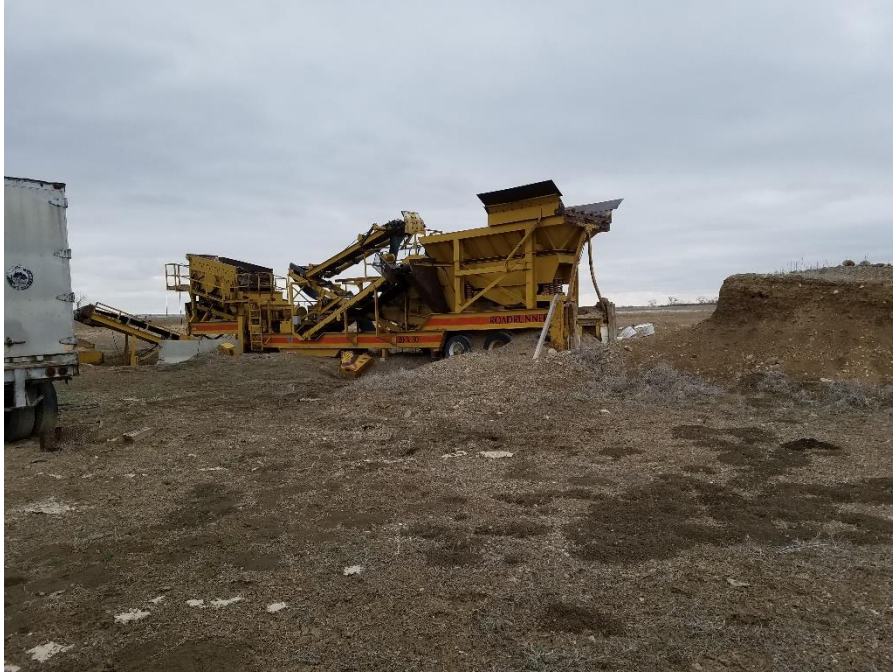
Figure 3. Old processing equipment near old pit area.

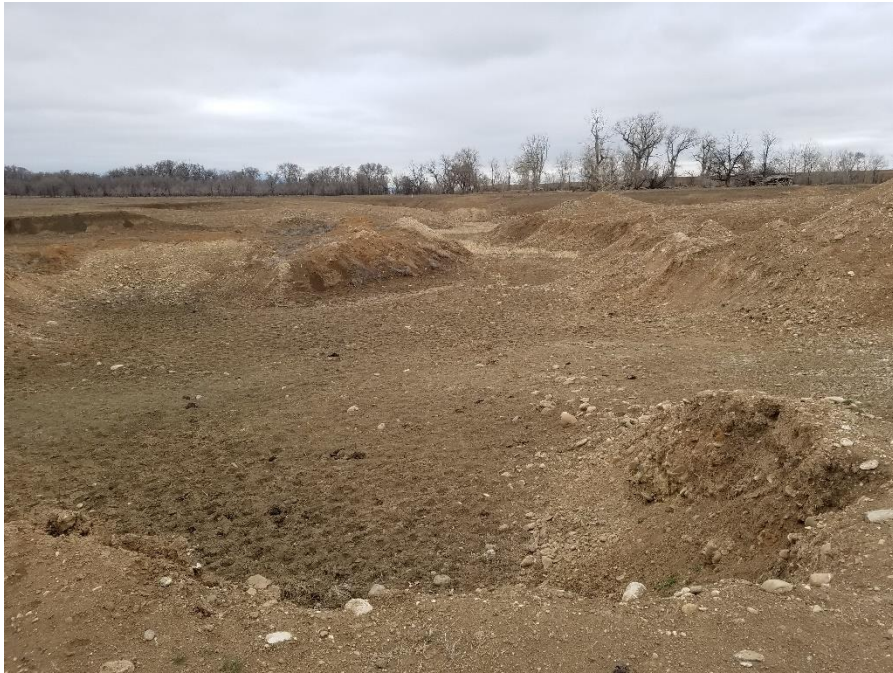
The older pit excavation located west of the active pit area consists of a shallow irregularly shaped pit with angle of repose pit slopes to near vertical slopes in places. It does not appear this area has been actively mined for a long time. Mr. Lucero indicated the County may continue mining in this area in the future but was not sure. There appears to be room to cut and fill and pit slopes to the required 3H:1V ratio.

Figure 4. From the east side of the old pit looking west.
