**MINERALS PROGRAM INSPECTION REPORT****PHONE: (303) 866-3567**

<b>MINE NAME:</b> Adams Pit	<b>MINE/PROSPECTING ID#:</b> M-1983-177	<b>MINERAL:</b> Sand and gravel	<b>COUNTY:</b> Bent
<b>INSPECTION TYPE:</b> Monitoring	<b>INSPECTOR(S):</b> Amy Eschberger	<b>INSP. DATE:</b> March 7, 2019	<b>INSP. TIME:</b> 10:45
<b>OPERATOR:</b> Bent County	<b>OPERATOR REPRESENTATIVE:</b> Robert Darnell	<b>TYPE OF OPERATION:</b> 110c - Construction Limited Impact	
<b>REASON FOR INSPECTION:</b> Normal I&E Program	<b>BOND CALCULATION TYPE:</b> None	<b>BOND AMOUNT:</b> \$0.00	
<b>DATE OF COMPLAINT:</b> NA	<b>POST INSP. CONTACTS:</b> None	<b>JOINT INSP. AGENCY:</b> None	
<b>WEATHER:</b> Clear	<b>INSPECTOR'S SIGNATURE:</b>

# M-1983-177 / Adams Pit / Bent County

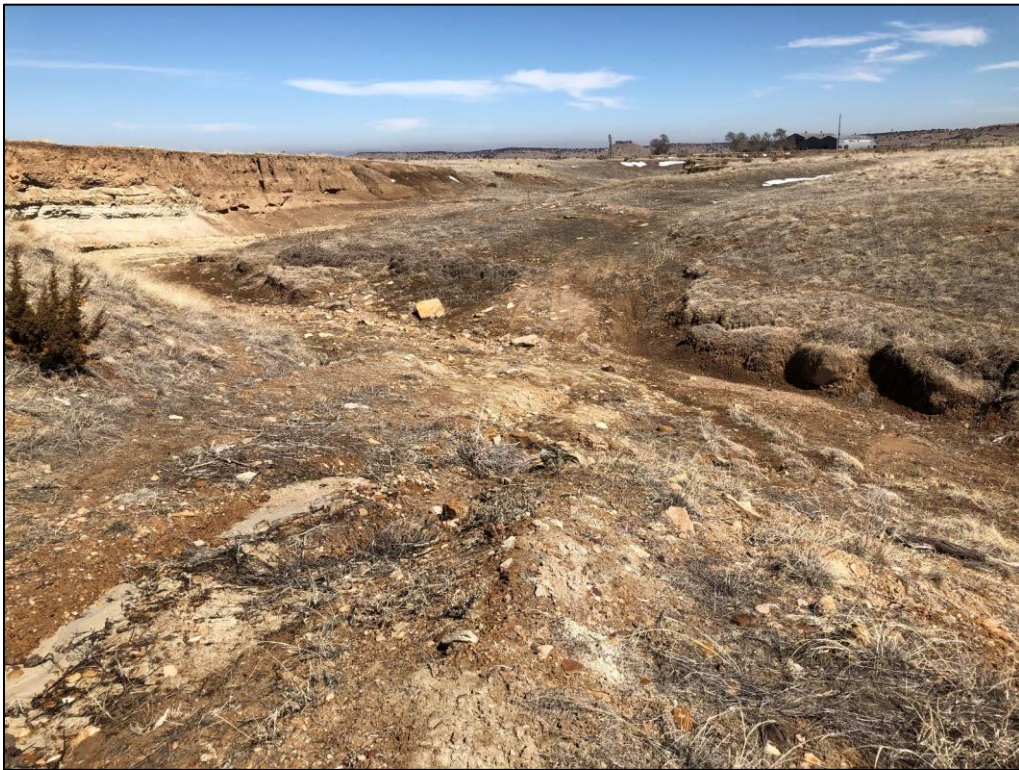
No standing water was observed on site, and the adjacent creek bed was dry. The creek bed appeared to be undisturbed by the operation, besides the crossing area. The crossing area does not include any alterations that would obstruct creek flow.

**Photo 1.** View looking northeast at portion of creek crossed by operation to access mining area west of the creek. Note creek dry during inspection.

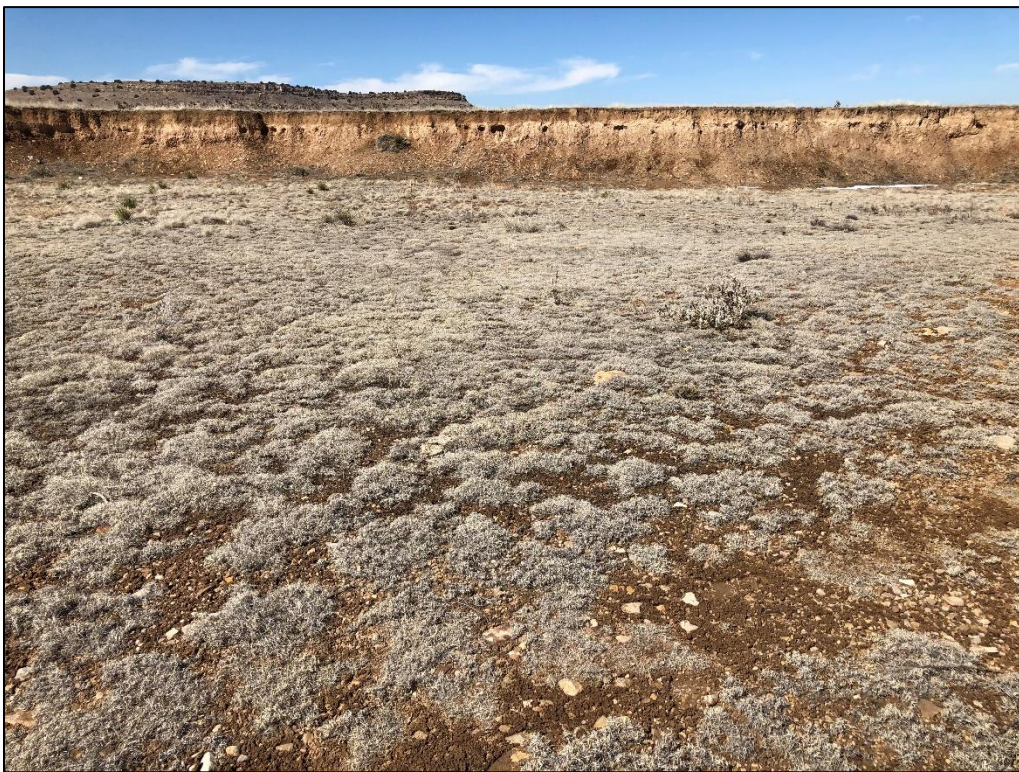
**Photo 2.** View looking west across excavation area, showing highwall in background. Note native grasses volunteering across disturbed area.

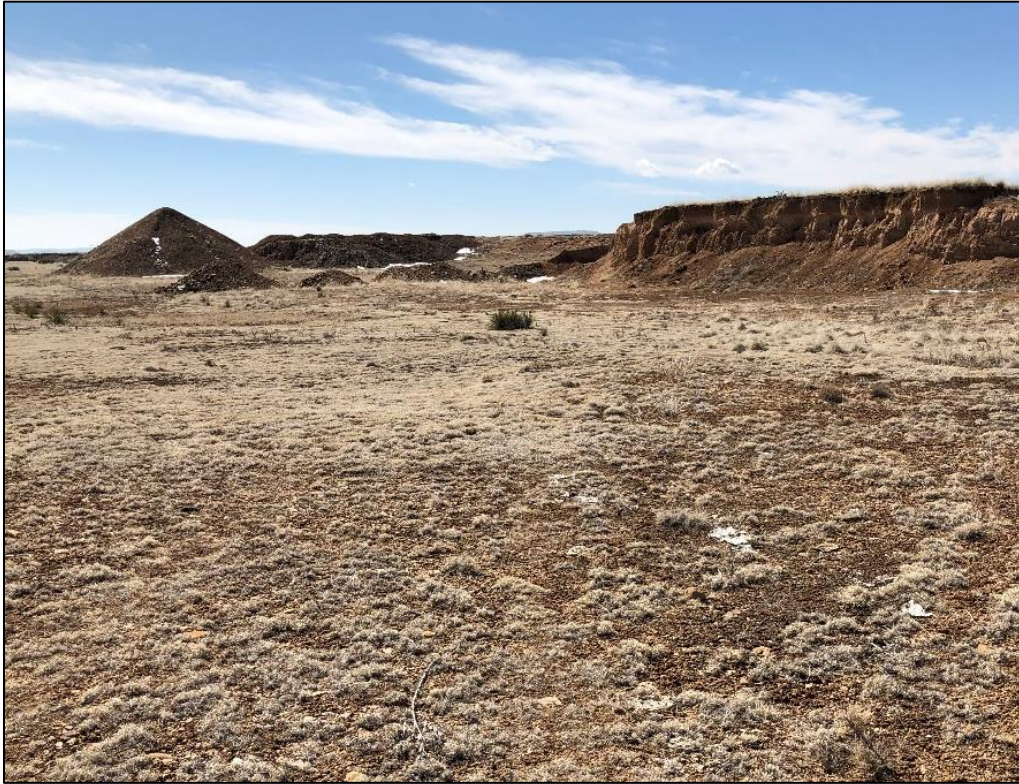
**Photo 3.** View looking west across excavation area, showing portion of highwall and a few small material stockpiles stored near highwall.

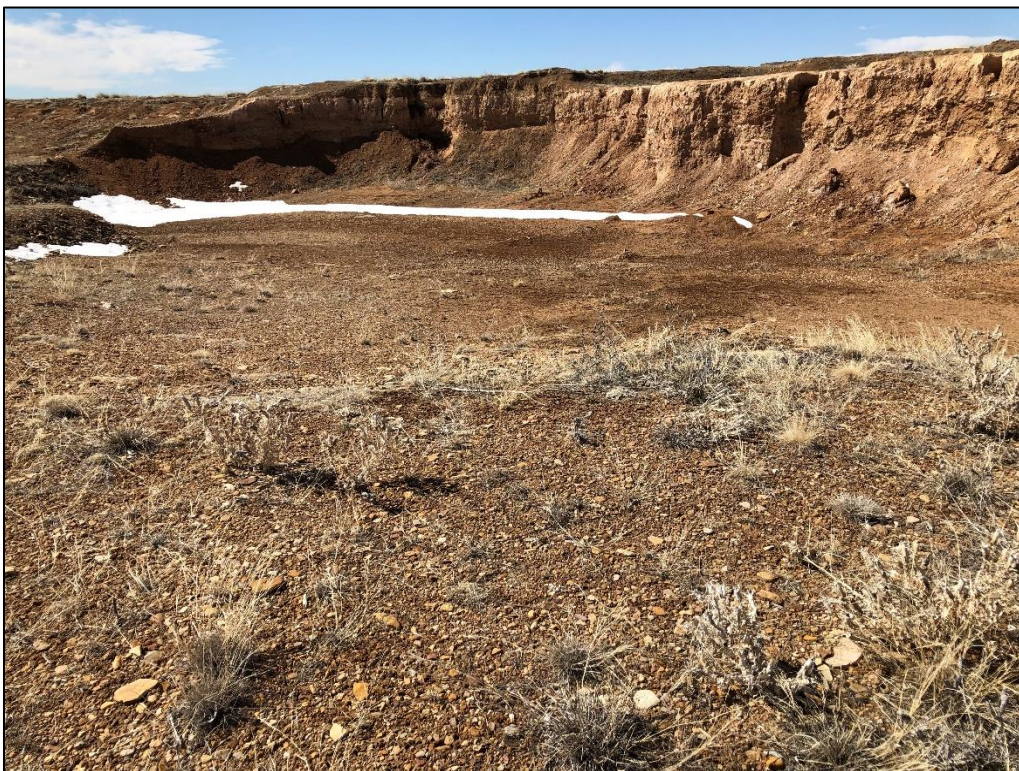
The operation appears to be following the approved mining plan. However, a portion of the highwall at the southwestern edge of the site is currently very close to the western permit boundary. Therefore, the operator should be careful not to disturb land outside the approved permit boundary in this area, especially when reclaiming this portion of the highwall. The Division estimates the operation has disturbed a total of 2.9 acres. No problems were observed.

**Photo 4.** View looking west across excavation area, showing portion of highwall, which is approximately 10 feet in height with near vertical slopes.

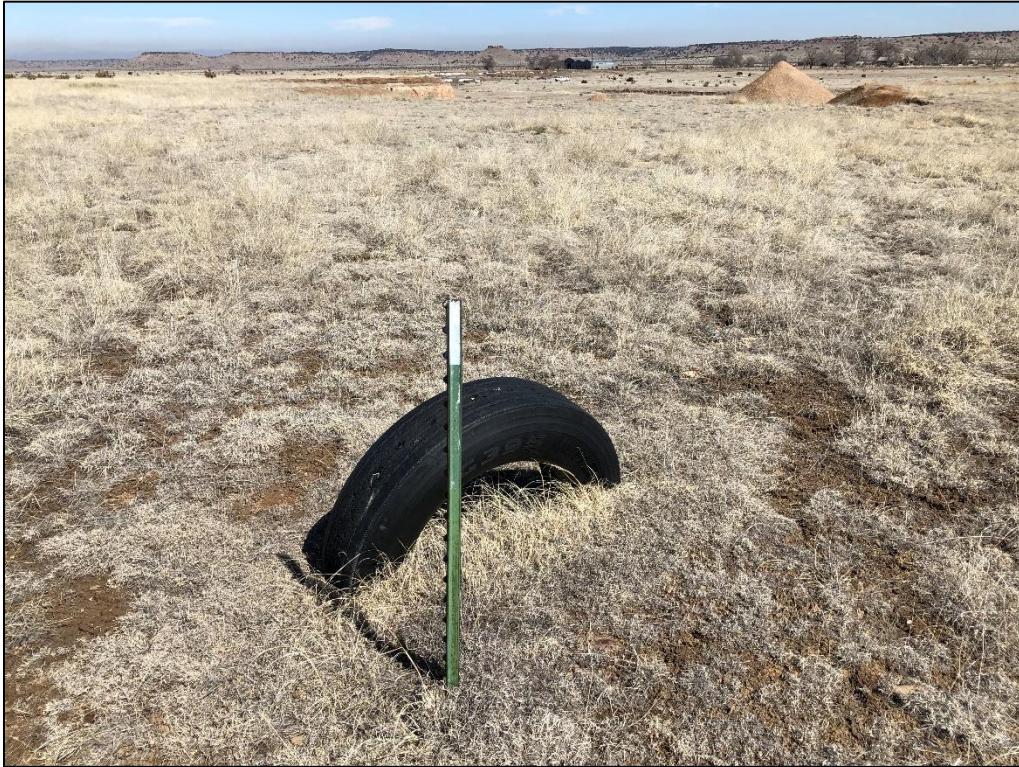
**Photo 5.** View looking north/northeast from southwestern corner of permit boundary, marked by a T-post and half-buried tire.

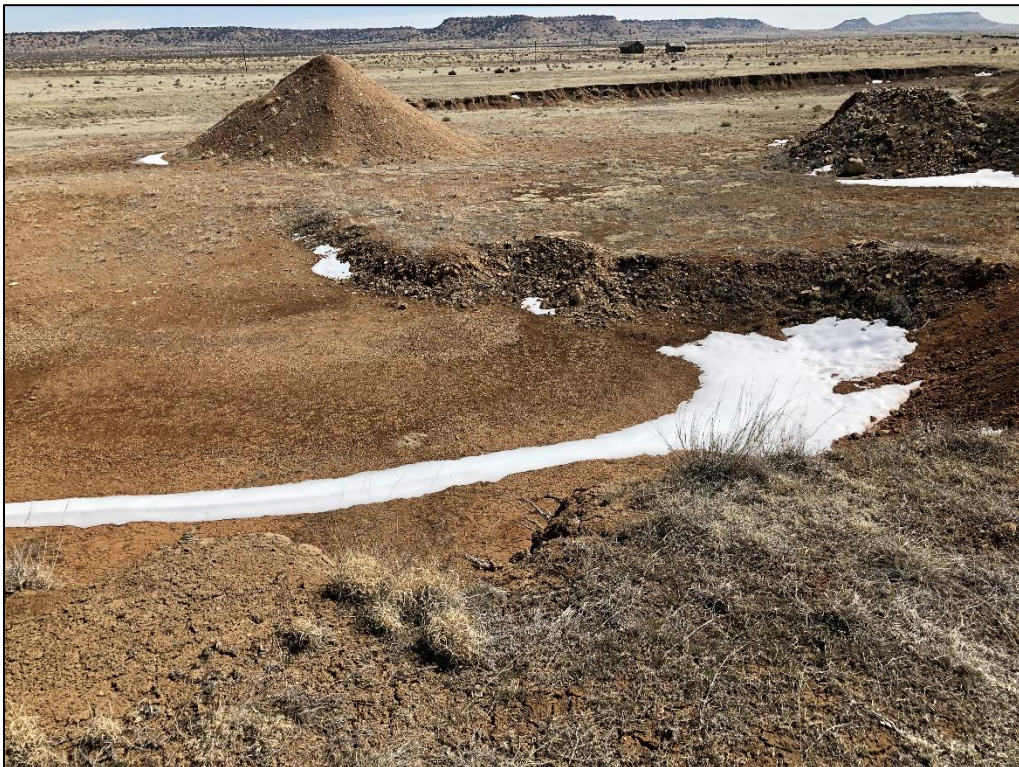
**Photo 6.** View looking southeast across excavation area from top of highwall, showing a few material stockpiles stored on pit floor.

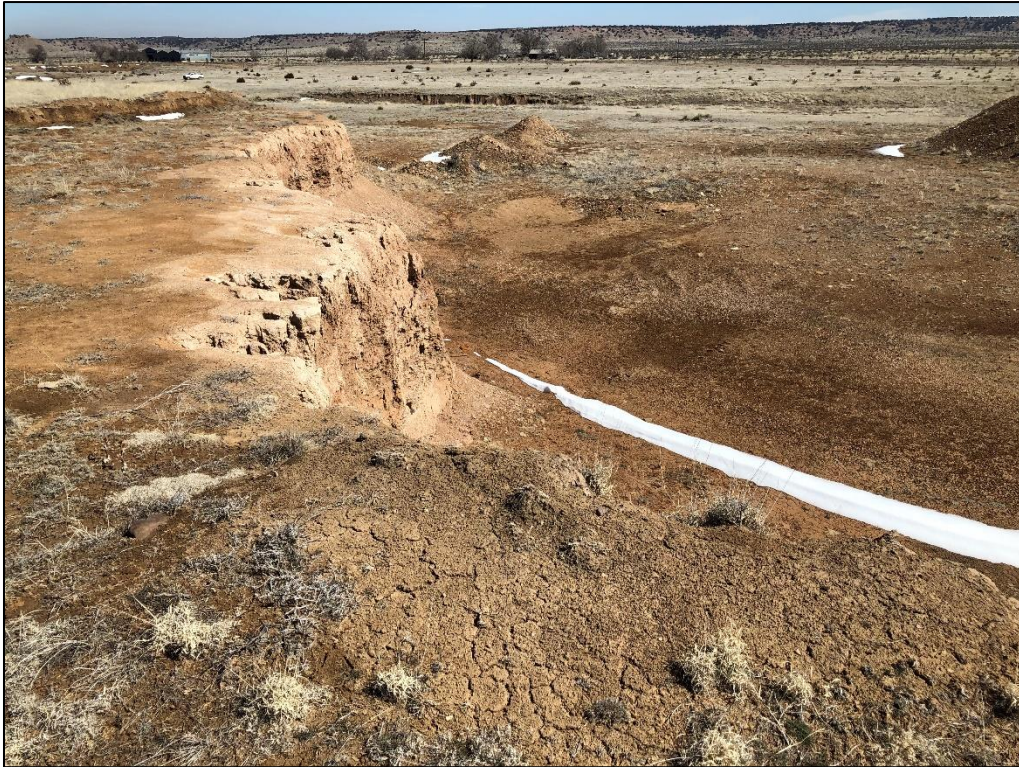
**Photo 7.** View looking northeast across excavation area from top of highwall.

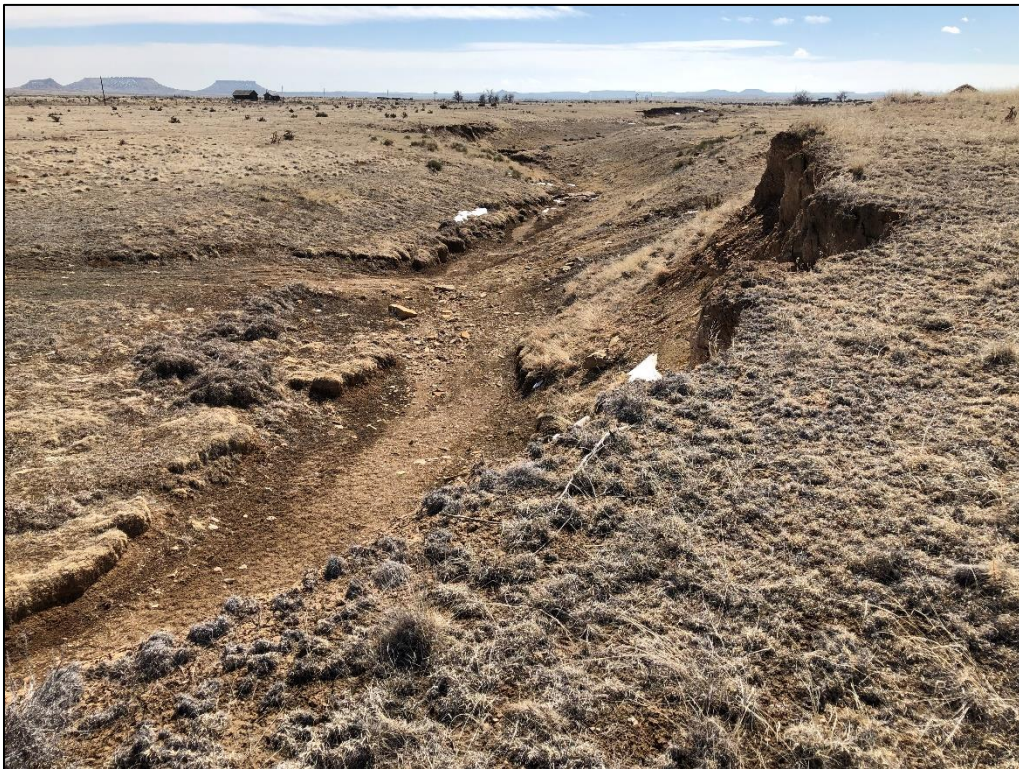
**Photo 8.** View looking south at (dry) creek bed from top of terrace along western edge of creek. The mine excavation is located further south from this point.
