MINERALS PROGRAM INSPECTION REPORT**PHONE: (303) 866-3567**

MINE NAME: Rocky Flat Gravel	MINE/PROSPECTING ID#: M-1982-129	MINERAL: Sand and gravel	COUNTY: Huerfano
INSPECTION TYPE: Monitoring	INSPECTOR(S): Patrick Lennberg	INSP. DATE: March 28, 2019	INSP. TIME: 12:00
OPERATOR: L. Otto Goemmer	OPERATOR REPRESENTATIVE: Pete Goemmer	TYPE OF OPERATION: 110c - Construction Limited Impact

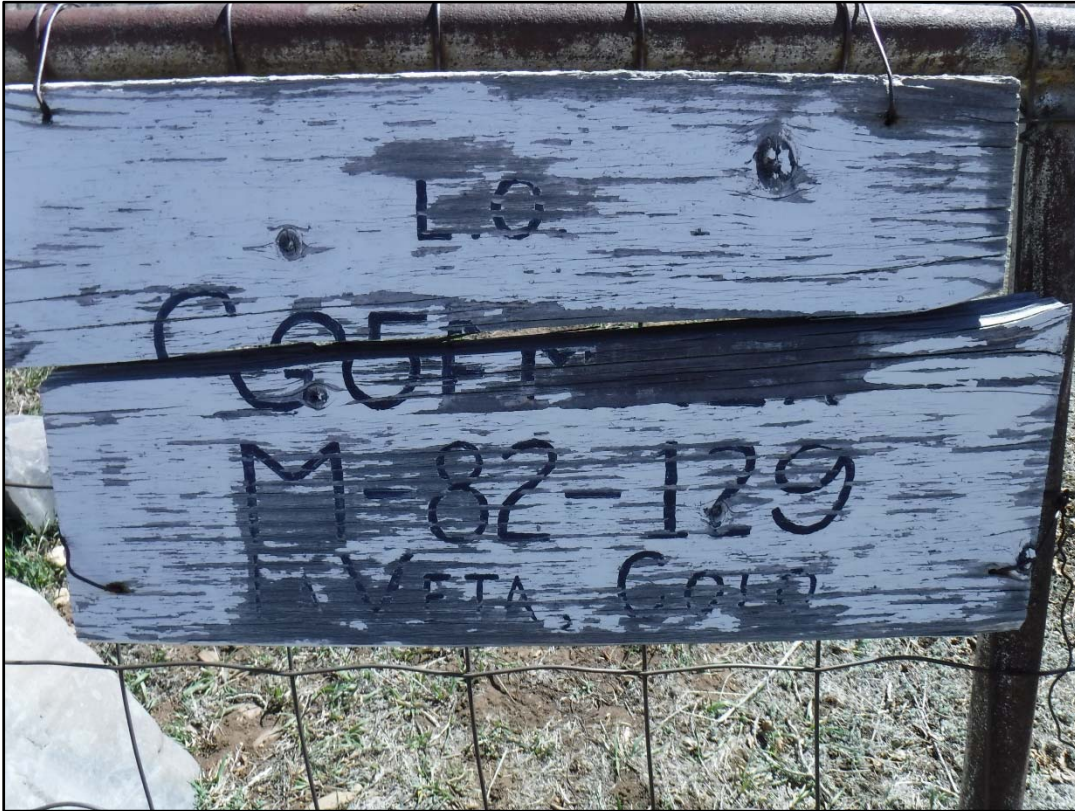
PROBLEM/POSSIBLE VIOLATION: The mine identification sign was not posted at the entrance of the mine site. This is a problem for failure to post a mine identification sign as required by Section 3.1.12(1) of the rule.

The Rocky Flat Gravel Pit is located approximately 2 miles southwest of La Veta, Colorado. The approved post-mining land use is rangeland. A mine sign was observed but is extremely faded and not legible. Because the sign is not clearly visible, pursuant to Rule 3.1.12, it is being cited as a problem in this inspection report and should be replaced.

Photo 1: Mine sign on gated entrance to site

CORRECTIVE ACTIONS: The operator shall, at the entrance of the mine site, post a sign which shall be clearly visible from the access road with the following: the name of the operator, a statement that a reclamation permit for the operation has been issued by the Colorado Mined Land Reclamation Board; and the permit number. The operator shall submit photo documentation that a proper sign has been posted by the corrective action date.

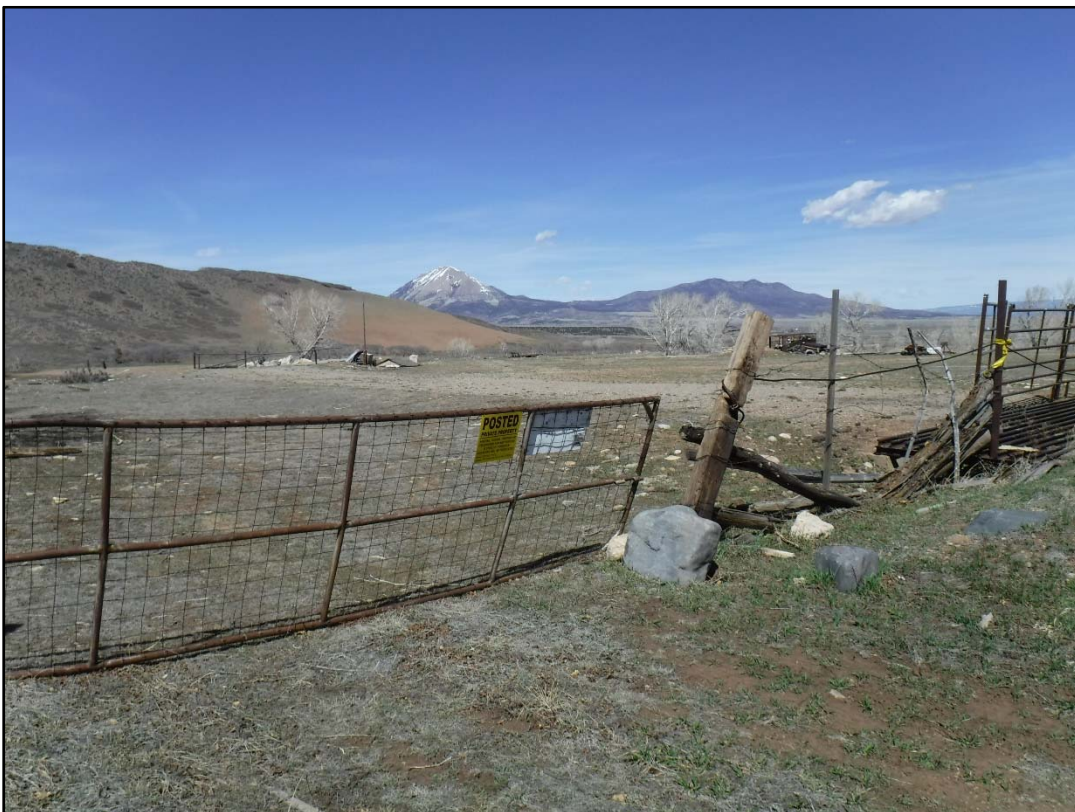
Photo 2: Gated entrance to site looking north towards pit area

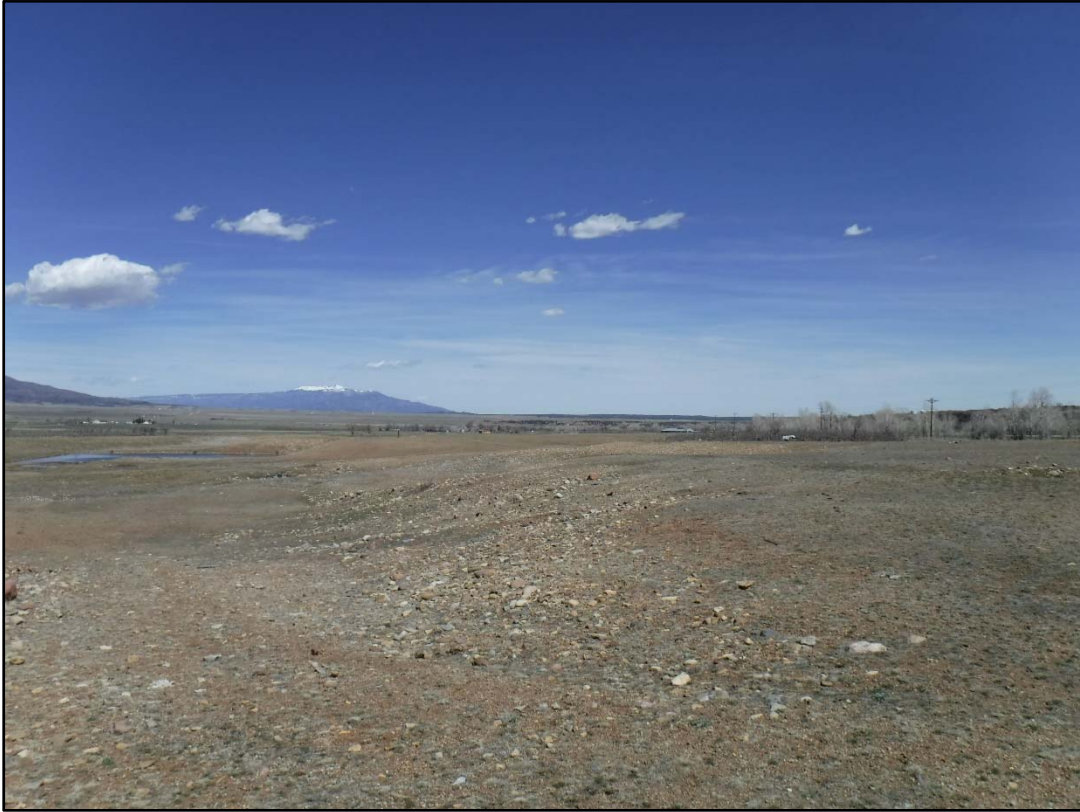
Photo 3: Looking north from the southern permit boundary

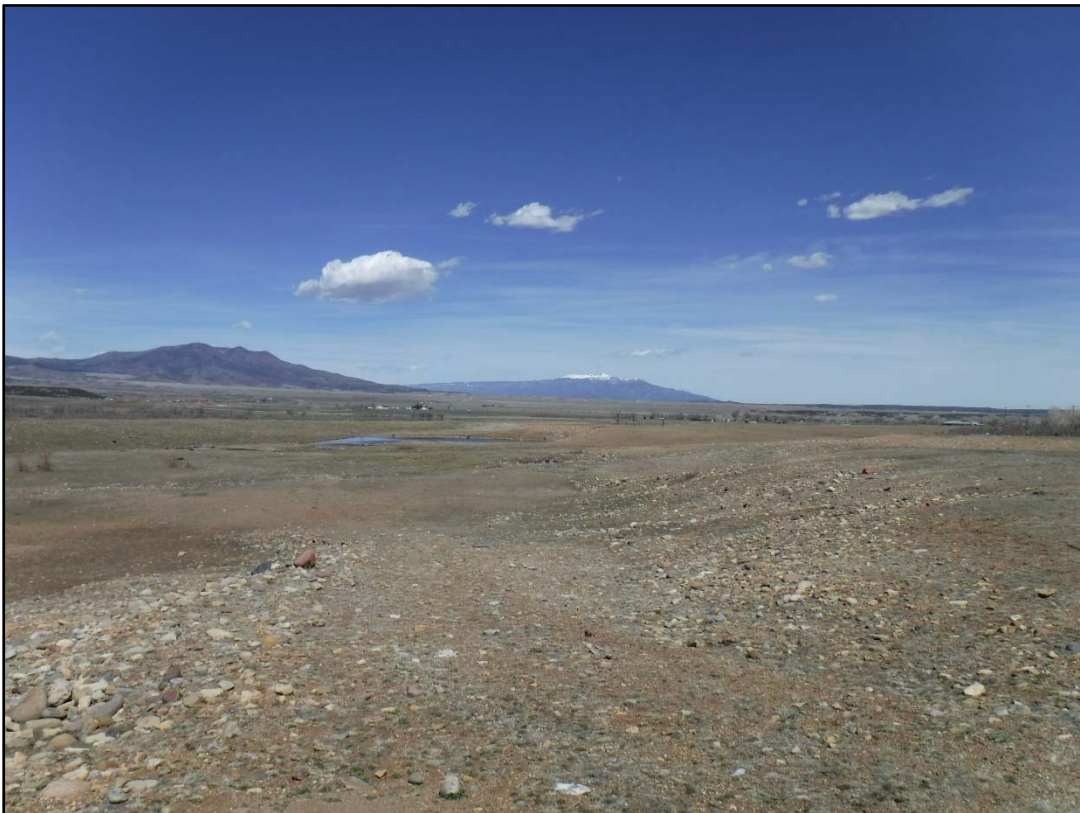
Photo 4: Looking north from the southern permit boundary

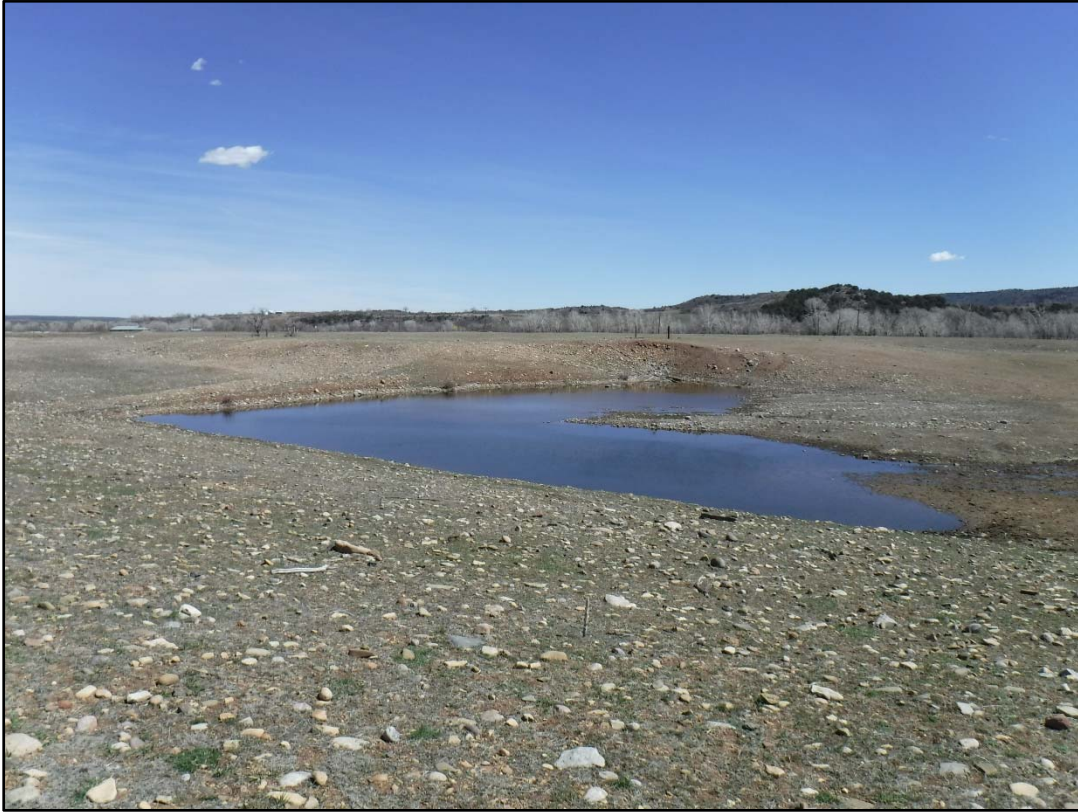
At the time of this inspection it was observed that approximately 0.45 acres of exposed groundwater and/or stormwater had been impounded at the site at the location of the berm. Prior inspections at the site had noted impounded water at the same location. The impounding of water is being cited as a problem in this inspection report. The Operator will be required to establish permanent positive drainage in the area to ensure that the water that is currently exposed is not groundwater, and backfill two feet above the current water surface level.

Photo 5: Looking east across the impounded water, area of standing water is ~0.4 acres and is about 2 feet deep

INSPECTION TOPIC: Hydrologic Balance**PROBLEM/POSSIBLE VIOLATION:** The site is improperly impounding surface drainage/runoff.**CORRECTIVE ACTIONS:** Operator shall remove impediments to proper surface drainage and backfill the area two feet above the current water surface level. Or, submit documentation from the State Engineer's Office demonstrating that the impoundment of water in this pit is authorized by that office.**CORRECTIVE ACTION DUE DATE:** 6/10/19**INSPECTION TOPIC:** Reclamation Success**PROBLEM/POSSIBLE VIOLATION:** Reclamation has not been carried to completion within five years of last mining activity at the site as required by Rule 3.1.3.**CORRECTIVE ACTIONS:** The operator shall, once all final grading is completed, seed with approved seed mixture the regraded portions of the site and suitably restrict grazing during the initial establishment. It is anticipated that final grading will not be completed until sometime in the summer so fall planting is expected. The operator shall submit documentation that seeding has been completed by the corrective action date.**CORRECTIVE ACTION DUE DATE:** 11/15/19

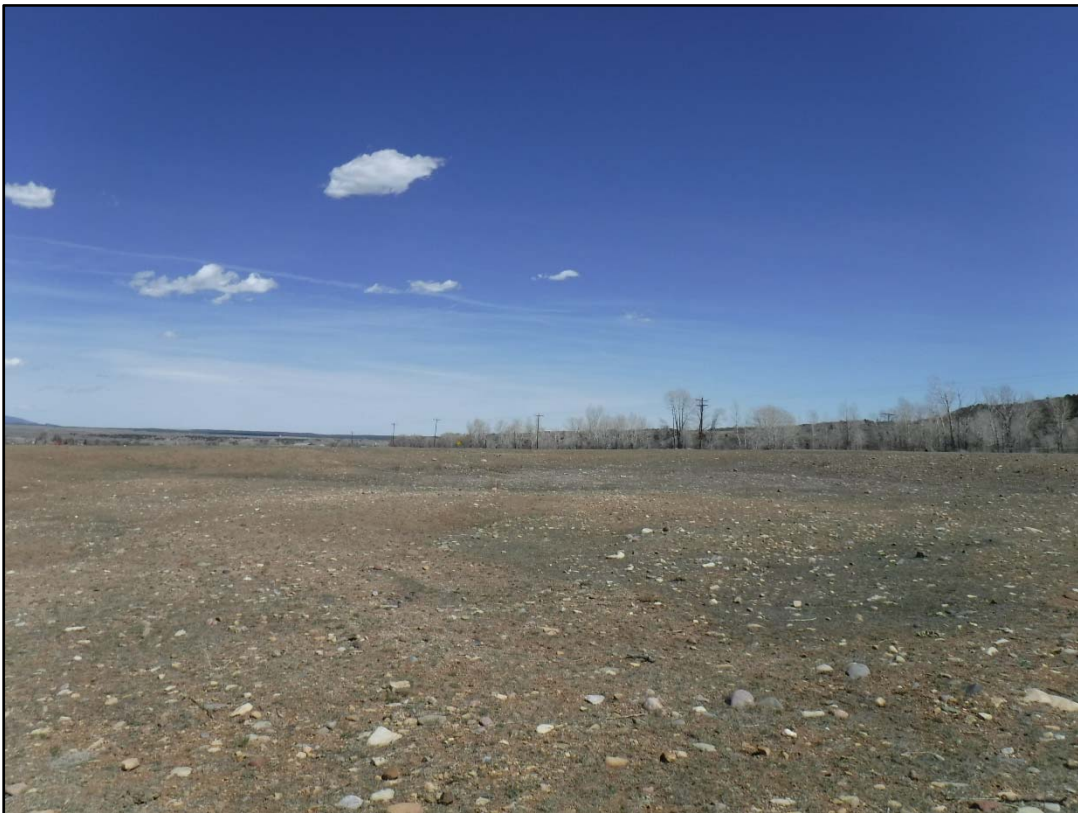
Photo 6: Conditions of the area east of the impounded water

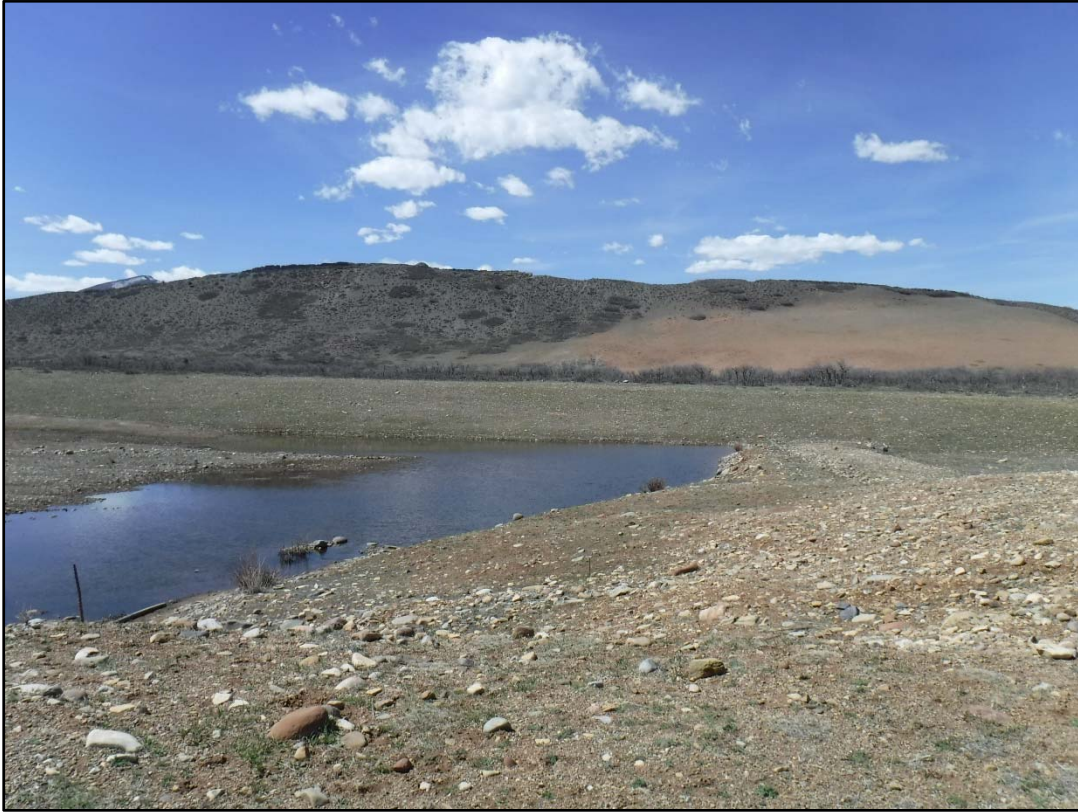
The original 7.5 acre permit area consists of a small basin where previous mining activity occurred. The basin daylighted to the south. The north, west and eastern aspect slopes have been graded to a 4:1 horizontal to vertical ratio or less. The slopes appeared stable and grass has established throughout the affected land. Lafarge operated a site directly to the north of this area known as the La Veta Pit (M- 2001 - 086). The northern boundary of the Rocky Flat Gravel Pit and the Lafarge excavation is separated by a berm. According to the Division's files the purpose of the berm was to keep water from flowing from the Rocky Flat Gravel Pit into the Lafarge site.

Photo 7: Berm that was constructed to separate the old Lafarge pit from the current pit area

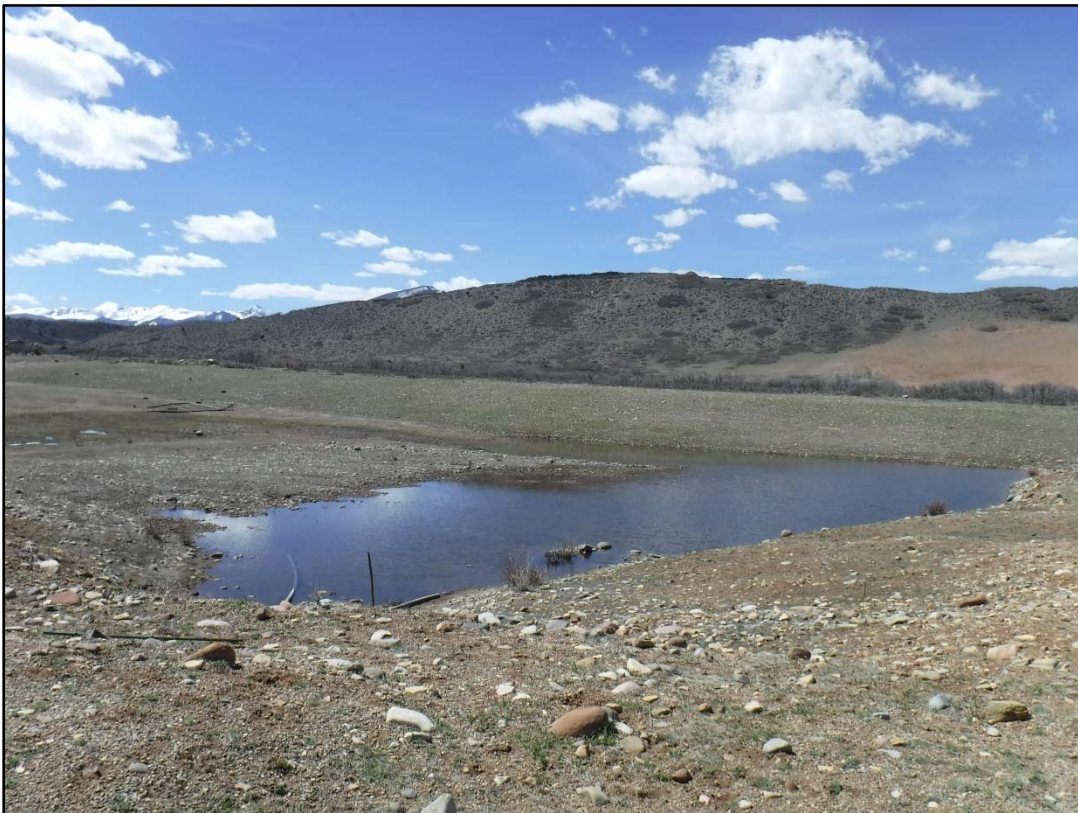
Photo 8: Looking southwest across impounded water
