MINERALS PROGRAM INSPECTION REPORT
PHONE: (303) 866-3567

MINE NAME: WSG-Sand Arroyo Pit #2	MINE/PROSPECTING ID#: M-2017-019	MINERAL: Sand and gravel	COUNTY: Huerfano
INSPECTION TYPE: Monitoring	INSPECTOR(S): Patrick Lennberg	INSP. DATE: March 28, 2019	INSP. TIME: 08:00
OPERATOR: The Walsenburg Sand and Gravel Company	OPERATOR REPRESENTATIVE: Gary Vezzani	TYPE OF OPERATION: 111 - Construction by Government Agency	
REASON FOR INSPECTION: Normal I&E Program	BOND CALCULATION TYPE: Partial Bond	BOND AMOUNT: \$30,000.00	
DATE OF COMPLAINT: NA	POST INSP. CONTACTS: None	JOINT INSP. AGENCY: None	
WEATHER: Clear	INSPECTOR'S SIGNATURE:

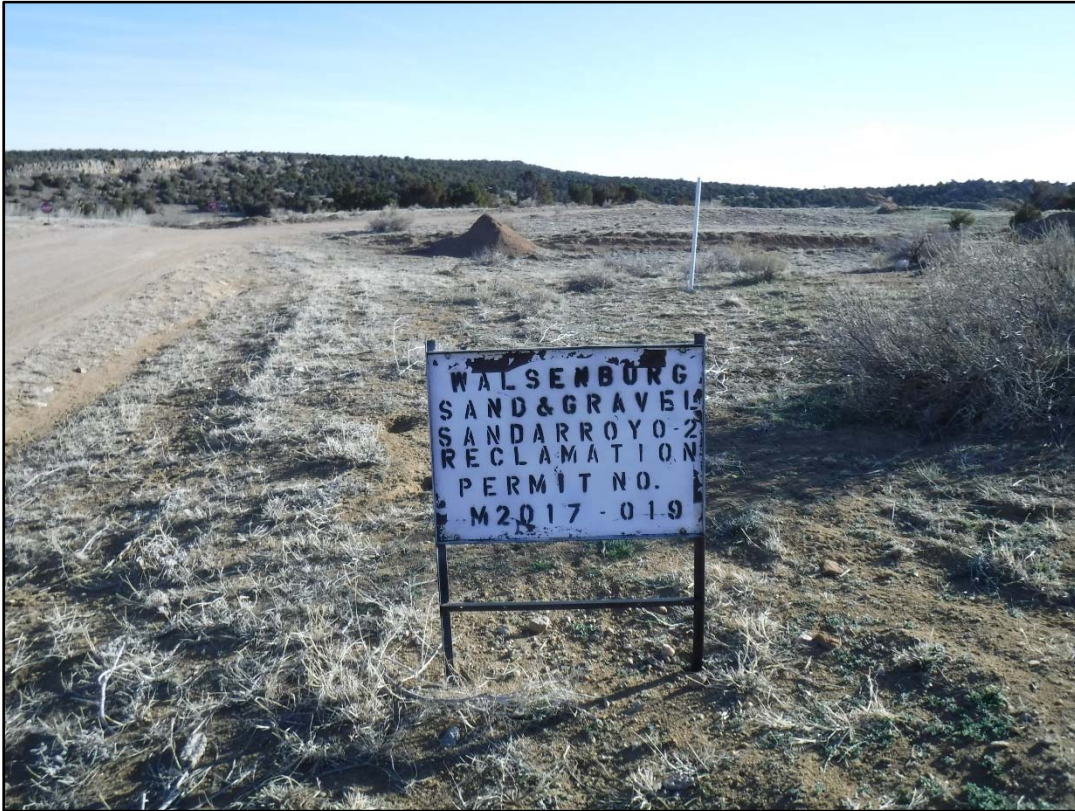
The Sand Arroyo Pit #2 is located approximately 6 miles west of Walsenburg, Colorado. The Sand Arroyo Pit #2 is a 111 permit that was permitted to support road construction on US Hwy 160. The approved permit area is 12 acres. The permit boundary shares a border with the Sand Arroyo Pit, permit M1978-283. The approved post-mining land use is rangeland. A mine sign was observed as required by Rule 3.1.12.

Photo 1: Mine sign at entrance off US Hwy 60

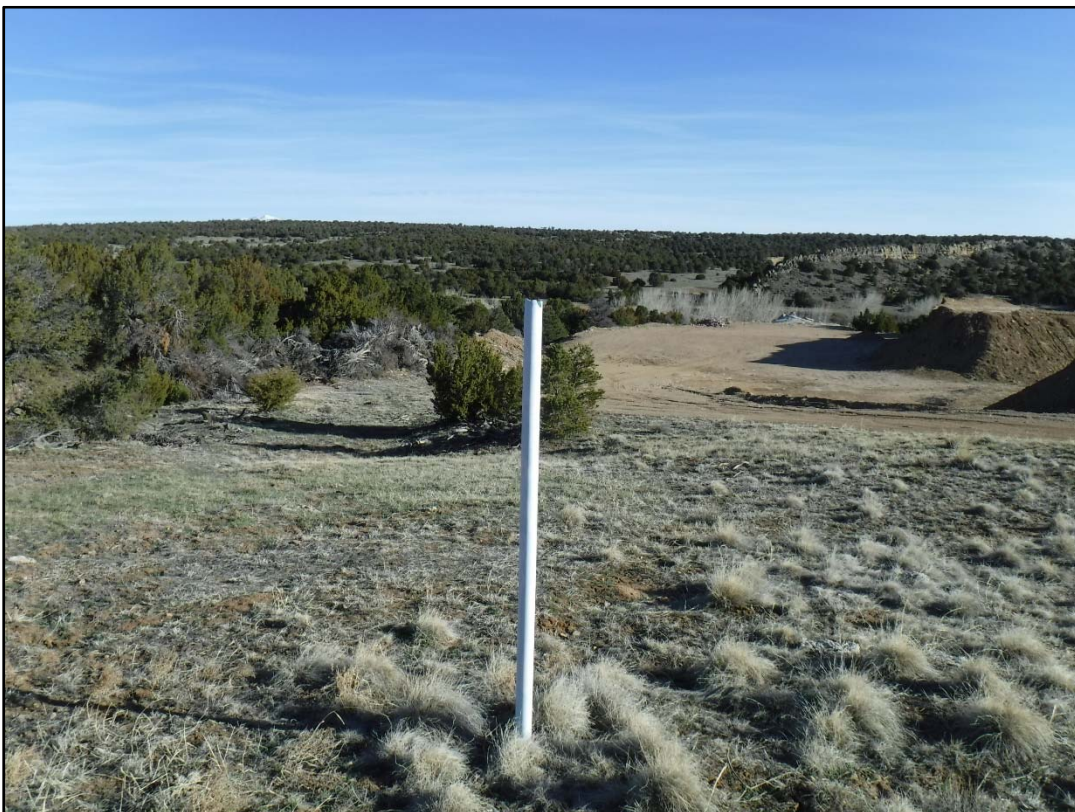
Photo 2: Typical boundary marker

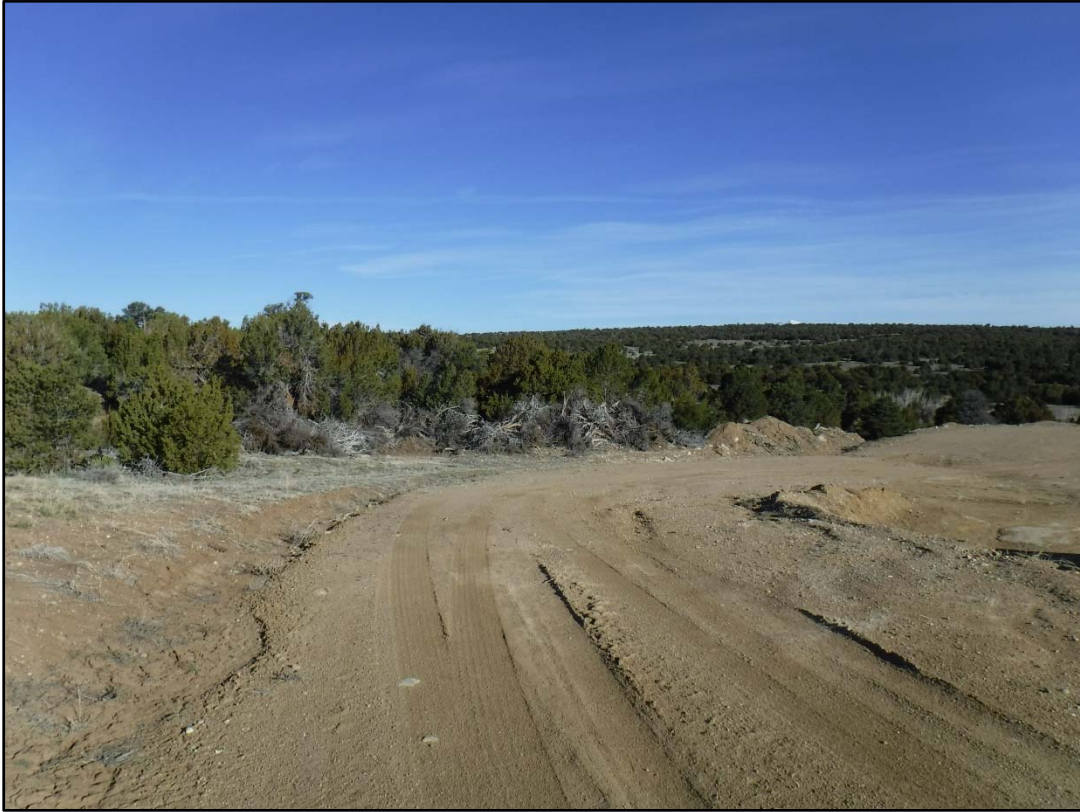
Photo 3: Haul road leading to pit, topsoil pile center right of picture.

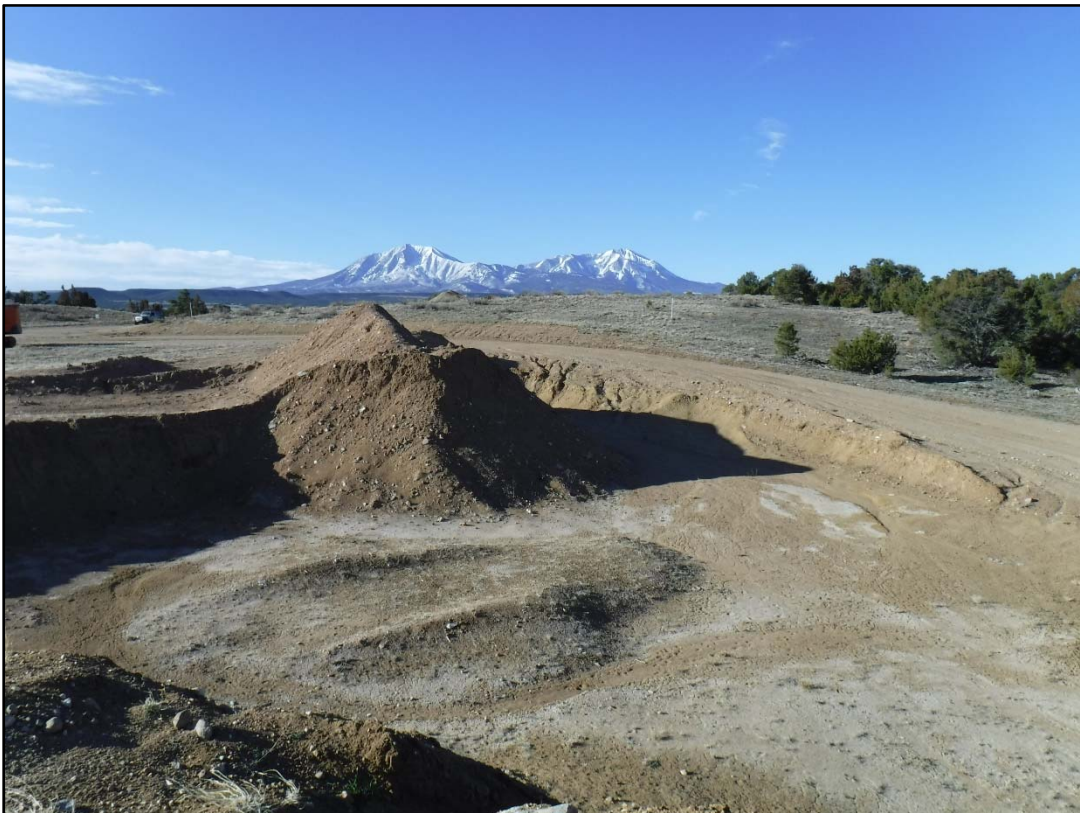
Photo 4: Mine pit area with a small processed stockpile.

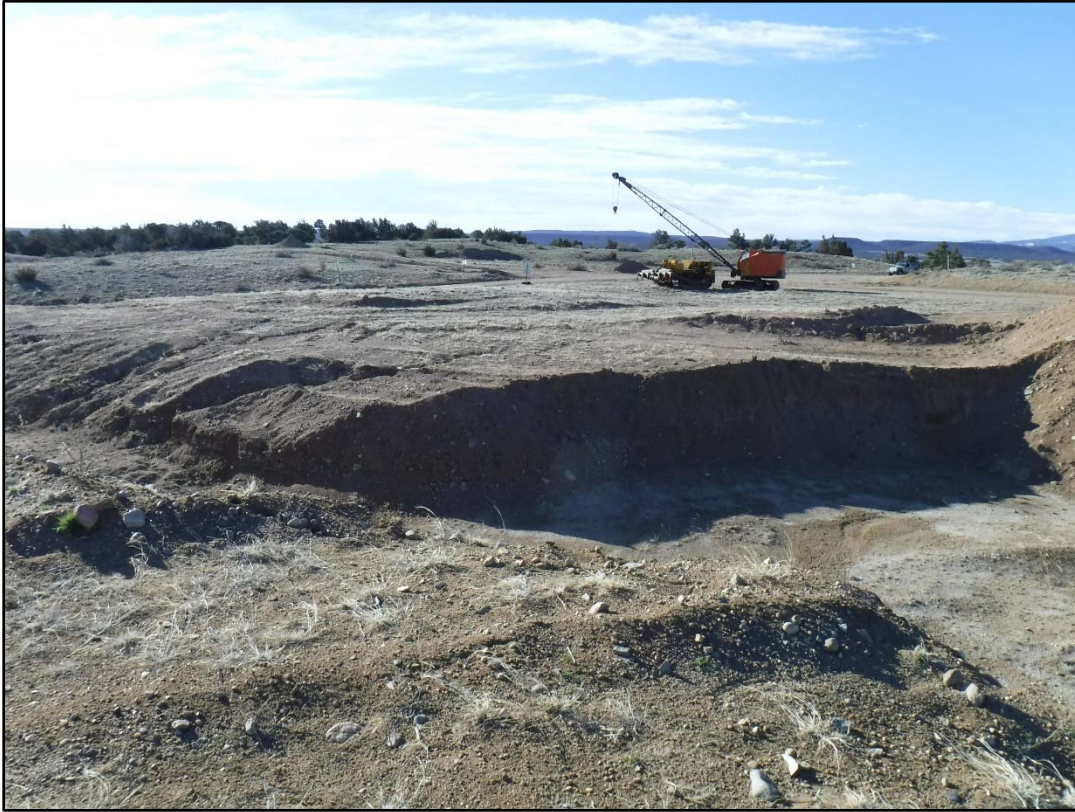
Photo 5: Typical highwall within the mined area.

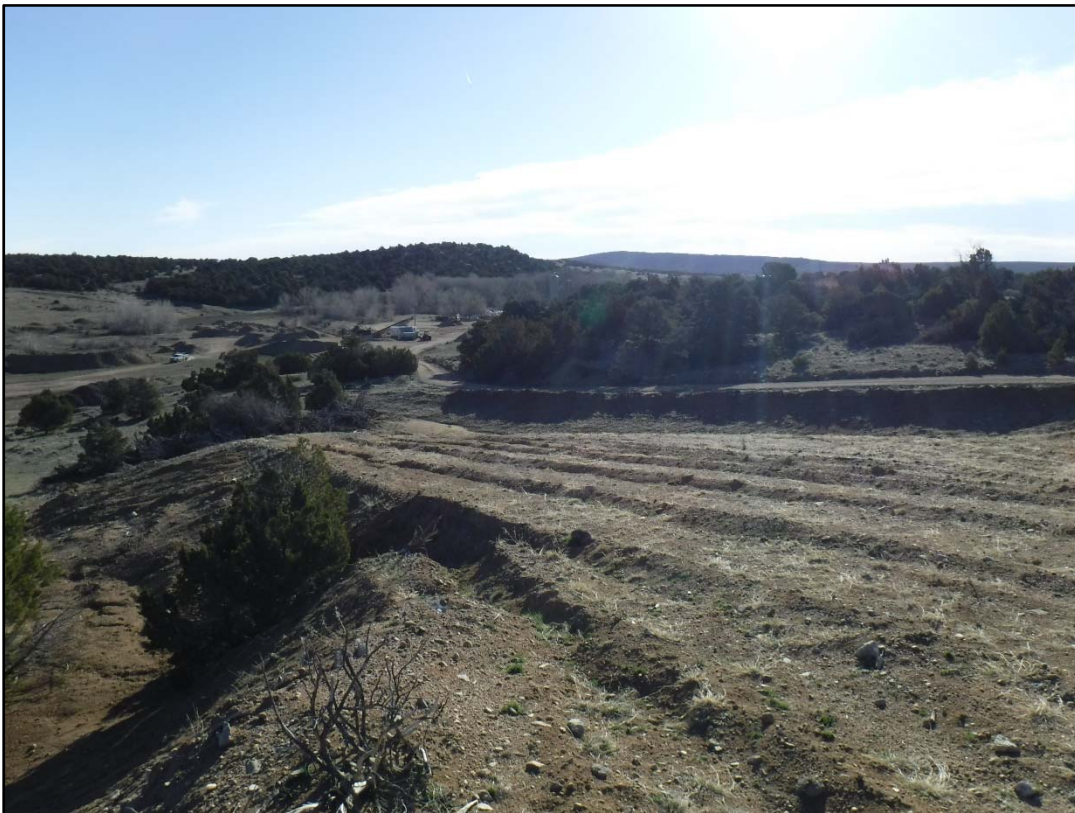
Photo 6: Some material that was processed and then blended into surrounding topography.
