MINERALS PROGRAM INSPECTION REPORT
PHONE: (303) 866-3567

MINE NAME: Ridley Pit	MINE/PROSPECTING ID#: M-2005-039	MINERAL: Sand and gravel	COUNTY: Bent
INSPECTION TYPE: Monitoring	INSPECTOR(S): Amy Eschberger	INSP. DATE: March 7, 2019	INSP. TIME: 12:45
OPERATOR: Bent County	OPERATOR REPRESENTATIVE: Robert Darnell	TYPE OF OPERATION: 112c - Construction Regular Operation	
REASON FOR INSPECTION: Normal I&E Program	BOND CALCULATION TYPE: None	BOND AMOUNT: \$0.00	
DATE OF COMPLAINT: NA	POST INSP. CONTACTS: None	JOINT INSP. AGENCY: None	
WEATHER: Clear	INSPECTOR'S SIGNATURE:

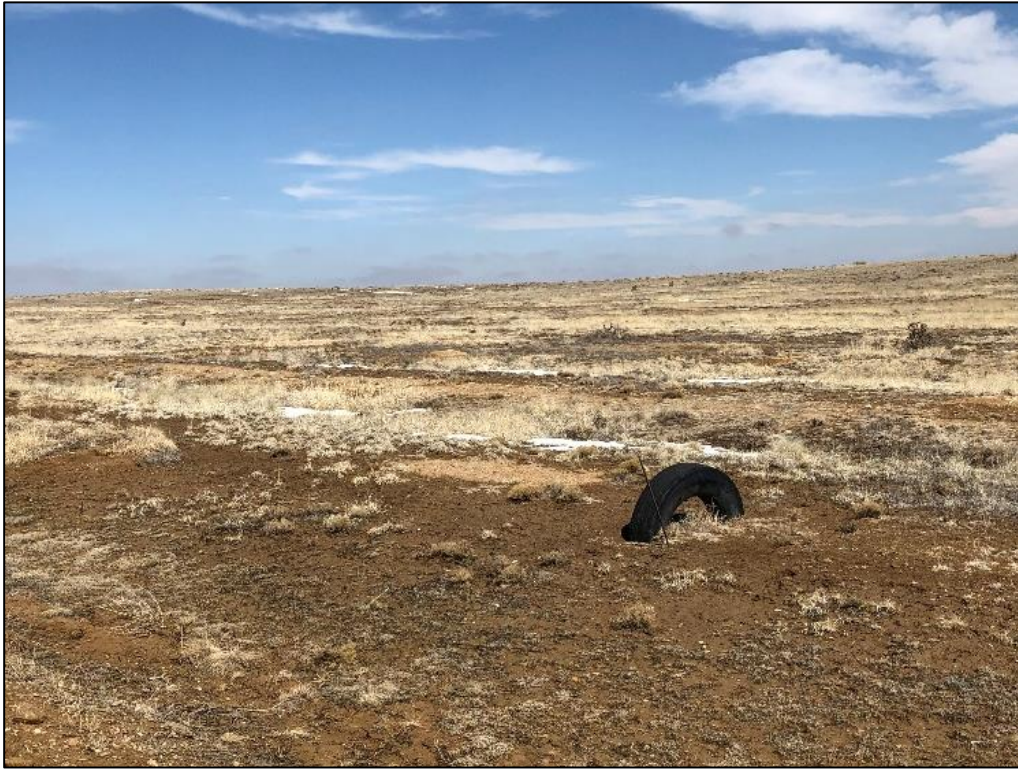
The site was not active during the inspection. The operation was approved for intermittent status in 2013 to operate for less than 180 days per year. According to the operator, recent activities have primarily included hauling off from stockpiled material. A permit sign was posted at the main site entrance off of Co Rd 16. The corners of the permit boundary were marked with T-posts and half-buried tires. However, a corner marker could not be located at the far southwestern corner. While the southern boundary in this area is delineated by a barbed wire fence, the operator should place a marker at the southwestern corner to better delineate the western boundary. This is especially important given the edge of the active pit is very close to the western boundary.

Photo 1. View looking east from Co Rd 16, showing southern corner of permit boundary marked by T-post and half-buried tire.

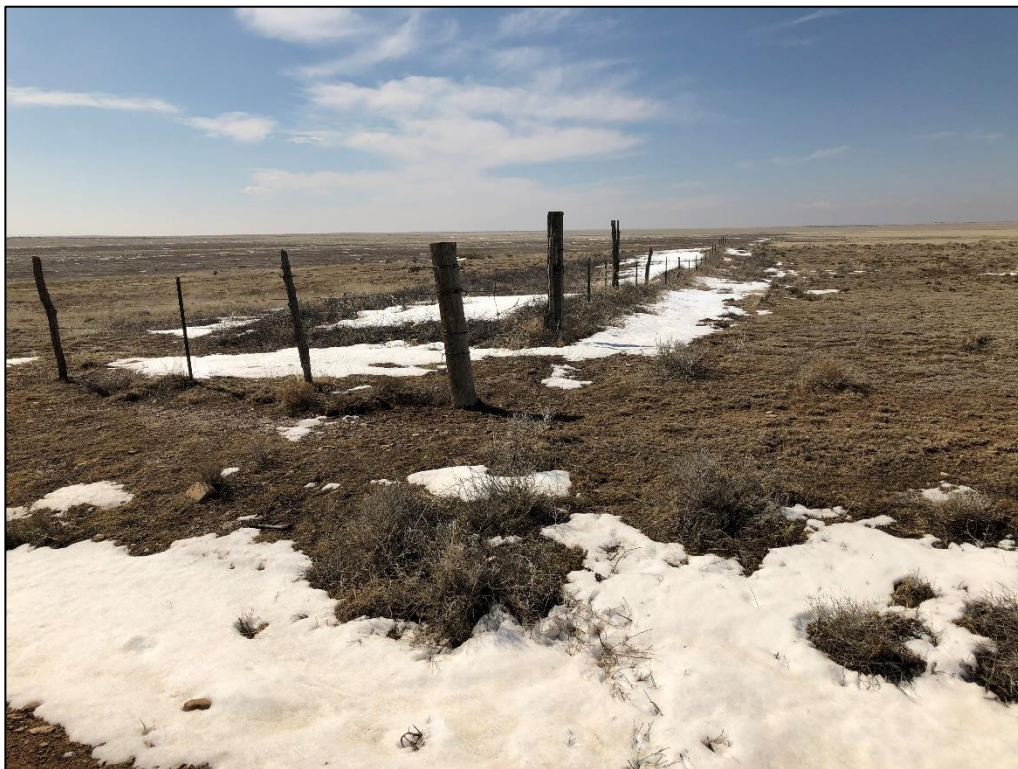
Photo 2. View looking west from Co Rd 16, showing barbed wire fence marking southern permit boundary west of the road.

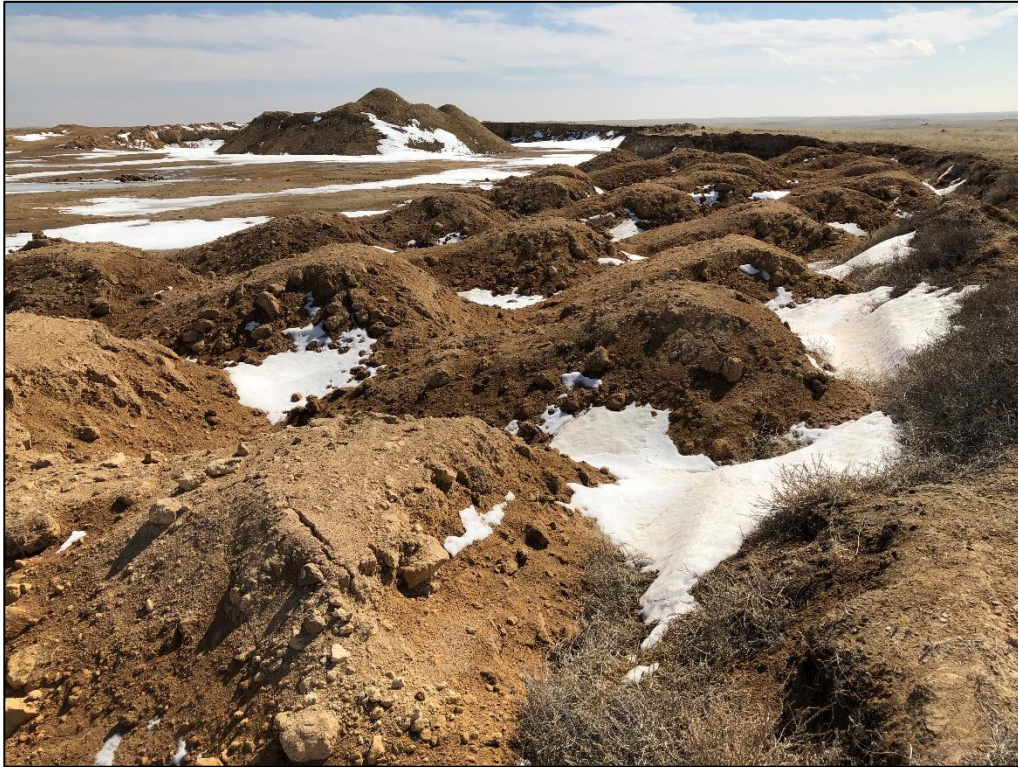
The active pit located west of Co Rd 16 is approximately 10 feet deep at its south/southeast edge, and shallower at its north edge due to the site topography. The highwall is approximately 700 feet in linear length with slopes ranging from near vertical to 2H:1V. Several material stockpiles are stored on the pit floor. Salvaged topsoil is stored at the edges of the pit. Mr. Darnell indicated the operation plans to expand the pit to the south, and will then expand the pit to the east (through the existing Co Rd 16). The Division estimates the active pit disturbance to cover 8.8 acres.

Photo 3. View looking south across western edge of active pit. Material shown in foreground will be used to backfill this slope for reclamation.

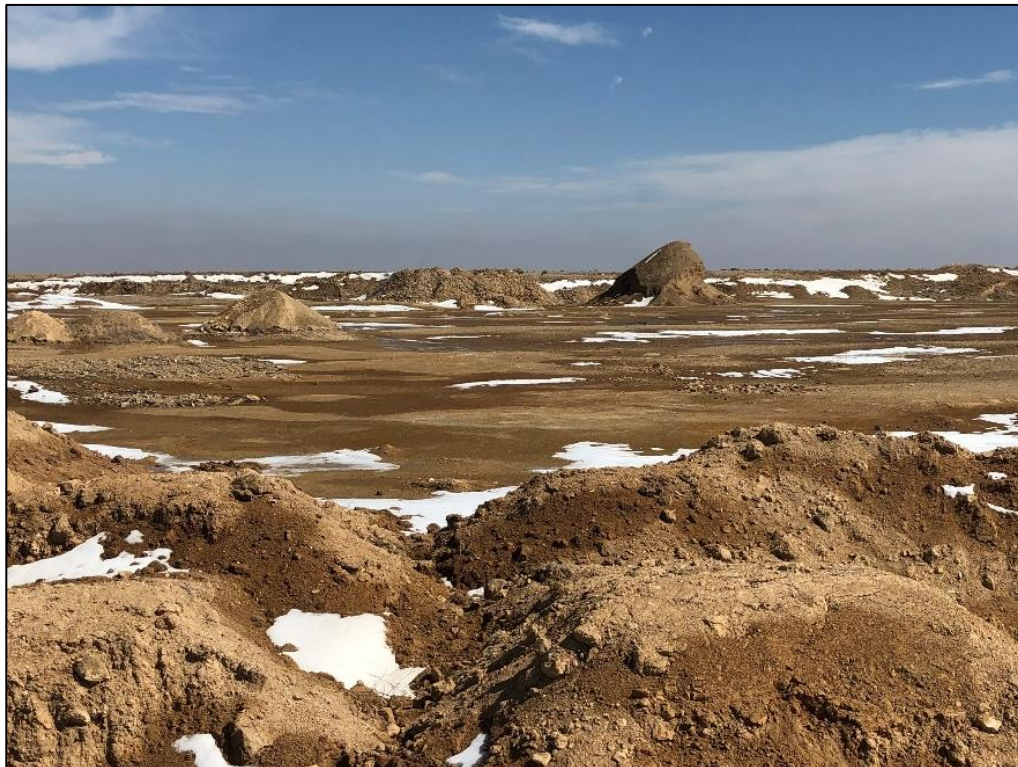
Photo 4. View looking east across active pit from its western edge. Note several material stockpiles stored on pit floor.

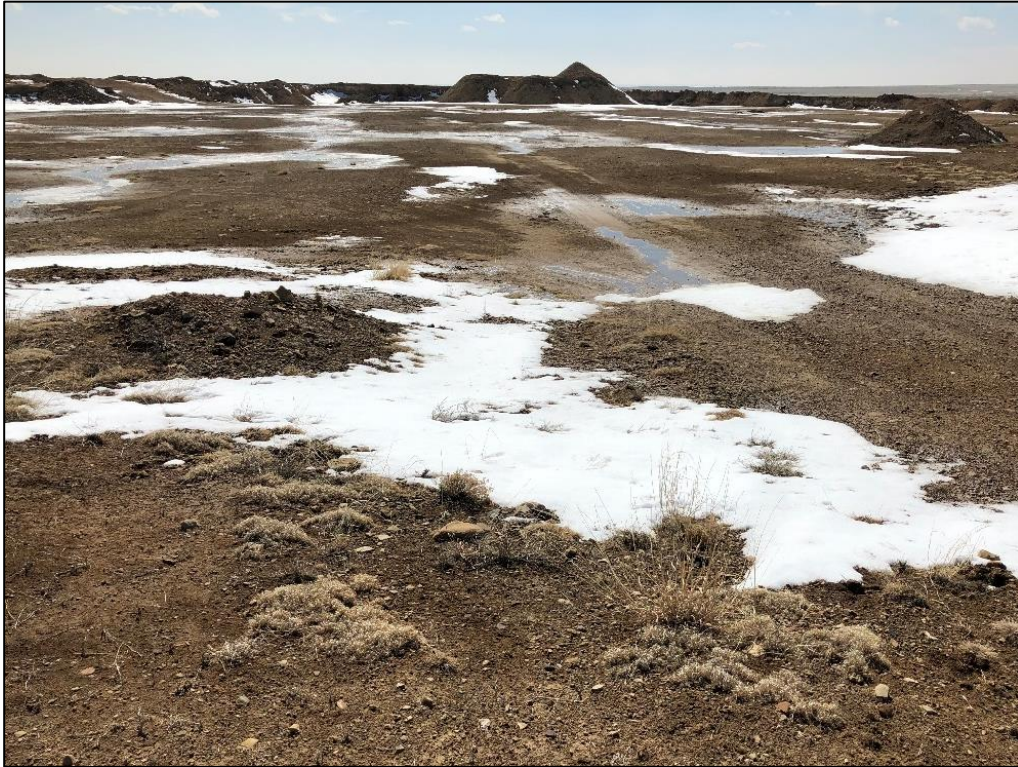
Photo 5. View looking southwest across active pit from its northern edge.

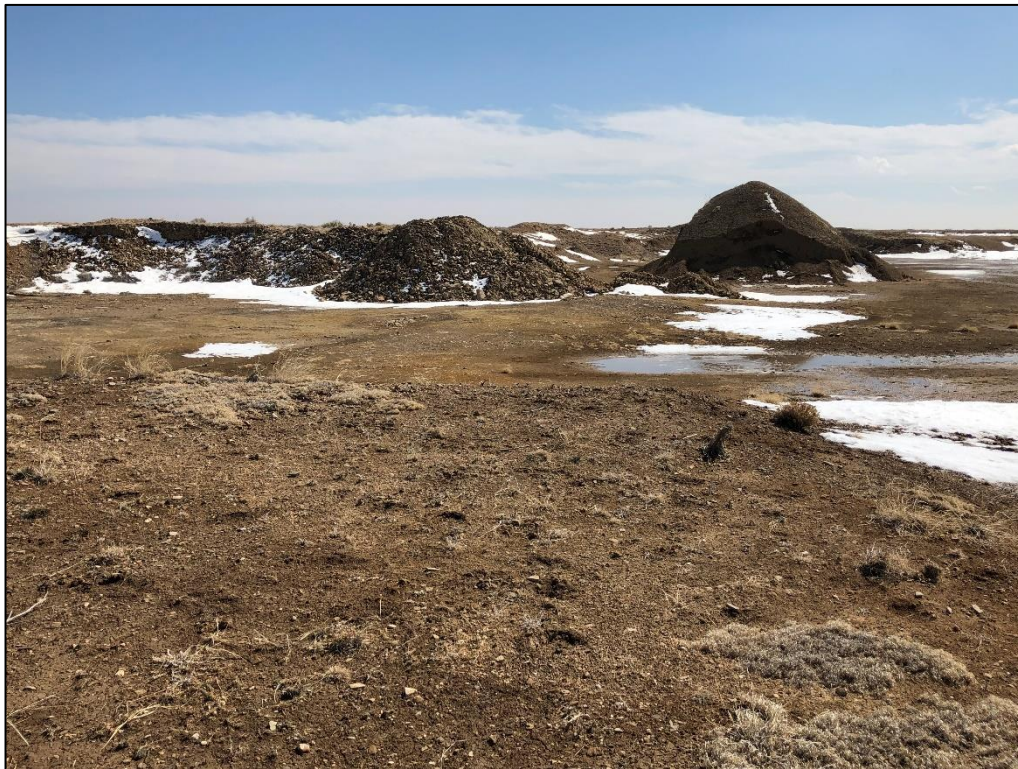
Photo 6. View looking east across active pit from its northern edge. Note material stockpiles stored on pit floor.

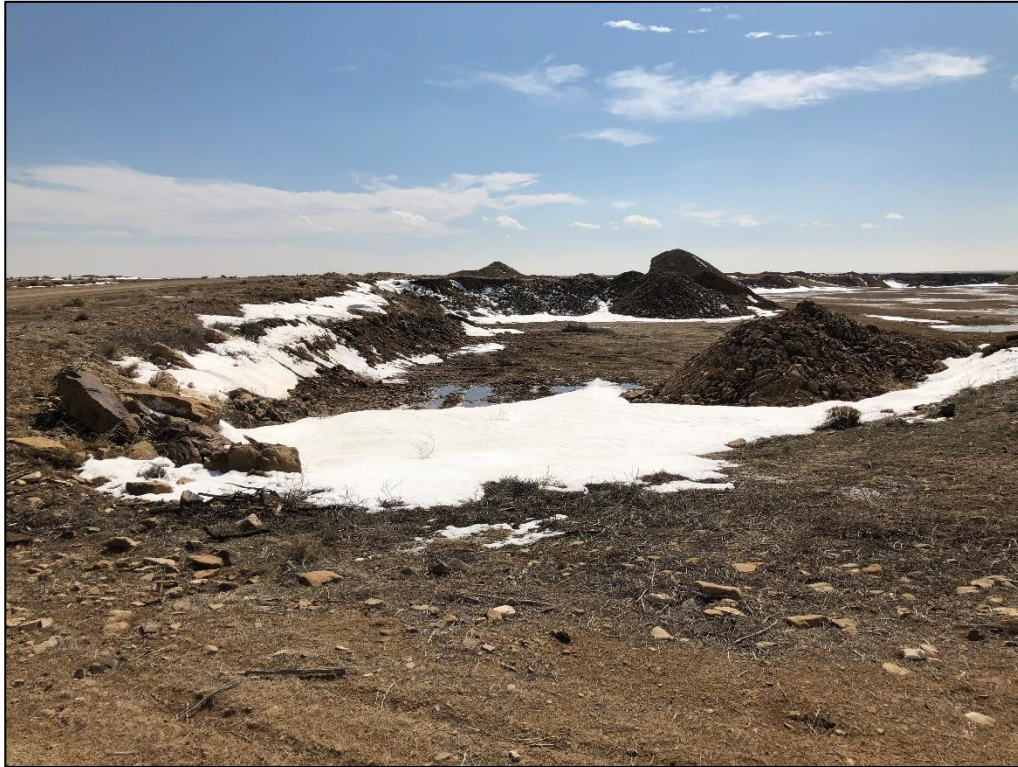
Photo 7. View looking south across eastern pit wall, which is approximately 5 feet in height in this portion of the pit.

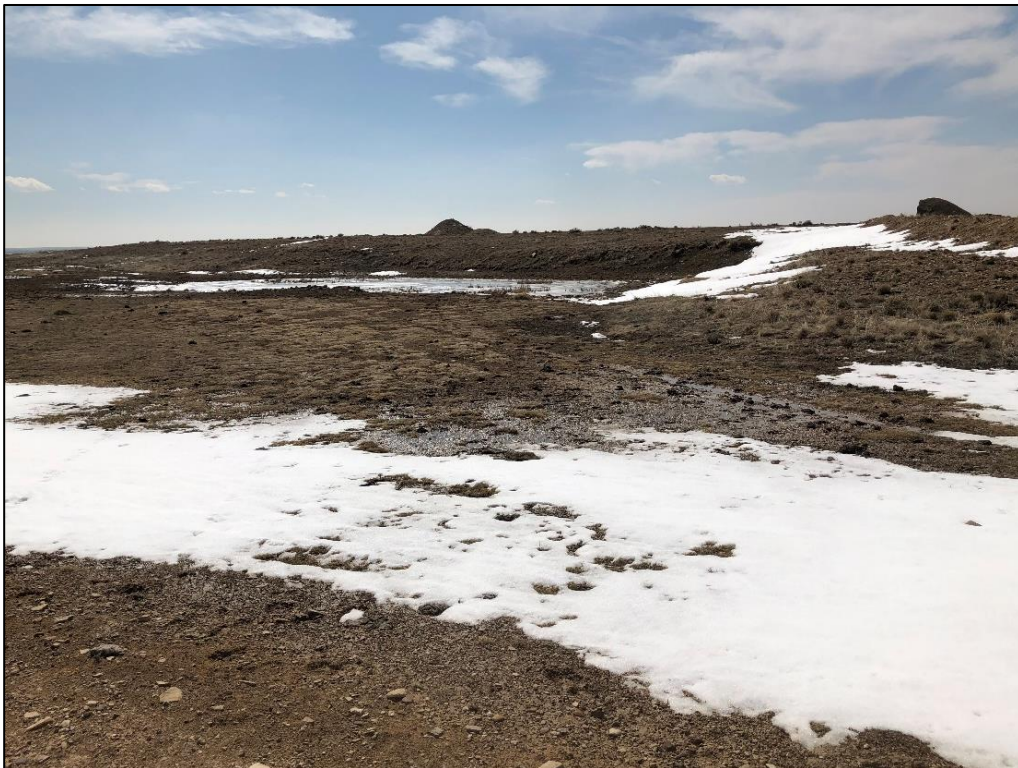
The disturbed areas to the east of Co Rd 16 (approximately 13.5 acres) are in reclamation, and the operation has no plans to continue mining on this side of the road. However, the areas directly adjacent to Co Rd 16 will be re-disturbed when the operation mines under the road. All slopes in this area have been graded to 3H:1V or flatter, and the land retopsoiled and seeded. Vegetative cover of these areas consists of native grasses, forbs, and some shrubs. The pre-law disturbances at the southeastern edge of the permit area were never disturbed by this operation, and have mostly self-reclaimed.

Photo 8. View looking southwest across western edge of reclaimed pit located just east of Co Rd 16. Portions of this area adjacent to the road will be re-disturbed when the operation mines under the road.

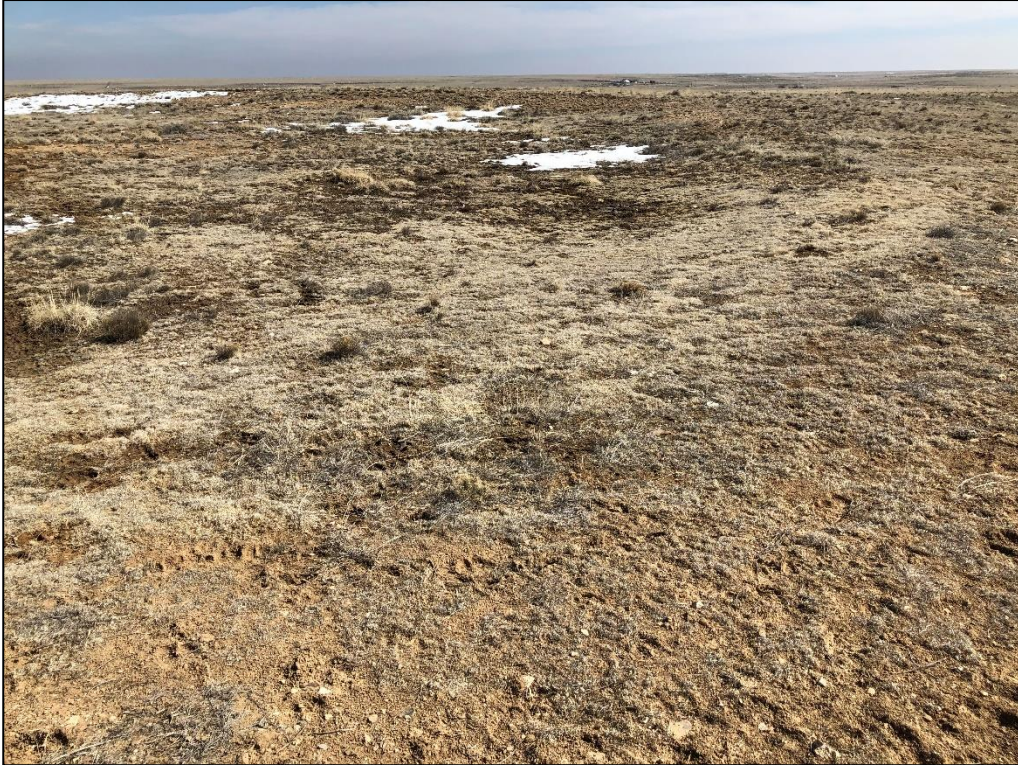
Photo 9. View looking east across reclaimed pit located east of Co Rd 16.

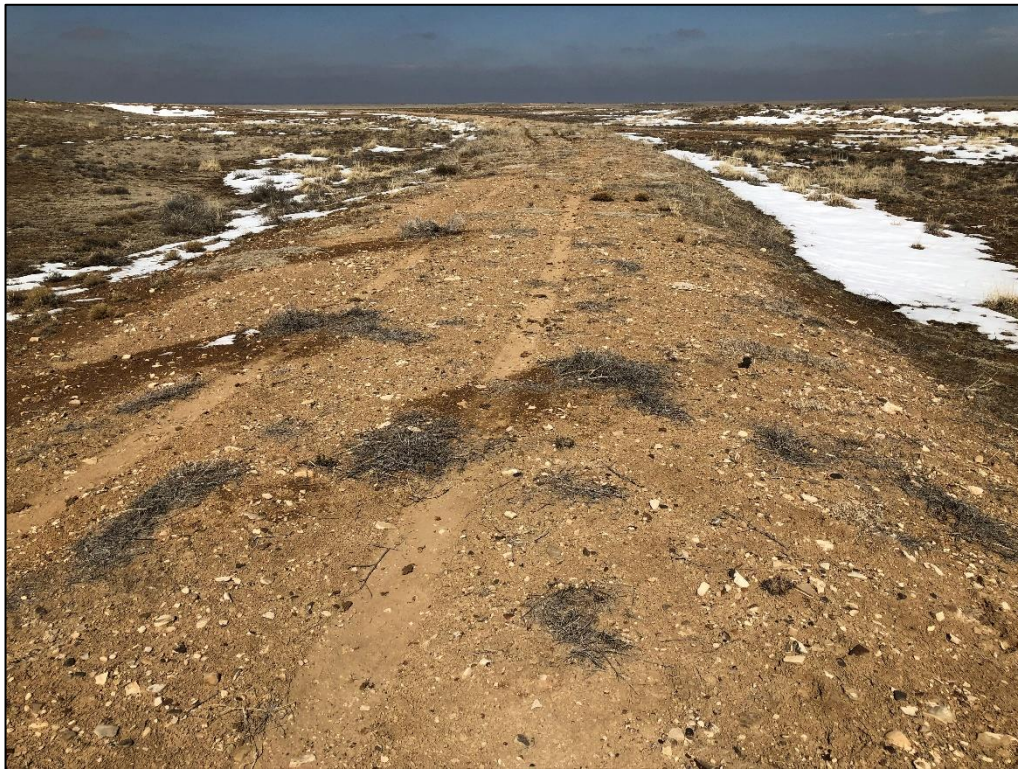
Photo 10. View looking north across dirt road constructed across reclaimed area located east of Co Rd 16. This is where a segment of Co Rd 16 will be relocated when the operation mines under the existing road.

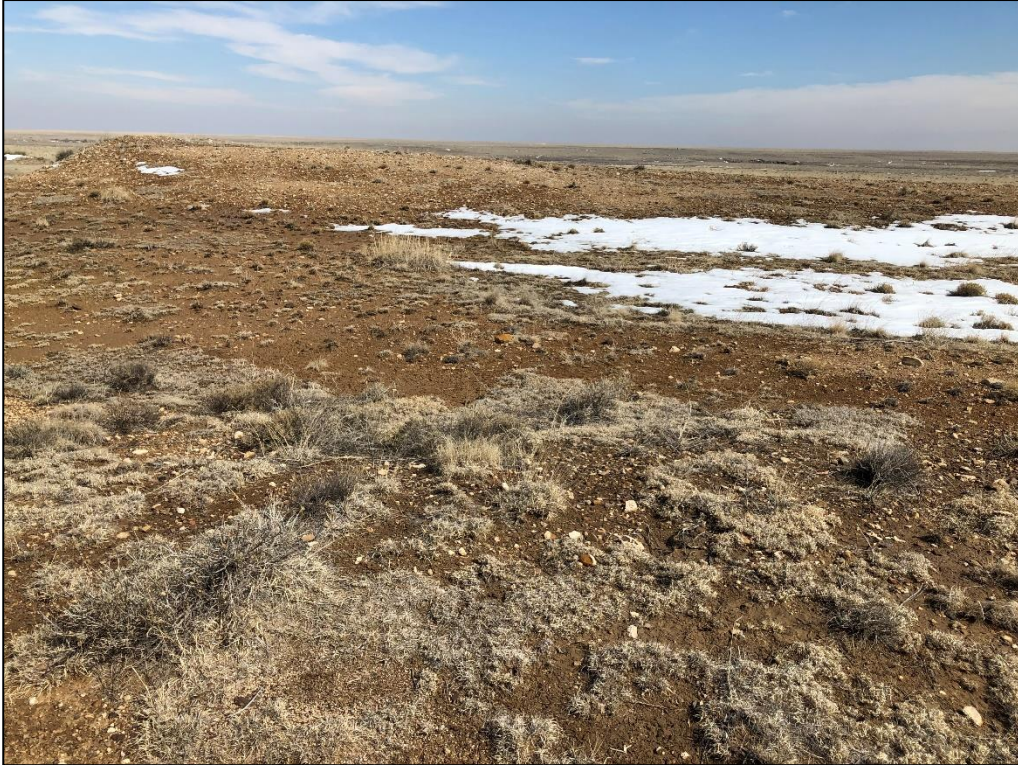
Photo 11. View looking east across northern portion of reclaimed pit disturbance located east of Co Rd 16.

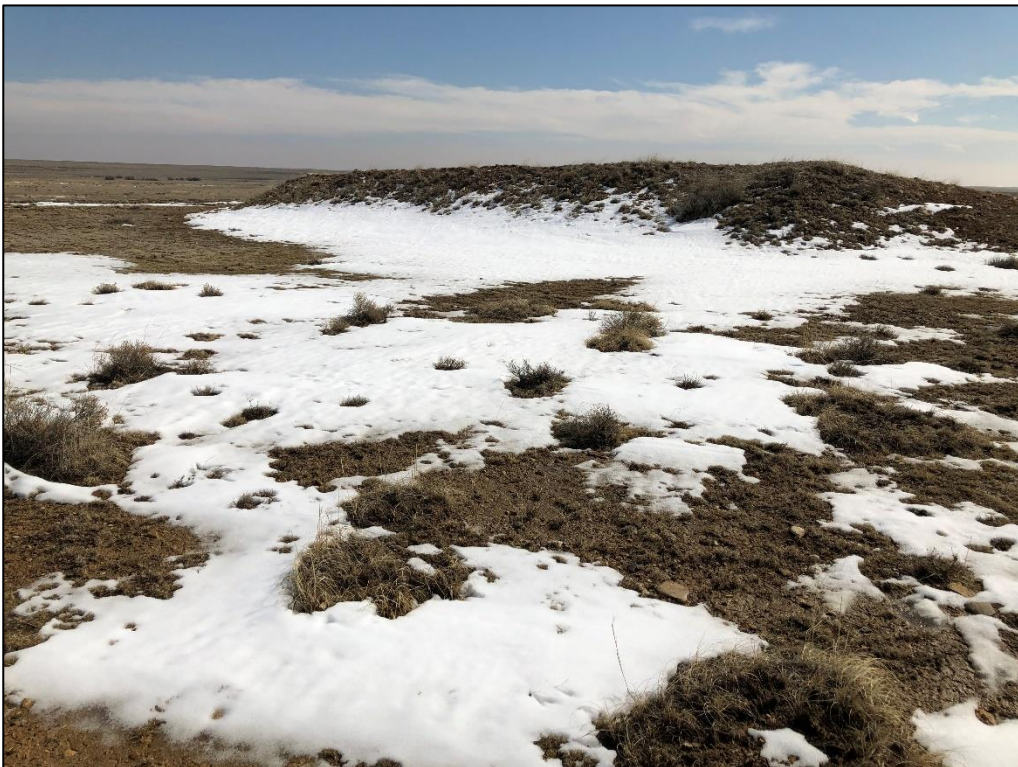
Photo 12. View looking southeast across northern portion of reclaimed pit disturbance located east of Co Rd 16.
